Learning from Earthquakes

Preliminary Observations on the Tokachi-Oki, Japan, Earthquake of September 26, 2003

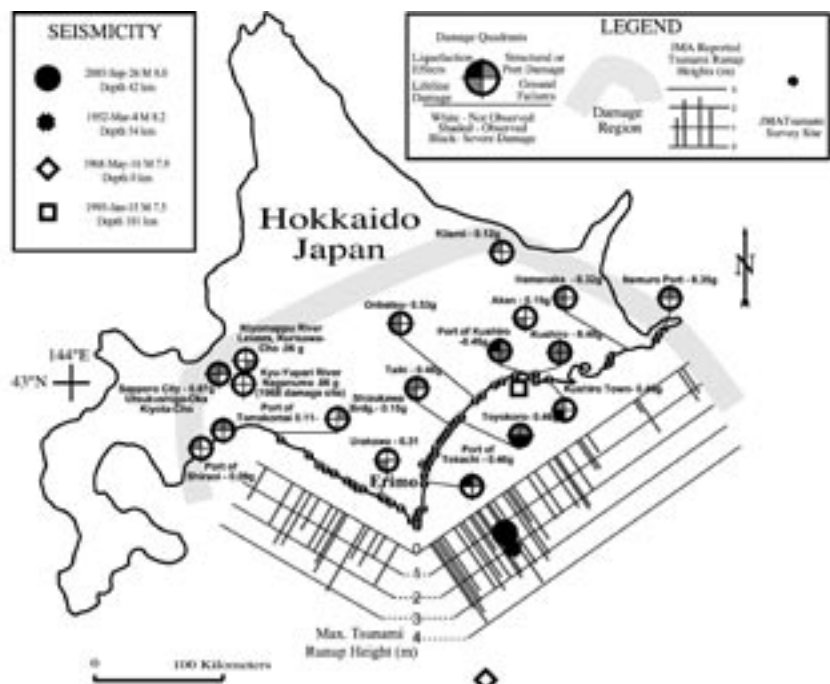
Accelerations recorded by seismic networks of Hokkaido indicate a region of high-intensity motion from the Hiroo area to Kushiro City, with PGA values in the range of 0.35 to 0.6g (Figure 1). The highest PGA (1.0g) is

an apparently anomalous recording at the Hiroo City Hall, behind the bluff overlooking the nearby Port of Tokachi (~0.45 g). Acceleration response spectra for Hiroo and Tomakomai are presented in Figure 2.

Figure 1. Observed effects of the earthquake. Peak ground accelerations and tsunami wave run-up heights as reported by JMA, PARI, and other organizations.

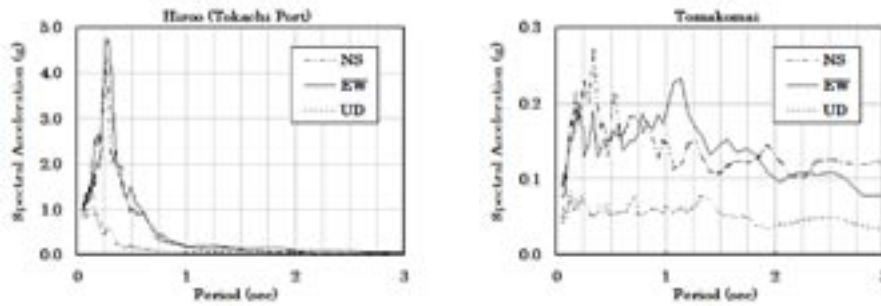
Figures 2a and b. Acceleration response spectra for ground motions recorded at (a) Hiroo at 5% damping, and (b) Tomakomai at 5% damping.

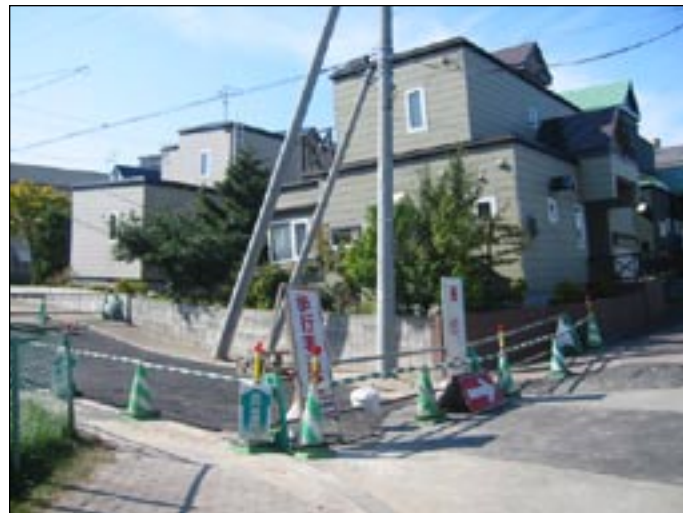
Sapporo, located approximately 200 km from the epicenter, had a recorded PGA of 0.07g. The team observed one isolated incident of liquefaction in the Utsukushigaoka suburb of southern Sapporo. Several sand boils were observed in the area, a low spot in the surrounding neighborhood. Seven houses were damaged from settlement, with the most severely damaged tilted up to 2.5 degrees (Figure 3). Liquefaction and structural damage were also observed in Sapporo after the 1968 Tokachi-Oki earthquake. The team visited sites where liquefaction had occurred in the 1968 earthquake, specifically in the Nishi-Naganuma area between the Ebetsu and Yubari

Figure 3. Settlement in the Utsukushigaoka suburb of southern Sapporo.

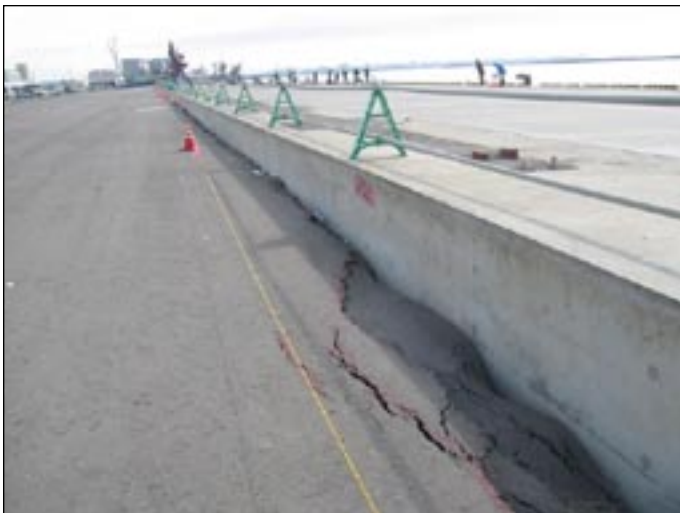
Figure 4.
Pier 4, Port of Kushiro.

Pier 4 was the most heavily damaged, with lateral movements of the 14 m-deep quay wall of approximately 10 cm, and settlements behind the wall from 60 to 100 cm (Figure 4). Sand boils were observed in an open area approxi-

mately 30 m from the wall behind a paved area. The paved area was underlain by mixed soil-cement, and it may be that settlement of rubble-fill beneath the soil-cement mixture, rather than liquefaction, was the cause of the observed damage. Directly adjacent to Pier 4 was a well-instrumented quay wall test section to study the behavior of improved and unimproved ground. The 130 channels of data acquisition, including pore pressure transducers and downhole accelerometers, should provide a wealth of new information for researchers.

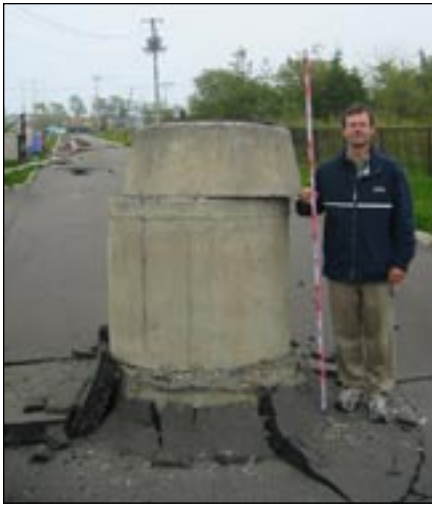
By far, the most widespread damage to lifelines was to the storm and sanitary sewer systems. Significant uplift of manholes was reported from Urakawa in the west to Hamanaka in the east. The team observed uplifts as high as 2 m in Otsu (Figure 5) and dozens as high as 1.5 m in a single subdivision of Shintoyo-Cho, immediately east of Kushiro City. In all cases, the uplift appeared to be related to liquefaction of the pipeline backfill material, and damage was aligned with the layout of the pipe network. Many sanitary sewers had been repaired by the time the team came through.

Figure 5. Uplifted manhole near sewage treatment facility in Otsu.

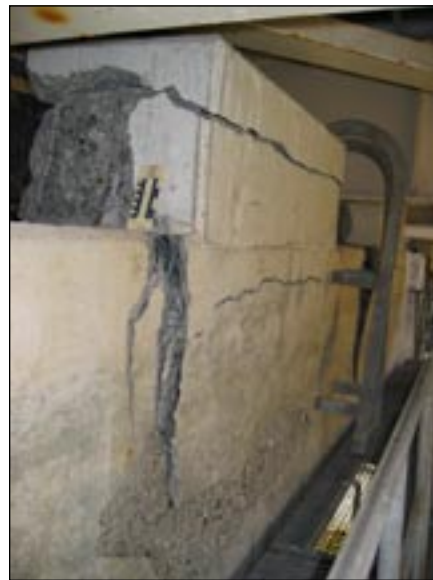
Northeast of Hiroo, there was damage to two bridges. In the Tomakomai area, the ground motion was just over 0.1g, but it was of long duration and dominantly long period motion. On the Shizukawa Bridge, the relative movement between the abutments and first piers resulted in significant damage to the shear keys (Figure 6), possibly as a result of pounding. Even so, the bridge did not collapse and was still in service. In no case was damage observed in the columns or at the foundation level, but it was concentrated at the pier-superstructure connection. This appeared to be the result of excessive relative displacement, either transverse or longitudinal, depending on the bridge.

Figure 6. Damaged shear key from the Shizukawa Bridge near Tomakomai City.

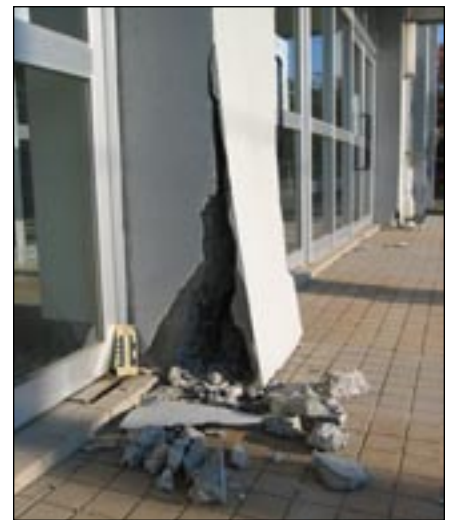
way collapsed after the two columns supporting it failed. The windowed roof observatory of the Taiki Town Hall collapsed as a result of strong shaking. In both cases, no other damage was reported in the main structures. Other buildings were damaged by excessive settlement, for example, the Urakawa Elementary School, where concrete spalled on columns after the entrance settled (Figure 7). The airport at Kushiro was closed for one day due to the collapse of the nonstructural hanging ceilings in the control tower and terminal building.

Figure 7. Damage to Urakawa Elementary School.
