Learning from Earthquakes

Preliminary Observations on the November 3, 2002 Denali Fault, Alaska, Earthquake

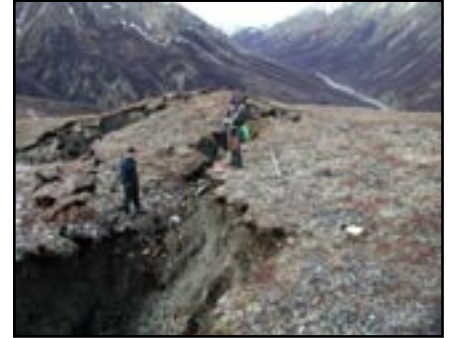
Figure 1 - Surface trace of Denali fault, 3 km west

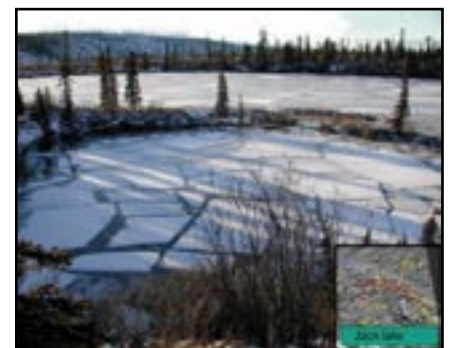
In addition to the liquefaction observations, lake-ice cracking supported directivity effects on ground motion. Many lakes dot the region and were for the most part frozen at the time of the earthquake. Cracking of the surface ice due to ground shaking (figure 7) was prevalent over the entire region. Cracked lake ice was observed within 30-40 km of the fault along the western portion of the rupture, whereas the affected region was much larger toward the east where lake ice cracking extended out to approximately 100 km from the fault.

Figure 7 -
Lake ice cracking close to
Denali and Totschunda faults

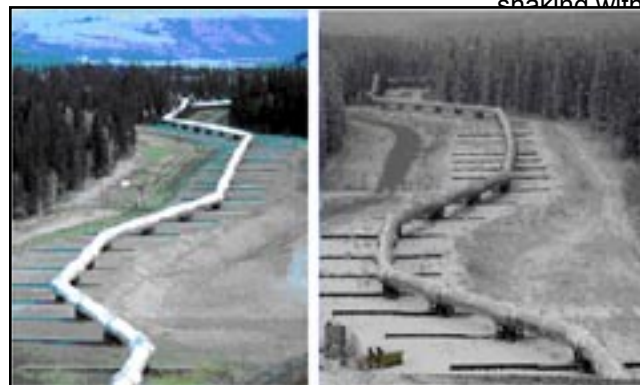
(TAPS) Performance: Design-level earthquakes rarely occur during the lifetime of a project, but this earthquake approached design criteria for a section of the pipeline system. TAPS was designed to accommodate the severe natural hazard environment of Alaska, including the presence of permafrost and the effects of great earthquakes. The 1287-km-long (800-mile) pipeline is placed above-ground for 676 km (53%) of its route to avoid locations of unstable permafrost. This unique pipeline design accommodates 6.1 m (20 feet) of horizontal and 1.5 m (5 feet) of vertical fault displacement at the fault crossing, using extra-long cross beams placed on the ground and extra-long sliding shoes (figure 9).

Figure 9 - Pipeline location pre-earthquake (left) and post-earthquake (right)

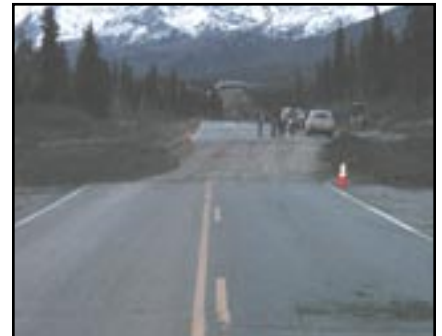
The Richardson Highway suffered cracking and slumping damage at several locations between MP 197 and 216.7. Approximately 2200 feet of the roadway at MP 216.3—where the Denali fault crosses the road—were completely destroyed as the ground slumped and cracked on the grade south of the bridge. There was a lateral shift of about 8 feet, with the south side finishing 2 feet lower than the north side. The cracking and slumping was confined to about 600 feet, but realignment of the roadway tangent between curves will be required to correct the lateral offset (figure 12).

Figure 12 - Fault offset on Richardson Highway

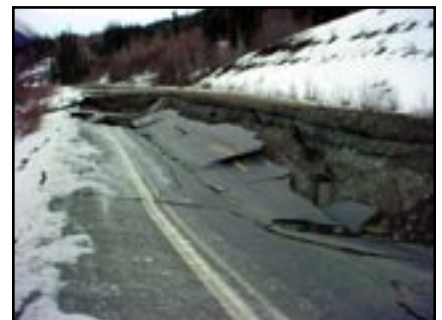
On the Tok Cutoff between MP 44 and MP 98, the most significant damage occurred near the Slana Slough bridge (at MP 75.5 to MP 77.2) and where the Denali Fault crosses the highway (at MP 80.2 and 82.6). The roadway was essentially destroyed in those areas (figure 13), requiring extensive work by state maintenance forces to open a lane through the damage.

Figure 13 - Liquefaction-induced lateral spreading on Tok Cutoff

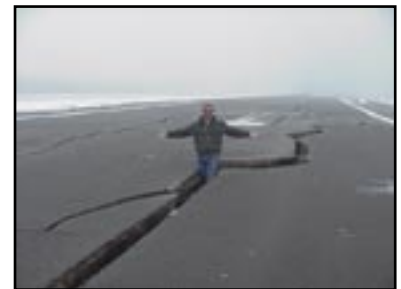
Figure 16 - Cracks in runway

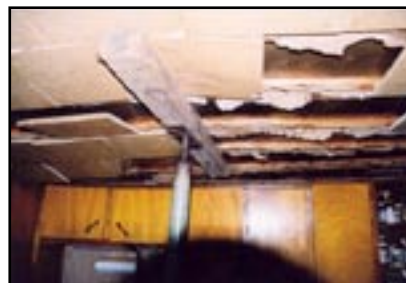
Figure 20 - Mentasta interior damage

There was major damage at the Mentasta Lodge, estimated at \$500,000, and also a partial collapse of a historic log structure at Gakona Lodge (figures 19 and 20).
