Learning from Earthquakes

Preliminary Observations on the November 3, 2002 Denali Fault, Alaska, Earthquake

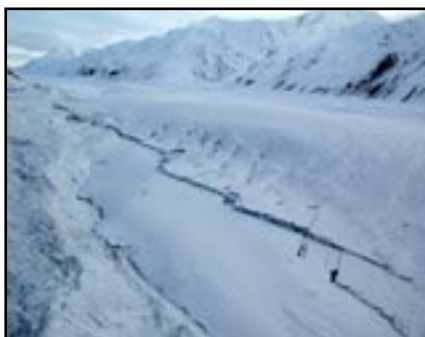
Figure 3 - Canwell Glacier showing trace of Denali Fault in glacier ice

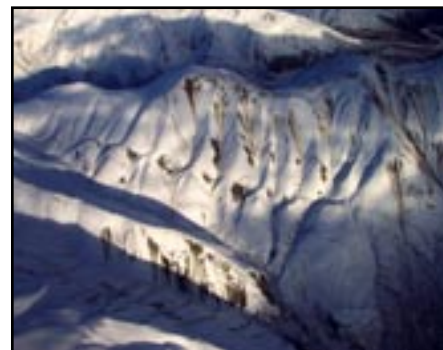
Figure 4 - View of Denali Fault trace at Gillett Pass

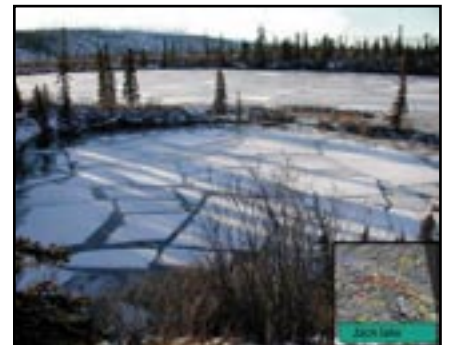
In addition to the liquefaction observations, lake-ice cracking supported directivity effects on ground motion. Many lakes dot the region and were for the most part frozen at the time of the earthquake. Cracking of the surface ice due to ground shaking (figure 7) was prevalent over the entire region. Cracked lake ice was observed within 30-40 km of the fault along the western portion of the rupture, whereas the affected region was much larger toward the east where lake ice cracking extended out to approximately 100 km from the fault.

Figure 7 -
Lake ice cracking close to Denali and Totschunda faults

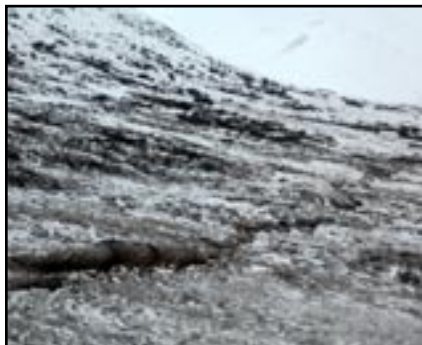
The Susitna Glacier fault splays off the western end of the Denali fault and had scarps up to 5 m high. Where it could be observed, the fault dips 10° to 25° to the north. This north-side upthrust fault is interpreted as the surface expression of the initial seismically inferred thrust faulting. Inferred average slip along the Susitna Glacier fault, based on the scarp height, was around 2 m. Slip along the Denali fault averaged about 5 m. The

Figure 6 -
Susitna Glacier thrust fault

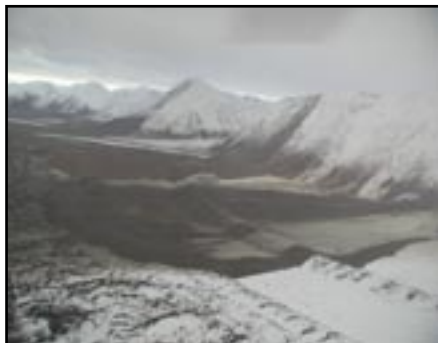
Rockfalls and landslides straddle the trace of the Denali and Totschunda faults. The most abundant large landslides were along the Black Rapids (figure 8), Canwell, and Gakona glaciers. The largest was on the northeastern side of Mount McGinnis, estimated at 20-40 million cubic meters of material. The landslides appeared to be unusually focused on the mountainsides adjacent to the surface trace of the faults, and were not spread over a wide area. The topography is not as steep along the eastern end of the rupture zone, so it is difficult to compare the landslides of the western and eastern parts of the surface rupture.

Figure 8 - View of East Algon slide of Black Rapids Glacier

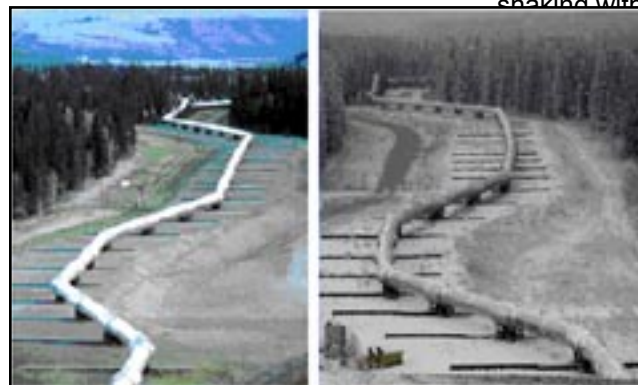
(TAPS) Performance: Design-level earthquakes rarely occur during the lifetime of a project, but this earthquake approached design criteria for a section of the pipeline system. TAPS was designed to accommodate the severe natural hazard environment of Alaska, including the presence of permafrost and the effects of great earthquakes. The 1287-km-long (800-mile) pipeline is placed above-ground for 676 km (53%) of its route to avoid locations of unstable permafrost. This unique pipeline design accommodates 6.1 m (20 feet) of horizontal and 1.5 m (5 feet) of vertical fault displacement at the fault crossing, using extra-long cross beams placed on the ground and extra-long sliding shoes (figure 9).

Figure 9 - Pipeline location pre-earthquake (left) and post-earthquake (right)

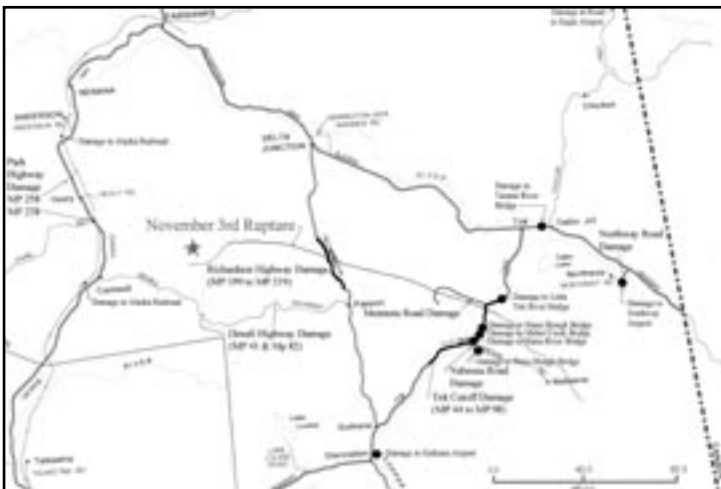
Roads, bridges, airports, and other transportation infrastructure were damaged during the earthquake due to poor soil, strong shaking, and proximity to the fault rupture. Figure 11 shows the location of the most serious damage. About \$30

Figure 11 - Damage to transportation infrastructure from the Denali fault earthquake

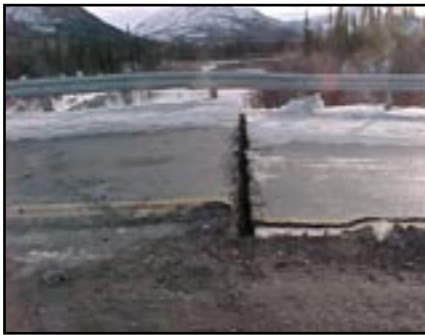
Both the Mabel Creek Bridge (at MP 76.3 of the Tok Cutoff) and the Slana Slough Bridge (at MP 75.8) are 41-ft-long precast, prestressed concrete "T" girder bridges with steel sheet pile abutments, built in 1979. The embankments settled several feet, and the top of the sheet pile abutments rotated backward (figure 14). Both bridges will be replaced.

Figure 14 - Embankment movement

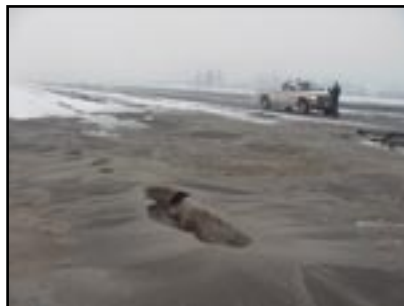
station, a fueling facility, a separate ski strip, a fire station and a small hotel and restaurant. During the earthquake, the soil liquefied (figure 15), causing large cracks to split the runway (figure 16). A \$10 million temporary fix was made. Due to the cold weather, the pavement could not be reinstalled, and the runway will require more work in the spring when the soil thaws.

Figure 15 - Sandboils in apron

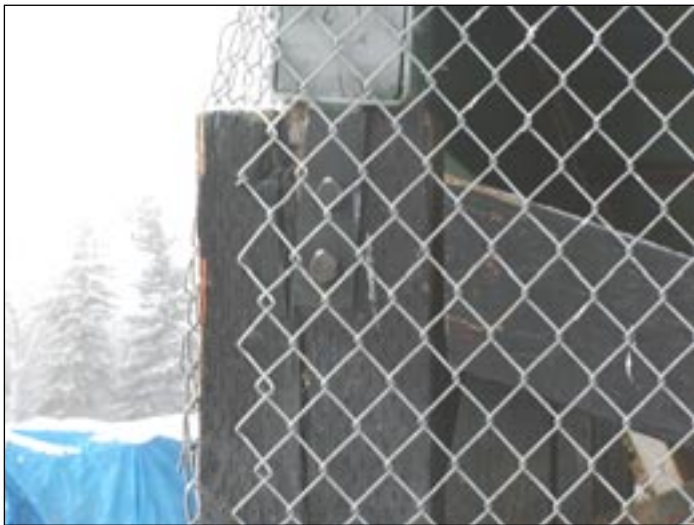
Building Performance: The communities of Slana and Mentasta felt the shaking strongly. Many people moved out of their houses, fearing the worst was not over. One local resident stated that "after a week of aftershocks, I am still sleeping on the office floor by the door. I don't plan on moving back to my bed in the loft 'til the earth quits rocking." Damage assessments were conducted in the villages of Mentasta, Tetlin, Tanacross, Mineral Lakes, Chistochina, Slana, Gakona, and the town of Tok. The structures in the communities examined were predominantly single story and of wood frame or log construction. The houses that were damaged were supported directly on the ground on timber foundations, or above ground on timber piling. Typical damage involved failure at the connection between floor beam and foundation

Figure 17 - Tetlin community building foundation damage

(figure 17). In general, damage to buildings was minimal when compared to what might be expected from an earthquake of this magnitude because of the ductile behavior of log residences.

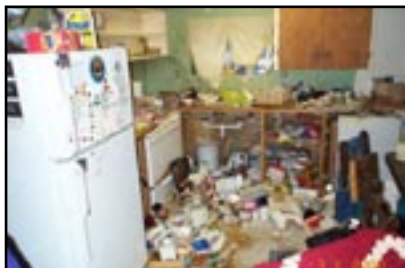
Most houses had interior nonstructural damage such as cracked gypsum wallboard, separation at non-load-bearing wall intersections, and some floor deformation. In addition, there was evidence of built-in cabinetry and equipment separation from wall surfaces. Overturned appliances and spilled cupboard contents were also a problem, and while they did not prevent re-occupancy of the homes, they required cleaning up (figure 18). Even though the damage to homes was not extensive, most of the residents have neither extra money nor the ability to obtain a line of credit or a loan, so making any kind of repairs will be difficult.

Figure 18 - Spilled contents in residence

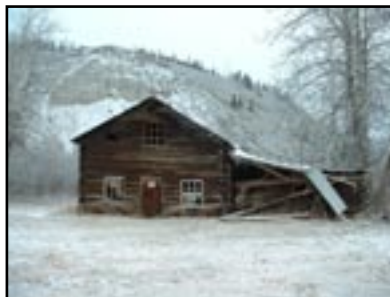
Figure 19 - Historic log structure at Gakona Lodge

There was major damage at the Mentasta Lodge, estimated at \$500,000, and also a partial collapse of a historic log structure at Gakona Lodge (figures 19 and 20).
