Learning from Earthquakes

The M_w 7.2 El Mayor Cucapah (Baja California) Earthquake of April 4, 2010

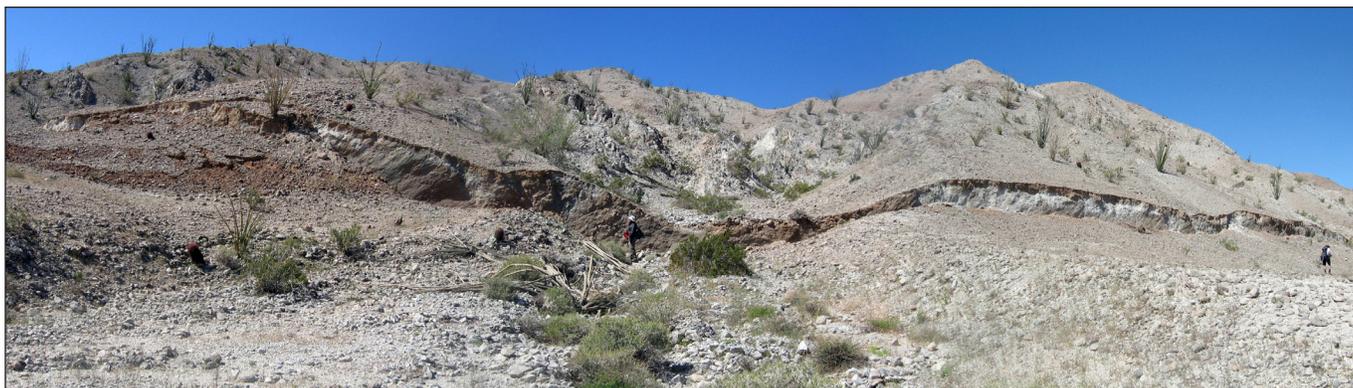
Figure 3 shows the maximum measured displacement along the Borrego fault in Borrego Valley, which

was about 3.1 m of strike slip and another 2 m of down-to-the-east dip slip on a nearly vertical fault, yielding oblique slip of nearly 4 m. A low-angle detachment intersects the footwall of the central portion of the Borrego fault at a segment boundary, and rupture bifurcates with a splay that follows the trace of the detachment in a more westerly direction. Over the next 6 km to the north, rupture steps left across a 2-km-wide zone, before finally consolidating on a fault named

Figure 3. Panoramic mosaic of the El Mayor-Cucapah earthquake rupture along the Borrego fault in Borrego Valley, Sierra Cucapah, Baja California, México. (photo: Tom Rockwell, photo-stitched by Karl Mueller)

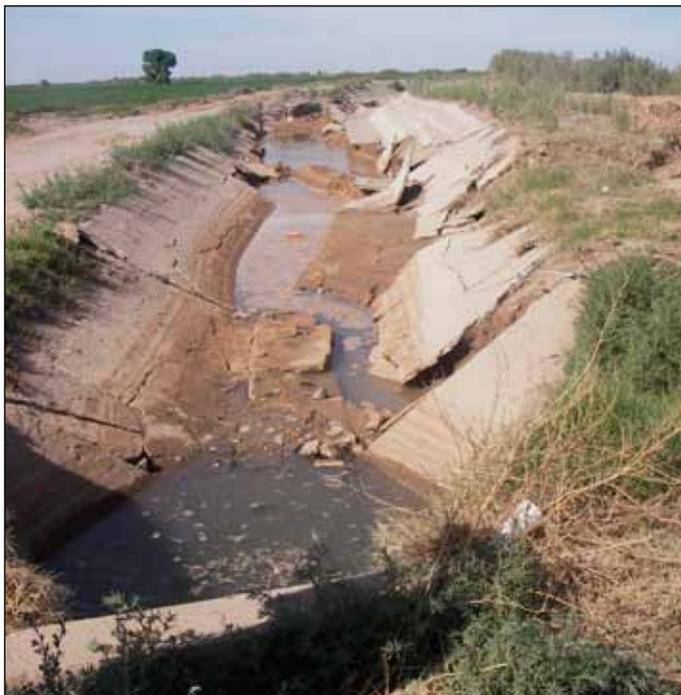
Figure 5. ▲ Damage to irrigation canal in Mexicali Valley.

fault rupture), and Imperial Valley (northeast of faulting). South of the border, liquefaction was widespread, particularly in the largely agricultural Mexicali Valley near the epicenter, where sand boils, lateral spreading, settlement, ground fissures, and flooding were observed. Loose saturated fine sand and non-plastic silts and shallow groundwater contributed to liquefaction. Impacts from liquefaction included topographic warping of the previously flat farmland, and damage to irrigation canals due to settlement, lateral spreading, and ejected sand filling the canals (Figure 5).

Liquefaction and lateral spreading caused cracking, settlement, and slumping of unreinforced concrete-lined irrigation canals (refer back to Figure 5). The Baja California government initially estimated that 57 km of major canals, 350 km of minor canals, and 380 km of drainage channels were damaged.

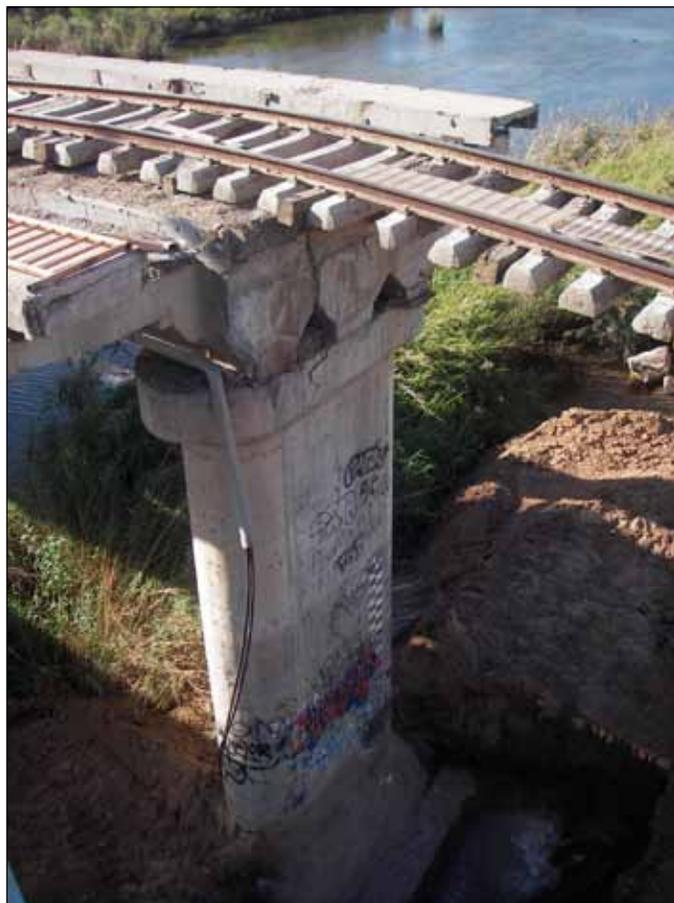
Figure 6. Unseated span of railway bridge near Guadalupe Victoria. ►

At parallel bridges that cross the Colorado River approximately 6 km southeast of Guadalupe Victoria, BC, the railway bridge collapsed when a simply supported span was unseated by liquefaction and lateral spreading of surrounding soil (Figure 6); the immediately adjacent and parallel highway bridge did not collapse, but suffered damage due to foundation settlement and strong ground shaking. Ground crack widths were measured along the eastern margin of the flood plain, and the sum of the crack widths was nearly 5 m, indicating significant lateral spreading displacements affecting the bridges.

The earthquake caused collapse of one span of Puente San Felipe, a railroad bridge over the Colorado River constructed in 1962. It is located approximately 5 miles southeast of Guadalupe Victoria, near the Baja California and Sonora border. The bridge is approximately 650 feet long, spanning the river with multiple spans, including a PC/PS concrete girder supported on concrete piers, with oblong sections supported on piles. Complete unseating of the girders due to both transverse movement of the superstructure and longitudinal pier movement was evident. The superstructure did not have any shear keys or any sizable anchorage to restrain lateral or longitudinal movements relative to the piers.

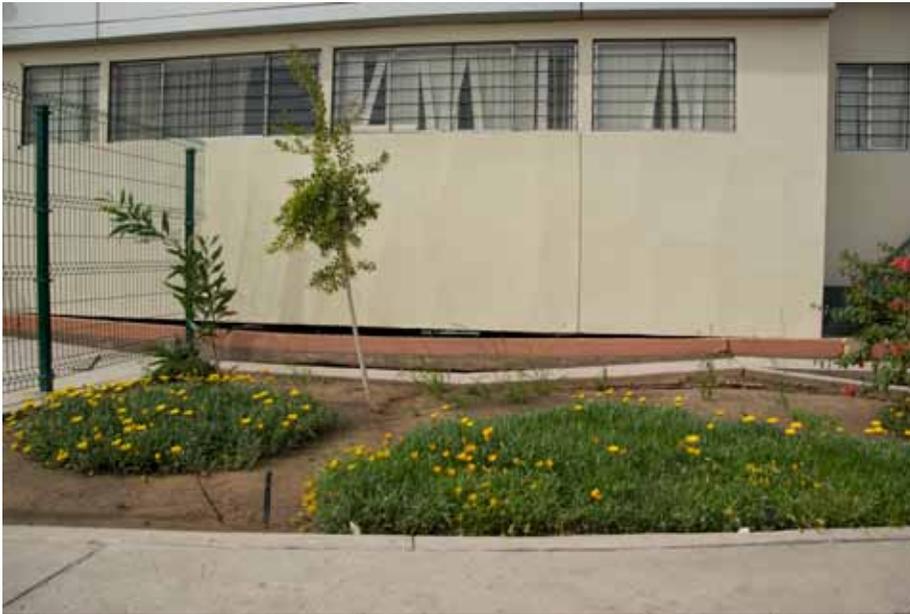
At a group of buildings and a pedestrian bridge at the Universidad Autónoma de Baja California campus, constructed in the New River flood plain, the buildings and bridge were damaged by liquefaction-induced settlement and some small lateral deformations. The buildings were founded on pile foundations

Figure 7. Settlement of base slab beneath four-story steel braced frame structure at Universidad Autónoma de Baja California, Facultad de Ciencias Administrativas site.

that showed no signs of liquefaction-induced settlement, but the floor slab separated from the walls of the building (Figure 7). Liquefaction and lateral spreading also damaged many homes along the Rio Hardy River in the Mexicali Valley to the south of the epicenter.

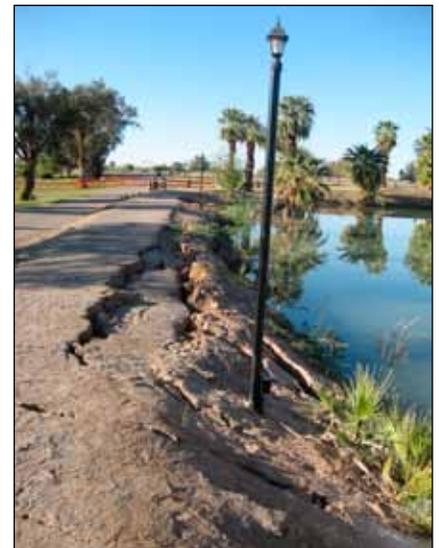
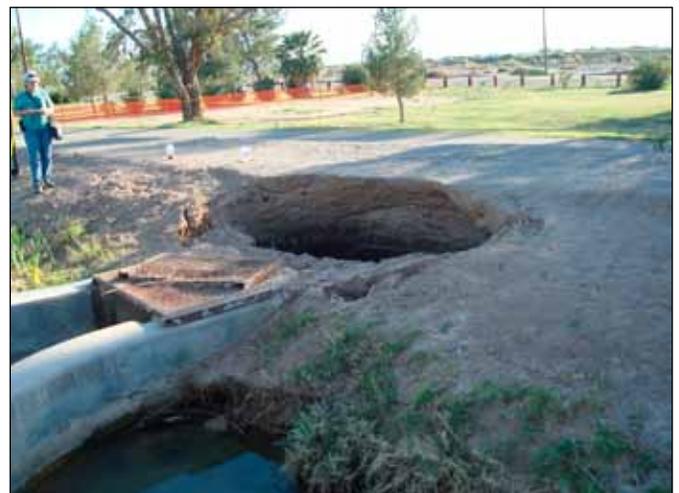
Other notable damage included liquefaction and lateral displacement of the dam embankment and adjoining Drew Road at the west-

Figure 8. (a) ▼ Liquefaction-related lateral spread of the crest of the Sunbeam Lake Dam (photo: Cindy Pridmore on 4/8/10). (b) ▼ Sinkhole forming on the Sunbeam Lake Dam adjacent to the outlet weir.

ern end of Sunbeam Lake south of Seeley (Figure 8), and liquefaction-induced slump of a levee that allowed overtopping of the levee likely by seiche waves generated in Fig Lagoon (Figure 9). Notable sites that liquefied during the 1979 Imperial Valley earthquake did not show evidence of ground failure in this event, including the Wildlife liquefaction array and the Heber Road site.

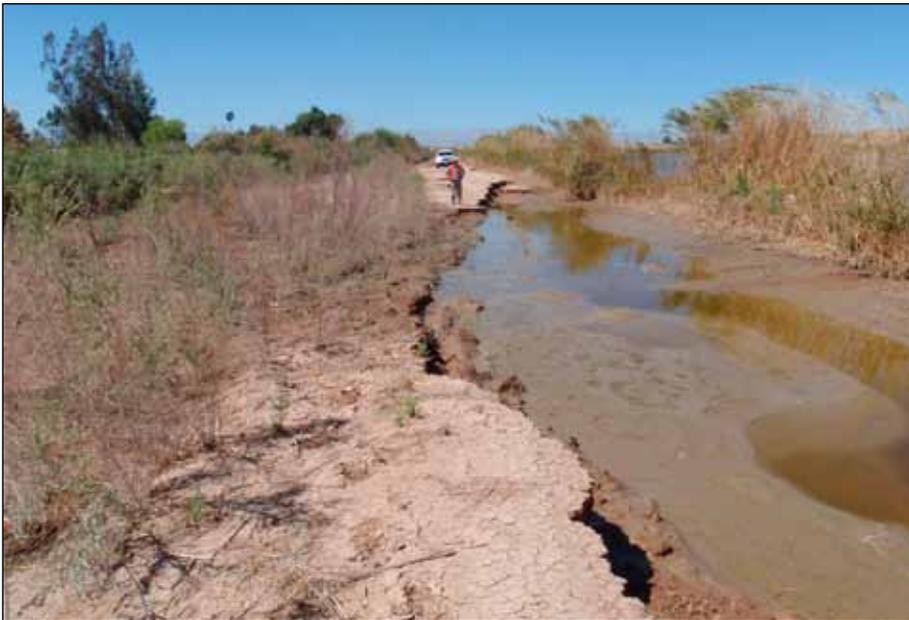
Figure 9. Breach in Fig Lake levee created by liquefaction-related lateral spread ground failure and settlement.

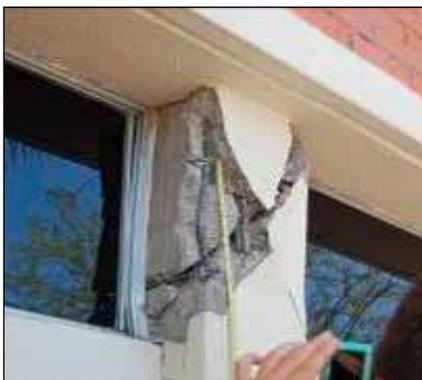
Figure 10. Short, nonductile concrete column severely damaged in high school building.

At a two-story concrete frame high school in Mexicali, built in 1958, shear cracks developed in the col-

umns and infill walls. The shear failure of the exterior columns can be attributed to the short-column effect introduced by the partial-height infill walls. The exposed concrete inside some of the damaged columns indicated poor concrete quality, i.e., poor consolidation and smooth aggregates (Figure 10). Retrofitted columns performed satisfactorily, but in some cases had damage below jacketed portions. The masonry infills were damaged by a combination of severe diagonal cracks and bed-joint sliding.

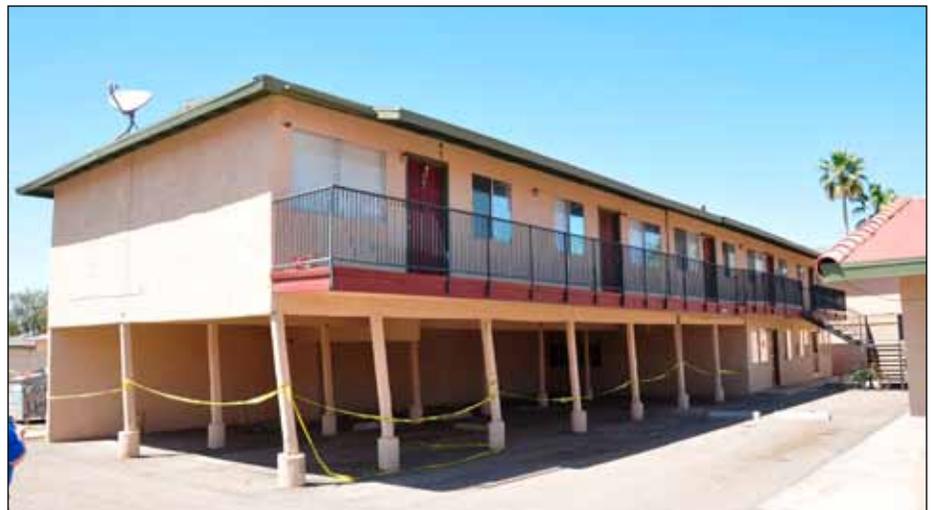
Figure 11. Soft story apartment with plaster walls in El Centro.

wood frame walls with plaster finishes to resist earthquake and wind forces (Figure 11). Longitudinal plaster walls on the east side at the north end of the building experienced a residual drift between 1 to 2 inches. The building was reported by neighbors as deteriorating with significant aftershocks, and government officials barricaded it to discourage access to the building's perimeter.

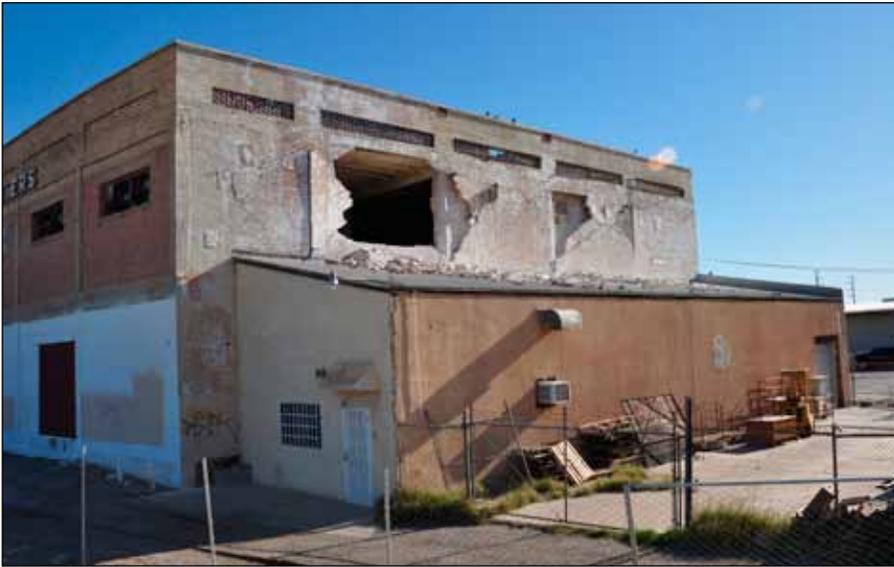
Figure 12. Concrete infill with a partial loss of infill brick walls.

A two-story nonductile concrete frame building in El Centro with unreinforced brick masonry infill walls was severely damaged (Figure 12). Its brick mortar joints had been repaired and one window opening was infilled with concrete masonry units after significant damage in the 1987 Superstition Hills earthquakes (EQE, 1988). The building was also damaged and repaired after the 1940 earthquake (Steinbrugge, NISEE, 1940). Cracks in concrete columns and beam-column joints on three elevations of the building depict a variety of responses of individual components. This building is worth further study regarding the efficacy of prior repairs, particularly since nearby ground motion recordings are available.

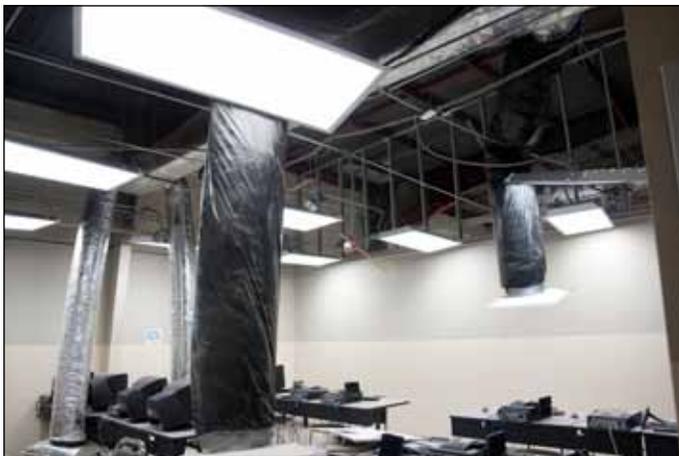
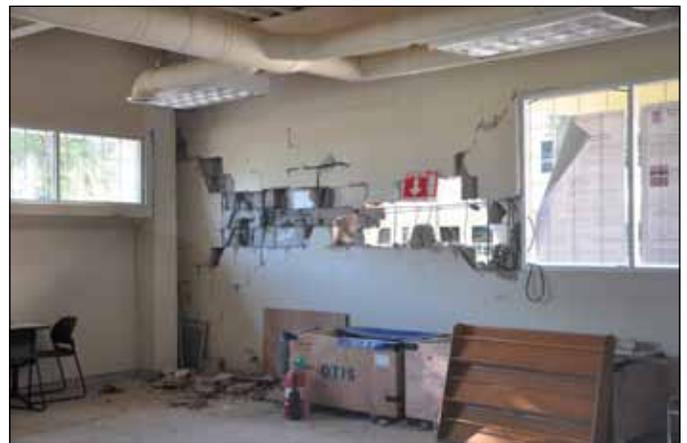
Figure 13. Mexicali campus of UABC: (a) extensive ceiling damage at the Electronics and Computer Laboratory building and (b) damaged CMU infill in the new eastern annex to the Engineering Institute buildings.

The Mexicali campus of the Universidad Autónoma de Baja California (UABC) is located approximately 44 km NE of the epicenter of the quake. The university was established in 1957 and has upwards of 16,000 students. In addition to structural damage, extensive nonstructural damage was observed, primarily in the form of ceiling, partition, and contents damage. All but one of 11 buildings on campus were closed, largely due to nonstructural damage. In the rooms of some buildings, over 80% of the ceiling tiles failed (Figure 13a). The buildings were mostly short (typically 2-3 stories) and constructed of masonry block or concrete frame with block infill. Damage to infill walls was also pervasive on the campus (Figure 13b).

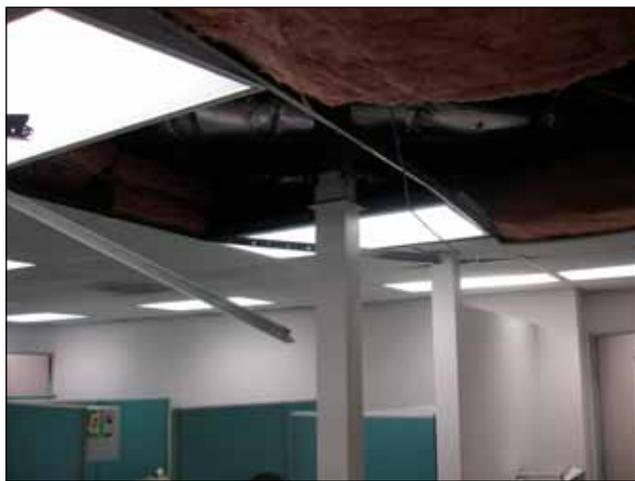
Figure 14. Typical interior damage to ceilings at the Medical Plaza building in El Centro.

The El Centro Regional Medical Center (ECRMC), a community hospital owned by the City of El Centro, has one- and two-story wings, constructed in 1956 and 2003, respectively. A neighboring Medical Plaza building and central plant serve the hospital. Minor nonstructural damage was observed in the main hospital and to its central plant, while the Medical Plaza building (Figure 14) was red tagged largely due to nonstructural damage. Fortunately, no injuries were reported. The ECRMC is an interesting case, as three strong-motion instrumentation

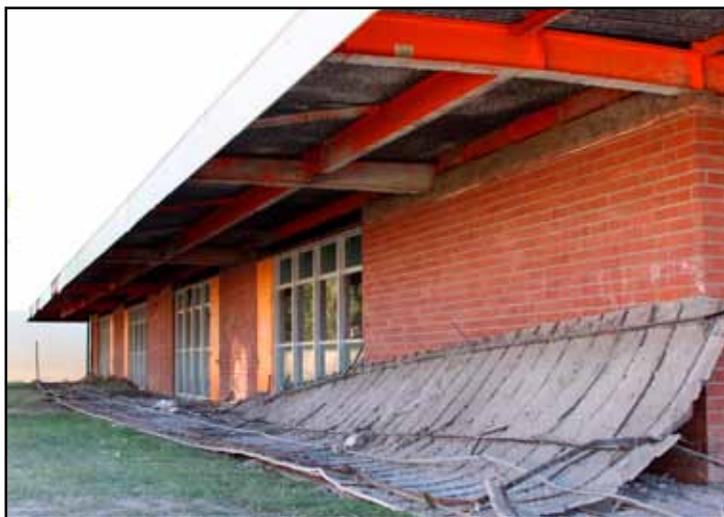
Figure 15. Collapse of exterior soffit at Jefferson Elementary School.

Jefferson Elementary School in Calexico, constructed in the 1960s, had significant nonstructural damage. Approximately 1200 square feet of exterior plaster ceiling soffits overhanging walkways fell in a progressive fashion (Figure 15). Fortunately, schools were not occupied at the time of the earthquake and no one was injured.

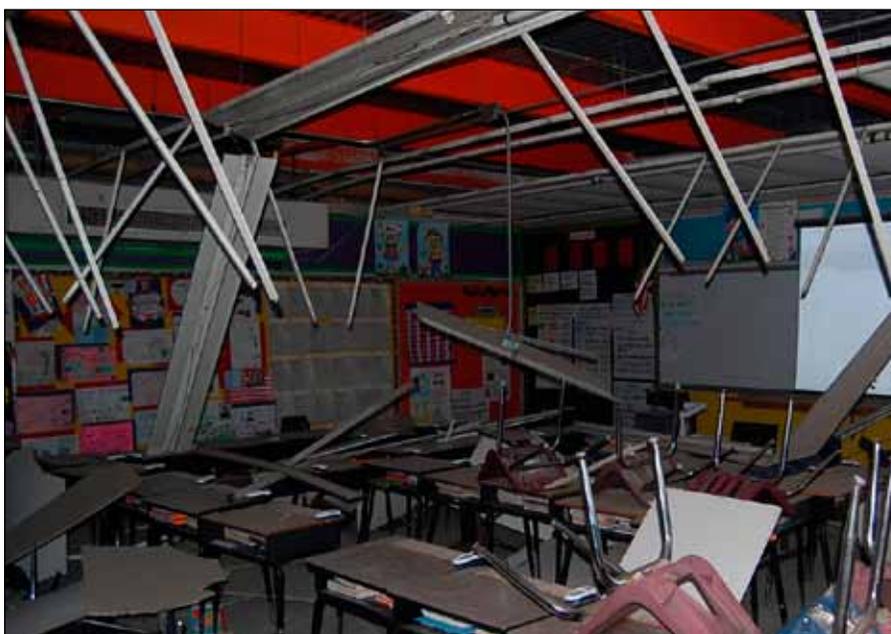
Figure 16. Fallen light fixtures and ceiling system components.

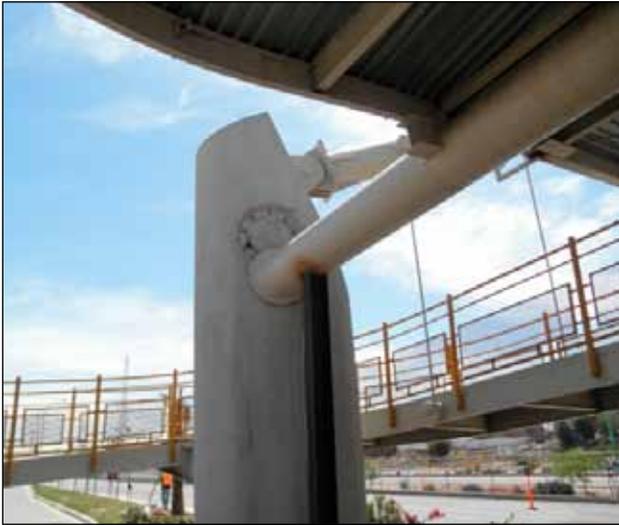
Figure 17. UABC pedestrian bridge strut-connection failure

The EERI team observed damage at the pedestrian bridge at UABC, a newly constructed 175-ft. steel arch tied to large diameter concrete piers. At the ends of the superstructure deck, transverse tubular steel struts were designed to provide longitudinal resistance to seismic

forces. The end plate of the struts was rigidly connected to the interior face of the piers. All welds of the anchor bolts connecting one strut to the concrete piers had completely fractured. Concrete columns supporting the spiral ramp structure and the anchor bolts were cracked. There was also liquefaction of the soil surrounding the foundation. The fracture may have been caused by excessive longitudinal seismic forces on the strut connections, combined with rotational demands as a result of pier movement in liquefied soil (Figure 17).

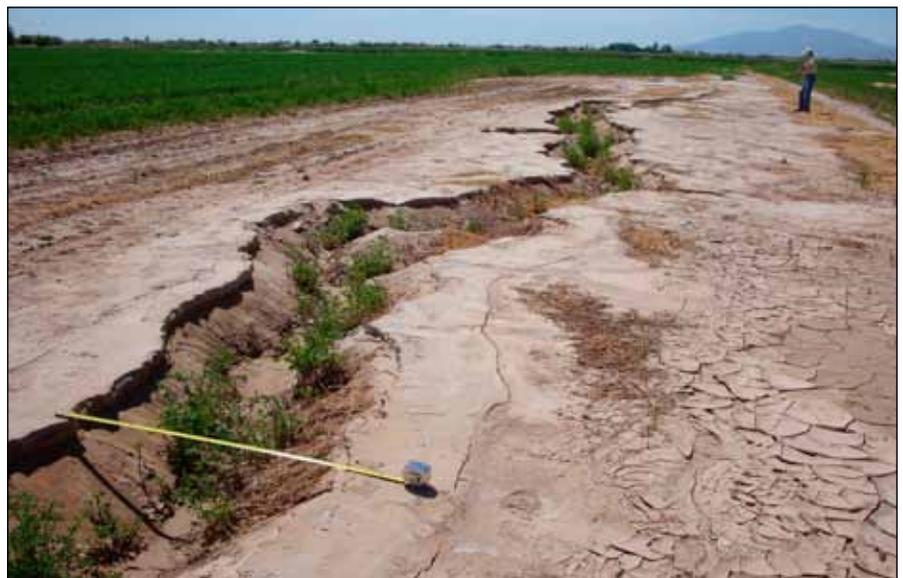
Figure 18. Fissure and sand boils in alfalfa field southeast of Cucapah, Baja California, México.

lack of irrigation and are likely to be lost for this season. In addition, massive sand boils and sand sheets blanketed portions of fields, and large-scale lateral spreading created scarps and fissures that crossed fields (Figure 18). The Baja California government reported that the earthquake also caused permanent regional ground tilting, which will disrupt gravity-controlled irrigation.

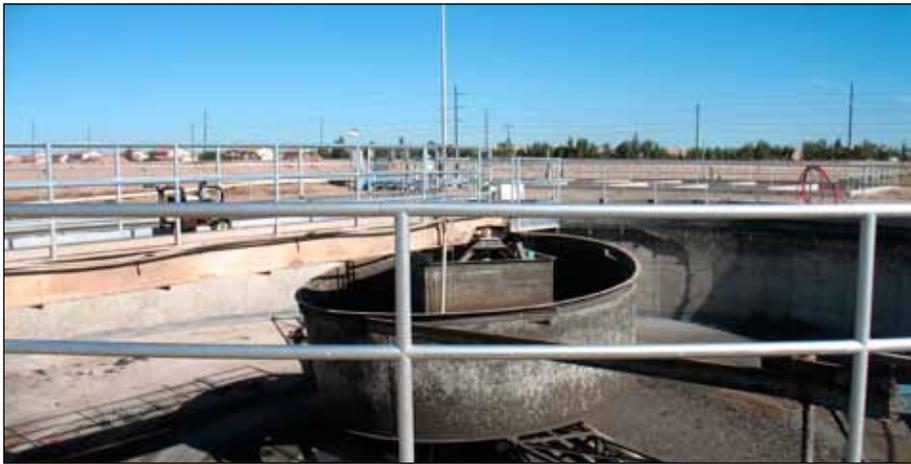
Figure 19. *El Centro damaged secondary clarifier and well assembly (photo: Jose Angel).*

At the El Centro wastewater treatment plant, there was structural damage to one primary clarifier and to two secondary clarifiers. The baffles of the primary clarifier were sheared off of the clarifier and broke. The clarifier also had some relatively superficial small cracks. The center well of the secondary clarifier No. 2 was twisted (Figure 19). The center column of the secondary clarifier No. 3 dropped about 5 inches. There is structural damage to the concrete walkways and inspection bridges of the aeration tanks. Interestingly, the damage to one of the clarifiers was similar to that reported in the 1979 Imperial County M_w 6.5 earthquake.
