Learning from Earthquakes

The M_w 7.0 Haiti Earthquake of January 12, 2010: Report #2

This second insert on the Haiti earthquake covers engineering failures and the social impacts of the quake. The first report in the April issue covered seismology and geotechnical aspects, primarily. The EERI team responsible for this report, including members from partnering organizations — the Network for Earthquake Engineering Simulation, the Mid-America Earthquake Center, Florida International University, Sherbrooke University, University of Delaware's Disaster Research Center and Western Washington University's Resilience Institute — visited Haiti from February 28 through March 7, 2010. The 18-member multi-disciplinary team included engineers, social scientists, city planners, architects, and geographers. The EERI team worked with the ASCE Technical Council on Lifeline Earthquake Engineering team and, together, the teams visited over 500 facilities and buildings in the heavily hit areas of Port-au-Prince, Léogâne, Petit Goâve, and Jacmel. The EERI team and its partners consisted of Reginald DesRoches, Georgia Institute of Technology (team leader); Susan Brink, University of Delaware; Peter

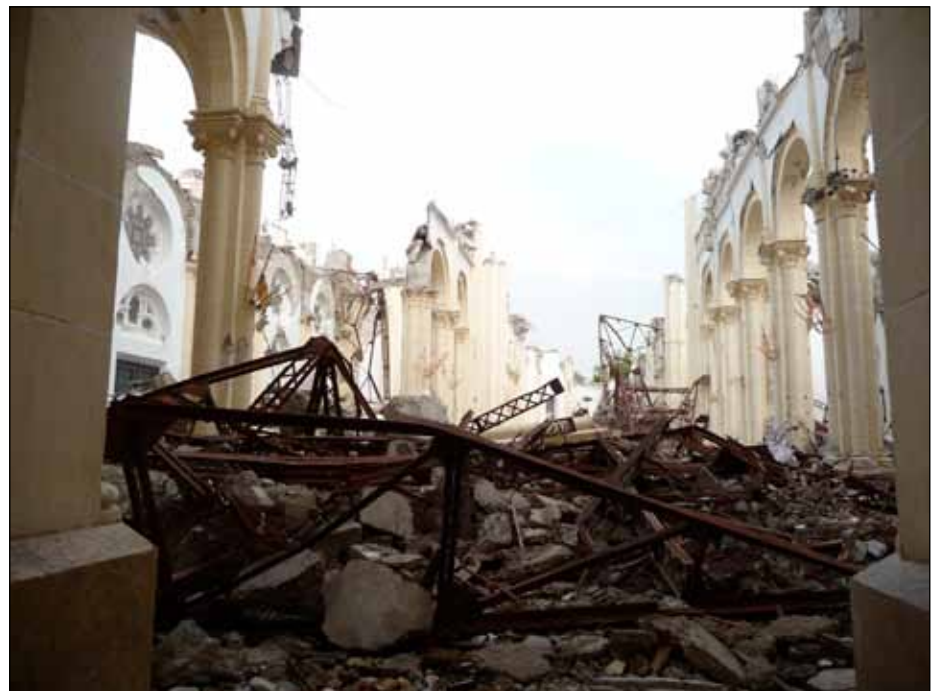
Reinforced Concrete: Many turn-of-the-20th-century structures built in the manner prevalent in Europe at the time were precursors to what is now the most common form of construction in Haiti. At the time these were built, it was unique to construct an entire building with poured-in-place concrete. This building type included two of the best known landmarks in Haiti, the National Presidential Palace and the National Cathedral (Figure 6), both of which collapsed catastrophically.

While the National Cathedral did have a light steel roof structure, it also had two large concrete domes on top of its towers, making them top heavy. In addition to collapses, the damage that we observed included severe shear cracks in columns and out-of-plane collapses of concrete walls.

According to our observations, the following are possible primary modes of failure: poor weight and wall distribution for seismic loading; corroded steel reinforcement as a result of aged carbonated concrete; and inadequately ductile concrete members to sustain repetitive stressing.

Figure 6. Collapsed roof, interior of National Cathedral, Port-au-Prince (photo: Martin Hammer).

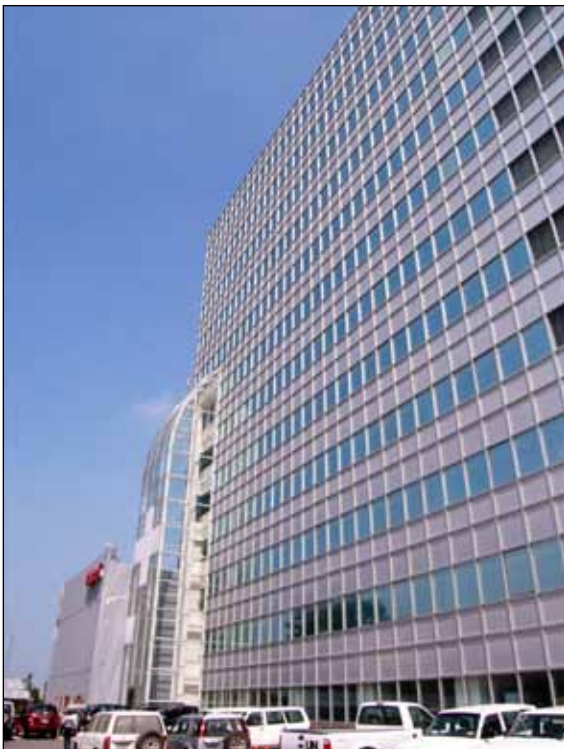
The Digicel building is the tallest engineered building in Port-au-Prince. One of its L-shaped structural walls can be seen along the left corner in Figure 7. Three such walls are present at as many corners of the building. The fourth corner has a large atrium with deep beams. An elevator core wall is near the atrium corner. The building performed well with light structural and some nonstructural damage. Spalling of concrete was visible in some columns, top and bottom; some beams in the upper floors suffered severe spalling and, in a few places, buckling of longitudinal bars. Adjacent three-story RC-MRF buildings were severely damaged.

Figure 7. The 12-story Digicel building with RC dual (frame-wall) structural system (photo: Anna Lang).

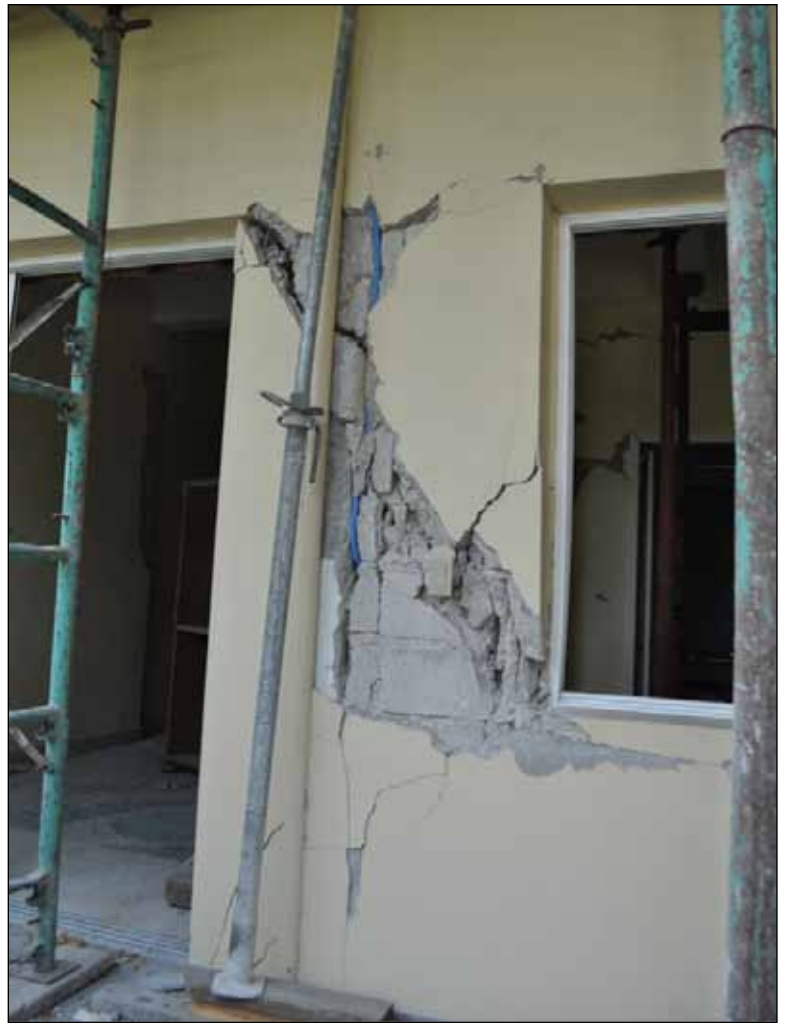
Figure 9 (left). Damage in a column due to captive condition, Petionville hotel (photo: Ayhan Irfanoglu).

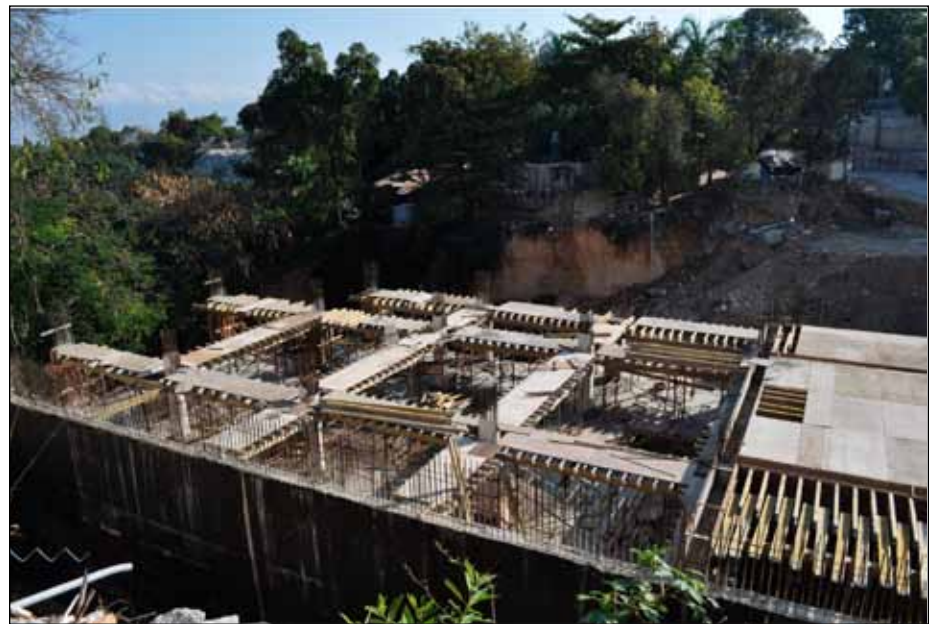
In the Petionville area, several modern engineered buildings were inspected. One of the hotels, a RC-MRF with reinforced CMU infill walls, suffered damage in its infill walls and a few captive columns at the ground story (Figures 8 and 9). Another RC-MRF hotel under construction (with three stories completed and three more to go) sustained no damage (Figure 10),

Figure 10. Garage of hotel under construction, sustained no damage (photo: Ayhan Irfanoglu)

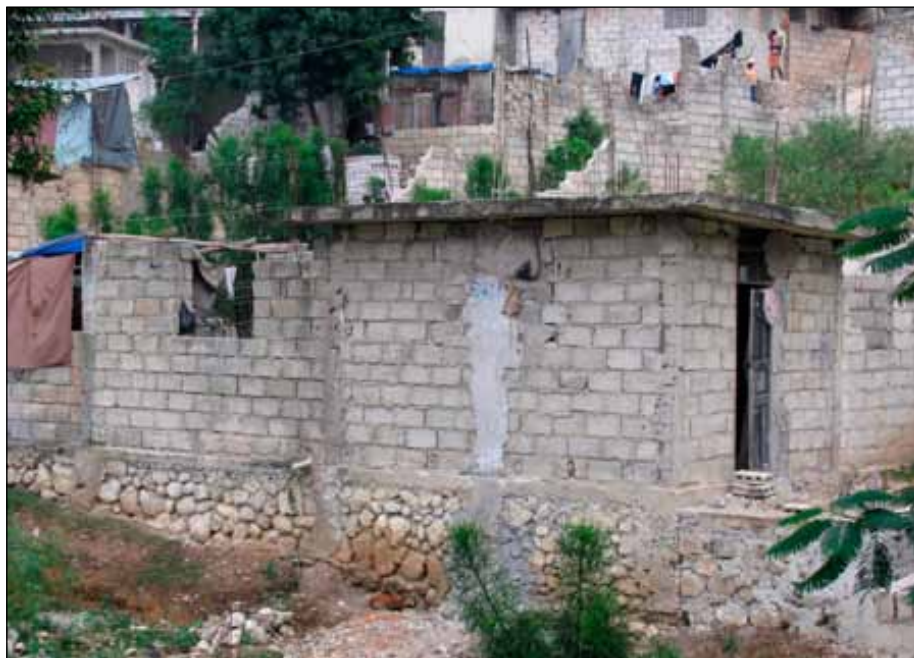
Construction Materials and Procedures: Concrete masonry blocks are commonly manufactured at or near the construction site. Type I Portland cement is used for all construction elements, including masonry blocks, foundation and wall mortars, roof and floor slabs, and columns and beams. Concrete mix proportions regularly lack sufficient cement and have a high water con-

Figure 12. Typical construction of a residence, showing a rock rubble foundation, confined masonry construction technique, and reinforced concrete slab. Note blocks added to the top of the walls and reinforcement emerging from the slab, ready for construction of another level (photo: Anna Lang).

tent for workability and reduced cost (see Figures 12 and 13).

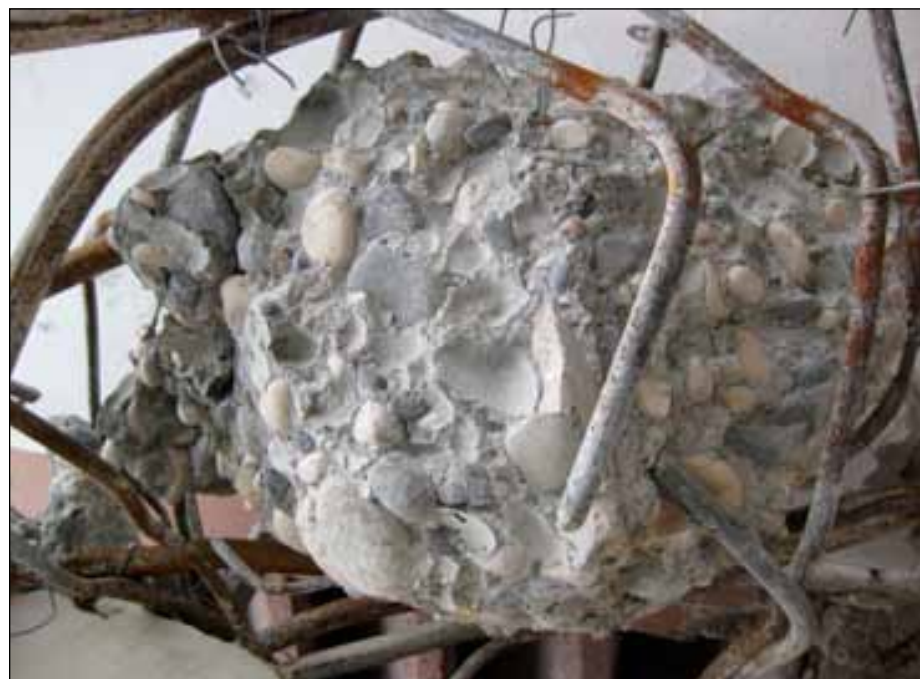
Poured-in-place concrete is not typically consolidated, so there are large air pockets and a lack of bond with the reinforcement. Further, the lack of sufficient cement in the concrete mix reduces bond strength.

Figure 13. Lack of sufficient cement bond, smooth reinforcement, and insufficient detailing (photo: Anna Lang).

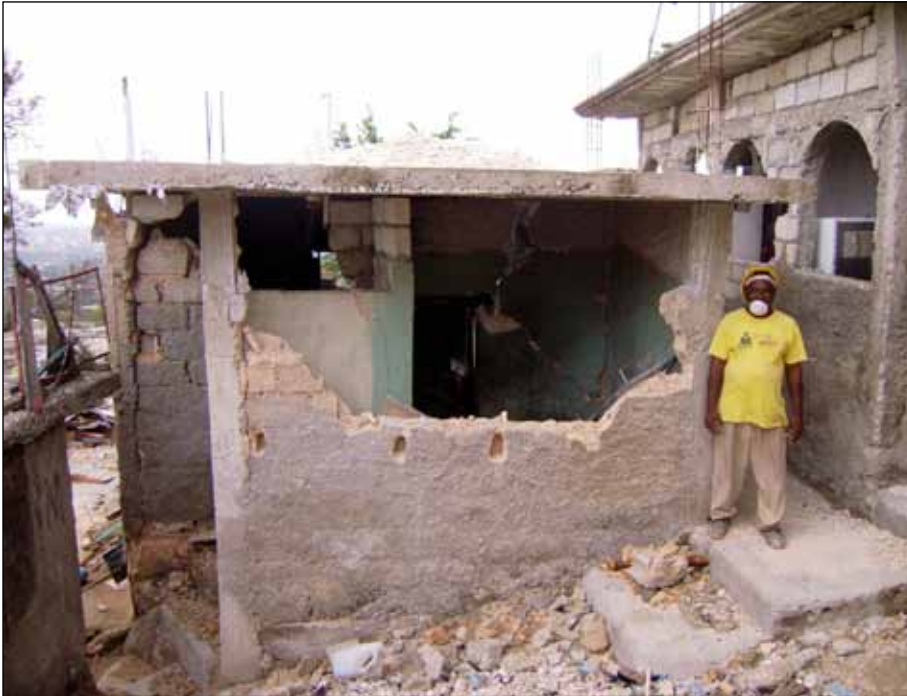
Figure 14. Typical out-of-plane failure of an infill masonry construction (photo: Anna Lang).

When these building types were excited during the earthquake, lateral load transfer primarily occurred at the column-slab connection. The walls are typically not load-bearing, and their strength capacity was reduced by a lack of friction between the blocks. Interaction between wall panels and columns resulted in localized damage, notably in the columns. Lateral capacity of the slender columns was generally insufficient to resist acceleration demands on the structure. P-delta effects ensued, proliferating collapse. Overturning and out-of-plane failures of wall panels were commonplace and caused the majority of complete structural collapses (Figure 14). Even when they didn't contribute to building collapse, these out-of-plane wall failures caused innumerable injuries and deaths.

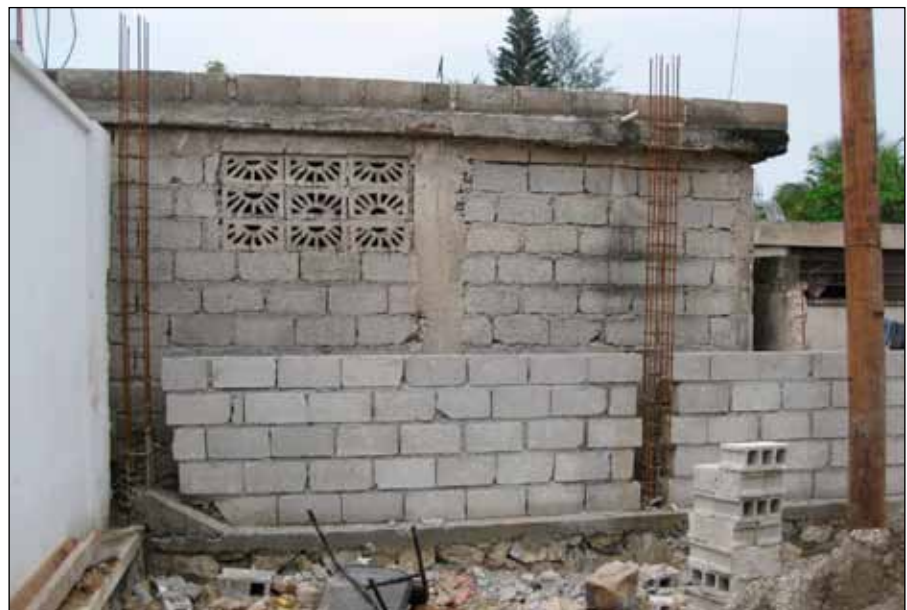
Confined masonry structures generally sustained little or no damage during the earthquake (Figure 15). A seemingly minor variation in the construction sequence resulted in

Figure 15. In foreground, new wall under construction shows staggering of blocks within the column cavity; this mechanically locks the masonry wall to the columns, causing them to act as a unit. In background, a typical one-story CM residence (photo: Anna Lang).

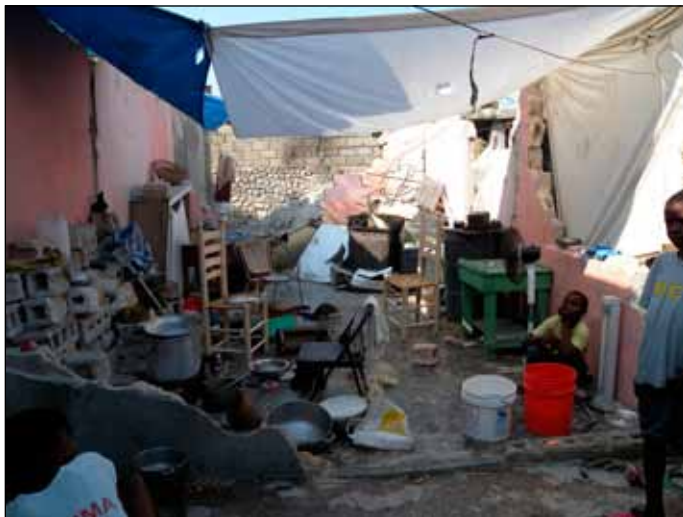
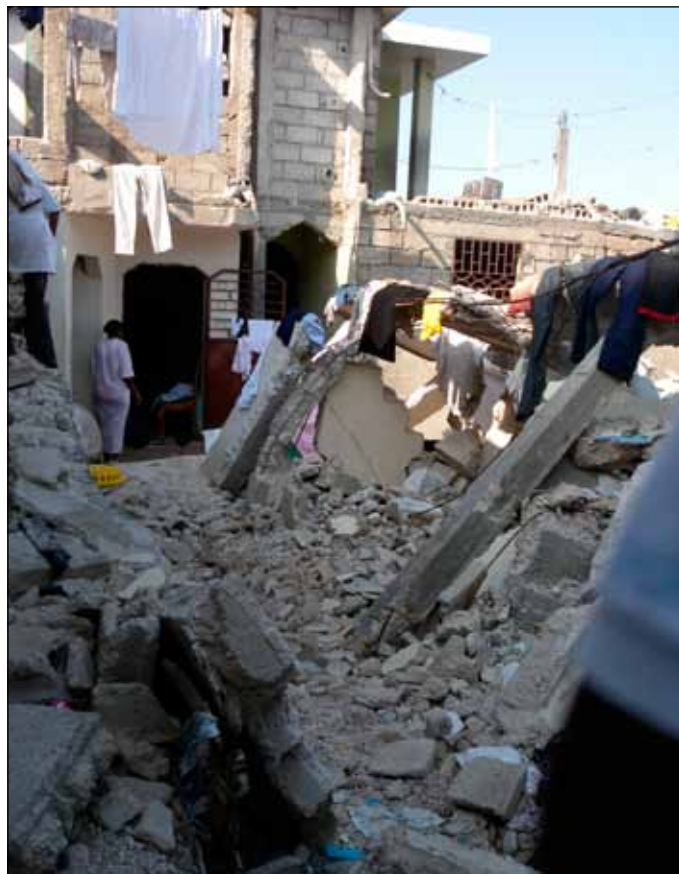
Figure 20 (a) ▲ and (b). ► Residents living in or next to damaged homes (photos: Rebekah Green).

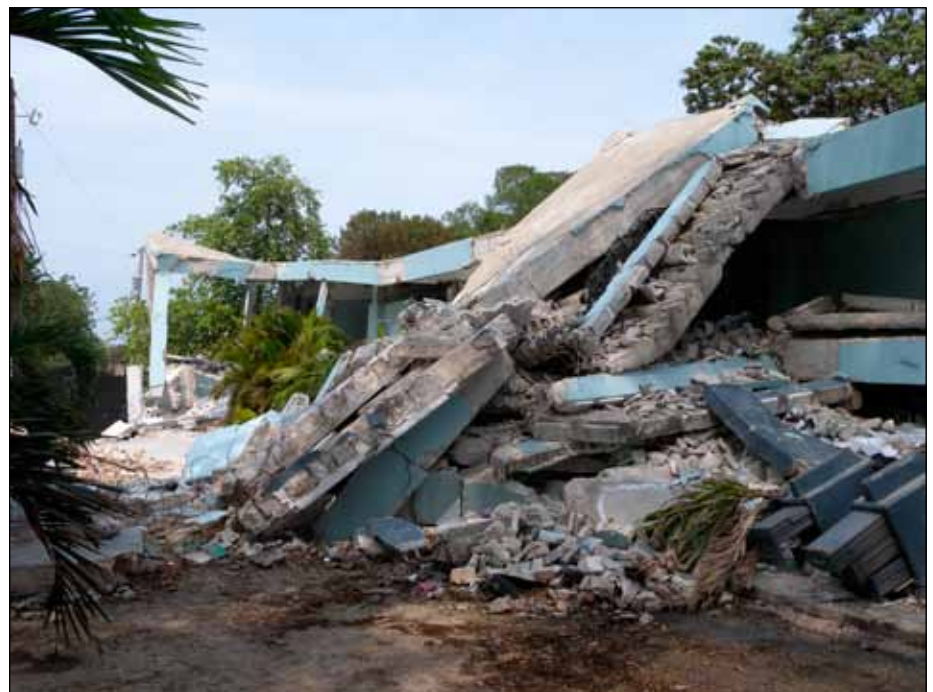
Approximately 50% of schools in Port-au-Prince were damaged (Figure 22); an estimated 400 or more tents are needed for temporary learning spaces.

Figure 22. Damaged school in Port-au-Prince (photo: Rebekah Green).
