Learning from Earthquakes

The M_w 7.0 Haiti Earthquake of January 12, 2010: Report #2

This second insert on the Haiti earthquake covers engineering failures and the social impacts of the quake. The first report in the April issue covered seismology and geotechnical aspects, primarily. The EERI team responsible for this report, including members from partnering organizations — the Network for Earthquake Engineering Simulation, the Mid-America Earthquake Center, Florida International University, Sherbrooke University, University of Delaware's Disaster Research Center and Western Washington University's Resilience Institute — visited Haiti from February 28 through March 7, 2010. The 18-member multi-disciplinary team included engineers, social scientists, city planners, architects, and geographers. The EERI team worked with the ASCE Technical Council on Lifeline Earthquake Engineering team and, together, the teams visited over 500 facilities and buildings in the heavily hit areas of Port-au-Prince, Léogâne, Petit Goâve, and Jacmel. The EERI team and its partners consisted of Reginald DesRoches, Georgia Institute of Technology (team leader); Susan Brink, University of Delaware; Peter

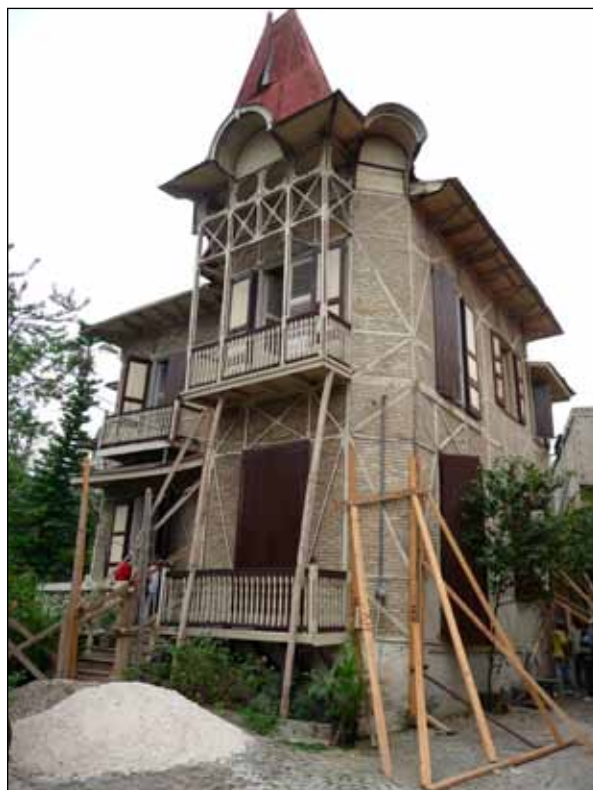
Figure 2. Timber frame with colombage (photo: Martin Hammer).

Both types of timber frame construction are inherently resistant to earthquakes. The all-wood buildings are light and flexible, and utilize the diagonal members and wood-sheathed walls to resist lateral loads. The colombage buildings are heavier, but dissipate energy through friction between the masonry panels and the timber members, and between the masonry units after their weaker mortar joints fracture. The diagonal wood members provide resistance as well (Figure 2).

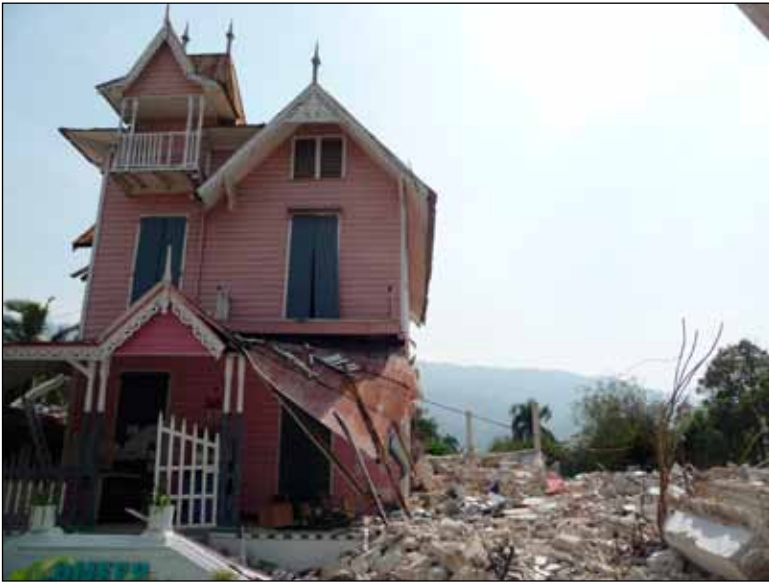
Figure 3. Wood frame building next to collapsed concrete and masonry building (photo: Martin Hammer).

masonry or concrete structure (Figure 3). However, many sustained moderate to serious damage due to the deterioration of wood members from termites or rot. The colombage buildings sometimes expelled masonry panels under out-of-plane loading. Additions made of unreinforced masonry or reinforced concrete usually suffered the most damage (Figure 4).

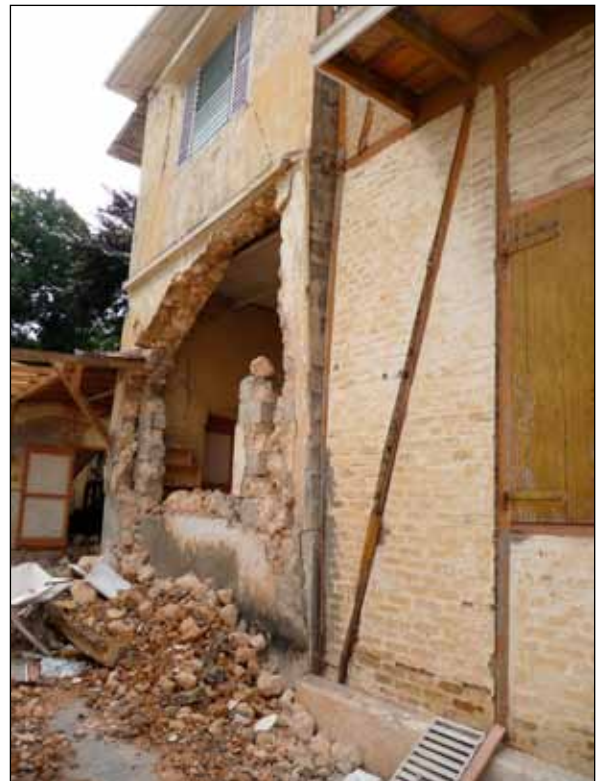
Figure 4. Colombage performed well, though the unreinforced masonry wall collapsed (photo: Martin Hammer).

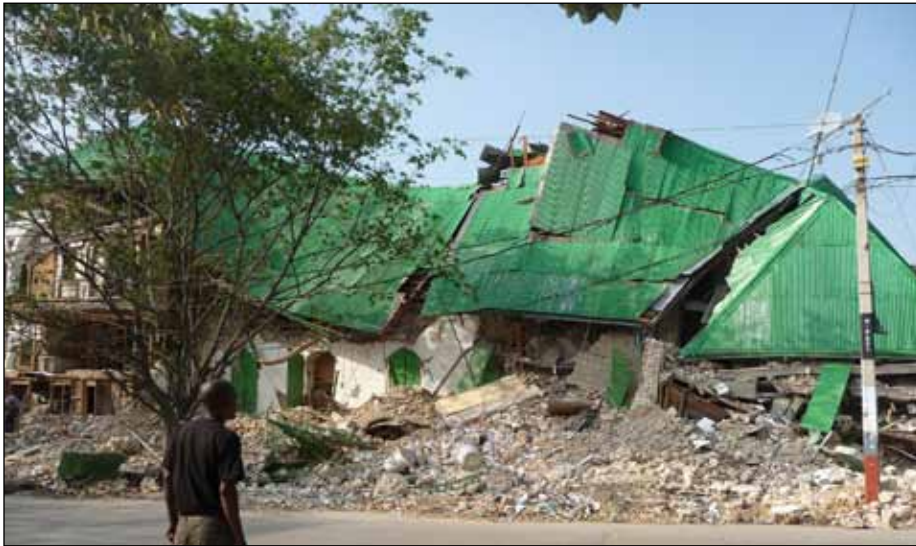
Unreinforced masonry construction predominates among buildings constructed between the late 1800s and the 1920s, often combined with the timber construction described above. The EERI team observed URM residential, academic, religious, and government buildings (Figure 5). The buildings were a combination of rough stone masonry and fired clay brick, with little or no smooth steel reinforcing along building corners or window and door heads. The stone masonry appeared to be the light colored limestone that is commonly acquired in the La Boule quarries in the hills around Port-au-Prince. Some URM buildings, such as the Haitian Ministry of Interior, failed catastrophically (Figure 5) even though the neighbor-

The failures we observed generally ranged from diagonal cracking in wall sections to absolute collapse; modes of failure included 1) lack of brick ties or brick headers between brick wythes, 2) lack of adequate steel reinforcing, 3) weak stone masonry where it was necessary for structural support, and 4) poor mortar quality due to poor aggregate quality, inadequate cement or lime, or poor maintenance.

Figure 5. Unreinforced masonry Ministry of Interior building (photo: Martin Hammer).

For those URM buildings that remain intact or that can be salvaged, it is advisable for an historic preservation and/or structural engineering professional to inspect them in greater detail to determine appropriate preservation and structural retrofit measures. These measures may include doweled through-wall anchors, parallel lateral bracing, or repairs to mortar.

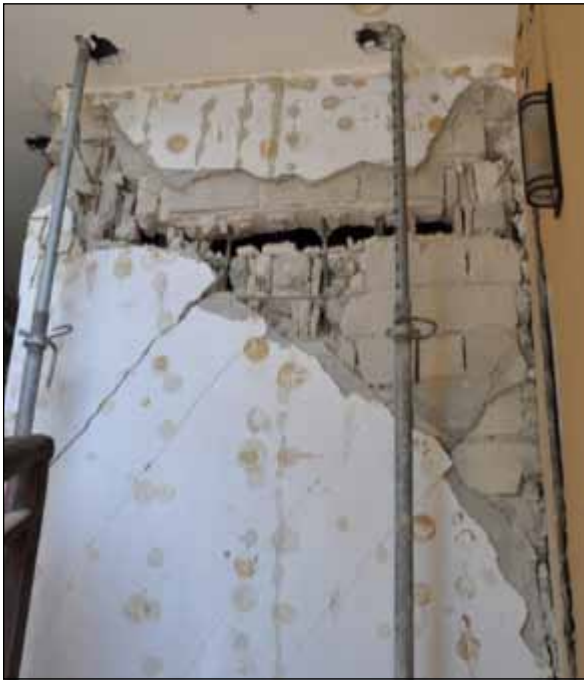
In the Petionville area, several modern engineered buildings were inspected. One of the hotels, a RC-MRF with reinforced CMU infill walls, suffered damage in its infill walls and a few captive columns at the ground story (Figures 8 and 9). Another RC-MRF hotel under construction (with three stories completed and three more to go) sustained no damage (Figure 10),

Figure 8. Reinforced CMU wall from a hotel in Petionville (photo: Amanda Lewis).

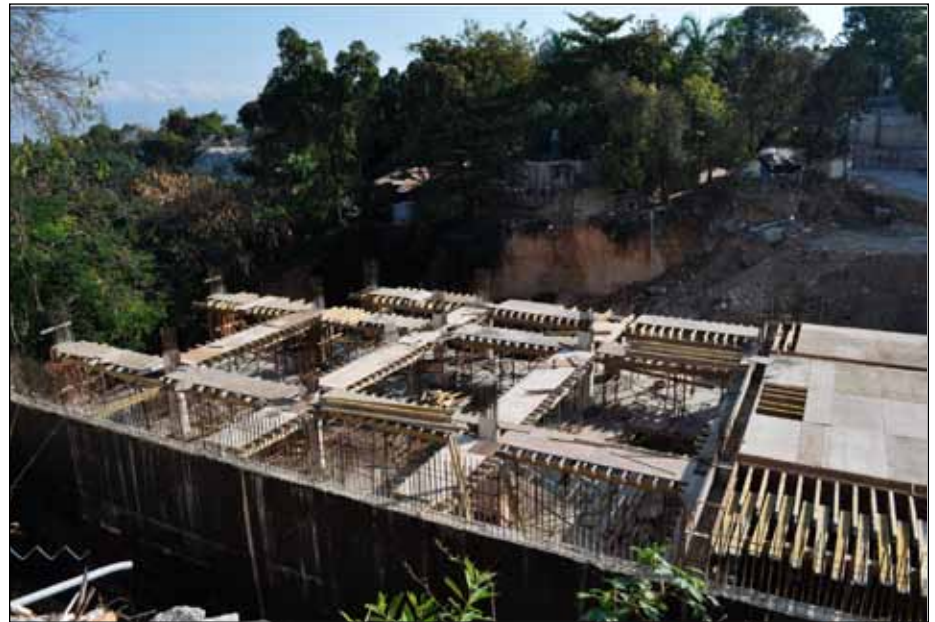
while an older construction RC-MRF multi-story hospital building adjacent to it collapsed totally.

Figure 10. Garage of hotel under construction, sustained no damage (photo: Ayhan Irfanoglu)

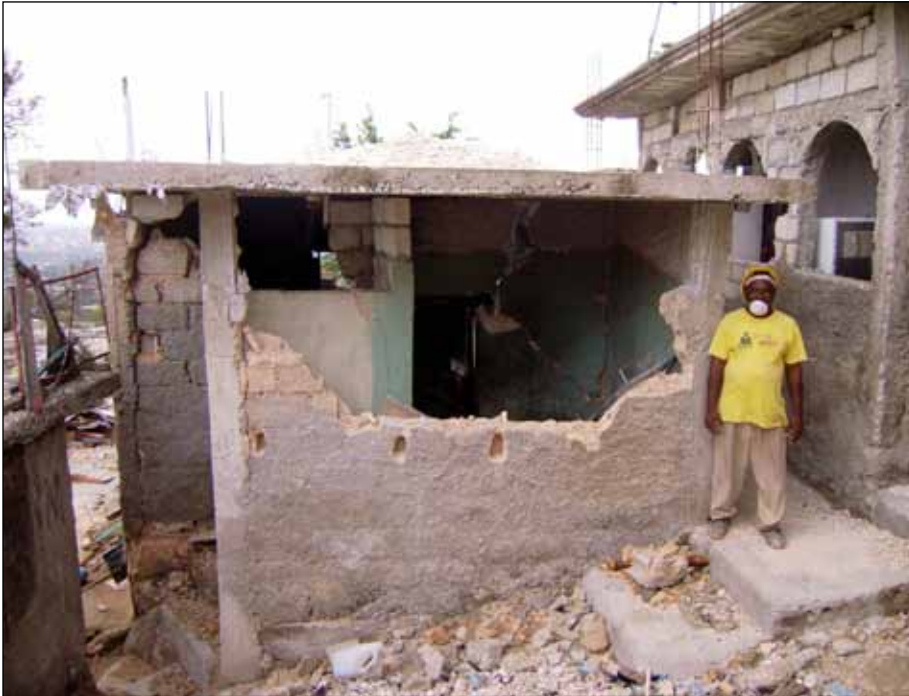
Figure 14. Typical out-of-plane failure of an infill masonry construction (photo: Anna Lang).

When these building types were excited during the earthquake, lateral load transfer primarily occurred at the column-slab connection. The walls are typically not load-bearing, and their strength capacity was reduced by a lack of friction between the blocks. Interaction between wall panels and columns resulted in localized damage, notably in the columns. Lateral capacity of the slender columns was generally insufficient to resist acceleration demands on the structure. P-delta effects ensued, proliferating collapse. Overturning and out-of-plane failures of wall panels were commonplace and caused the majority of complete structural collapses (Figure 14). Even when they didn't contribute to building collapse, these out-of-plane wall failures caused innumerable injuries and deaths.

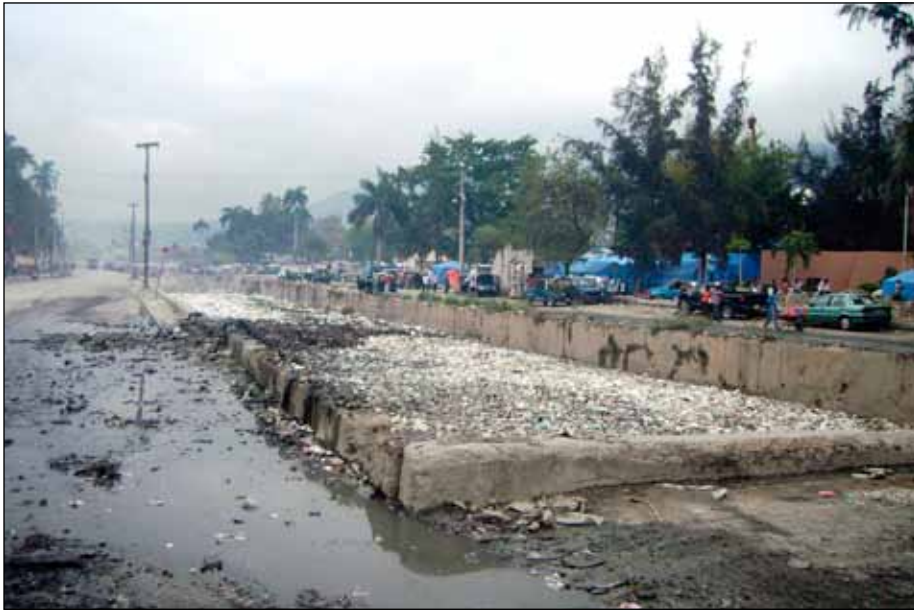
Figure 18. Sediment and debris (mostly plastic bottles) build-up in drainage channel at highway overcrossing (photo: Anna Lang)

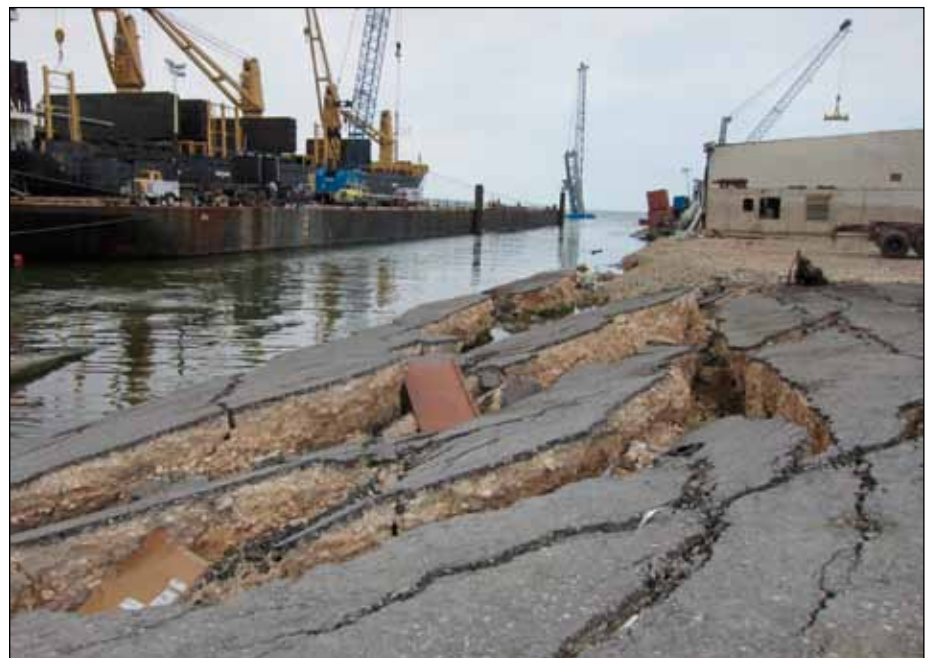
The North Wharf was a pile-supported marginal wharf 1,500 feet long and 68 feet wide, supported on 20-inch square pre-stressed concrete piles with five vertical and two batter piles per bent. A 110-foot-by-40-foot Ro-Ro pier was adjacent to the east end of the North Wharf. Both collapsed into the bay during the earthquake, primarily because of liquefaction-induced lateral spreading of the backfill soils (Figure 19). There may also have been corrosion and prior damage that contributed to the damage. Two

Figure 19. Liquefaction-induced lateral spreading damage to the APN North Wharf. Note the barge on the left was used to replace the North Wharf for post-earthquake recovery efforts. The mobile container crane is shown in the water at the west end of the submerged wharf (photo: Stu Werner).

large warehouses (each approximately 500 feet by 135 feet) were located in the backland of the wharf and were heavily damaged by the lateral spreading. A gantry container crane and a mobile container crane along the North Wharf were partially submerged due to the collapse of the wharf structure.

The U.S. military also began efforts to repair the uncollapsed segment of the South Pier by constructing a reinforced concrete cap to encase the upper few feet of the severely damaged piles. This was expected to be completed in early April. APN is planning to rebuild the North Wharf facilities to bring the port back into full operation.

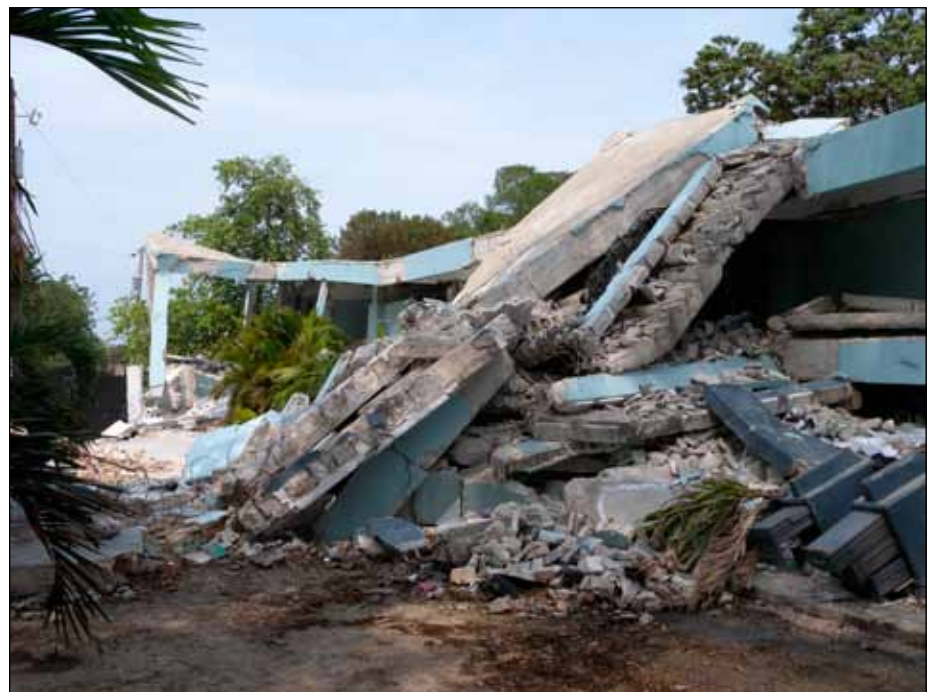
Approximately 50% of schools in Port-au-Prince were damaged (Figure 22); an estimated 400 or more tents are needed for temporary learning spaces.

Figure 22. Damaged school in Port-au-Prince (photo: Rebekah Green).
