## Learning from Earthquakes

# The M 6.3 Christchurch, New Zealand, Earthquake of February 22, 2011

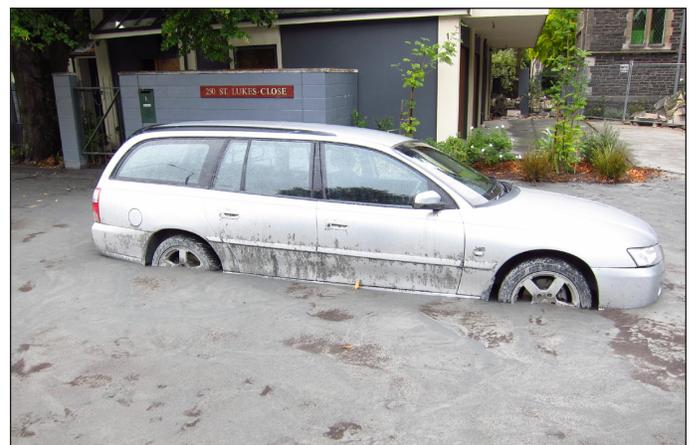
**Figure 4.** Severe liquefaction in the CBD (photo: Kam)

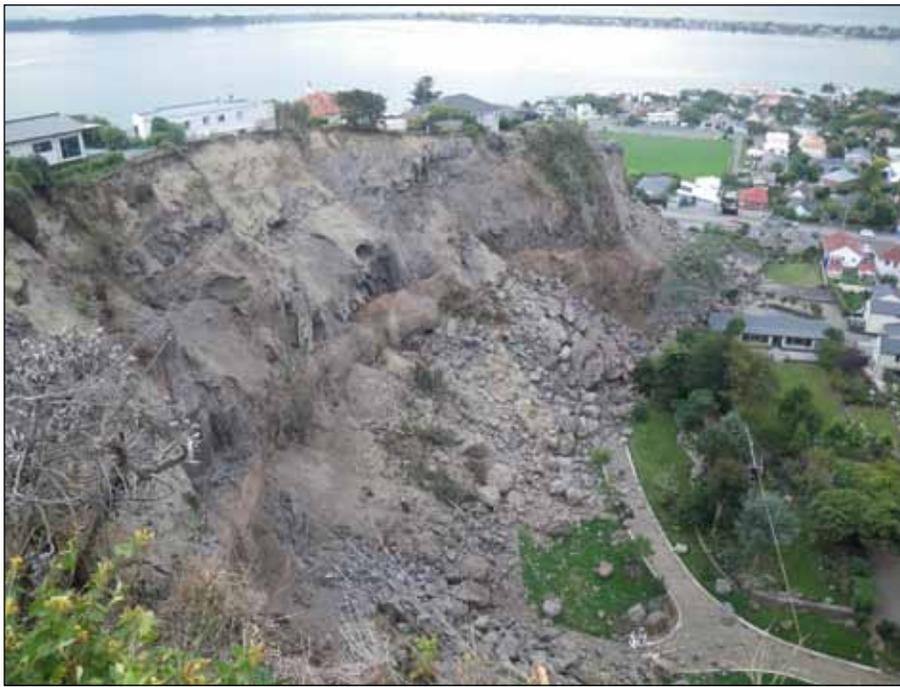
In some cases, entire cliffs collapsed (Figure 5), while in others boulders up to 5m in diameter were dislodged. Tension cracks 10-20m back from the cliff edges, often through residences, are being monitored. The prodigious rockfall was likely due, in part, to a number of source areas having been loosened in the September earthquake; furthermore, the February quake produced significant vertical ground accelerations as well as topographic effects that increased ground motions.

**Figure 5.** Large and damaging rockfall behind Moa Cave Guest house, Red-cliffs (photo: Mote).

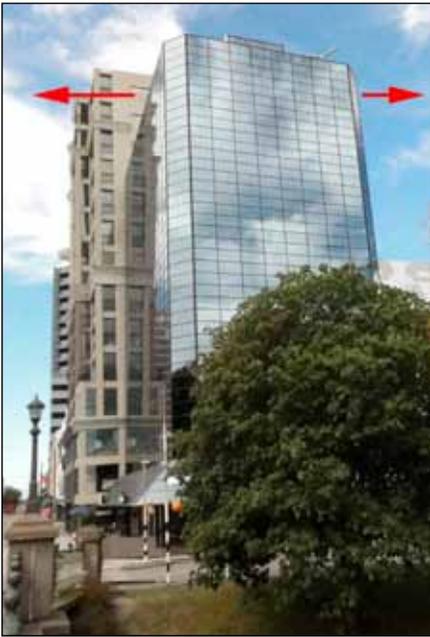
**Figure 6.** Differential movement of adjacent buildings (approximately 700mm at roof level) due to foundation rotation (photo: Elwood).

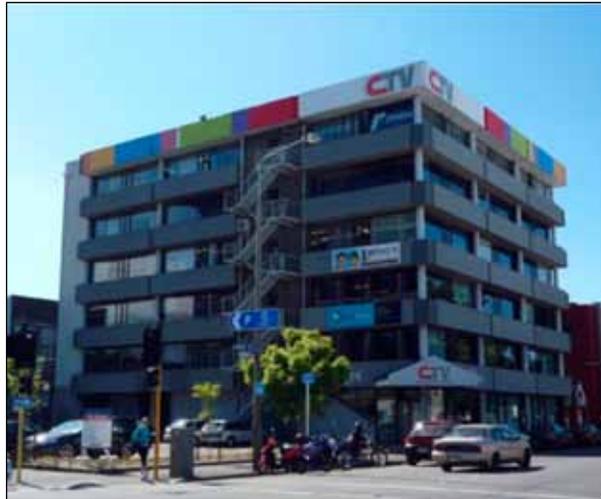
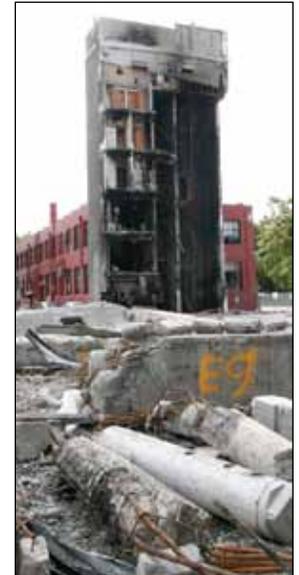
**Figure 7.** Collapsed reinforced concrete buildings: (a) ▲ The CTV Building and core wall (photos: Kam, Berkowitz); (b) ▼ The PGC Building (photo: Elwood).

Two reinforced concrete office buildings collapsed (Figure 7): the Canterbury Television (CTV) Building, which caused approximately half the fatalities in the quake, and the Pyne Gould Cooperation (PGC) Building, where 12 people perished. The six-story reinforced concrete CTV building was designed in the mid-1980s and consisted of a coupled shear wall on the south side and a core wall on the north side of the building. The entire building, with the exception of the core wall, collapsed (Figure 7a). The PGC building, designed and built in the early 1960s, was a five-story reinforced concrete frame building with a core wall offset towards the rear of the building. The top four stories collapsed onto the intact first story, with some floor slabs appearing to detach from the core wall (Figure 7b).

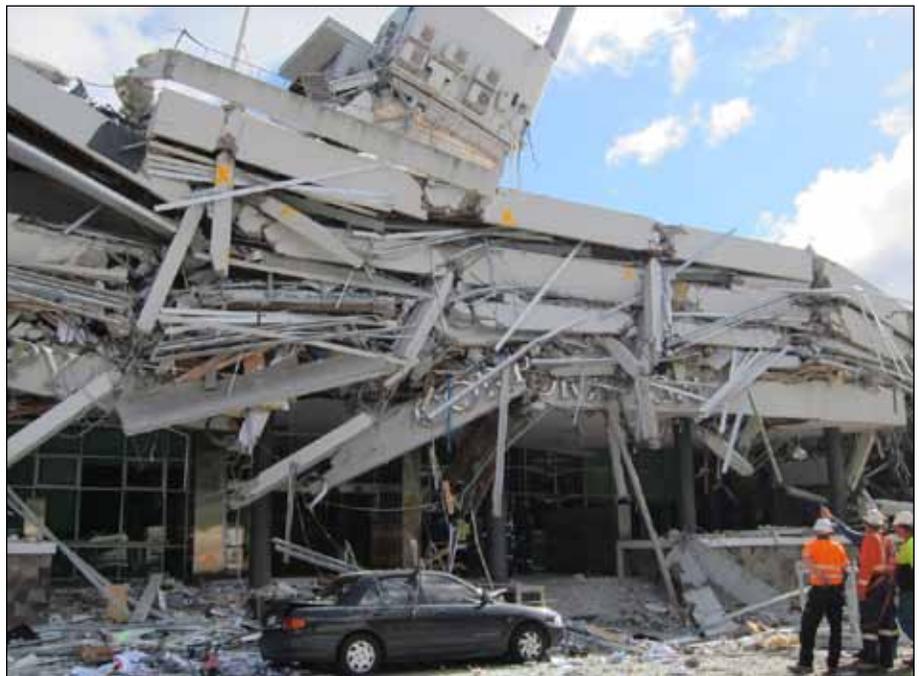
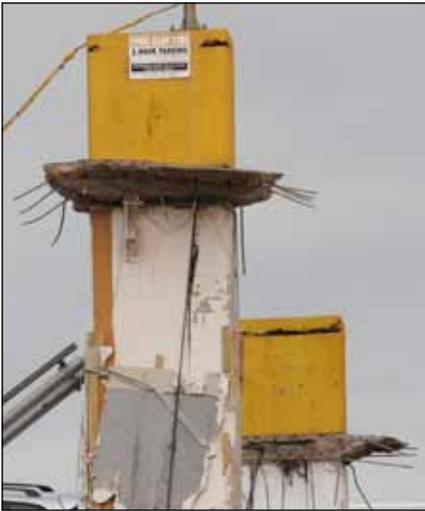
**Figure 8.** Punching shear failures in parking garage (photo: Berkowitz).

Punching shear failures of a prestressed floor slab resulted in partial collapse of a concrete parking garage at the south edge of the CBD (Figure 8). After the earthquake, a permanent twist and residual lateral displacement could be observed in the 19-story Hotel Grand Chancellor, one of the tallest buildings in Christchurch (Figure 9). The east side of the building cantilevered over an

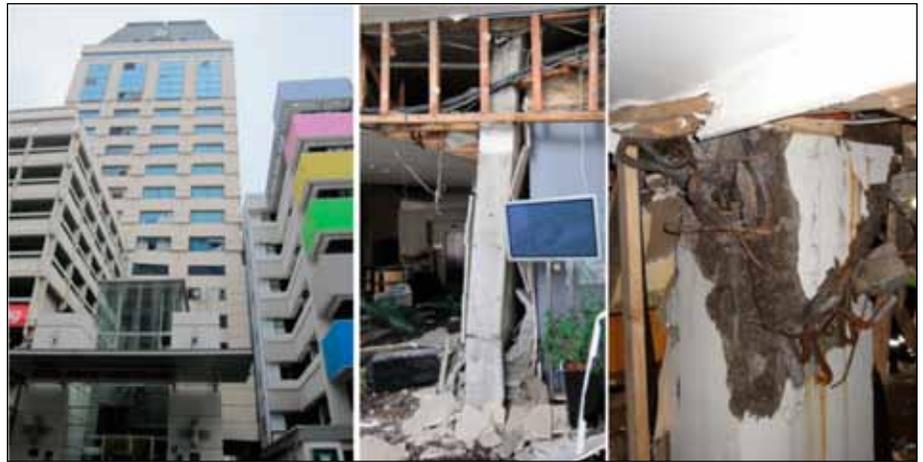
**Figure 9.** A permanent twist and residual lateral displacement in the 19-story Hotel Grand Chancellor (photos: Elwood, Comerio).

adjacent laneway by the means of transfer girders located on the seventh story, and out-of-plane shear failure was observed at the base of the wall providing the prop for the southernmost transfer girders. Three columns in the same grid line as the transfer girders on the sixth story also exhibited shear and axial failures. The building was surveyed for several days following the earthquake and the lateral displacement was not found to be increasing despite many aftershocks. The dam-

aged wall was stabilized within a week of the earthquake, but the building is now set for demolition.

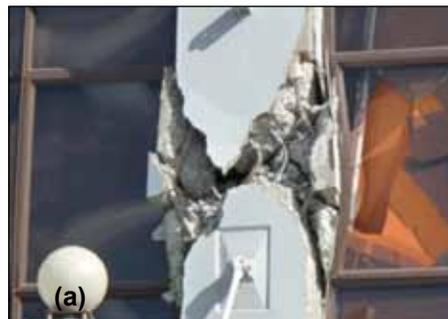
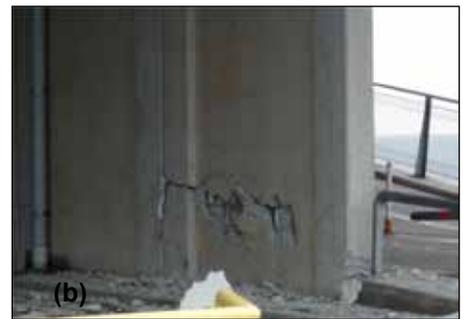
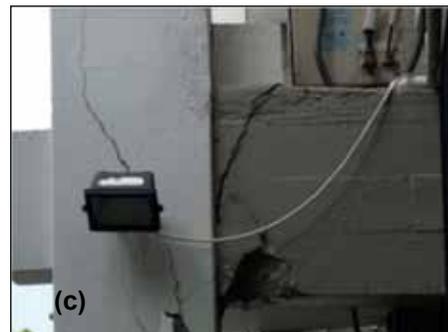
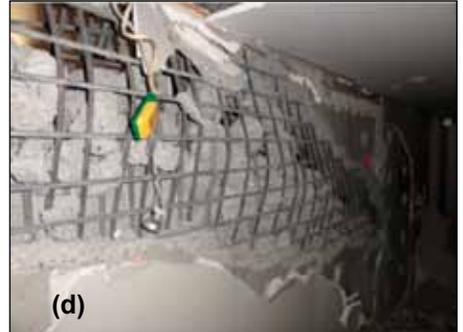
**Figure 10.** Examples of damage in concrete buildings: (a) column shear failure, (b) precast wall damage, (c) beam-column joint, (d) wall damage (photos: Sritharan).

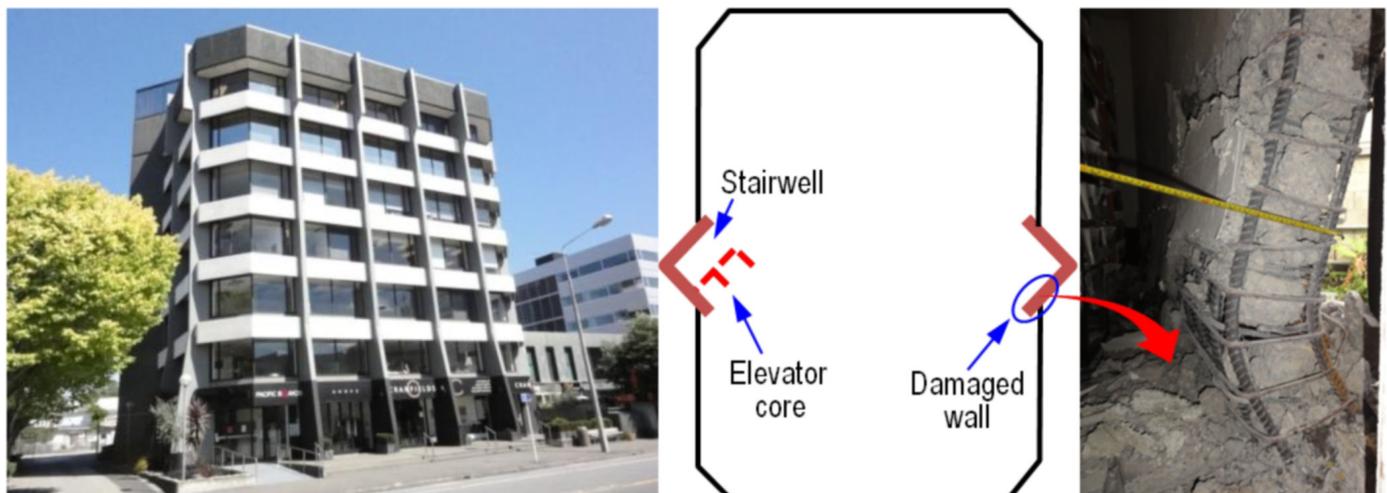
Figure 11. Damaged wall with good reinforcement details (photos: Sritharan, Elwood).

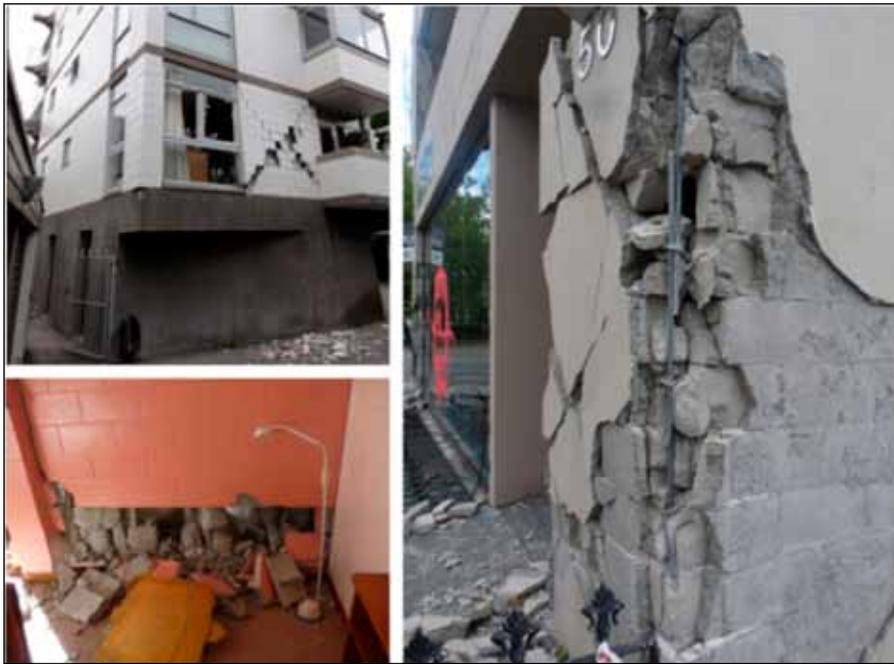
sitating demolition. Typical damage included shear failure of walls and failure of walls and columns due to poor grouting of reinforcement within the masonry cells (Figure 12).

**Figure 12.** Examples of reinforced masonry damage in multi-story buildings (photos: Jaiswal and Sritharan).

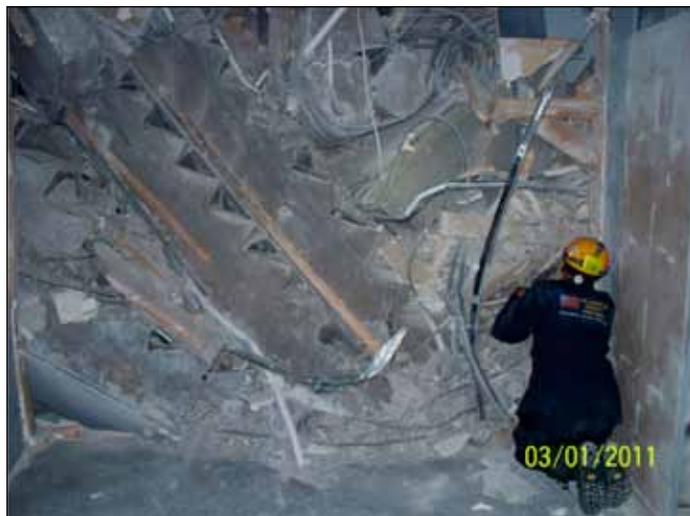
**Figure 13.** Collapsed precast concrete stairs in multi-story building (photo: Carri).

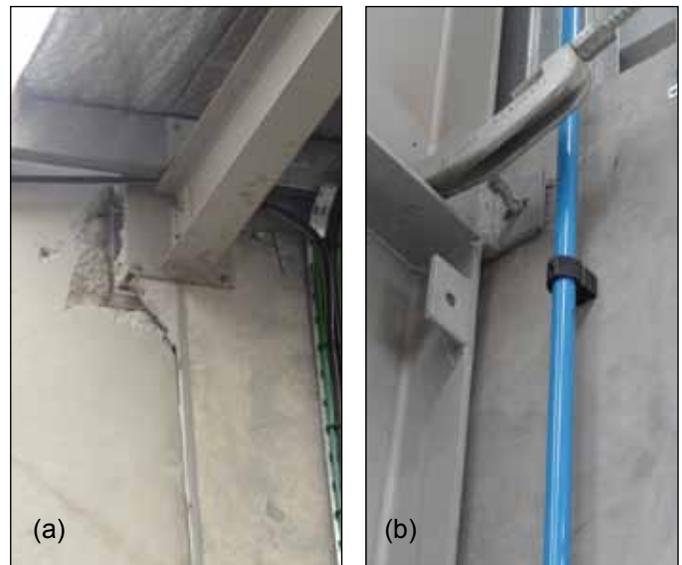
**Figure 14.** Damage to industrial buildings at steel-to-concrete connections: a) roof beam-panel connection in load-bearing tilt-up building; b) steel frame-panel connection in building with nonload-bearing concrete panels (photo: Marshall).

one foot (Figure 14a); note the absence of a continuous ledger at the diaphragm to concrete panel connection. On the west wall, the panels had cracked near midspan and deflected outward six inches.

In several buildings with steel frames and concrete precast panels, flexibility of the steel frame relative to the concrete panels likely resulted in failure of the connection between the frame and precast panels (Figure 14b). In one case, 12 wall panels dropped from a single warehouse. Typically, the end wall panels cracked because they were stiffer than the steel frame.

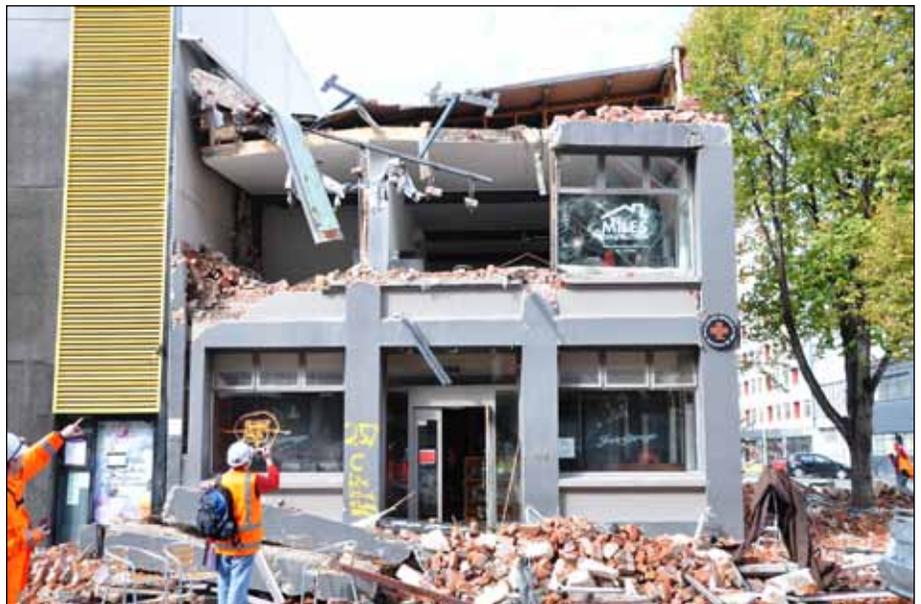
**Figure 15.** The EERI Team studies the performance of this heavily damaged, retrofitted URM building that pounded against the building on the left and partially collapsed (photo: Turner).

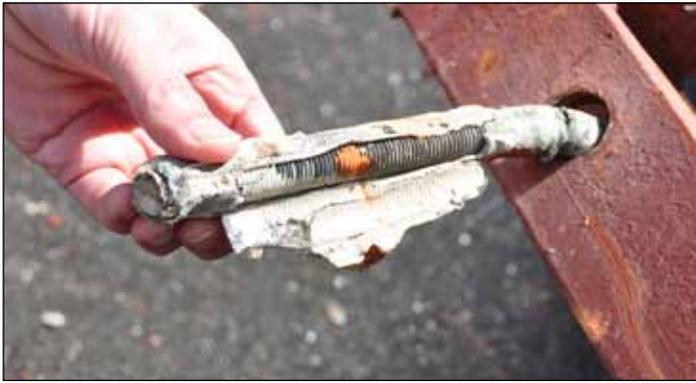
**Figure 16.** This adhesive anchor at a URM parapet connection pulled out. A wire screen with white adhesive around the threaded rod had been inserted into a hole in the brick (photo: Turner).

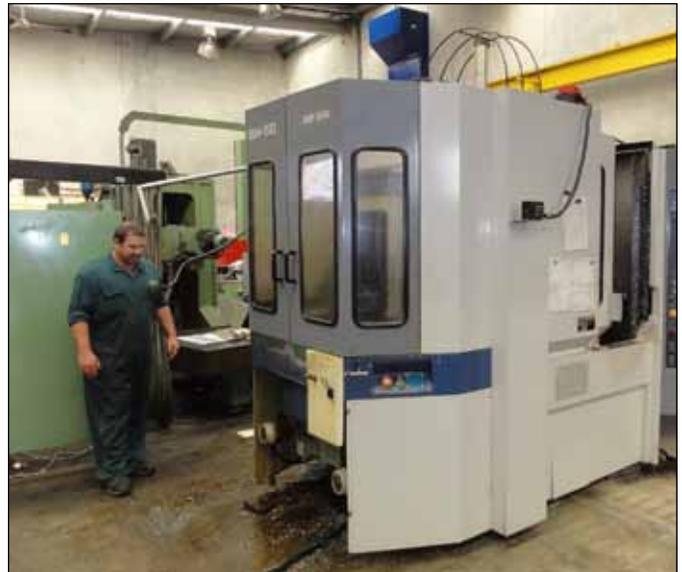
observed with substantial non-structural damage to critical equipment and supporting infrastructure. At one location, high vertical and horizontal accelerations moved 25,000-pound machining equipment about one meter from the original position, as shown in Figure 17. Workers at the facility described seeing the large equipment literally “bounce” across the floor. At a nearby textile facility, precision equipment was damaged by the ground motion; the misaligned equipment would have caused short-term production disruptions, but widespread liquefaction damaged the factory floor slabs and put the facility out of business for an undetermined period of time. As was the case in September, numerous storage rack collapsed in warehouses (Figure 18), necessitating the disposal of damaged goods.

**Figure 17.** Equipment weighing 25,000 lbs moved approximately one meter (worker’s foot indicates the original position of the equipment) (photo: Marshall).

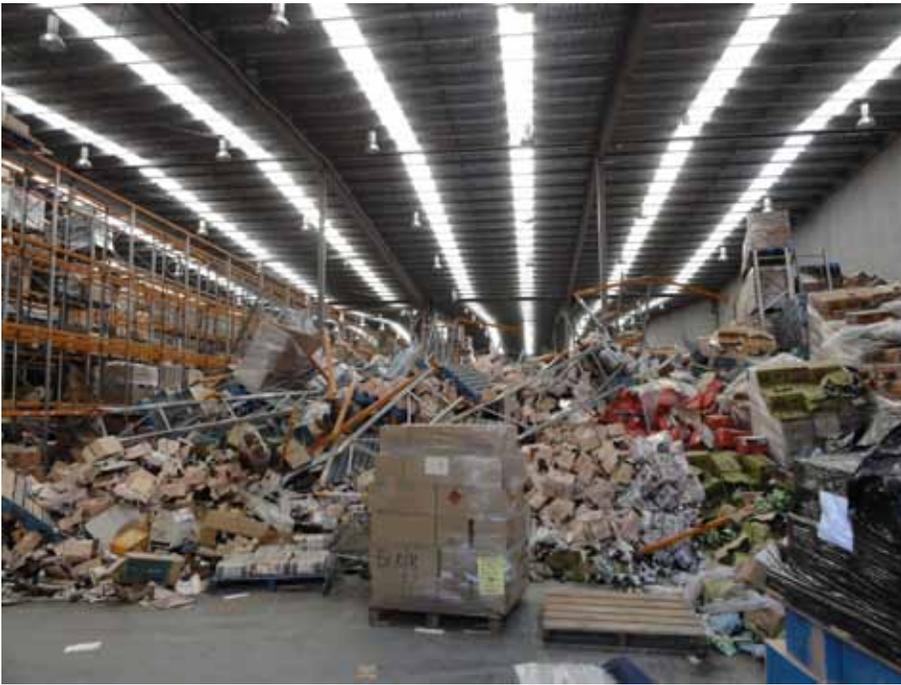
**Figure 18.** Collapse of storage racks (photo: Elwood).

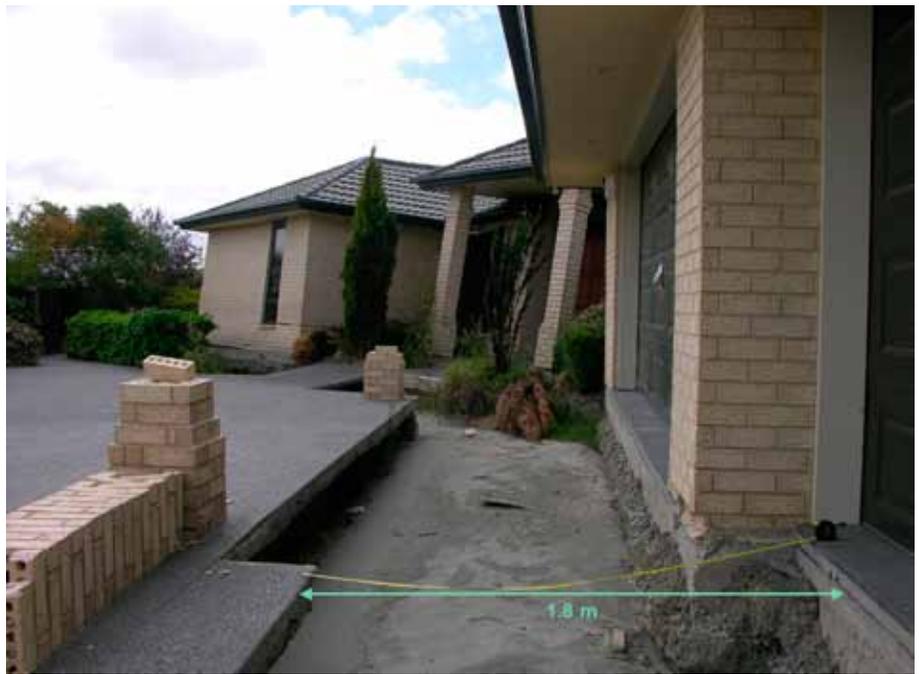
**Figure 21.** A house in Kaiapoi moved on its foundation in both the September and February earthquakes a total of 1.8m (photo: Lai).
