# CALTRANS BRIDGES DURING WHITTIER 1987 EARTHQUAKE

ROUTE 605/5 SEP. (BR No. 53-1660)

A short Seismic Report from the Office of Structures Design by the Post Earthquake Investigation Team describes the number of bridges affected by the Whittier event. The details of damage to the Route 605/5 Separation bear repeating:

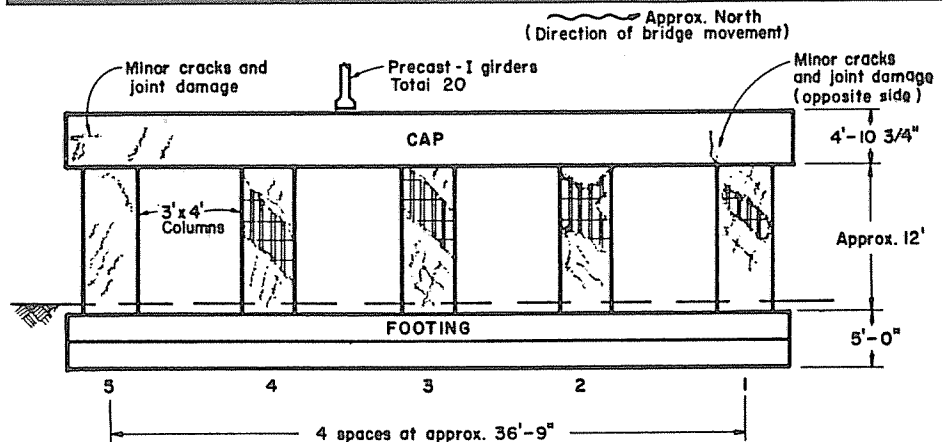
BENT 6 EAST FACE

The most damaged area was Bent 6, the center support for the two main spans. All 5 columns were damaged with the three interior more damaged than the 2 exterior columns. Major cracking occurred on the east and west faces (wide sides) of

all columns. Minor cracks were observed on the north and south faces (short sides). The shear reinforcement in the middle column fractured at two levels and necked at another; however there was no evidence of rebar fracture in the remaining four columns. Also there were cracks in the bent cap adjacent to the most southerly column (column #5).
