# PRELIMINARY REPORT ON THE OHIO EARTHQUAKE OF JANUARY 31, 1986

By Neil J. Monroe, M.EERI, and John D. Stevenson, M.EERI

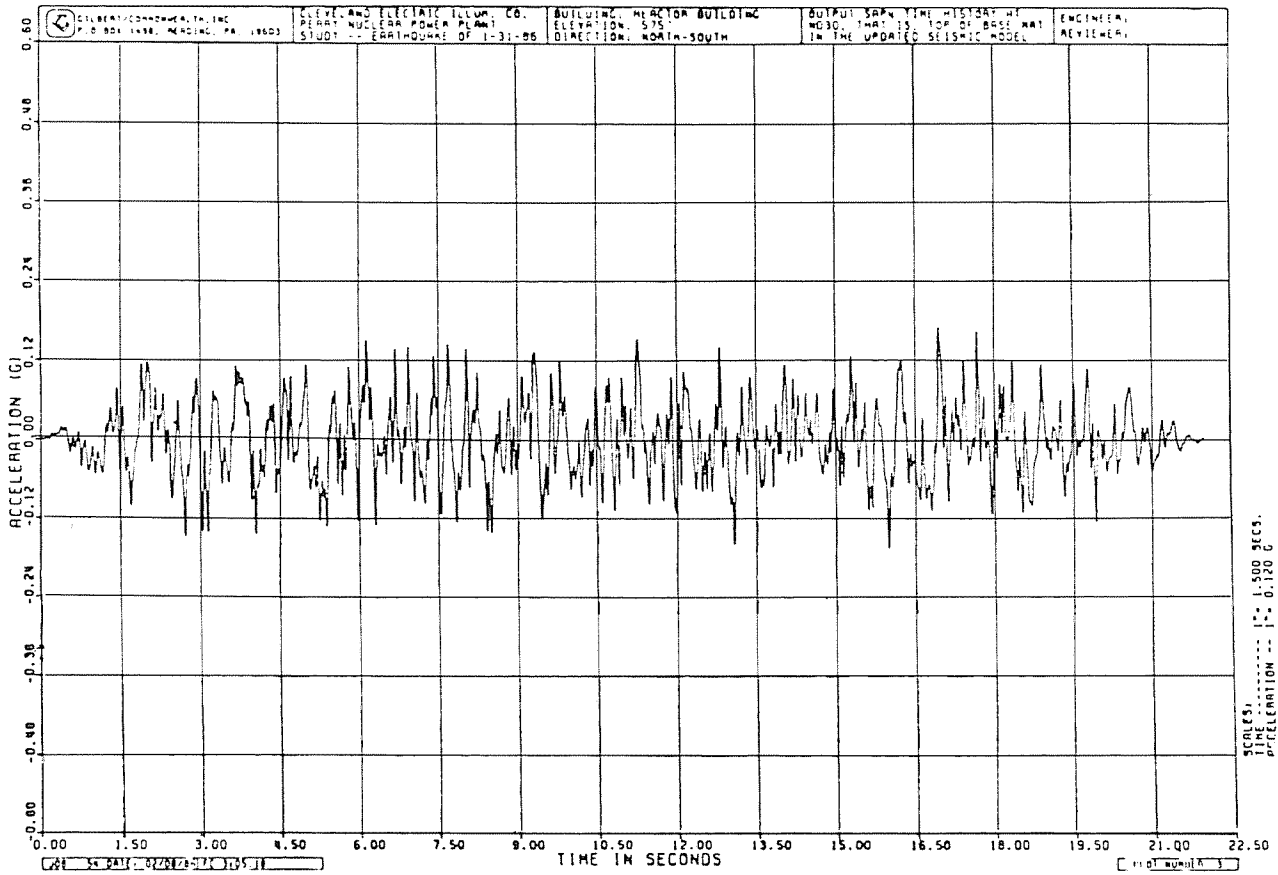
Figure 1. Perry Design Time History Ground Motion Based on R.G. .60 Spectra

The time history seismic design basis for the Perry Station is shown in Figure 1. By way of comparison, the measured time history from the earthquake is shown in Figure 2. Obviously, the measured earthquake is characteristic of short duration, low energy, high frequency motion with little potential for damage. The design basis motion contains high energy, broad frequency and long duration associated with damaging strong motion earthquakes as shown in the Figure 1 time history motion.

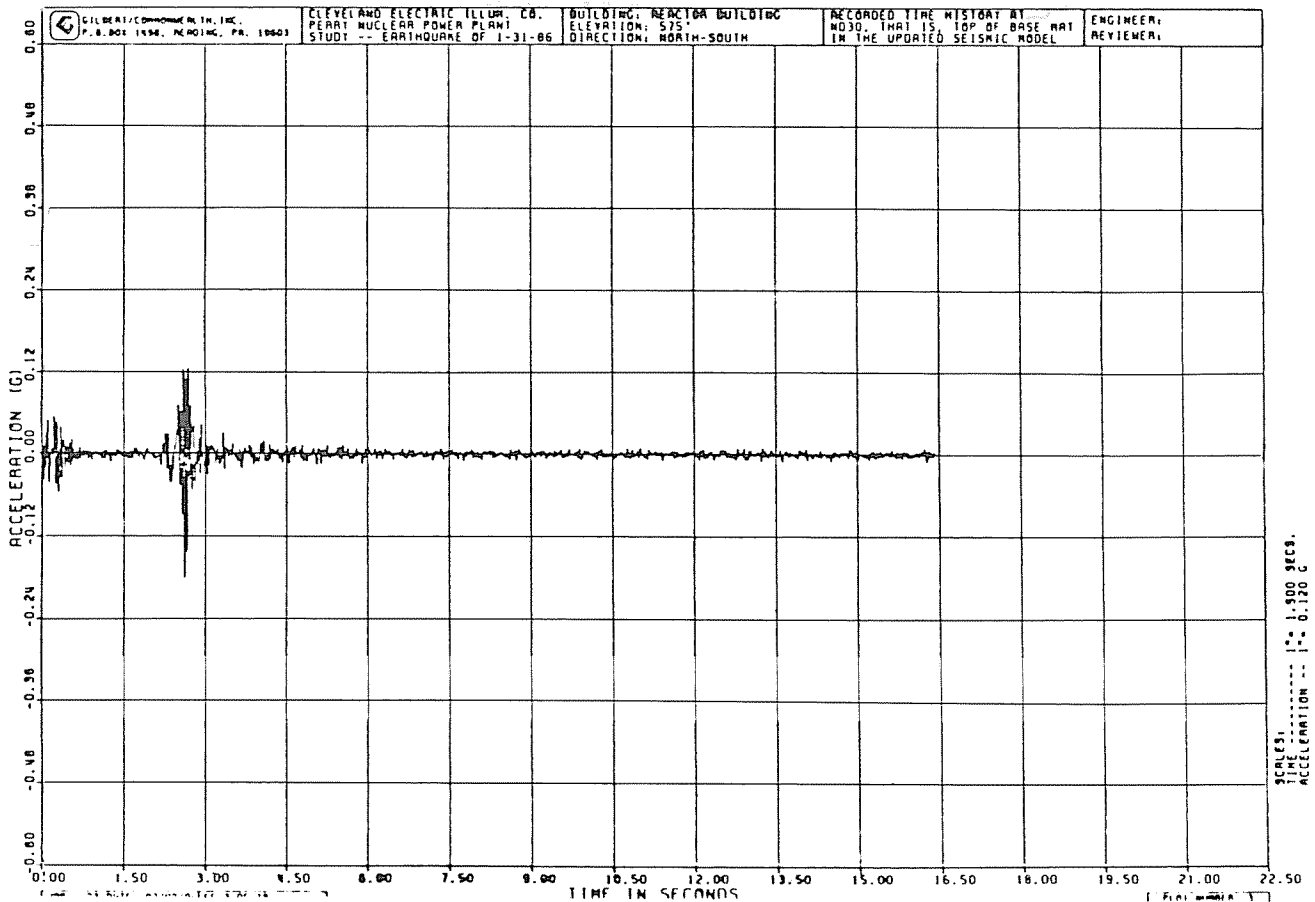
Figure 2. Recorder Motion of Ohio, 1986 Earthquake Motion at Base of Perry Containment Structure
