THE CENTRAL PERUVIAN EARTHQUAKE OF AUGUST 15, 2007 : A PRELIMINARY REPORT

The Central Peruvian Earthquake of August 15, 2007 : A Preliminary Report

Prof. Richard E. Klingner
The University of Texas at Austin
Member, Reconnaissance Team
Peru - Japan Disaster Mitigation Center

Structures Seminar
The University of Texas at Austin
August 29, 2007

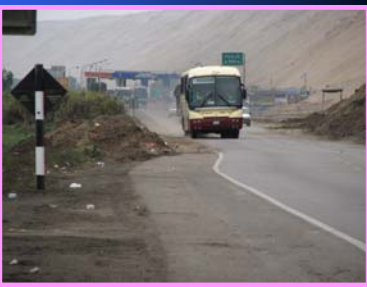
Along the way, geotechnical damage was evident...

- gross lateral movement of highway due to ground shifting

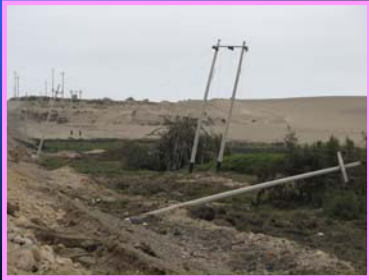
... along the way, geotechnical damage was evident

- *overturned utility poles, probably due to liquefaction*

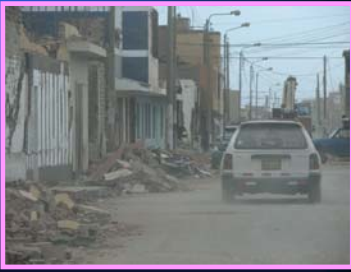
Pisco was badly damaged

- *Pisco has a population of about 120,000*
- *about half of the buildings in Pisco were destroyed*

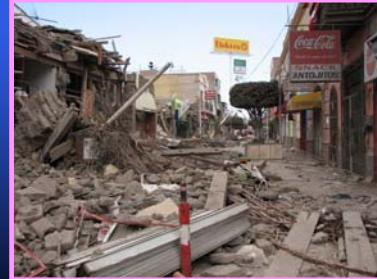
... adobe structures generally collapsed

- this is typical of damage in Pisco
- about half the city's buildings , most of adobe , collapsed

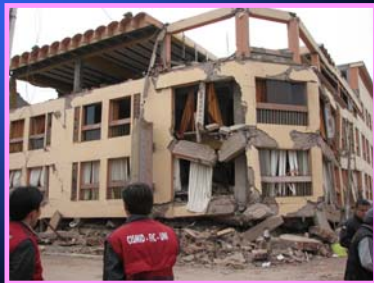
... problems with plan eccentricity

- Embassy Hotel
- corner building

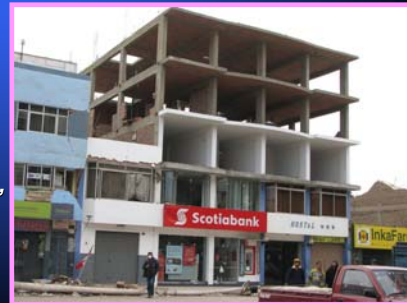
problems with walls perpendicular to street only ...

- building to west of main plaza
- decent detailing , note damage to infills

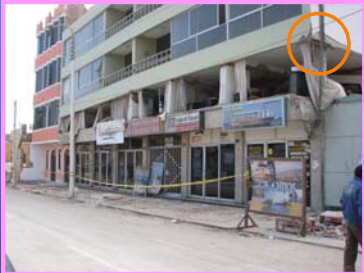
... problems with walls perpendicular to street only

- building to northeast of main plaza
- note collapsed columns at 2nd story

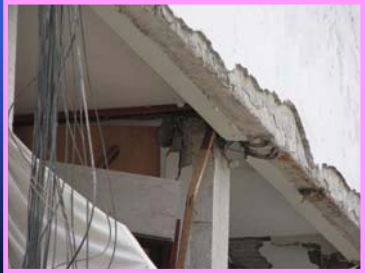
... problems with walls perpendicular to street only

- insufficient lateral resistance parallel to street
- detailing problems with columns

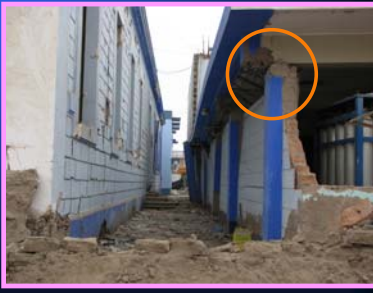
... problems with captive columns

- note partial infill of right-hand building

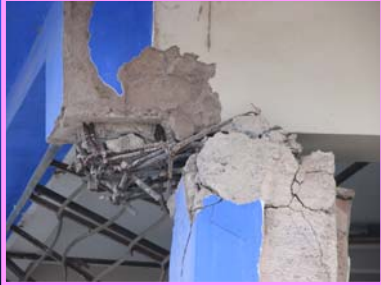
... problems with captive columns

- captive column created by partial infill has collapsed

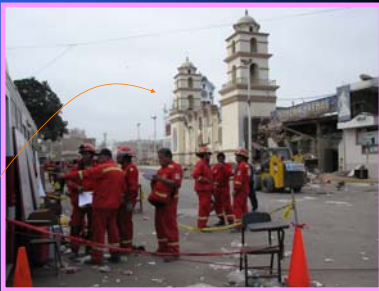
Church of San Clemente, main plaza

- volunteer firefighters (search and rescue)

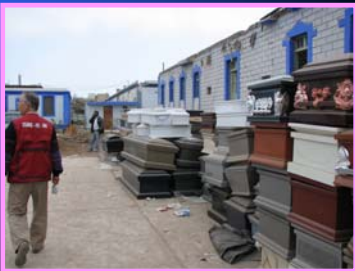
- more than 500 dead
- medical facilities almost totally destroyed
