## Learning from Earthquakes

### Bolivian Earthquakes of May 22-23, 1998: A Summary Report

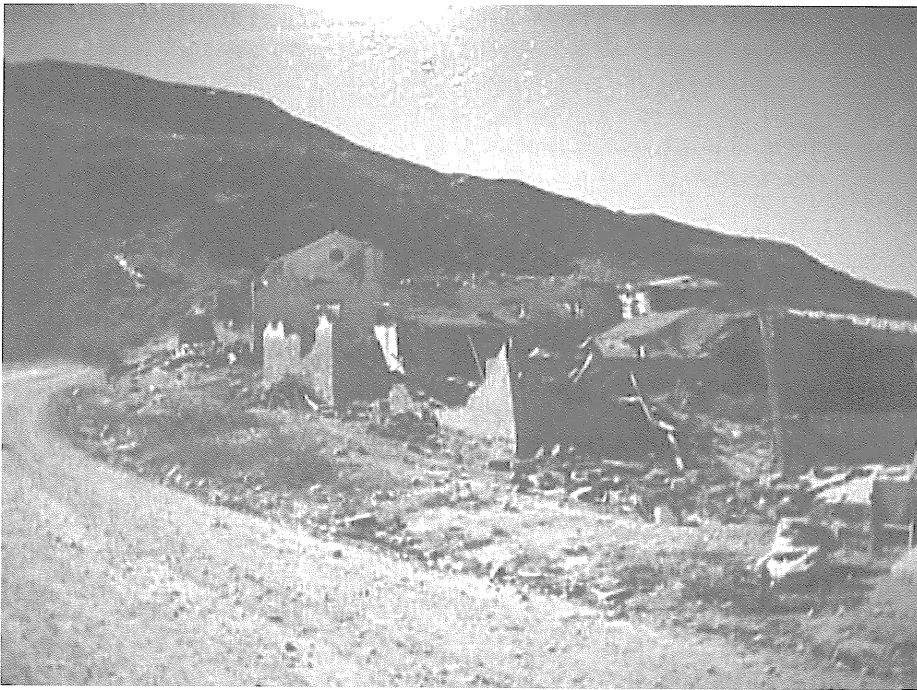
Single-story "adobe" (unburnt, sun-dried mud brick) buildings, mostly residences and small shops, greatly dominate this remote region. In fact, there are several relatively large, adobe-style communities in the region that were abandoned when the mining of tin ore ceased several decades ago.

Early reports indicated that 70-80% of the buildings in Totorá and Aiquile were damaged, and about 50% of them (200 buildings) "will have to be torn down." Aftershocks added to the damage and also accelerated the tearing down of damaged structures by relief workers.

*Figure 2 – A high percentage of the adobe buildings was damaged.*

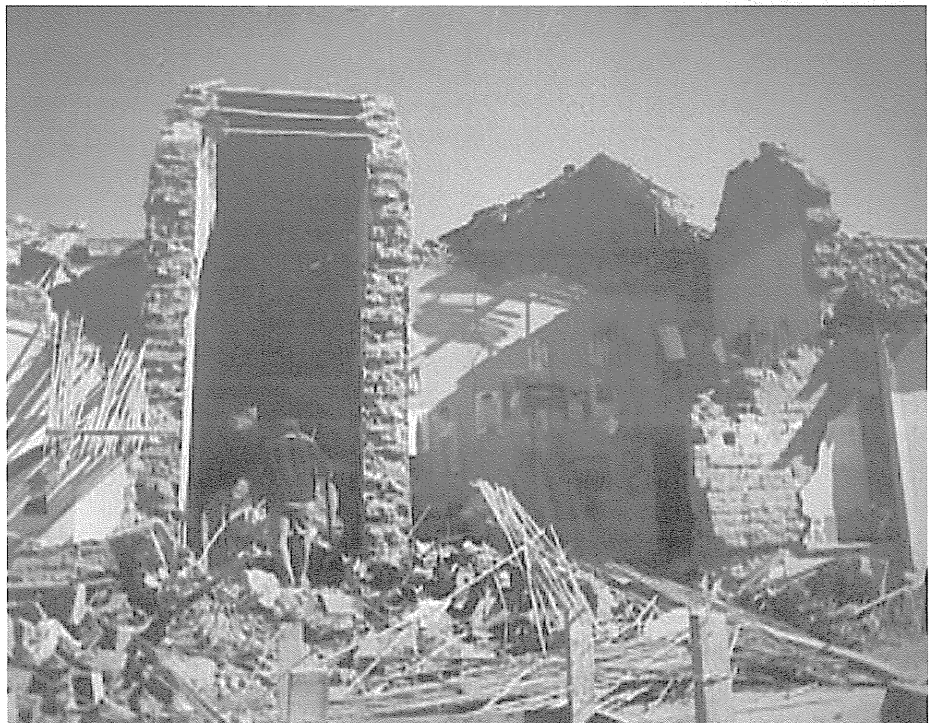
*Figure 3 – Searching an adobe structure after the dust had settled.*
