Kuril Islands Earthquake of October 4, 1994

Contributed by Harry Yeh (Department of Civil Engineering, University of Washington). A preliminary report on the earthquake was reported in the November issue of the Newsletter. The effects of the earthquake were also felt in Japan, as reported in the December Newsletter, where it was referred to as the "Hokkaido Toho-oki" earthquake. The publication and distribution of this report was funded by National Science Foundation Grant #BCS-9215158.

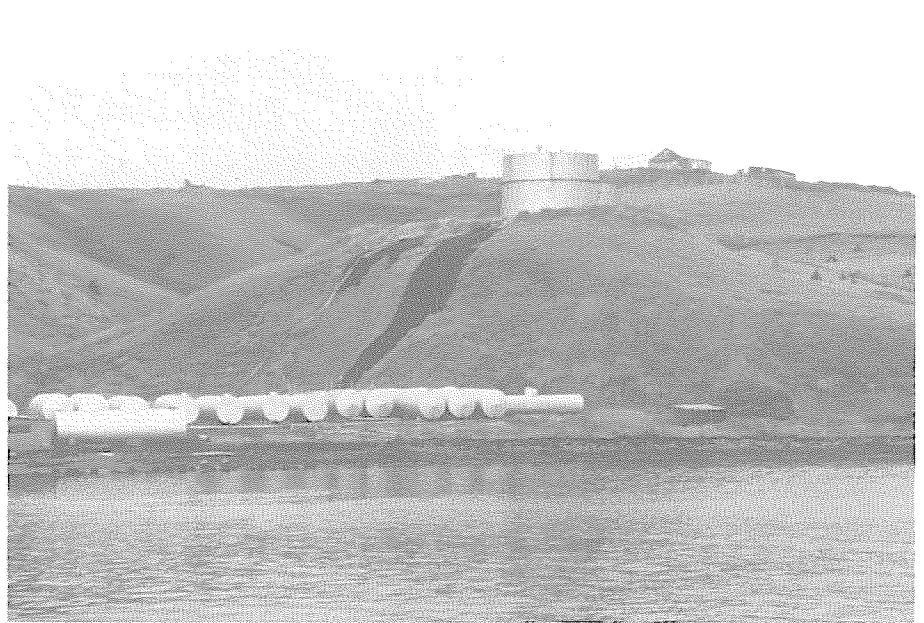
Figure 1—Oil leak damage from storage tanks in Malokurilsk.

Oil storage tanks in the villages of Malokurilsk and Krabozavodsk suffered major damage: oil leaked from nearly every tank situated on the hills overlooking the villages. Both ports were heavily contaminated (Figure 1), and as of October 25, there were no signs of a clean-up operation. The tank damage was most likely caused by failure of the foundation; all the tanks were placed on hillside cut-and-fill terraces.

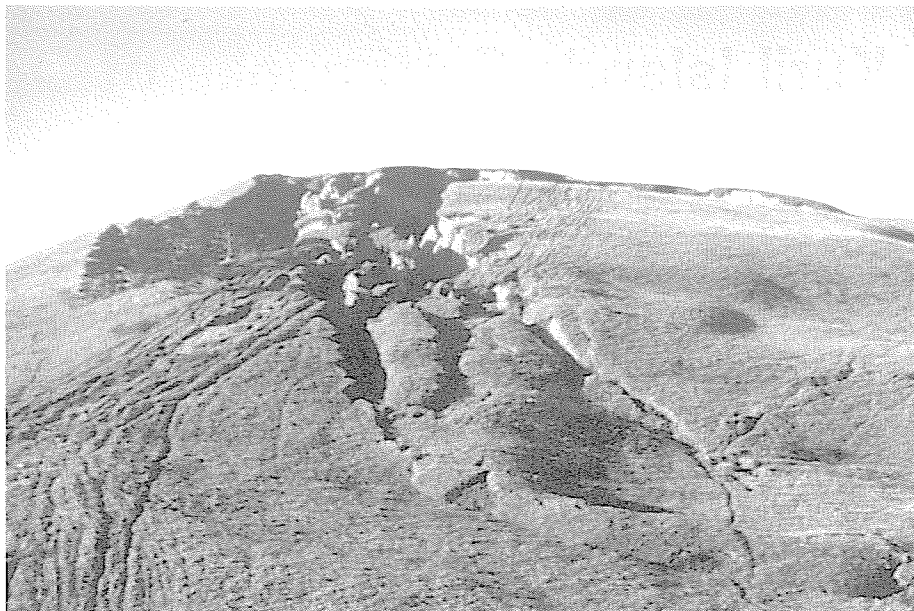
Many large landslides and fissure formations were observed on Shikotan. Near Malokurilsk, major fissure formations were observed on a grass-covered hill (Figure 2). It appears that a massive landslide

occurred into the sea, causing the formation of this fissure approximately 200 m from the sea cliff. Other significant fissure formations were found in Krabozavodsk, and were also located at a hill top leading to the sea cliff. Another landslide in Malokurilsk carried the radio station used for vessel navigation into the sea.

Figure 2—Major fissure formation near Malokurilsk, Shikotan. The fissure, maximum 30 m wide, 15 m deep, and approximately 350 m long, is formed parallel to the major landslide (approximately 80 m high) along a sea cliff. Note that the size of trees shown is approximately 5 m high.
