The National Palace is located in the heart of Managua on the south side of La Plaza de la Republica. It consists of three floors and a basement.

## 30,000 Lin. Ft. of Cracks Repaired In Nicaragua's National Palace

By E. Rappacioli & M. Rivas Davies  
Pro-Con S. A., Managua, Nicaragua

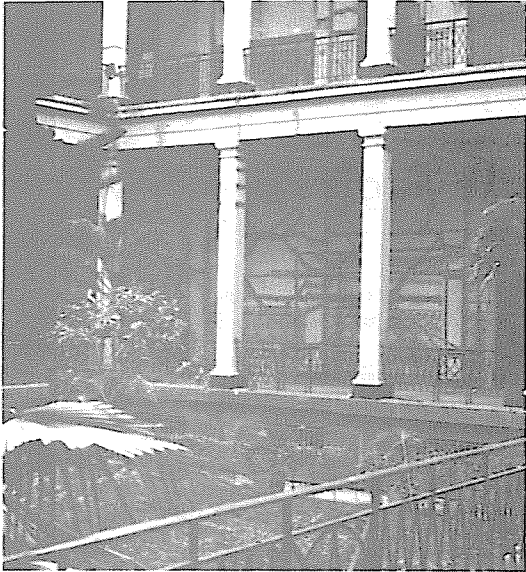
All walls of the three floors facing the courtyard were cracked, as were the perimeter columns.

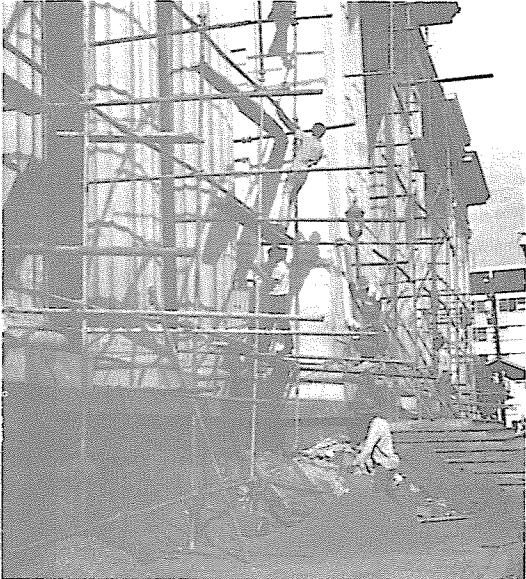
(Above) Six workmen sealed crack surfaces with a temporary seal and two technicians manned each of seven pumping machines. (Below) Repaired roof structure shows typical concrete cracking pattern.
