# World Housing Encyclopedia Report

Country: El Salvador

Housing Type: Vivienda de Adobe (Adobe house)

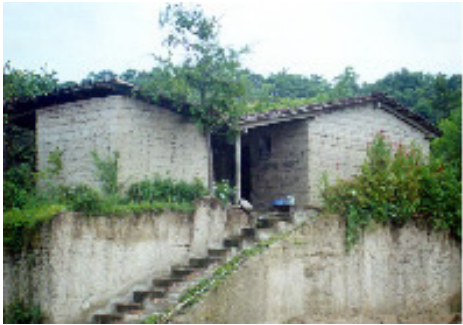
FIGURE 1: Typical Building

Rural: Adobe houses are generally small structures, 5 m X 6 m in plan, having load-resistant walls made of adobe bricks with thickness between 0.3 and 0.5 m. Usually, they are single family dwelling (5 people) houses. Wood planks that support metal sheets covered by tiles can constitute the roof. In some cases, the roof can be a thatched roof supported on wood purlins.

Urban: Adobe houses are much bigger in urban areas than in rural areas. Their plans are 15 m X 30 m or bigger. One floor structures. The wall thickness can easily reach 1 m and wall height can reach 3 m or more.

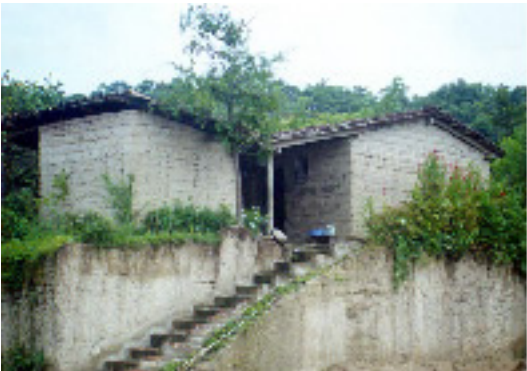
FIGURE 1: Typical Building

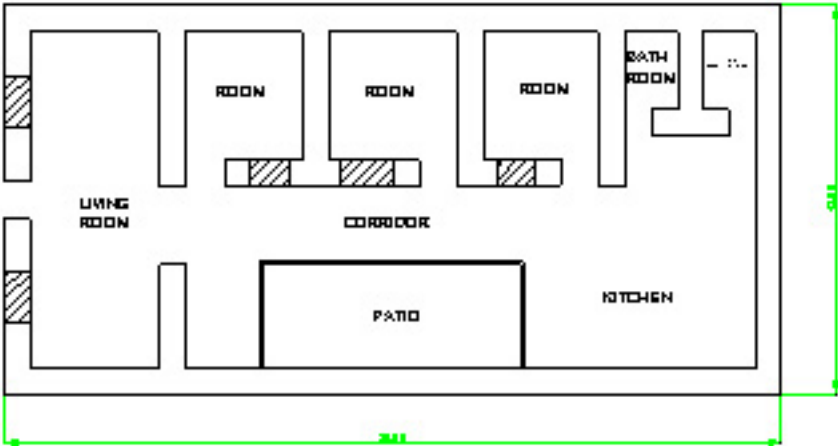
FIGURE 3A: Plan of a Typical Building

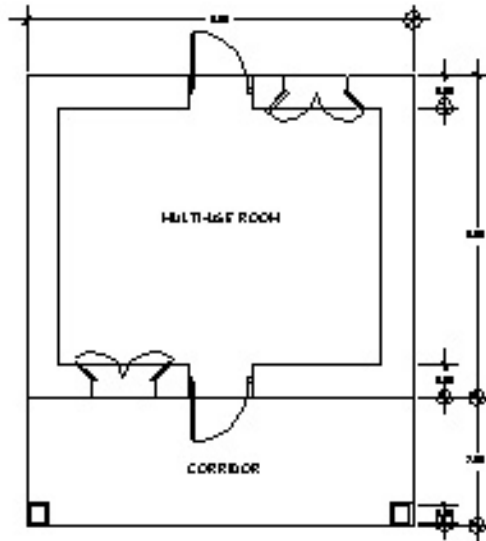
FIGURE 3B: Plan of a typical rural dwelling

Rural: Houses have four walls, two of which have openings. Openings are less than or equal to 30% of the wall area. The other two walls generally do not have openings.

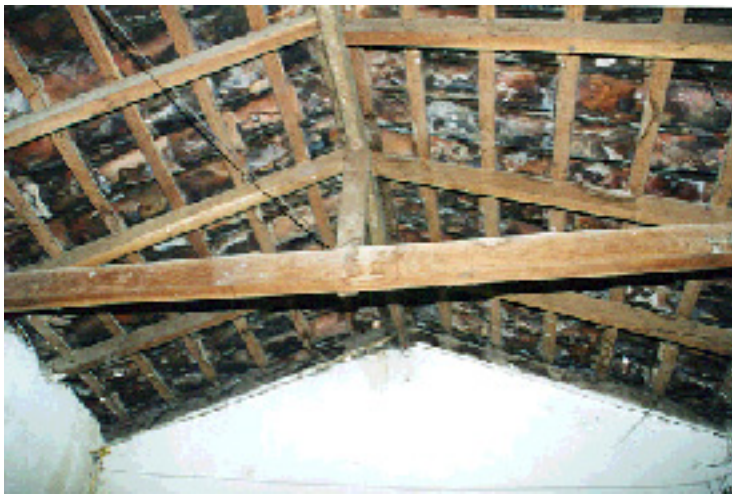
FIGURE 4A: Critical Structural Details-An illustration of wood beams supporting clay tiles and roof-walls connections

Roof loads are directly transmitted to the shear walls by wood purlins or beams. The beams directly rest on the top of the walls. Walls take the entire gravity load. Walls transfer the load to the foundation.

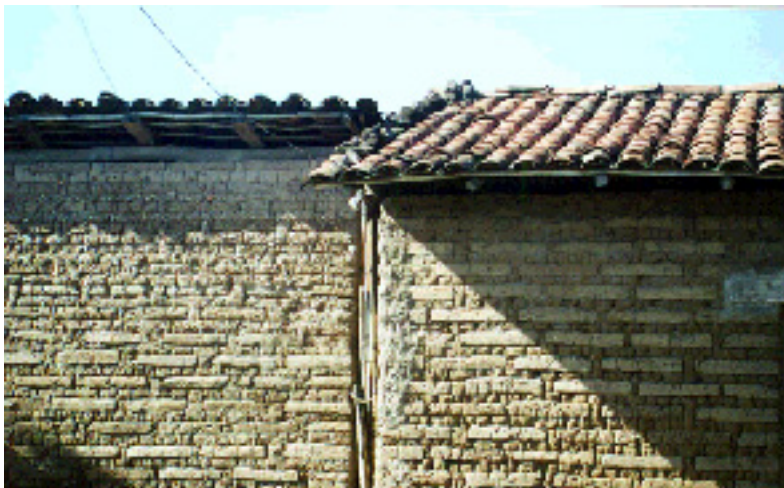
FIGURE 4B: Wall connections

Structural Element	Seismic Deficiency	Earthquake-Resilient Features	Earthquake Damage Patterns
Wall	There is a lack of dependable joints among walls, especially at the top of walls. This causes adjacent walls to open up during an earthquake.		Damages due flexural and shear effects.
Frame (columns, beams)			
Roof and floors	There is inadequate vertical and horizontal load transfer mechanism from roof to walls.		Total and partial collapse of the roof due to material degradation and loss of support from walls.

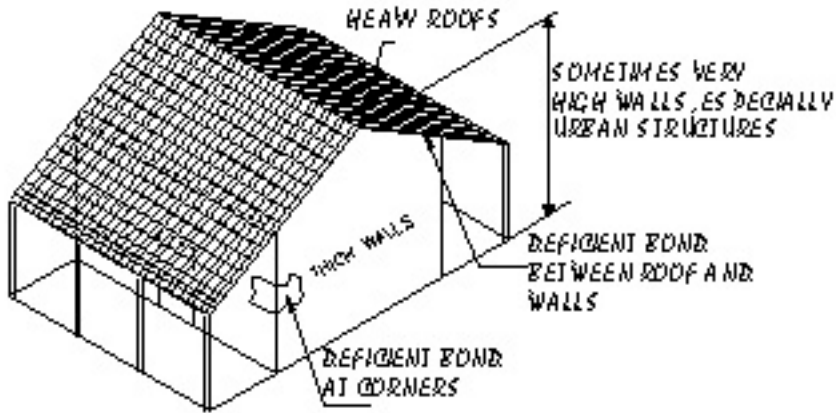
FIGURE 5A: An Illustration of Key Seismic Features and/or Deficiencies

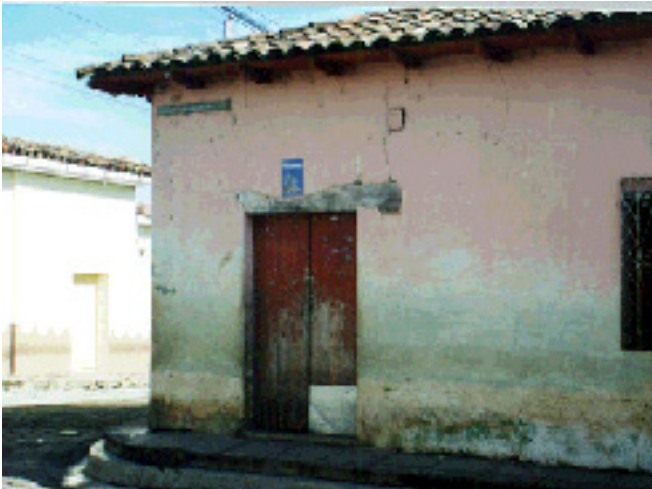
FIGURE 5B: Deficient bedding of lintels

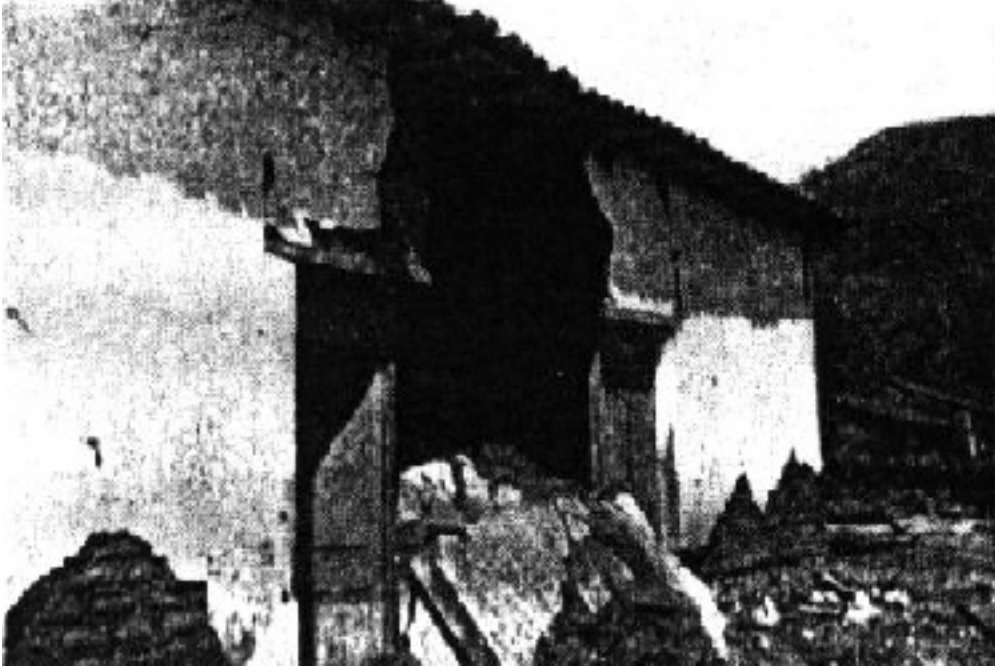
*FIGURE 6A: Damage to an adobe house in the 1936 San Vicente earthquake*

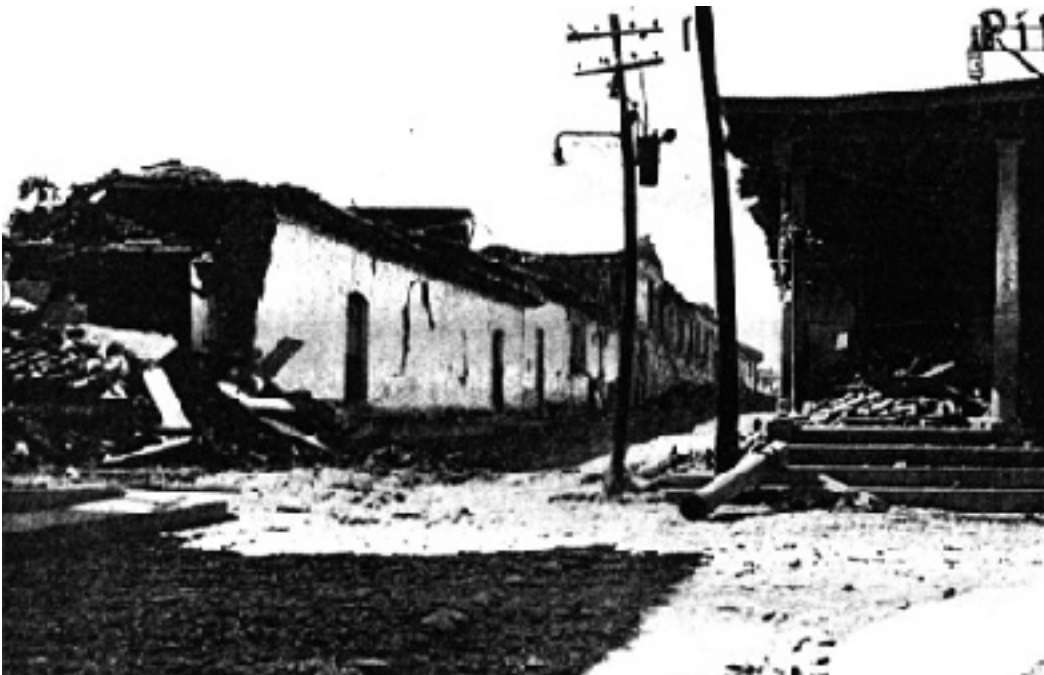
*FIGURE 6B: Damage to adobe houses in the 1936 San Vicente earthquake*

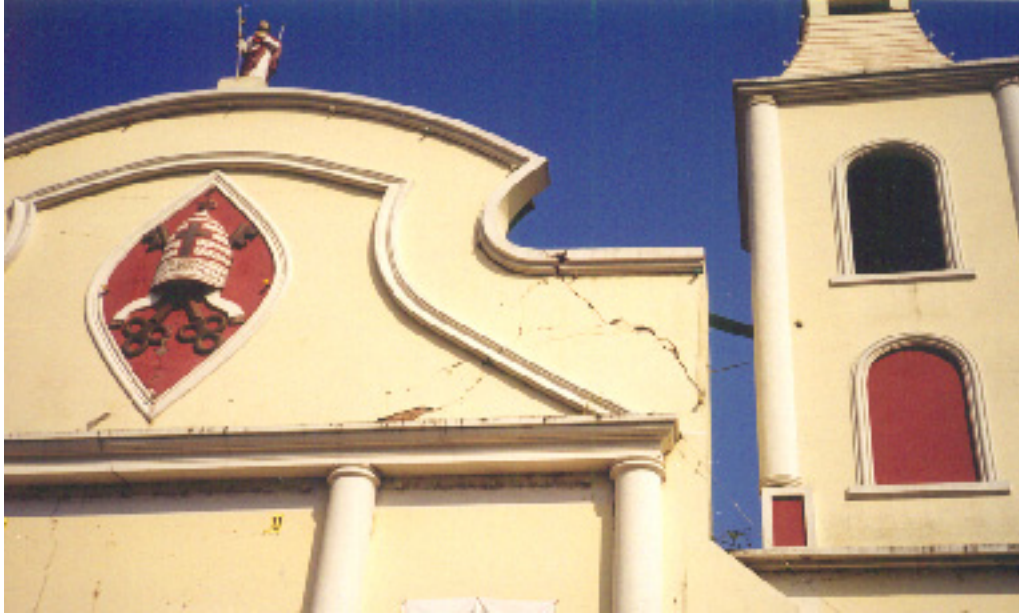
*FIGURE 6C: Damage to an adobe church in the 1999 Apastepeque earthquake*

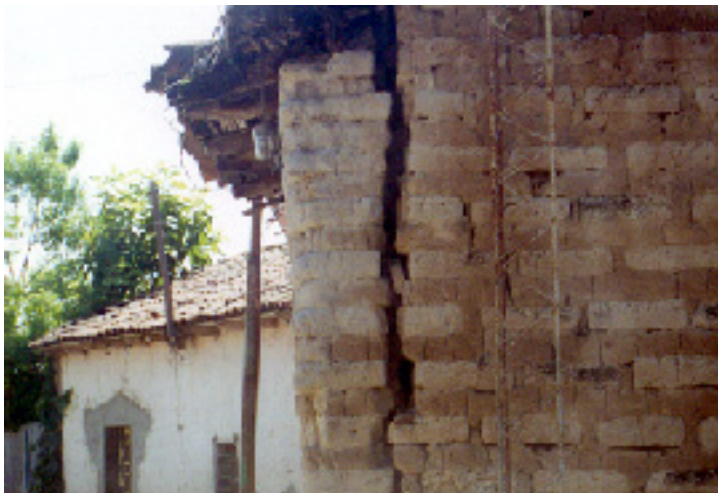
*FIGURE 6D: Wall damage (corner separation) in the 1999 Apastepeque earthquake*

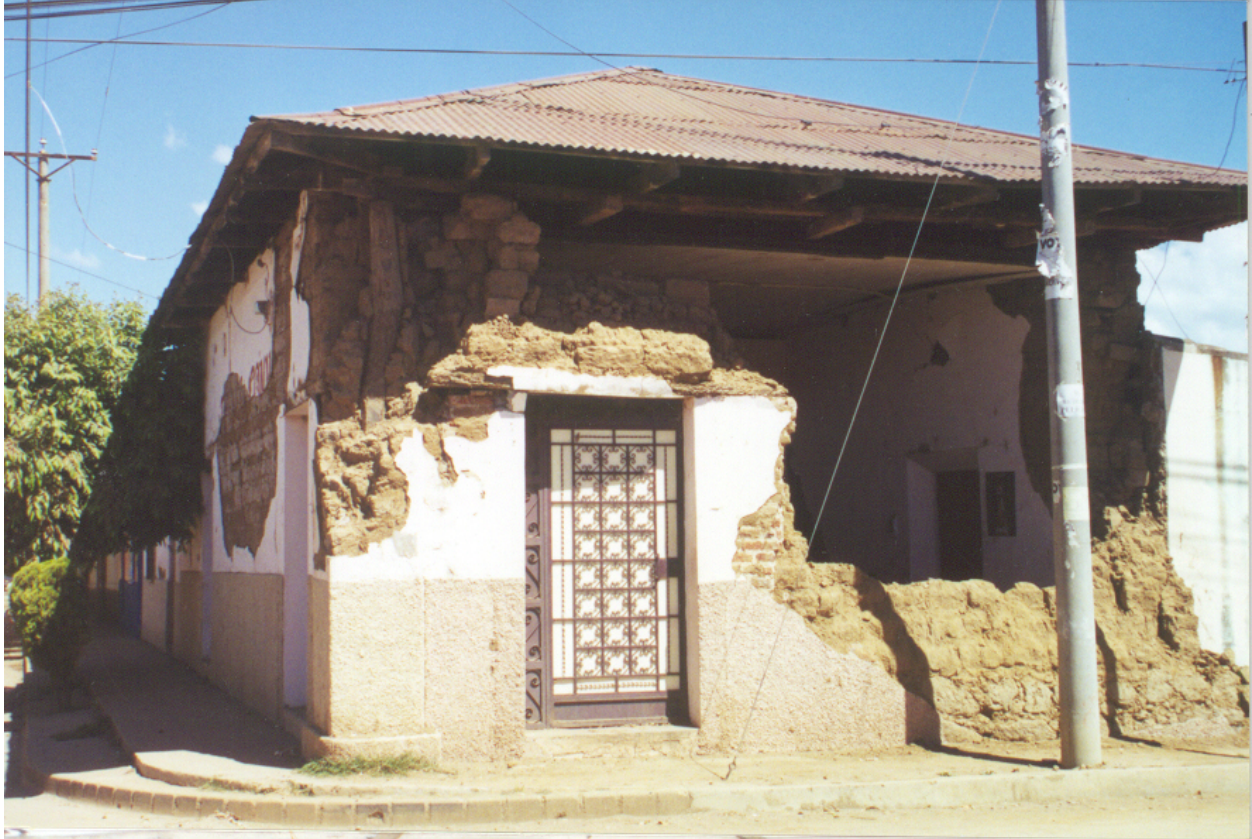
*FIGURE 6E: Damages in the town of Juayua due to the January 13, 2001 earthquake*

*Additional Comments:* 1986, San Salvador, 5.4 (MMI), VIII El Salvador had two big earthquakes at the beginning of 2001. The first one was on 13 January 2001 with its epicenter located in the Pacific Ocean and with magnitude  $M_w = 7.7$ , with a maximum estimated intensity of VIII (MMI). The second one happened on 13 February 2001 with epicenter at San Juan Tepezontes and  $M_w = 6.5$ ; the estimated intensity was VIII in some places, however in many of the affected areas its intensity was VII (MMI). One of the most important features of these two EQ is that they destroyed adobe housing in many places throughout El Salvador.

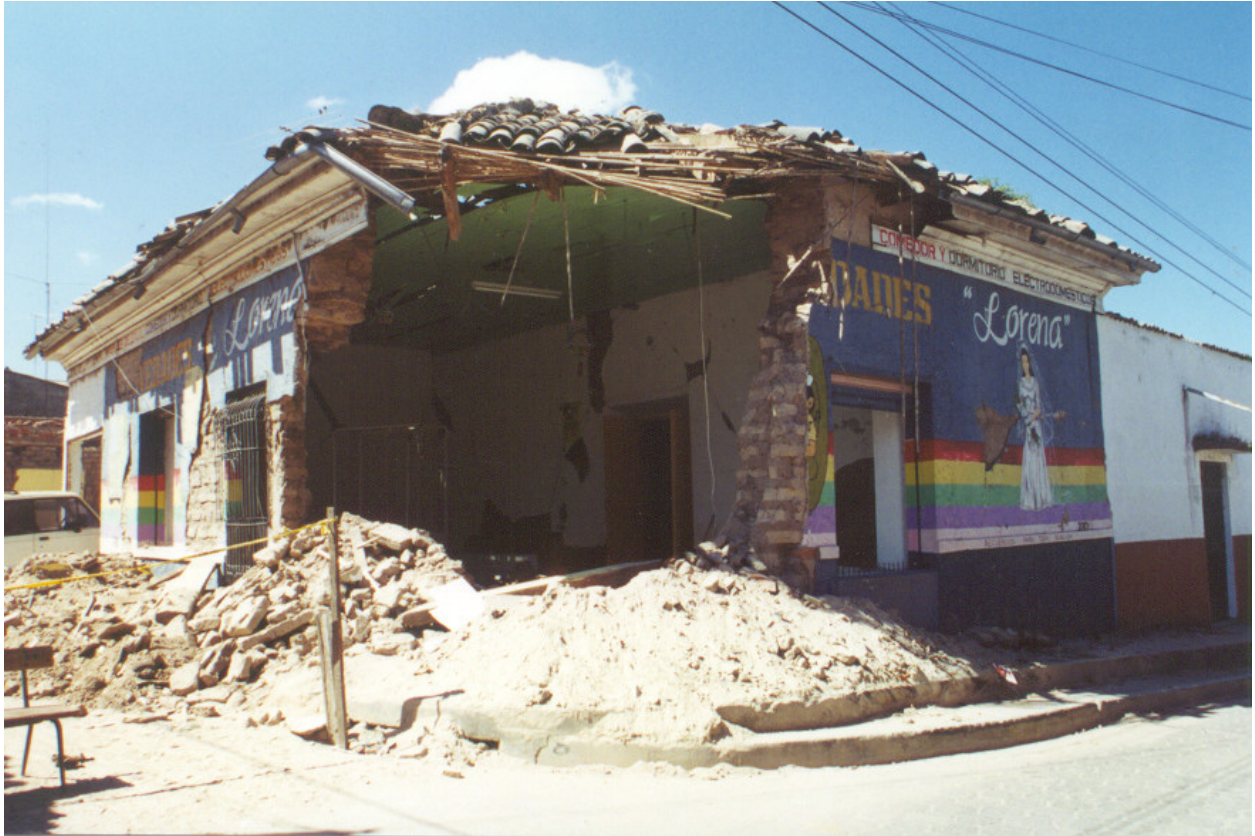
*FIGURE 6F: Damages in the city of Cojutepeque due to the February 13, 2001 earthquake*

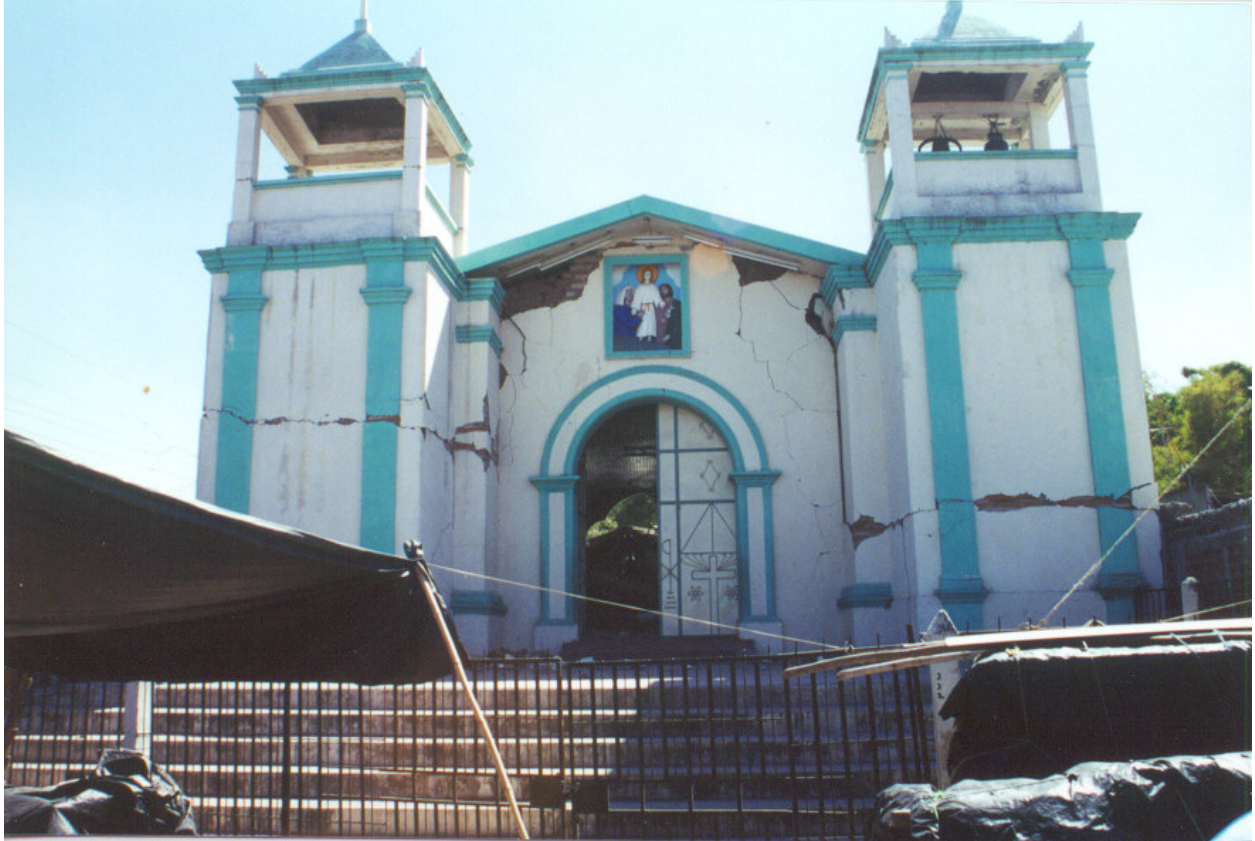
*FIGURE 6G: The San Jose church, Cojutepeque, damaged in the 13 February 2001 earthquake*

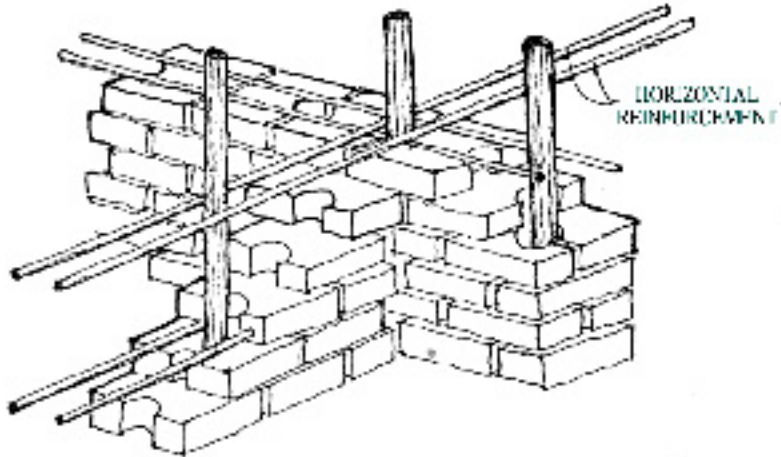
FIGURE 7B: Seismic Strengthening: Vertical and Horizontal Reinforcement

Type of intervention	Structural Deficiency	Description of seismic strengthening provision used
Retrofit (Strengthening)	Walls: There is lack of dependable joints among walls, especially at the top of walls. This causes adjacent walls to open up during an earthquake.	Collar Beam or Lintel Band: This feature ties the walls together. Buttresses: This feature helps to retain the integral action of walls and facilitate the connection of collar beams with each other. Vertical and Horizontal Reinforcement using bamboo: This features tries to provide reinforcement similar to that for concrete structures. Adobe bricks have to be molded appropriately to use this kind of strengthening technique.
	Roof: Very heavy elements.	Sheets of metal: Use this feature instead of clay tiles

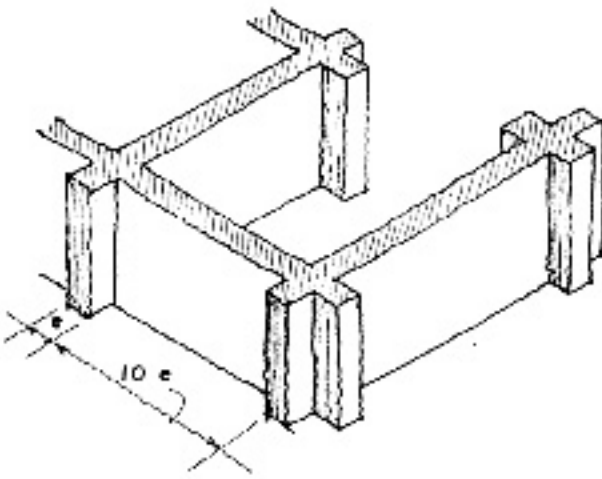
FIGURE 7C: Seismic Strengthening : Wall Buttresses
