World Housing Encyclopedia Report

Country: India

Housing Type: Reinforced concrete frame building with masonry infill walls designed for gravity loads

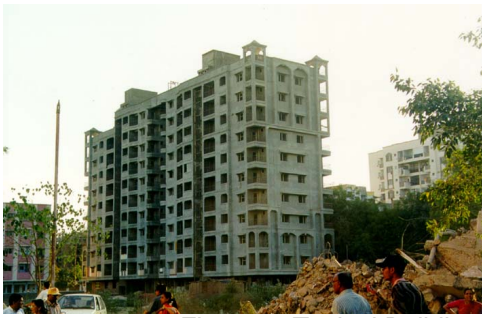
Figure 1: Typical Building

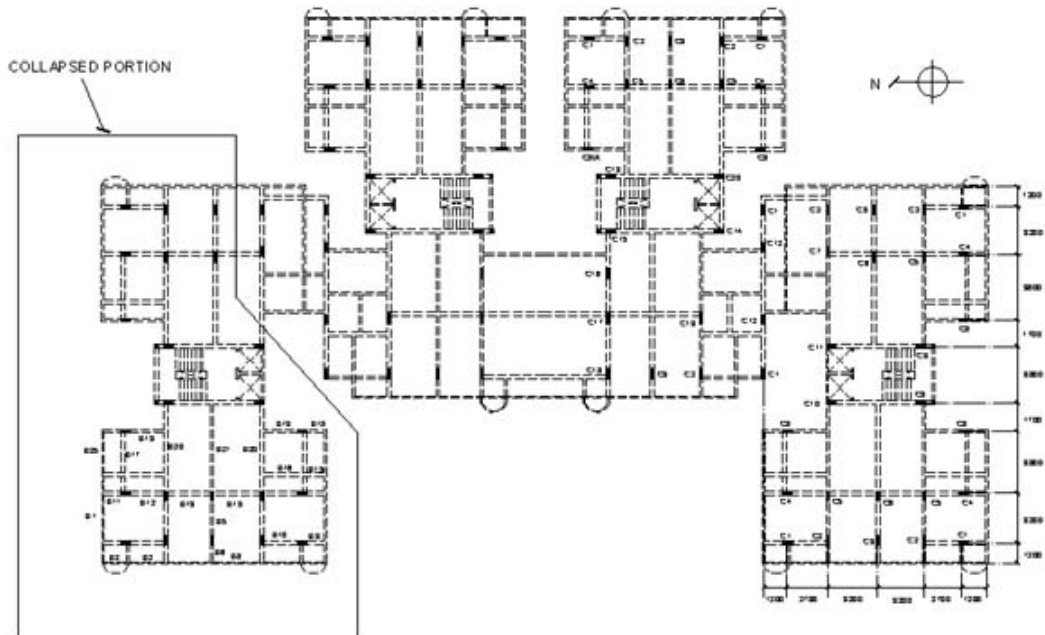
Figure 3: Plan of a Typical 10-story Building at Ahmedabad

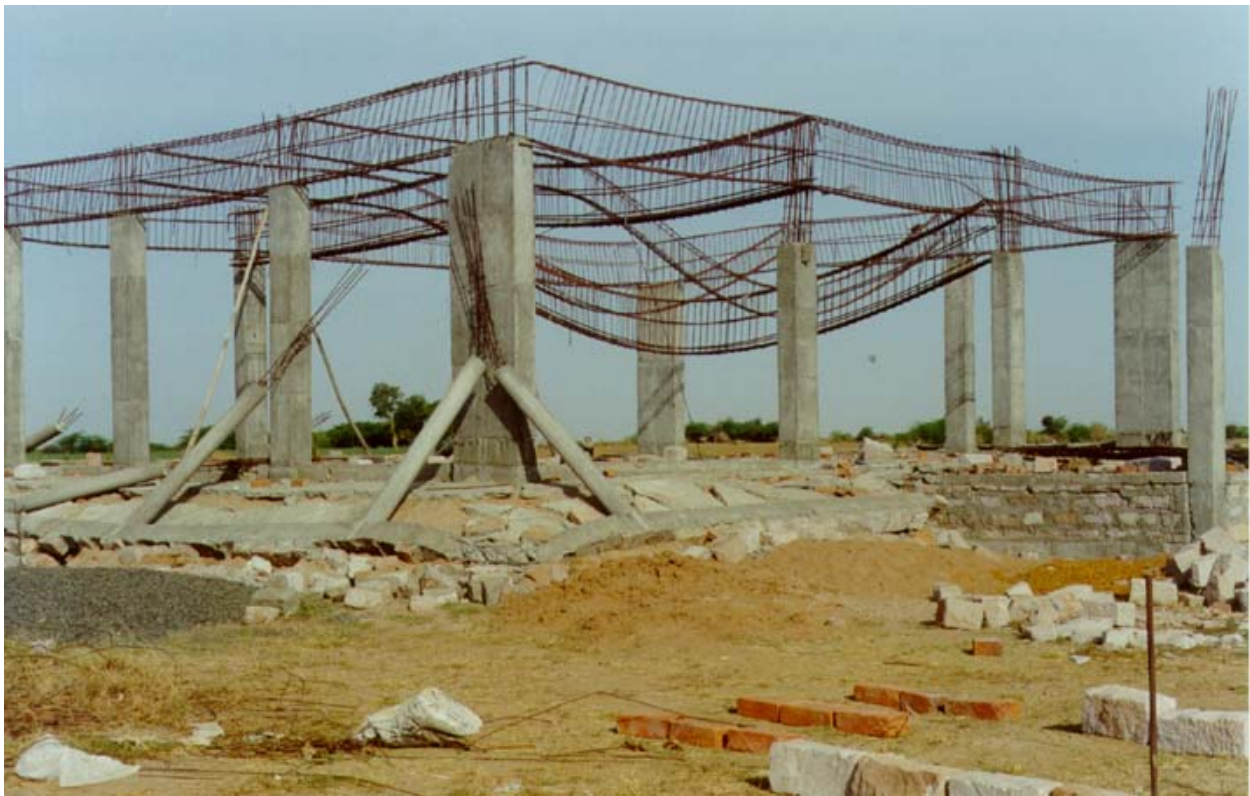
Figure 4: Critical Structural Details

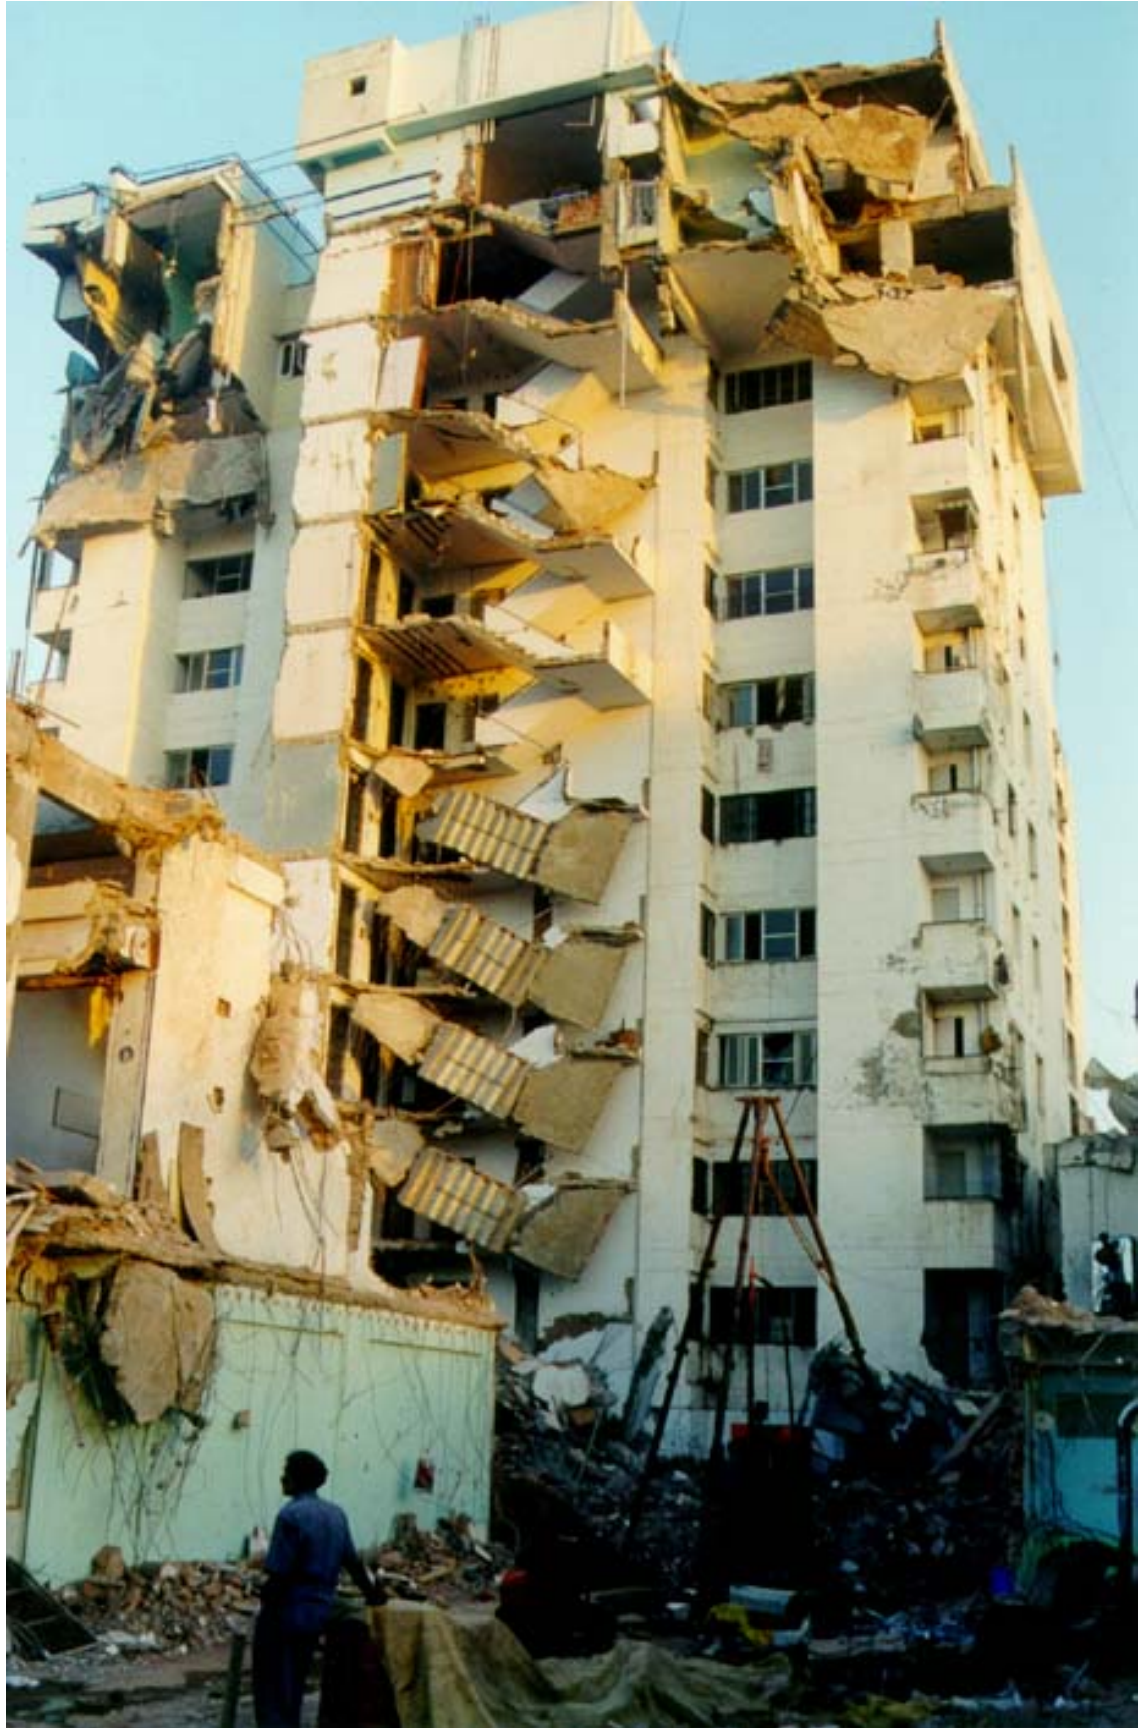
Figure 6A: A Photograph Illustrating Typical Earthquake Damage

Additional Comments: Building construction of this type (without any seismic features) suffered significant damage during Koyna (1967) and Killari (1993) earthquakes. Some damage was also observed during Jabalpur (1997) earthquake. The main damage patterns consisted of: - Shear cracks in walls, mainly starting from corners of openings. - Vertical cracks at wall corners - Partial out of plane collapse of walls due to concatenation of cracks. - Partial caving-in of roofs due to collapse of supporting walls. - Shifting of roof from wall due to torsional motion of roof slab. This type of construction was also severely affected by the 2001 Bhuj earthquake (M 7.6). In the epicentral region, several buildings of this type suffered total collapse of the walls resulting in death and injury to large number of people. The overall performance was dependent on the type of roof system: buildings with lightweight roof suffered relatively less damage while buildings with RCC roofs suffered much greater damage. (Source: IIT Powai 2001) Importance and effectiveness of seismic provisions, in particular RC lintel and roof bands (bond beams) was confirmed both in the 1993 Killari earthquake (see Figure 5A) and in the 2001 Bhuj earthquake (Figure 6J). Buildings with seismic provisions performed substantially better and did not suffer collapse, whereas similar construction without any seismic provisions was severely affected by the earthquake.

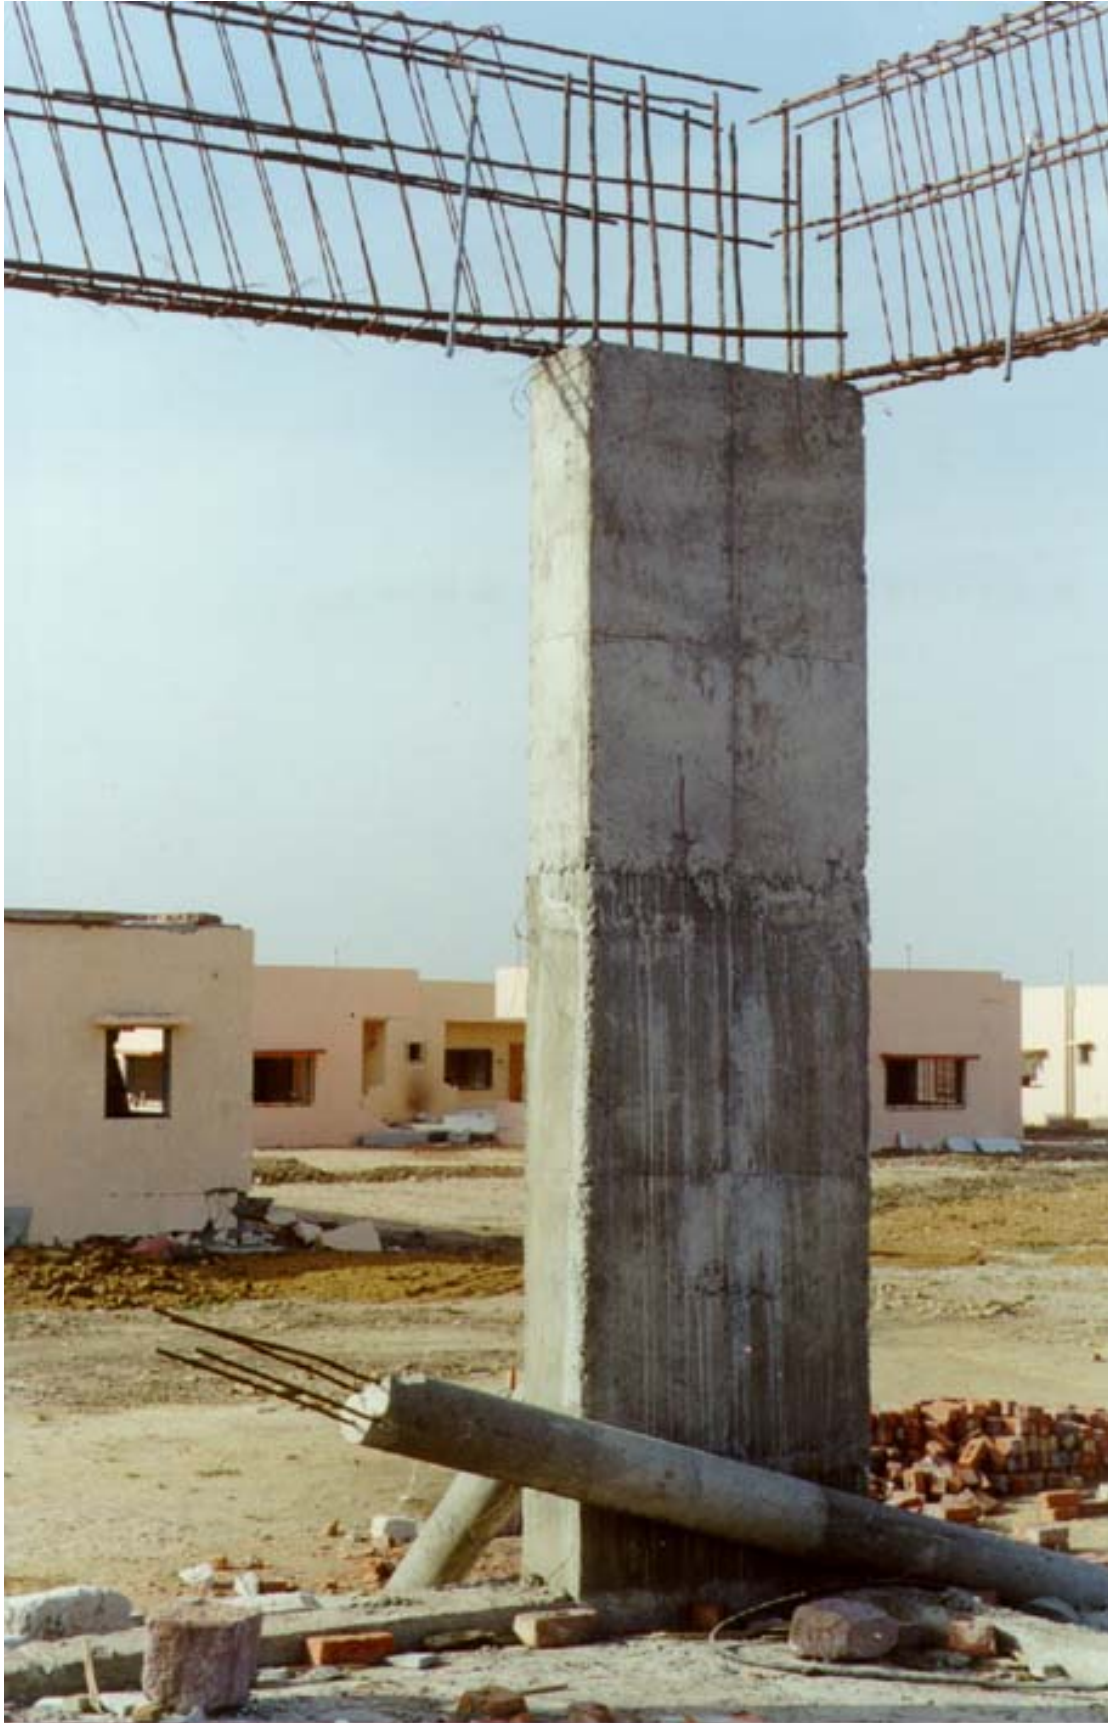
Figure 6B: Improper Reinforcement Detailing of Beam-Column Joint

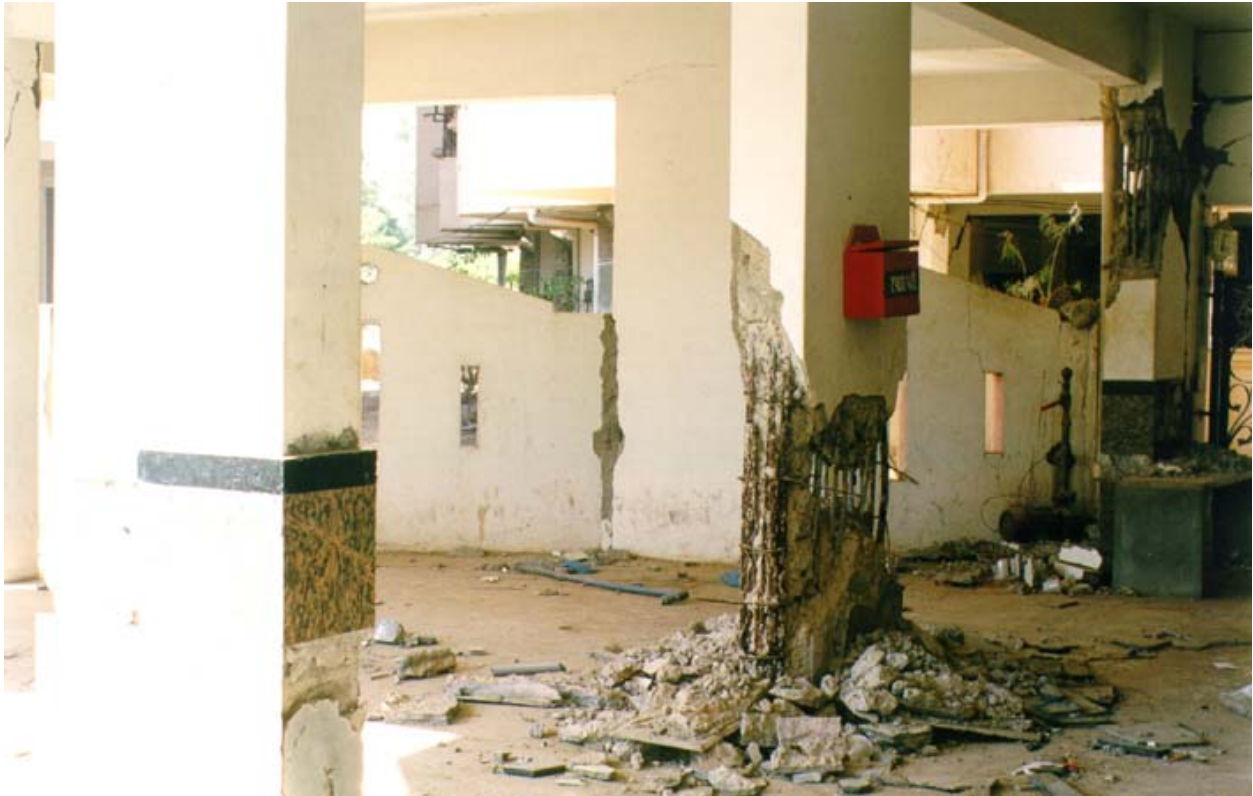
Figure 6C: Severe Damage and Plastic Hinging of Ground-Floor Column Due to Improper Confinement of Concrete and Lapping of Large Number of Longitudinal Bars

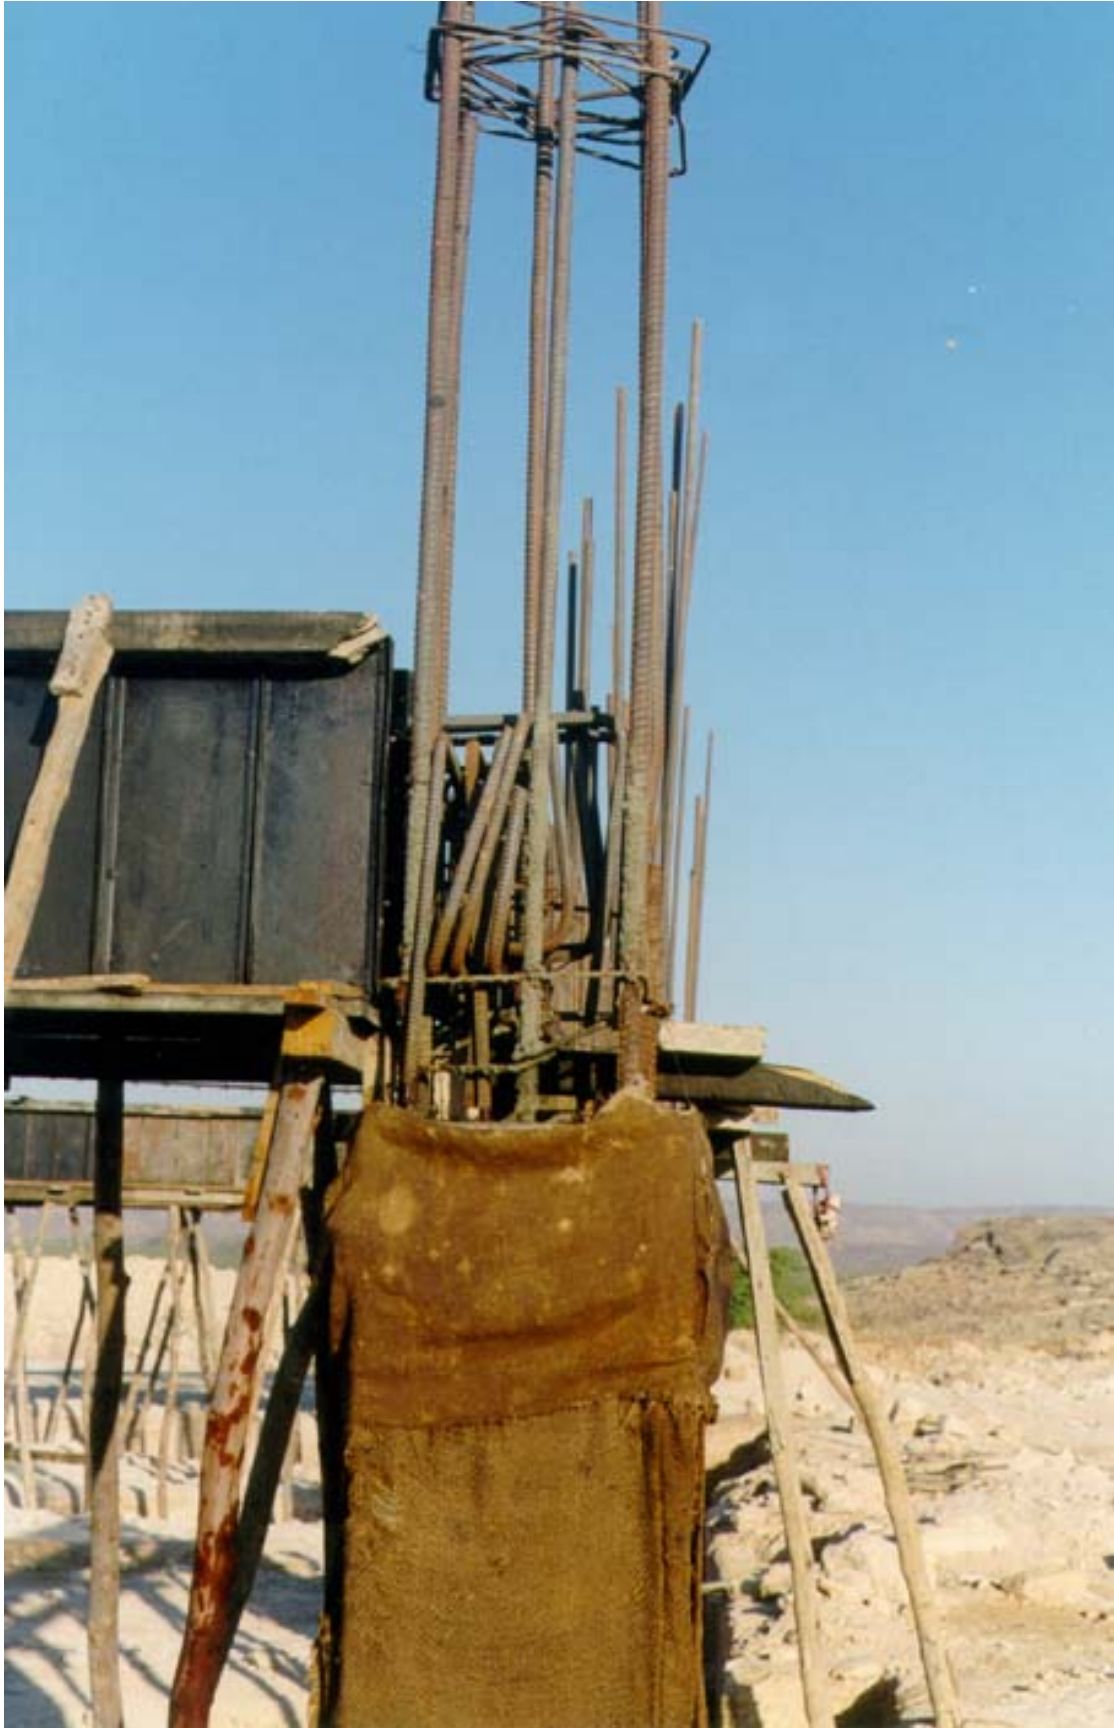
Figure 6D: Beam-Column Junction with Congestion of Reinforcement Illustrating Improper Construction Practice

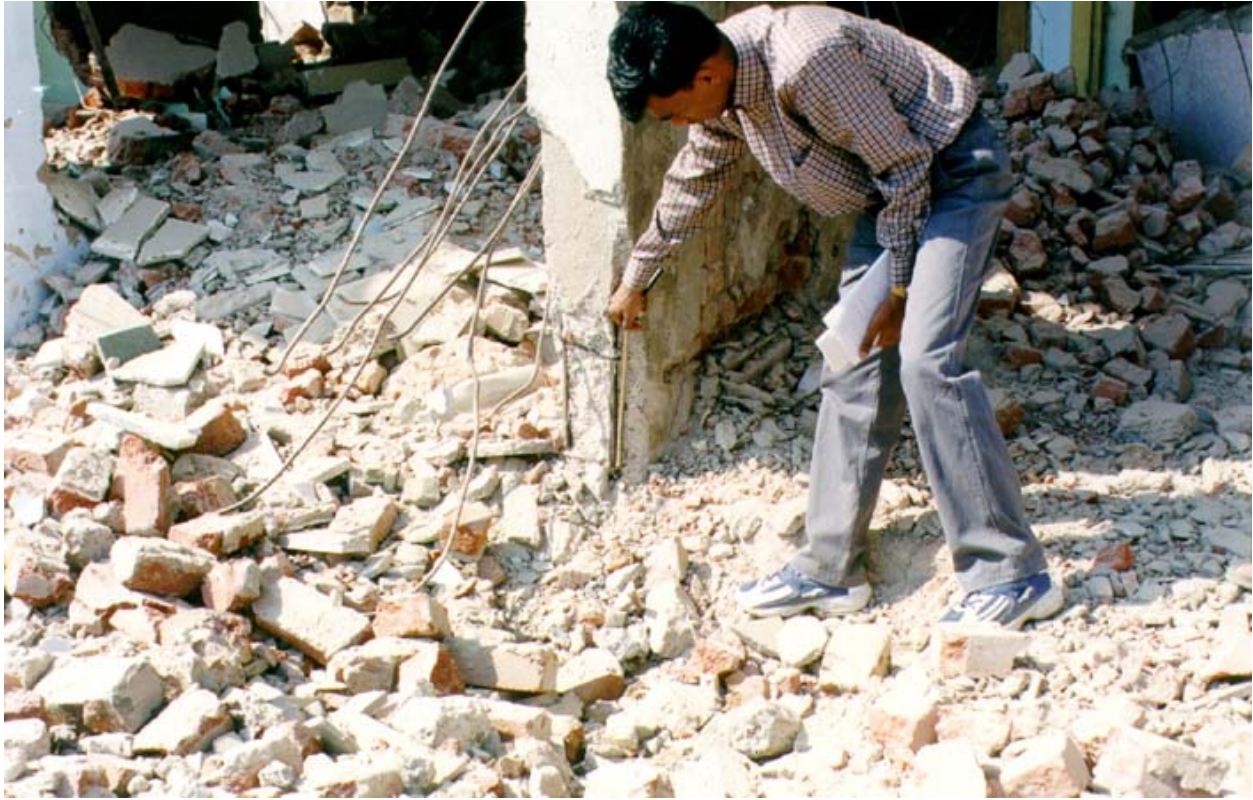
Figure 6E: Damage to Ground Floor Columns Due to Inadequate Lateral Confinement of Reinforcement Bars

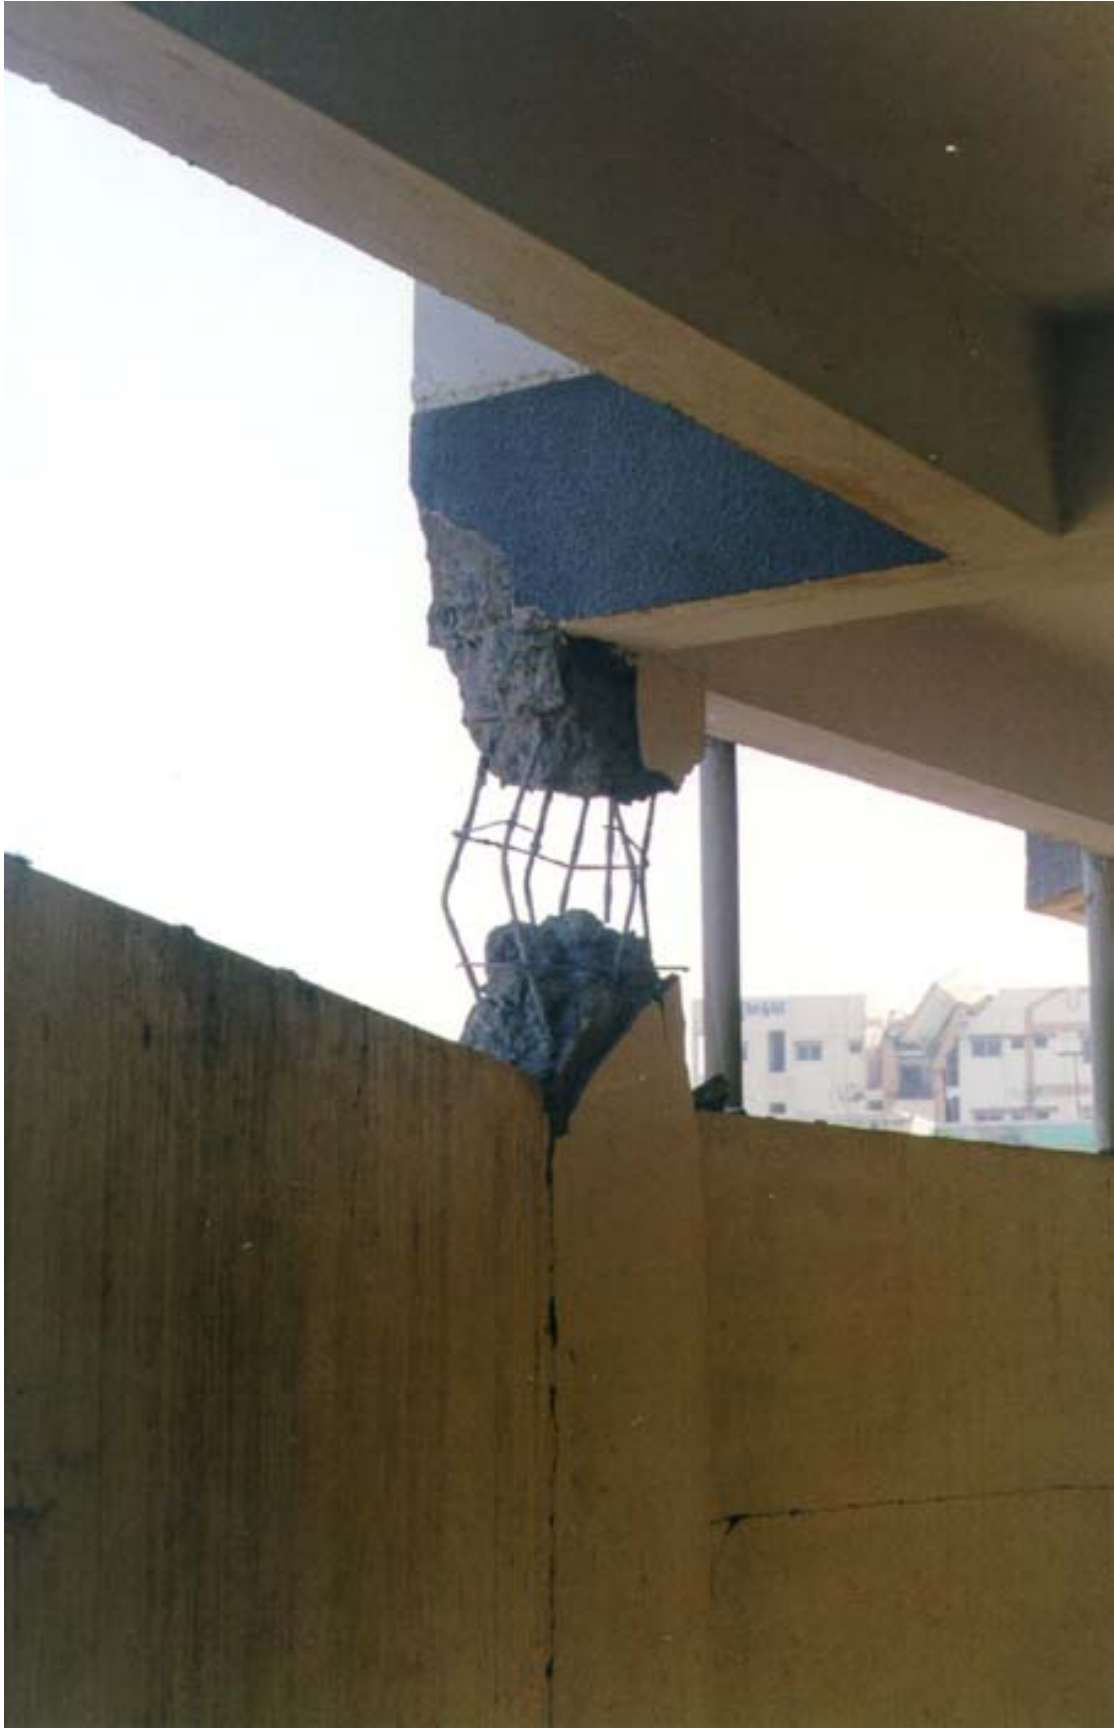
Figure 6F: Failure of Column Below the Beam-Column Joint Due to Short Column Effect

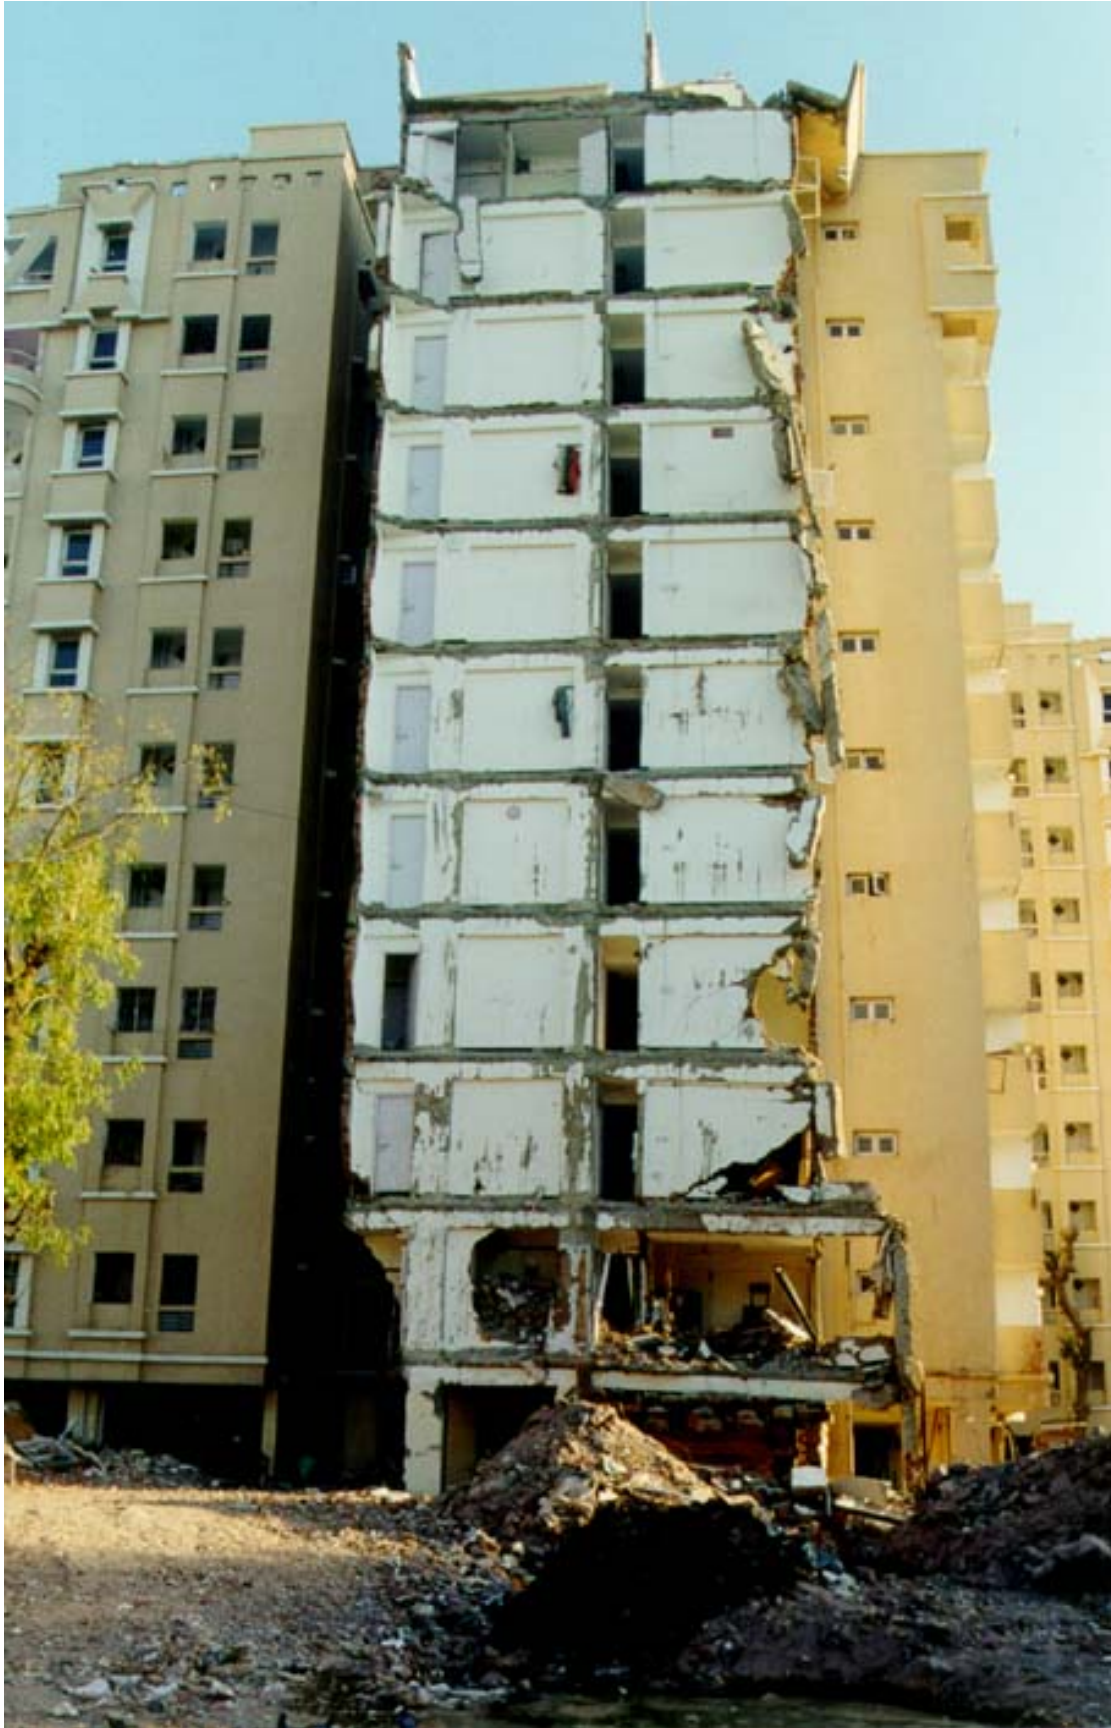
Figure 6G: View of the intact portion of an apartment building (2001 Bhuj Earthquake)

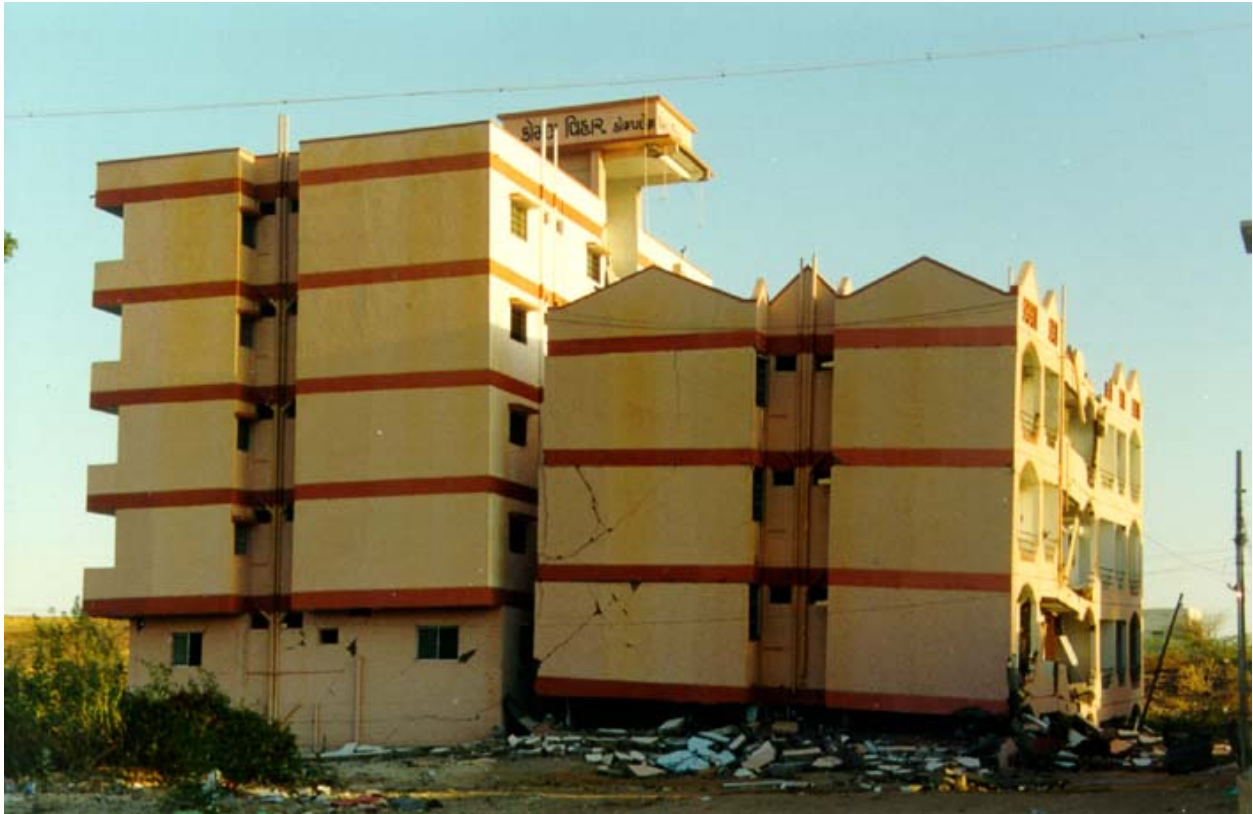
Figure 6H: Failure of Lower Two Stories of the Right Wing of an Apartment Building With Soft Storey; Note that the Left Wing Without Soft Storey is Apparently Undamaged (2001 Bhuj Earthquake)

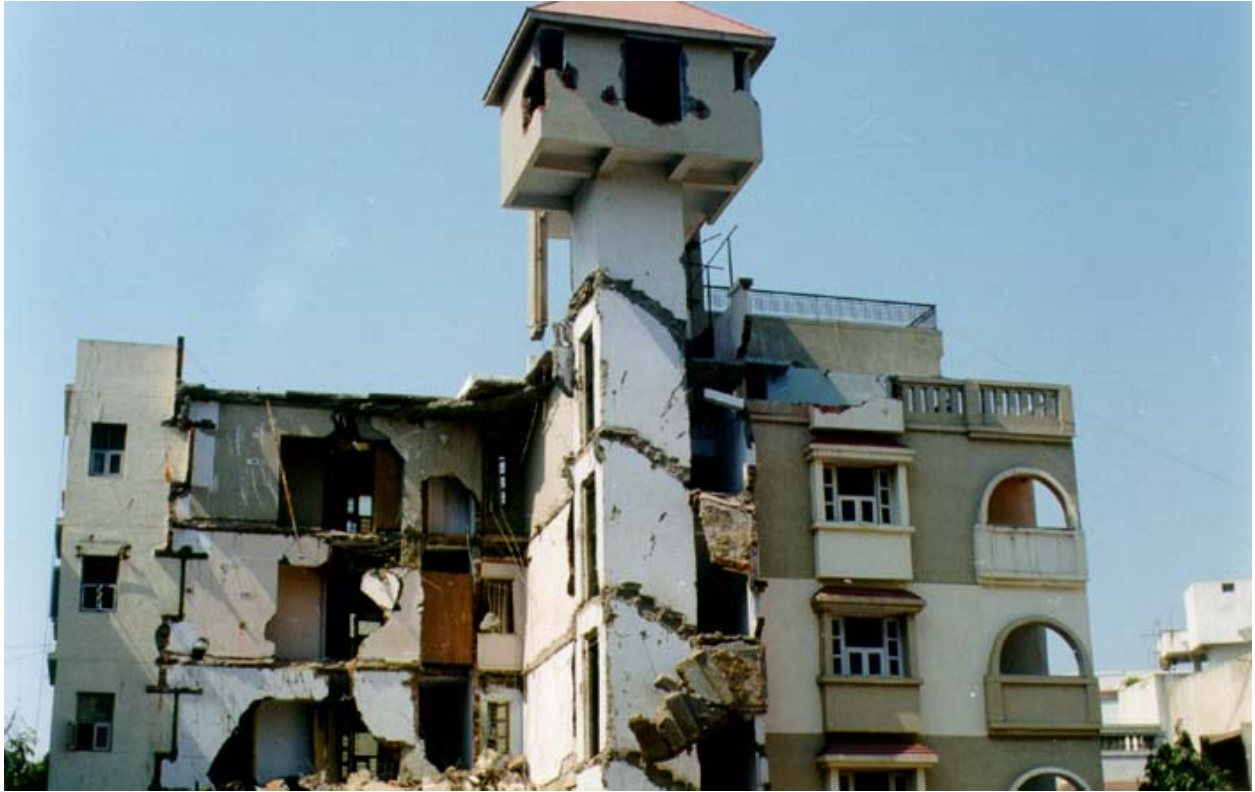
Figure 6I: Under-Utilization of Shear Capacity of Elevator Core Due to Improper Diaphragm Action of Slabs Resulted in Failure of an Apartment Building (2001 Bhuj Earthquake)

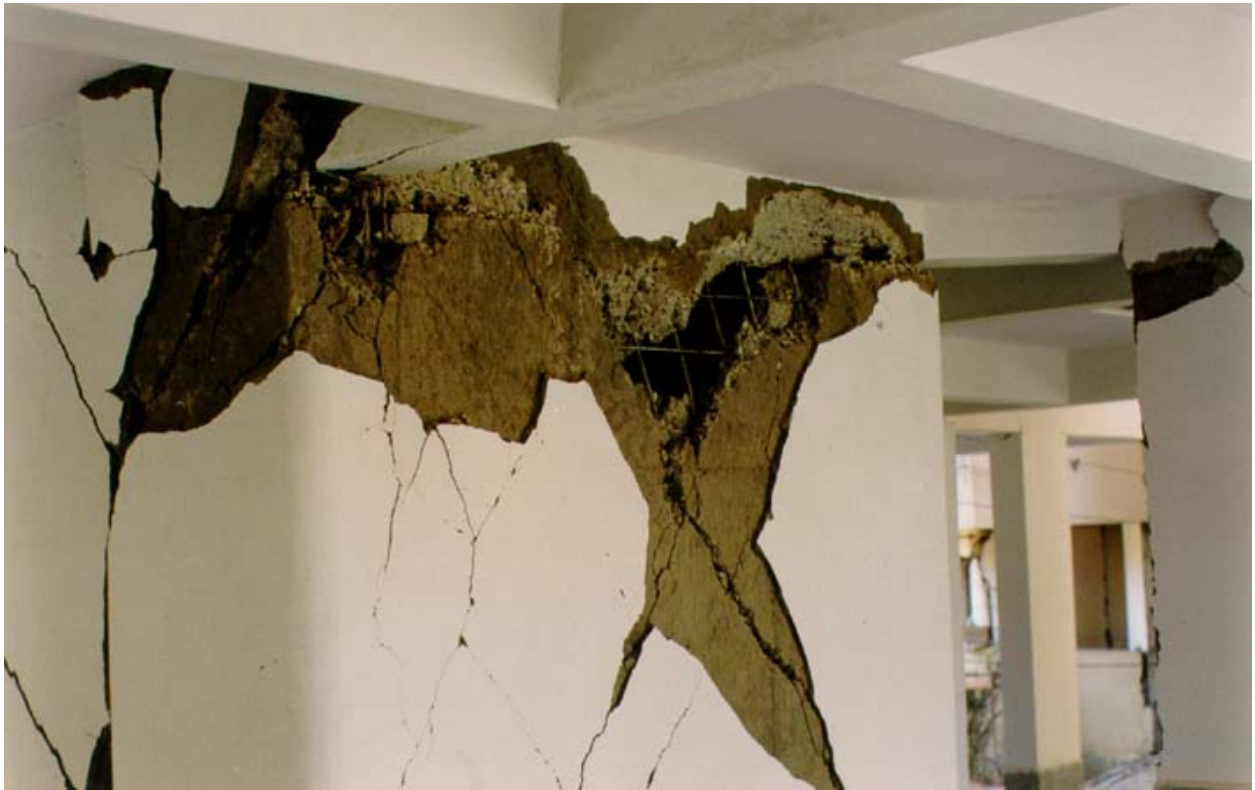
Figure 6K: View of Shear Damage of an Elevator Core (2001 Bhuj Earthquake)

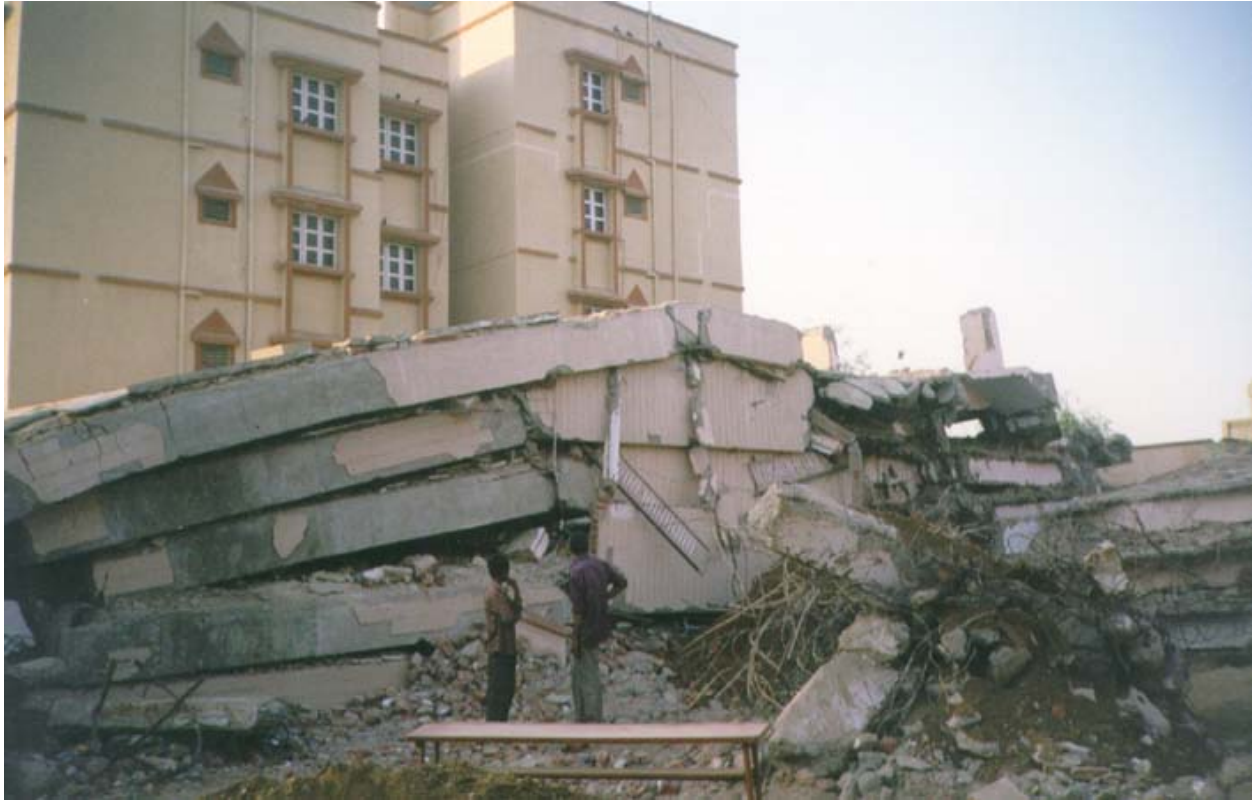
Figure 6L: Pancake Collapse of a Multi-Storey Building Due to Weak Column-Strong Beam Design (2001 Bhuj Earthquake)

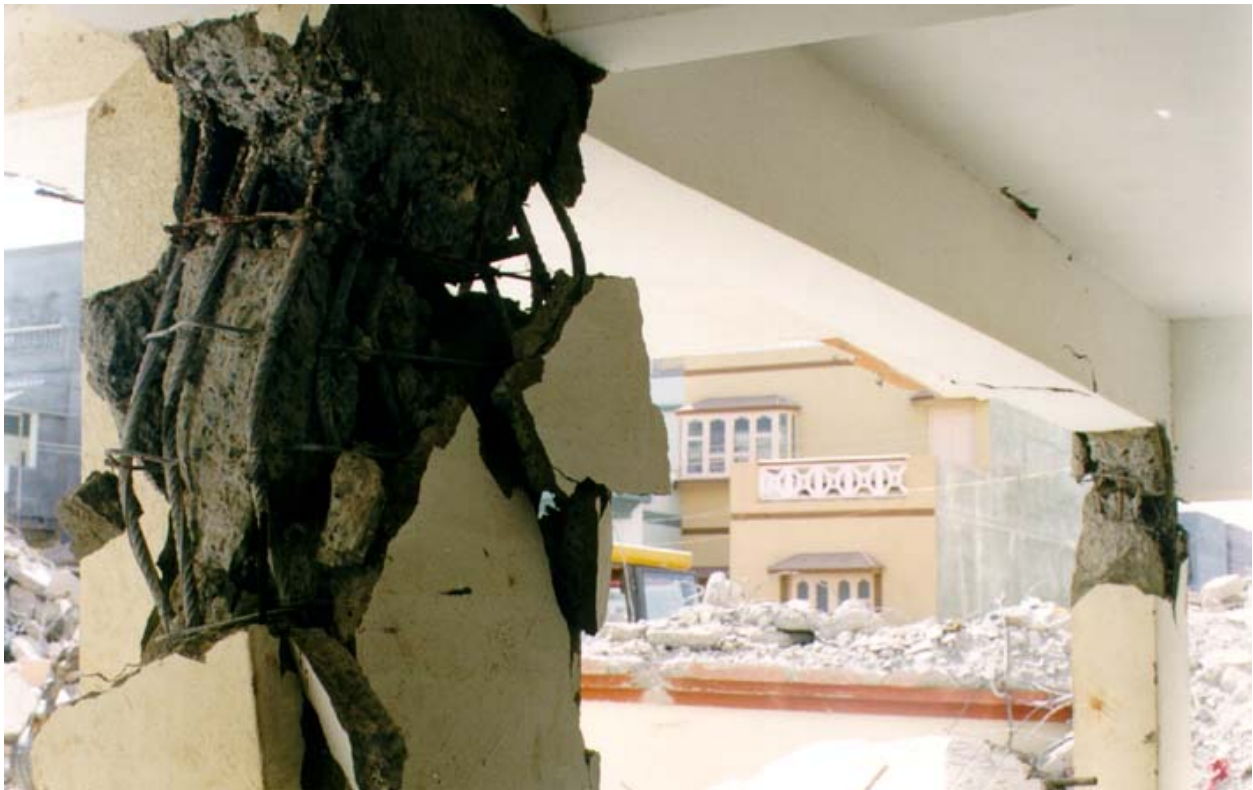
Figure 6J: Shear Failure of Column Just Below the Beam-Column Junction Due to Poor Construction

Material and Insufficient Lateral Reinforcement (2001 Bhuj Earthquake)

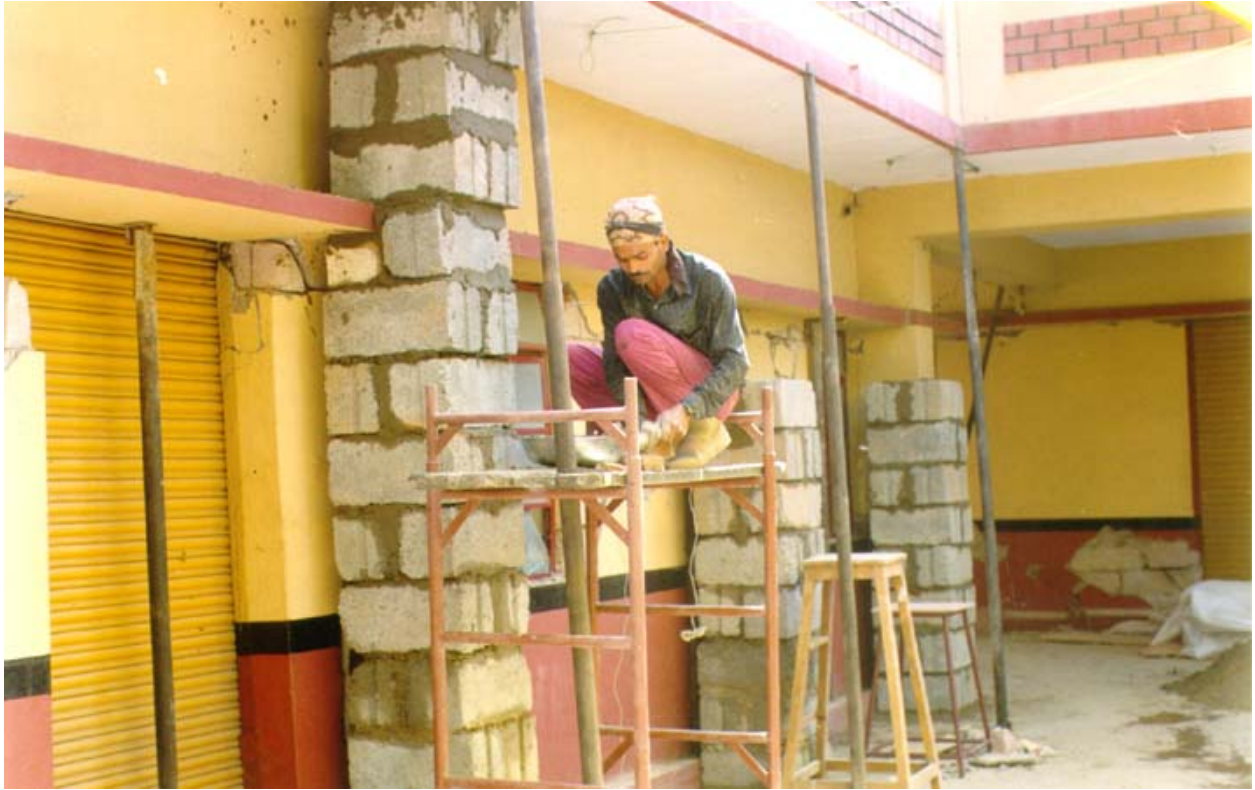
Figure 7A: Illustration of Seismic Strengthening Techniques

Type of intervention	Structural Deficiency	Description of seismic strengthening provision used
Retrofit (Strengthening)	Unreinforced masonry infill panels often dislodge from RC frame during out of plane vibration because of poor connection with frame members. Frequent crushing of masonry infill also results due to low strength of bricks and mortar. In plane stiffness of masonry wall is underutilized due to lack of adequate connection in some cases.	Damaged walls can be repaired by filling cracks using epoxy or cement slurry of adequate strength. Walls with significant cracks may require local replacement of crushed masonry blocks before grouting. Walls that have suffered very significant damage including partial or full collapse may need to be replaced with new wall.
	Beams and Columns are not connected rigidly to provide moment-resistant action. Most joints exhibit weak column strong beam behavior. All longitudinal reinforcement are often spliced at the same section resulting in stress concentration in concrete.	The cracks in the beams or columns are grouted with cement slurry of adequate strength and design cover is ensured while jacketing of the existing beams and columns. Reinforcement as per the newly designed sections can be placed and proper bond between existing and new construction is maintained. Extent of corrosion to existing reinforcement is properly measured as per the procedures and suitable measures can be taken to avoid the further rusting of the reinforcement.

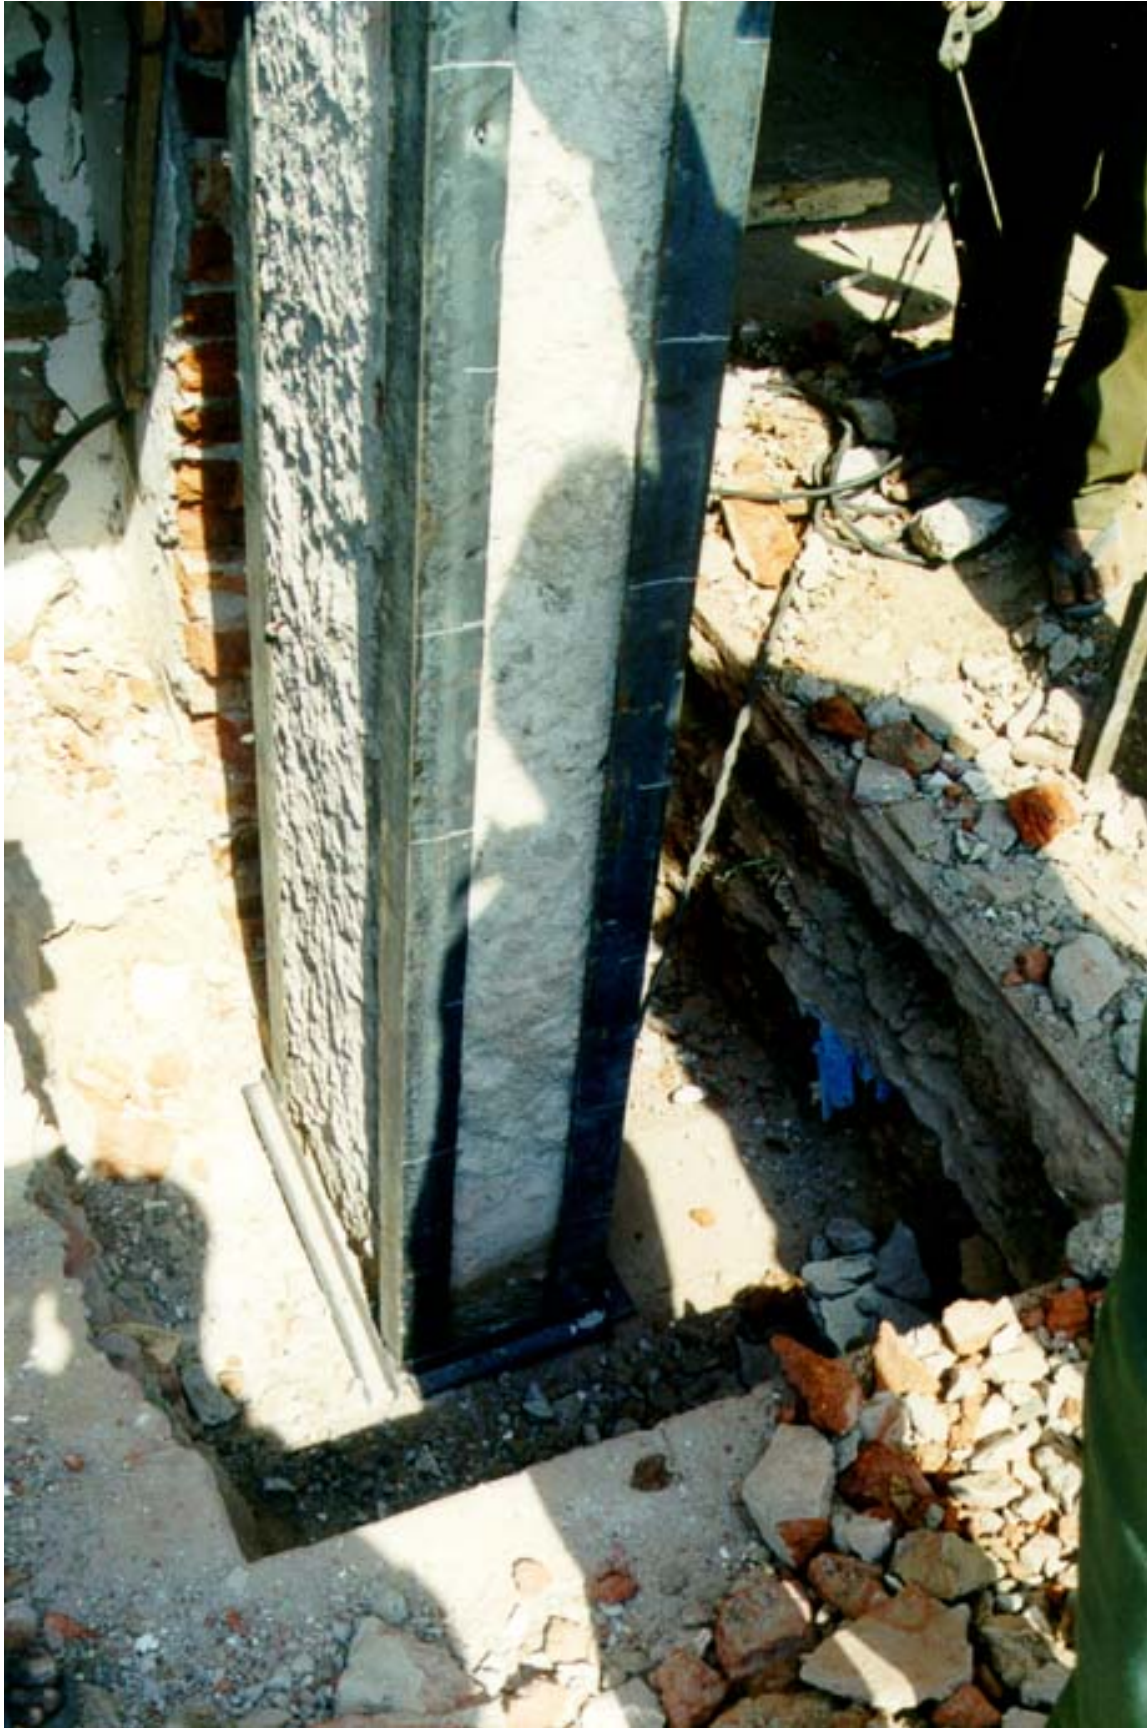
*Figure 7B: Seismic Strengthening of Columns by Jacketing from Top of Footing - Correct Technique
(2001 Bhuj Earthquake)*
