World Housing Encyclopedia Report

Country: India

Housing Type: Reinforced concrete frame building with masonry infill walls designed for gravity loads

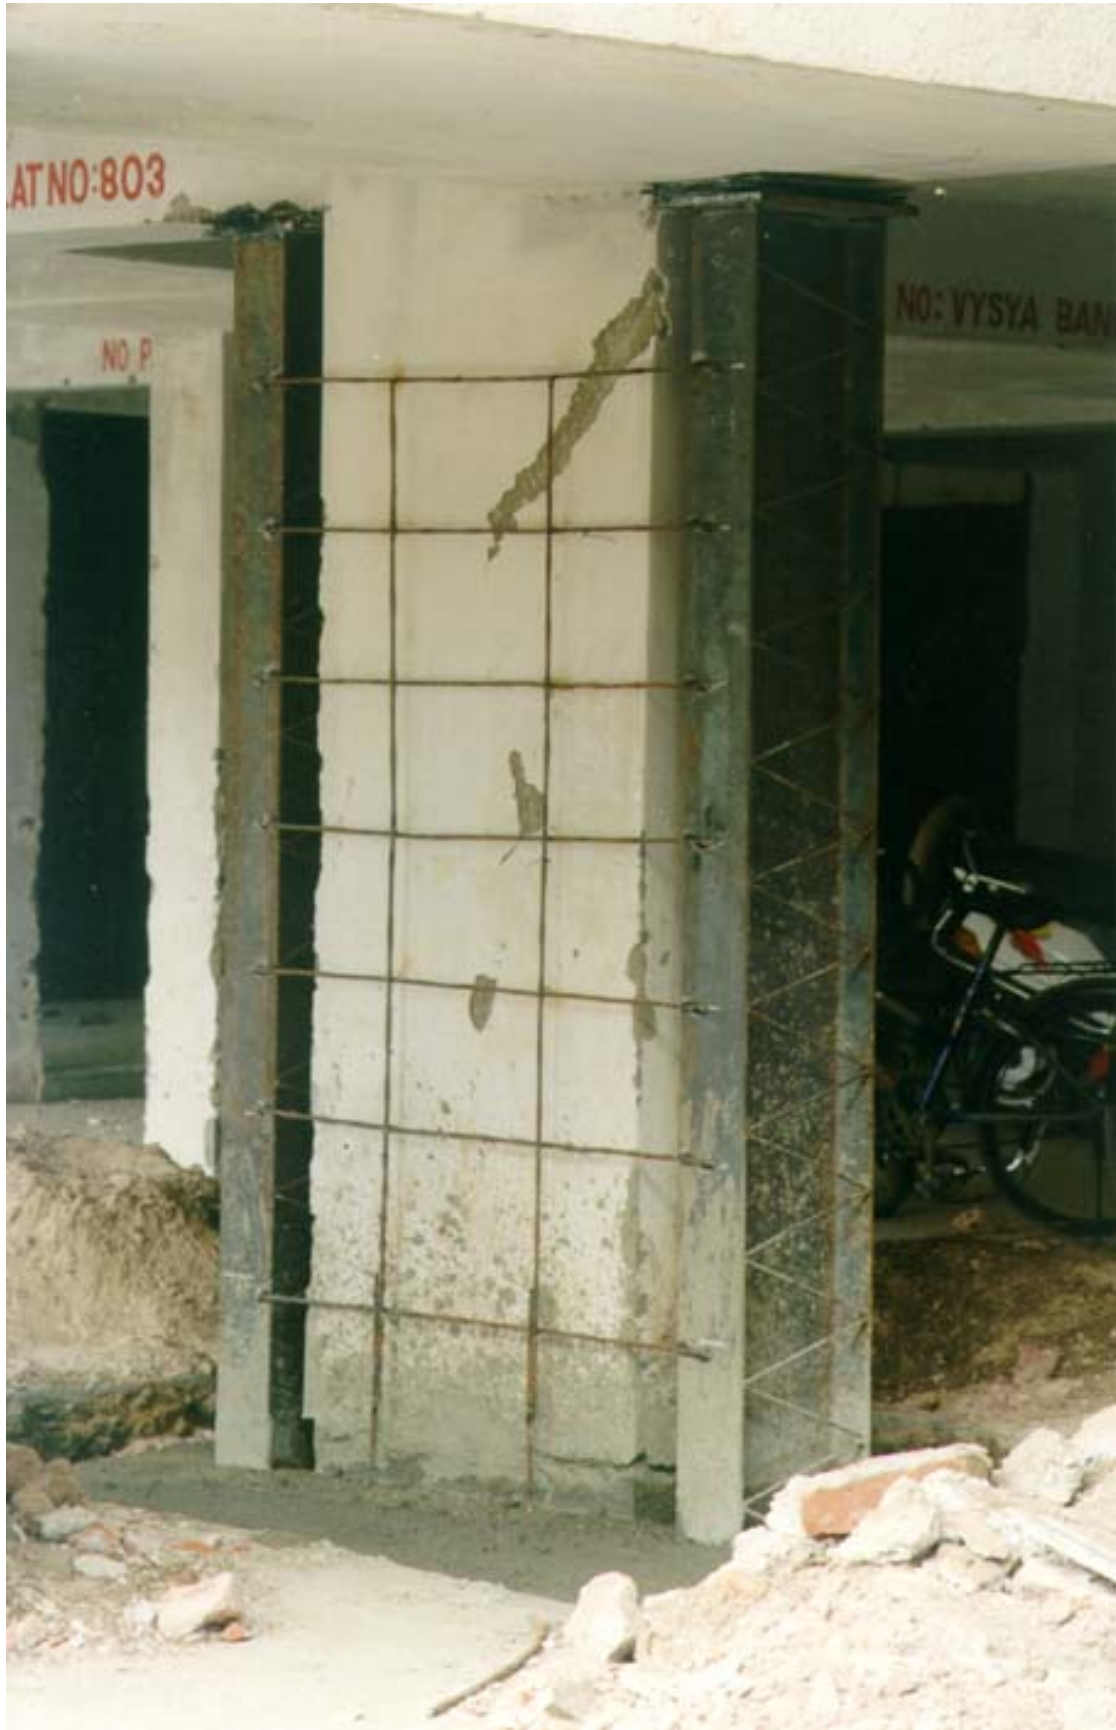
Figure 7C: Seismic Strengthening of Columns by Jacketing from Floor Level - Improper Technique (2001 Bhuj Earthquake)

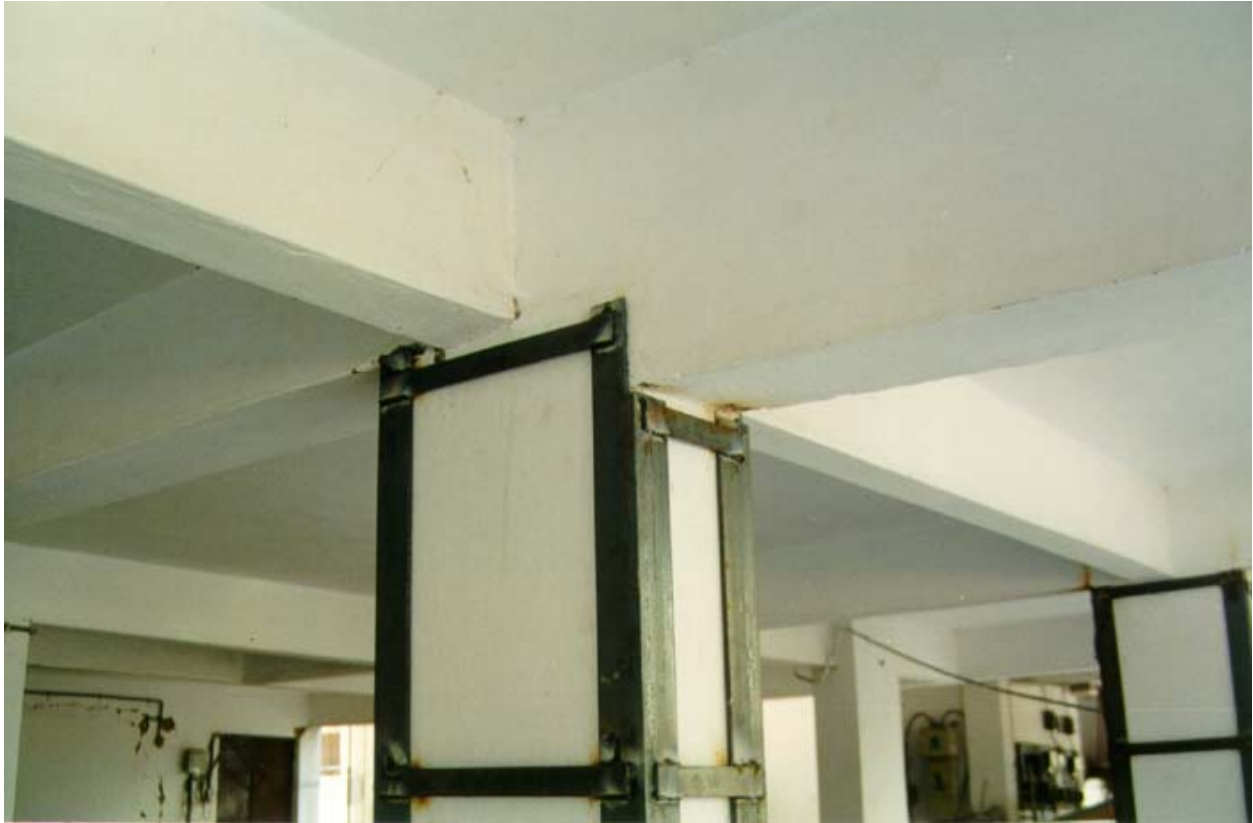
Figure 7D: Termination of Column Jacket Steel at Beam Soffit Level Resulting in No Increase in Moment Capacity of Column (2001 Bhuj Earthquake)

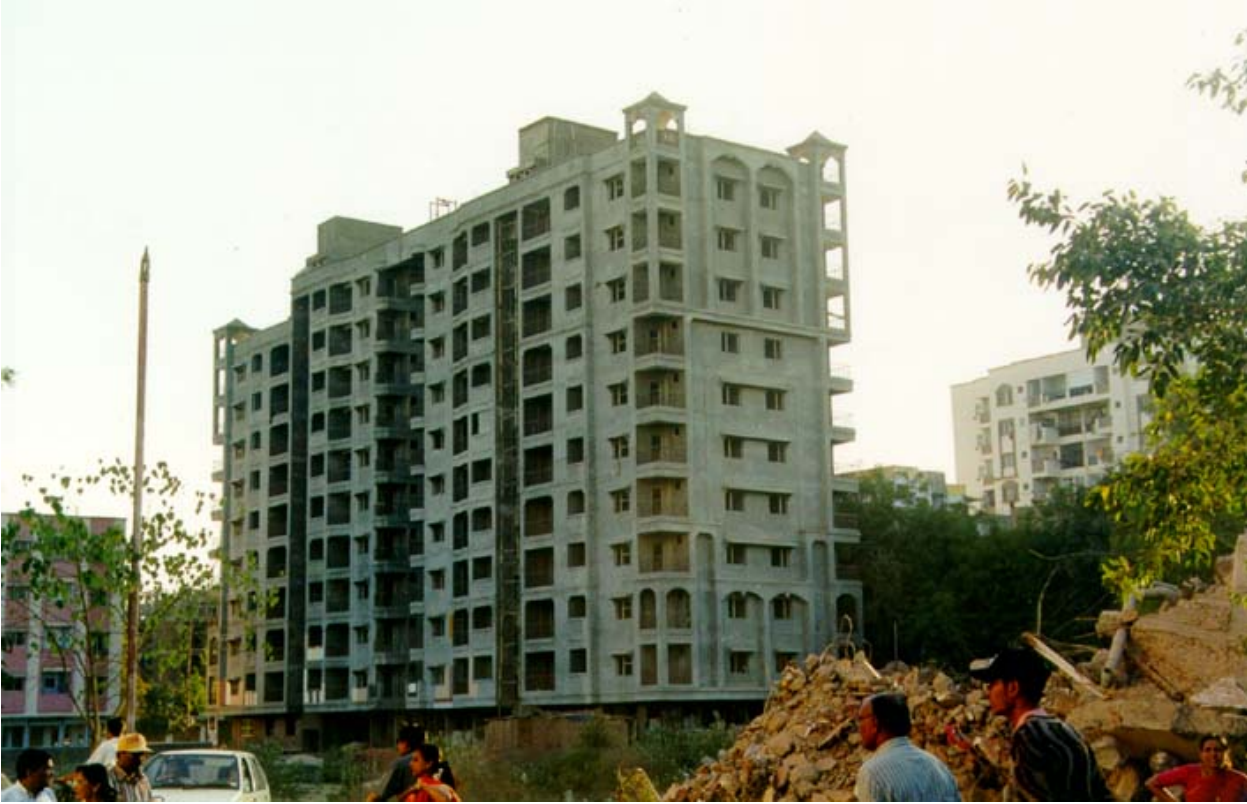
Figure 1: Typical Building
