# World Housing Encyclopedia Report

Country: India

Housing Type: Rural mud house with pitched roof

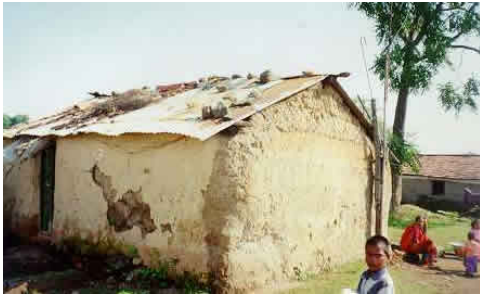
FIGURE 1: Typical Building

This is a typical rural construction found throughout India, except in the high rainfall areas (northeastern part of the country). It is a single family house, mainly occupied by the poorer sections of the population. The main load bearing system consists of mud walls which carry the roof load. In some cases wooden posts are provided at the wall corners and at intermediate locations. The wooden posts and walls are not structurally integrated, and therefore the loads are shared by the walls and the frame. There are very few openings (doors and windows) in these buildings; in rural areas there are usually no windows at all. In general, this type of construction is built by the owners and local unskilled masons and the craftsmanship is very poor. This building type is classified as grade-A (most vulnerable) as per the IAEE building classification and IS Code 1893:1984. This is a low-strength masonry construction and it is considered to be extremely vulnerable to seismic forces.

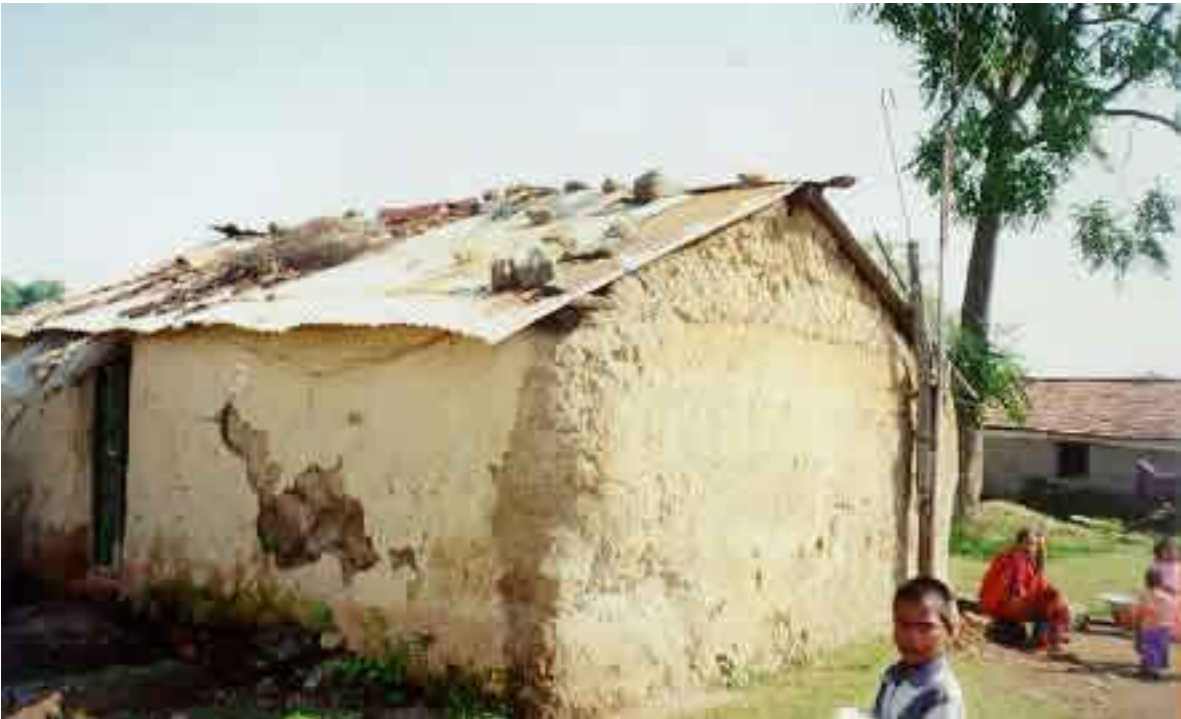
FIGURE 1: Typical Building

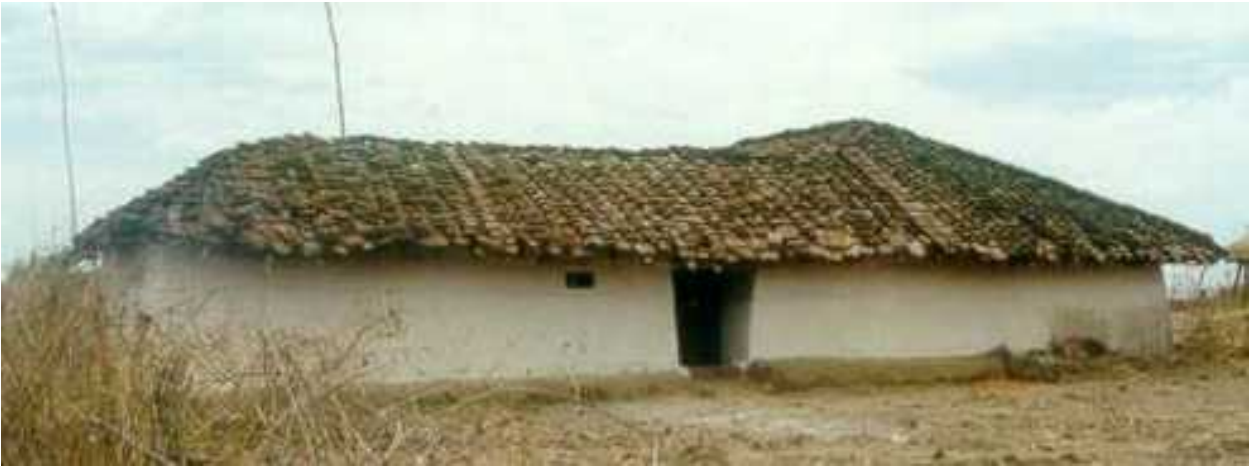
FIGURE 1A: Typical Building (Source: Sudhir K. Jain, IIT Kanpur)

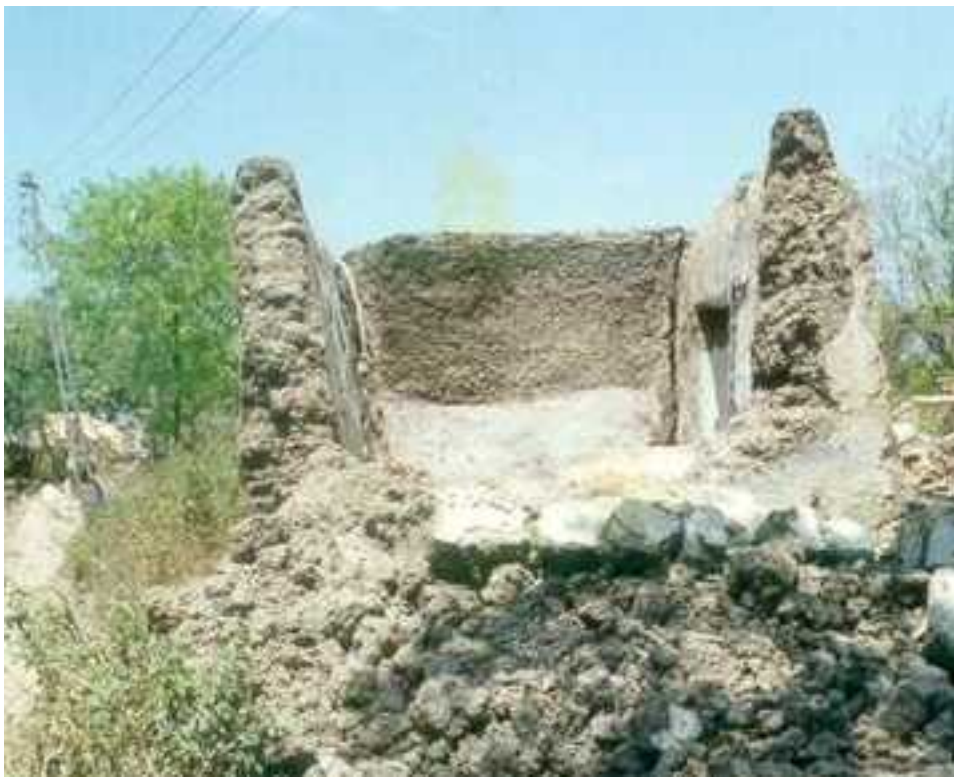
*FIGURE 4: Critical Structural Details - wall section (Source: Sudhir K. Jain, IIT Kanpur)*

Foundation: Trench of about 2.5 feet is excavated along the walls. Stone blocks are rammed with mud into the trench to form consolidated foundation. Timber posts, if used, are erected during the ramming of stones. The load-bearing wall is erected above the ground level. The stone walls are sometimes constructed up to 2 feet above ground level, and the mud wall is extended above this level.

Wall construction: The wall is made up of mixed mud with wheat husks and water (mud-polymer composite). Generally the wheat husk is mixed and kept for about a week to give it a homogenous texture. The mud mortar is placed and rammed to make it compacted. The wall is erected up to about 2.5 feet in each lift and allowed to dry for one or two days before the next lift.

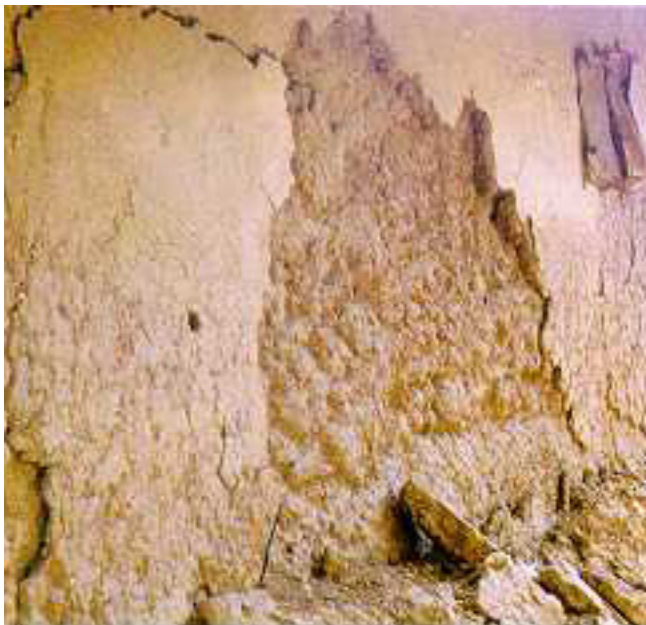
*FIGURE 6: Typical Earthquake Damage*

*Additional Comments:* Jabalpur earthquake of May 22, 1997 seriously affected the life and damaged properties in the epicentral area. It is estimated that about 33,000 buildings in the urban areas and 24,000 buildings in the rural areas were partially damaged or completely destroyed. A typical earthquake damage is shown on Figure 6 (Source: BMTPC Publication, 1997, Part-1, Earthen Houses With Clay Tile Roofing Guidelines for Damage Assessment and Post-Earthquake Action).

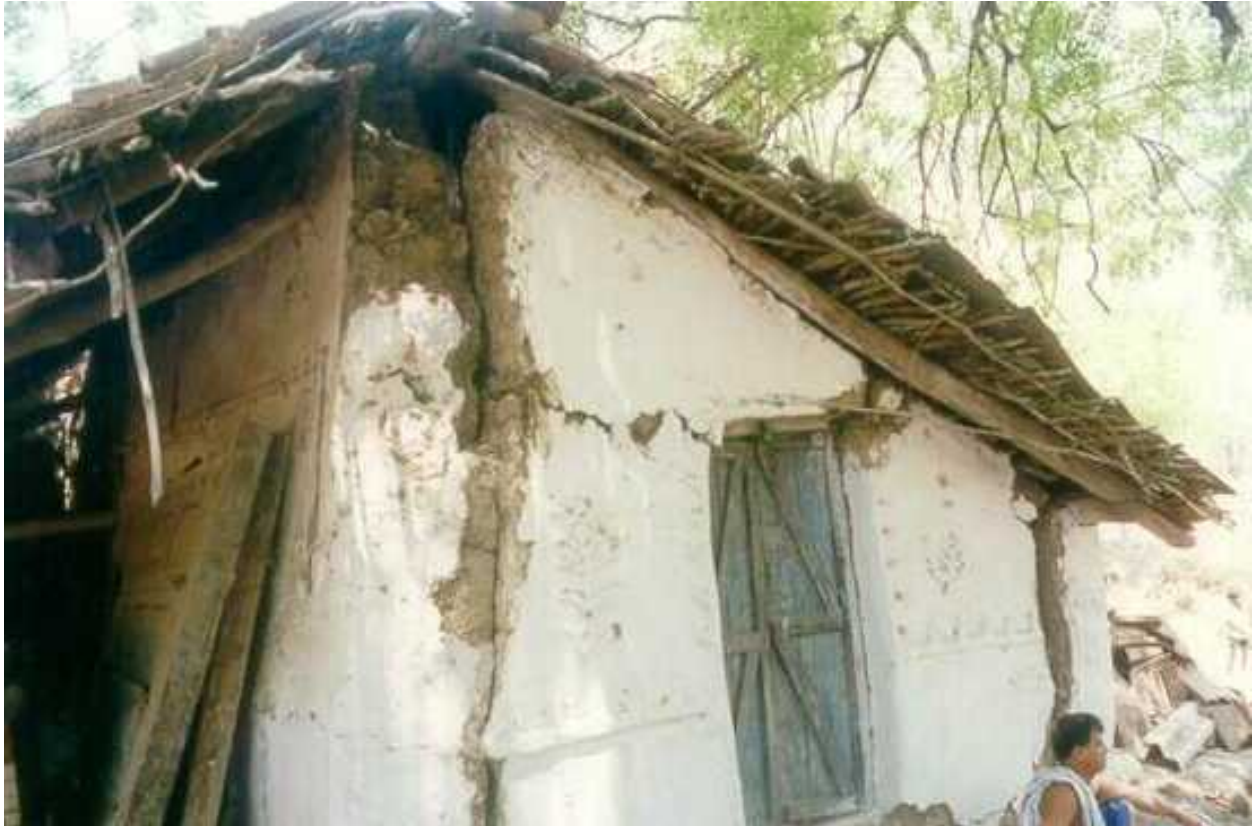
*FIGURE 6A: Typical Earthquake Damage - Cracking and Separation of Walls in the 1997 Jabalpur earthquake (Source: Sudhir K. Jain, IIT Kanpur)*

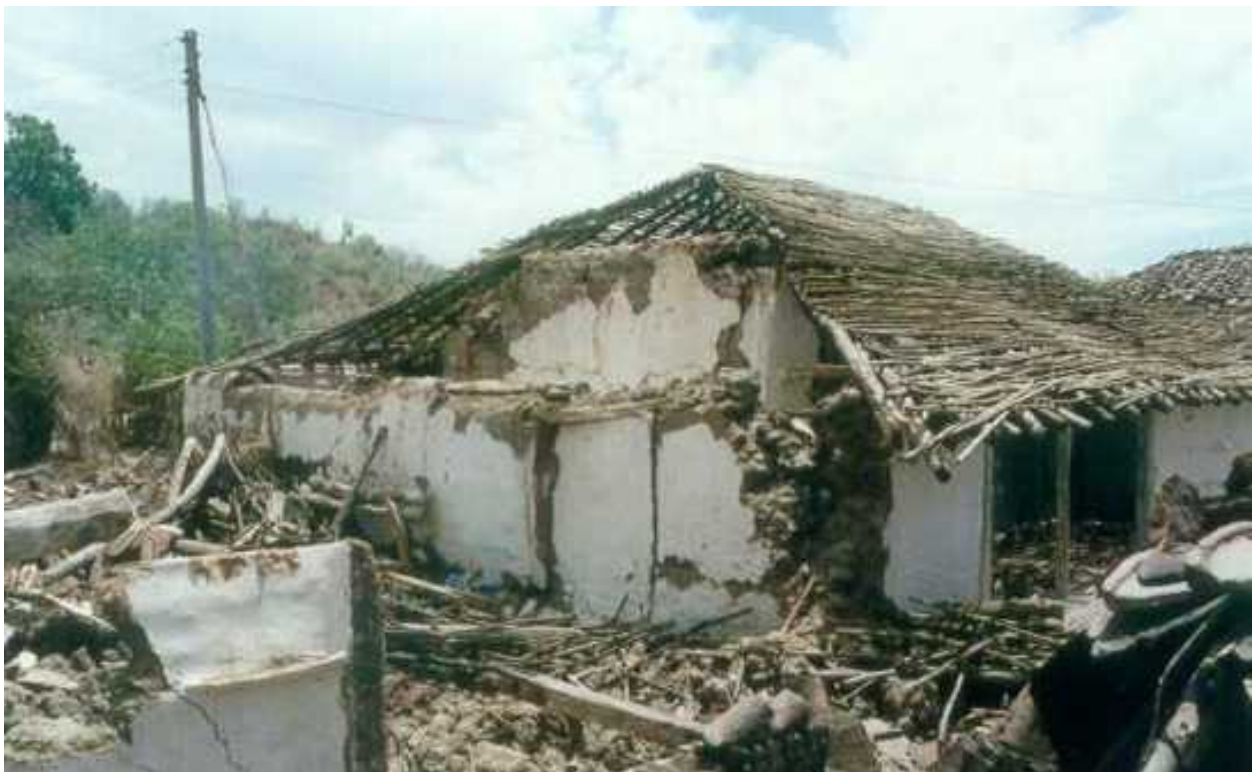
*FIGURE 6B: Typical Earthquake Damage - Building Collapse in the 1997 Jabalpur earthquake (Source: Sudhir K. Jain, IIT Kanpur)*

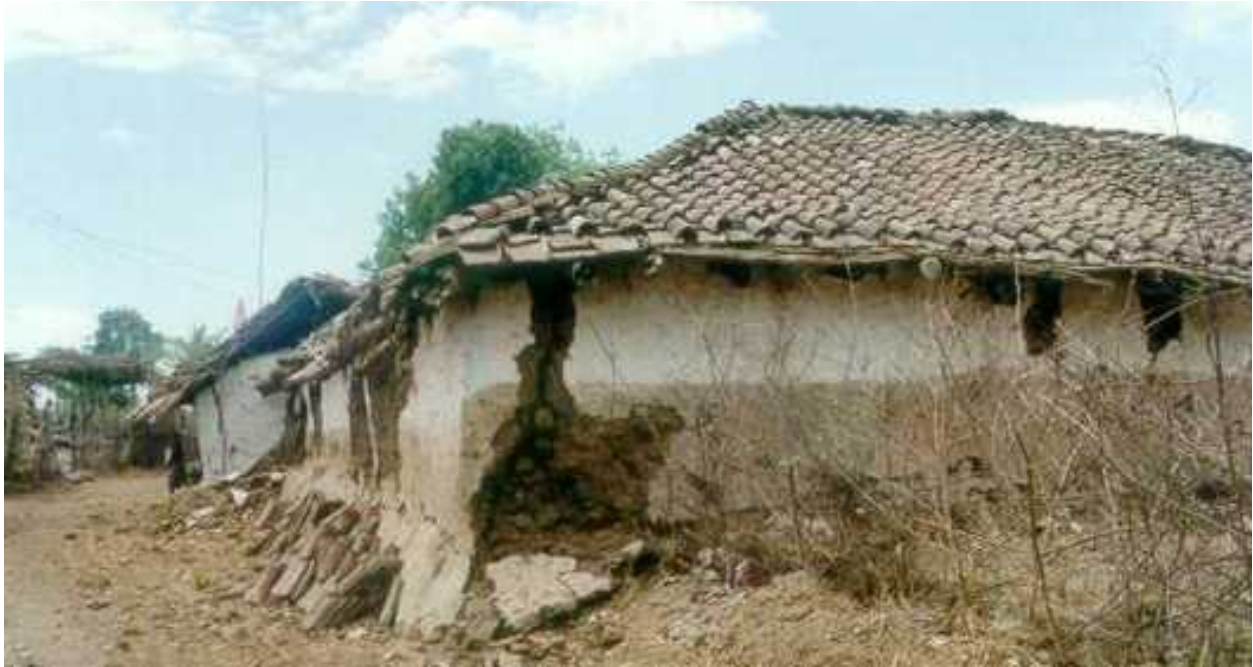
*FIGURE 6C: Typical Earthquake Damage - Crushing of Mud Walls in the 1997 Jabalpur earthquake (Source: Sudhir K. Jain, IIT Kanpur)*

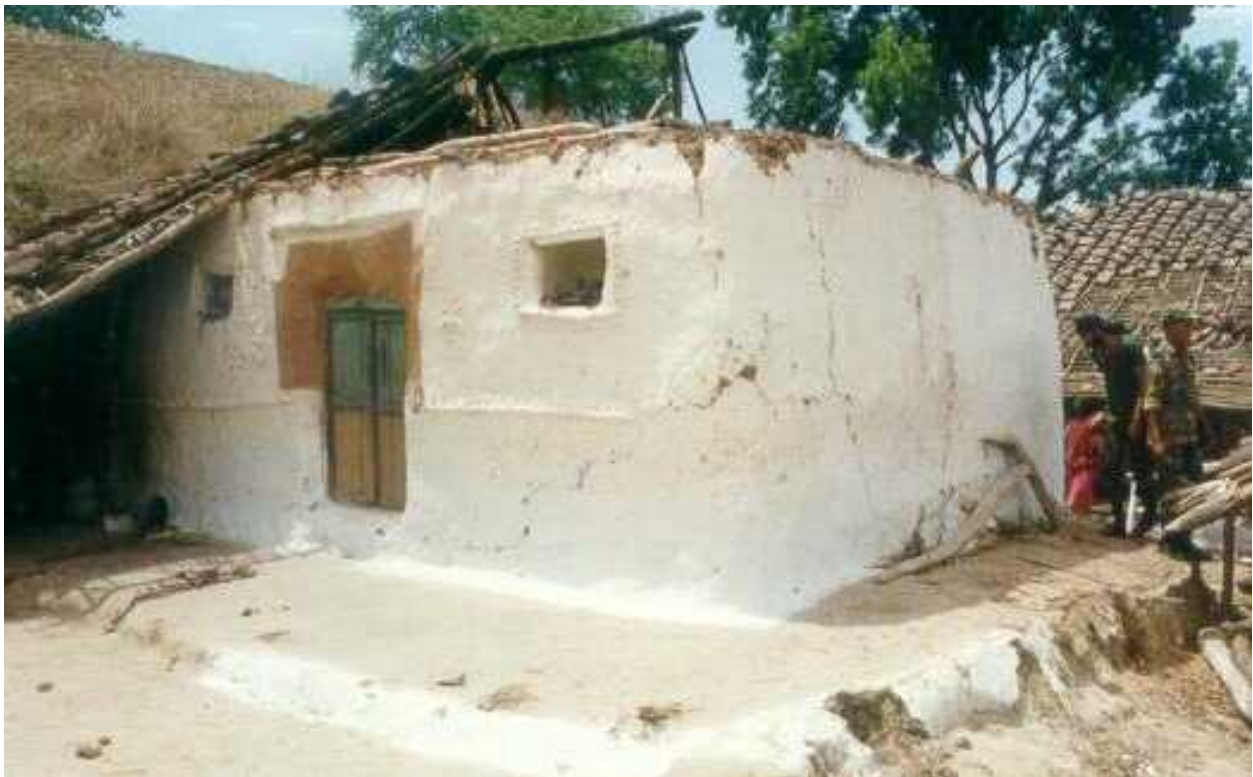
*FIGURE 6D: Typical Earthquake Damage - Roof Collapse in the 1997 Jabalpur earthquake (Source: Sudhir K. Jain, IIT Kanpur)*
