# World Housing Encyclopedia Report

Country: India

Housing Type: Traditional rural house in Kutch region of India (bhonga)

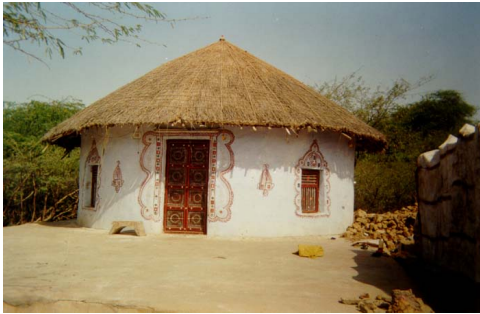
Figure 1A: Typical Building

Bhonga is a traditional construction type of the Kutch district of Gujarat state in India, which has a very high seismic hazard. A Bhonga consists of a single cylindrically shaped room. The Bhonga has a conical roof supported by cylindrical walls. Bhonga construction has existed for several hundred years. This type of house is quite durable and appropriate for prevalent desert conditions. Due to its robustness against natural hazards as well as its pleasant aesthetics, this type of housing is also known as "Architecture without Architects". This type of housing performed very well in the recent M 7.6 Bhuj earthquake of 2001. Very few Bhongas experienced significant damage in the epicentral region, and damage that did occur can be mainly attributed to poor quality of the construction materials or improper maintenance of the structure. It was also observed that the failure of Bhongas in the last earthquake caused very few injuries to the occupants due to the type of collapse.

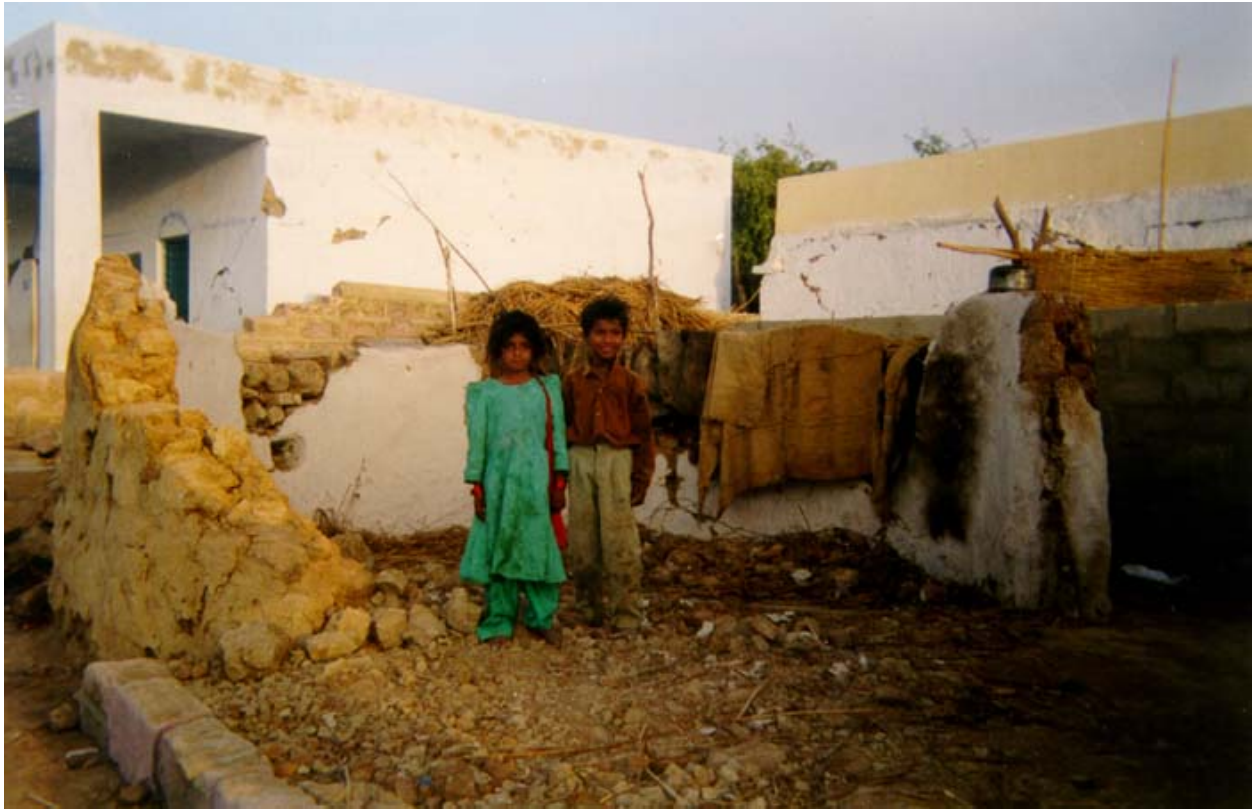
FIGURE 6A: A Photograph Illustrating Typical Earthquake Damage (2001 Bhuj earthquake)

Structural Element	Seismic Deficiency	Earthquake-Resilient Features	Earthquake Damage Patterns
Wall	Poor quality of construction materials (especially the use of adobe blocks and mud mortar)	Excellent resistance to lateral loads due to the shell action of cylindrical walls.	Minor damage for walls constructed with cement mortar and significant damage for walls constructed with mud mortar were observed after Bhuj earthquake.
Frame (Columns, beams)	Not Applicable		
Roof and floors	Roofs are simply supported on the walls. Sometimes, vertical posts are used to support the wooden joists, but the connection is not proper.	Roofs have good resistance due to their light weight and use of highly ductile materials.	Only minor damage to the roofs were observed during the Bhuj earthquake, even for Bhongas whose walls had totally collapsed. The roof was able to maintain its structural integrity due to its light weight and weak connection between the roof and the wall.

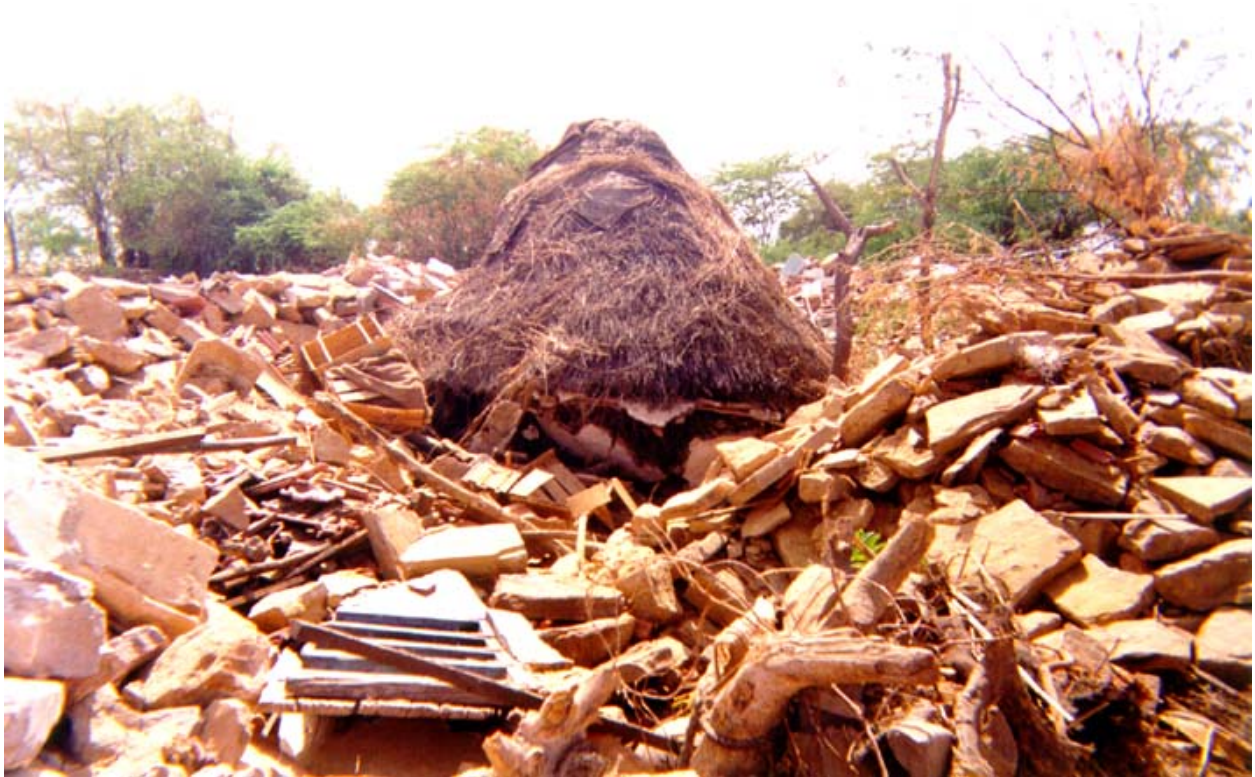
*Figure 6B: A Photograph Illustrating Typical Earthquake Damage (2001 Bhuj earthquake)*
