# World Housing Encyclopedia Report

Country: India

Housing Type: Unreinforced brick masonry walls with pitched clay tile roof

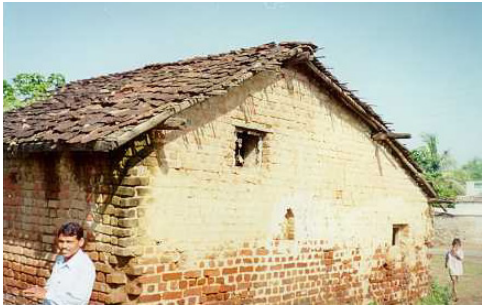
FIGURE 1: Typical Building

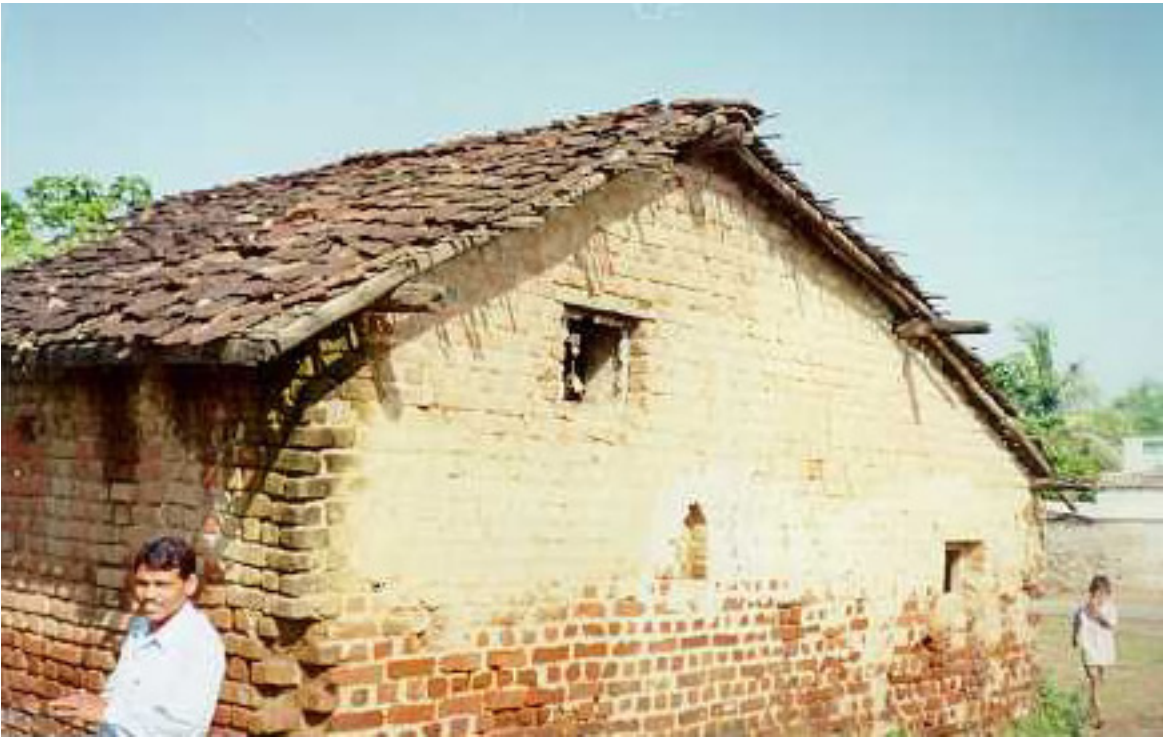
FIGURE 1: Typical Building

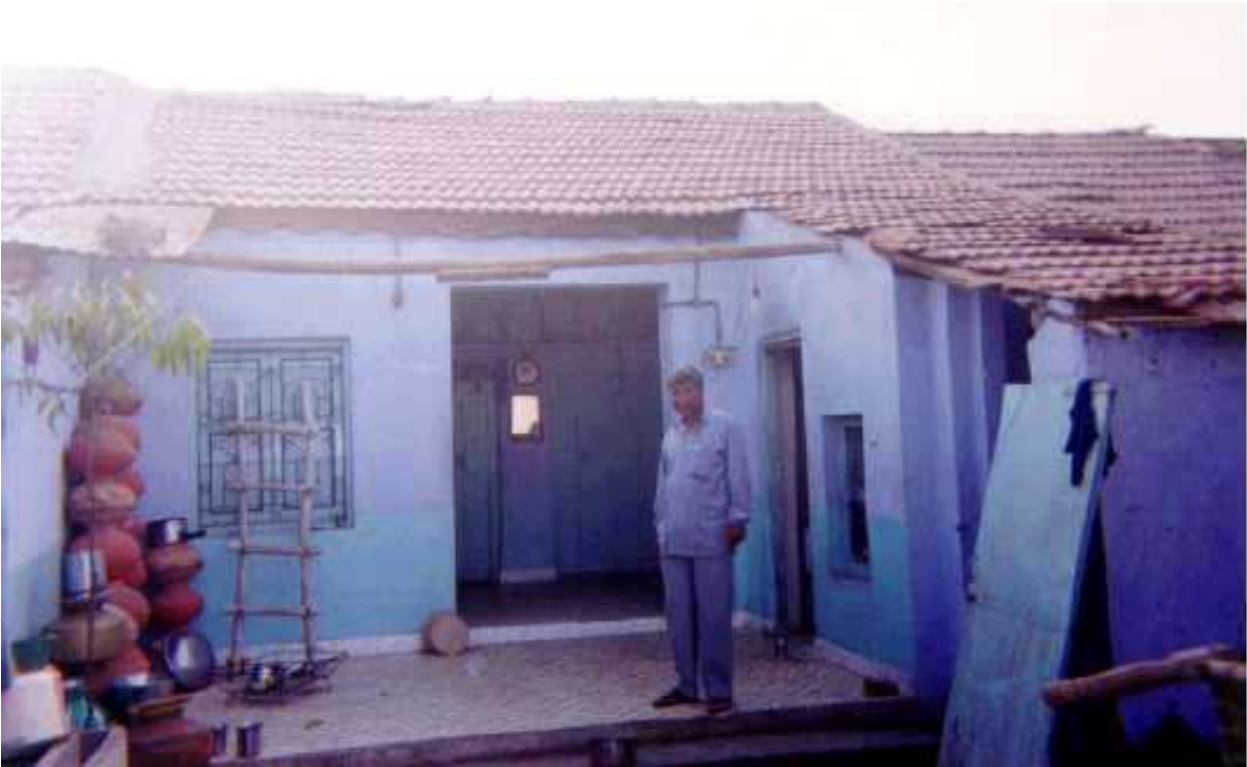
FIGURE 1A: Typical Rural Building in Maliya village, Gujarat (Source: IIT Powai 2001)

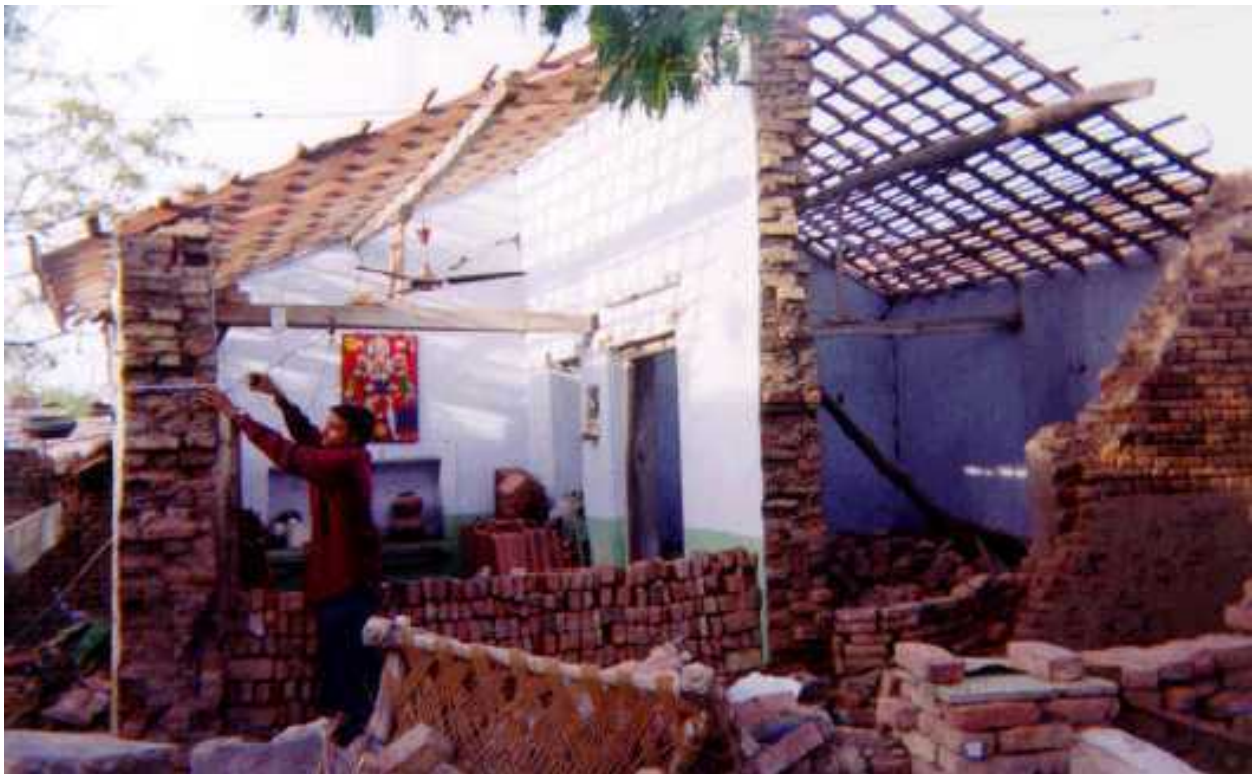
FIGURE 2A: Key Load-bearing Elements - typical village house in Gujarat (Source: IIT Powai 2001)

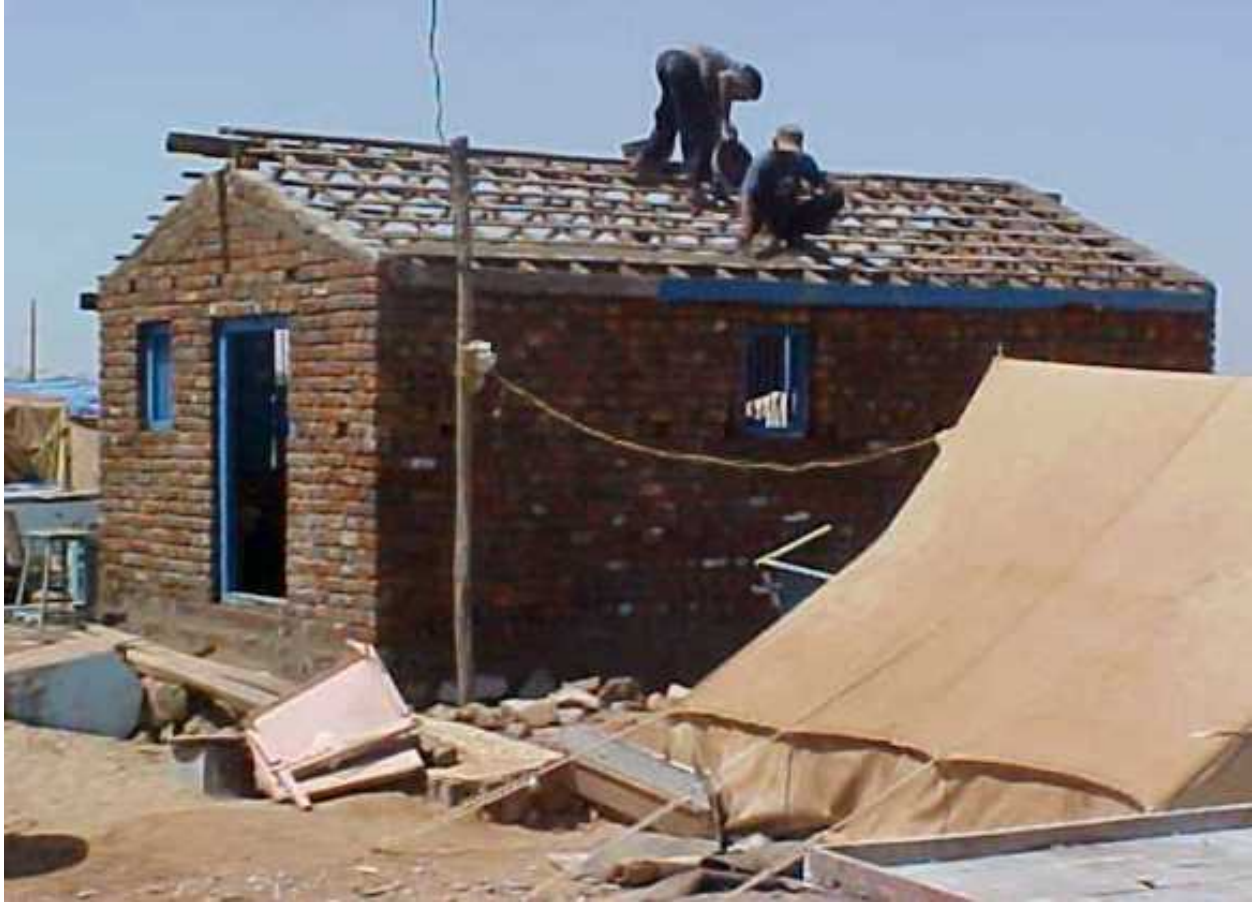
*FIGURE 2B: Key Load-Bearing Elements - Roof Construction (Source: Sudhir K. Jain, IIT Kanpur)*

3. Roofing: The roof truss is either made up of bamboo, wood or built up steel section. The spacing between purlines and rafters are generally not regular. Older buildings often used heavy clay tiles on the roof cladding. The cladding material and roof tiles are not usually firmly anchored to the trusses and wall.

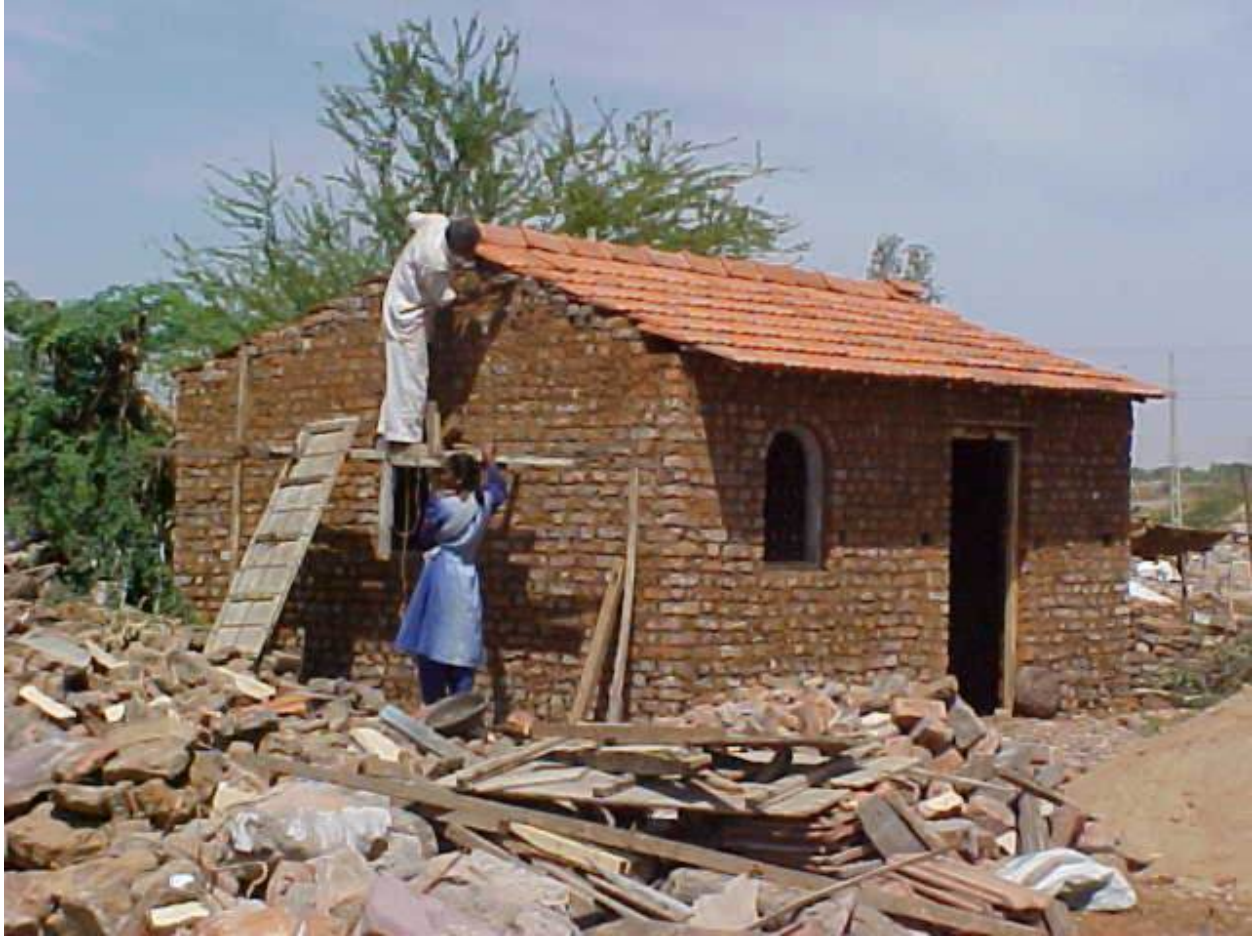
FIGURE 2C: Key Loadbearing Elements - Laying of Mangalore Roof Tiles (Source: Sudhir K. Jain, IIT Kanpur)

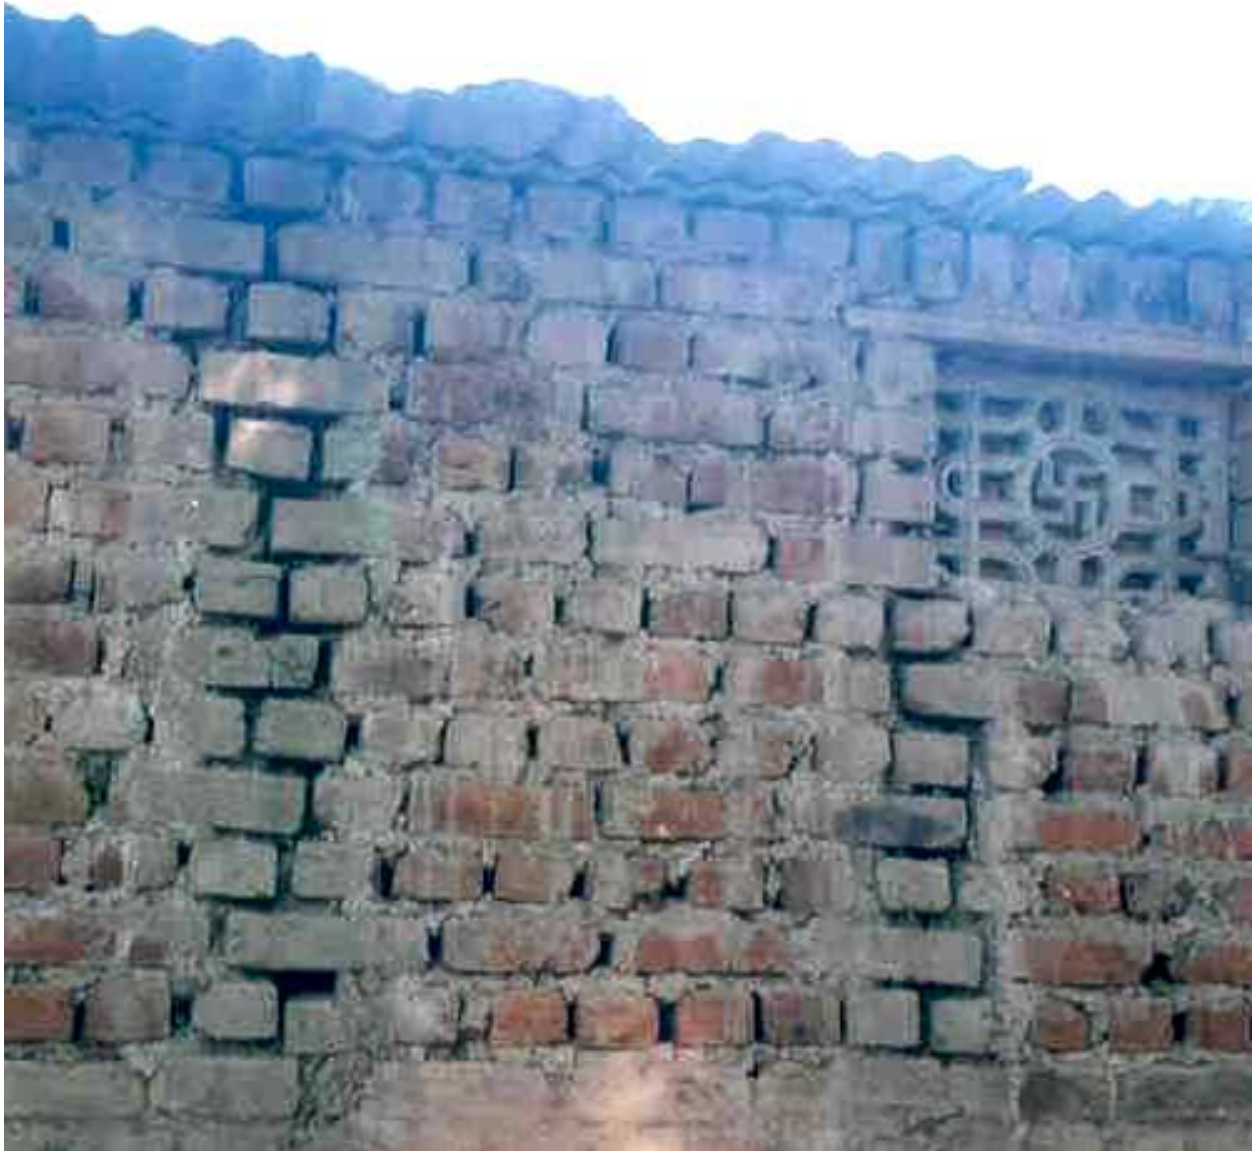
*FIGURE 4: Critical Structural Details - Elevation of Brick Masonry Wall in Mud Mortar (Source: Svetlana Brzev)*

2. Wall: The wall is constructed in mud or cement mortar using procedure similar to that of foundation. Buildings of such type in rural areas are found to be having poor workmanship. English bond is generally used for wall construction.

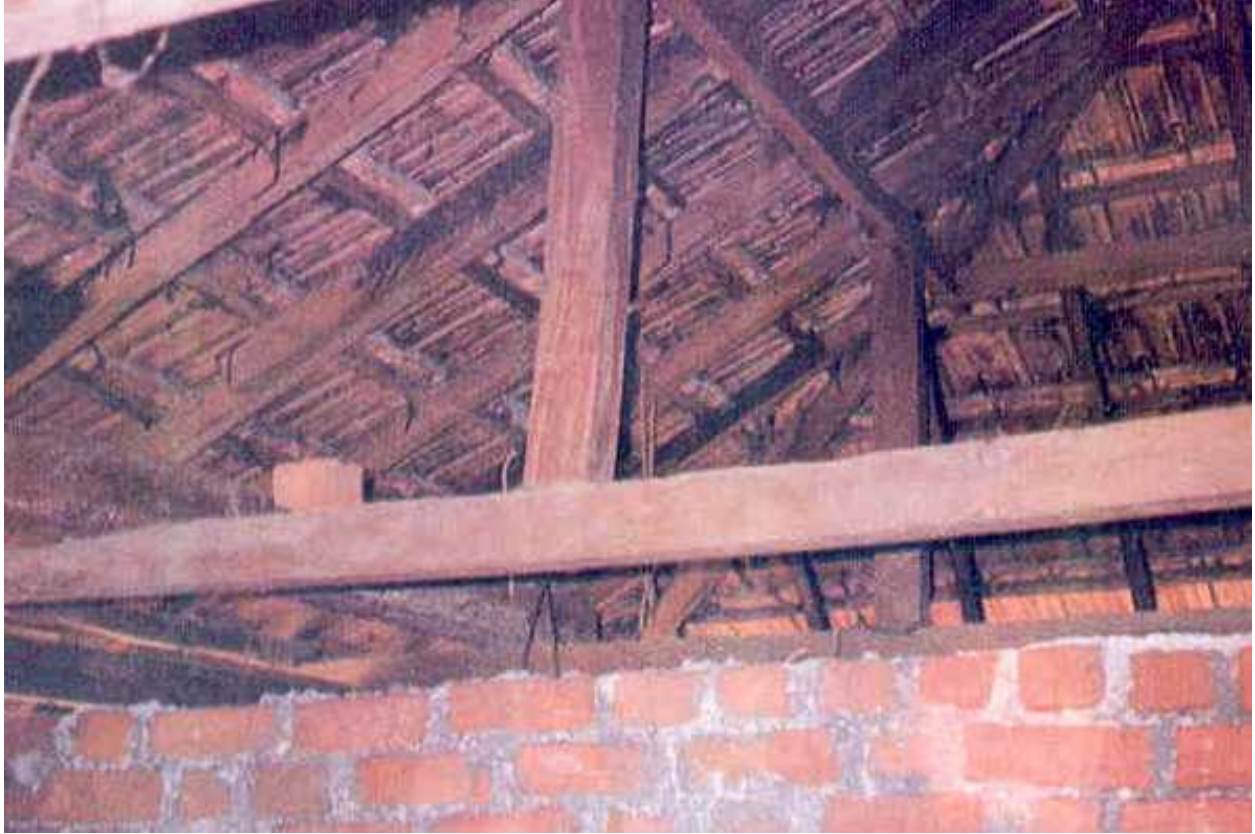
*Figure 4A: Critical Structural Details - Good Quality Roof Construction (Source: GOM 1998)*

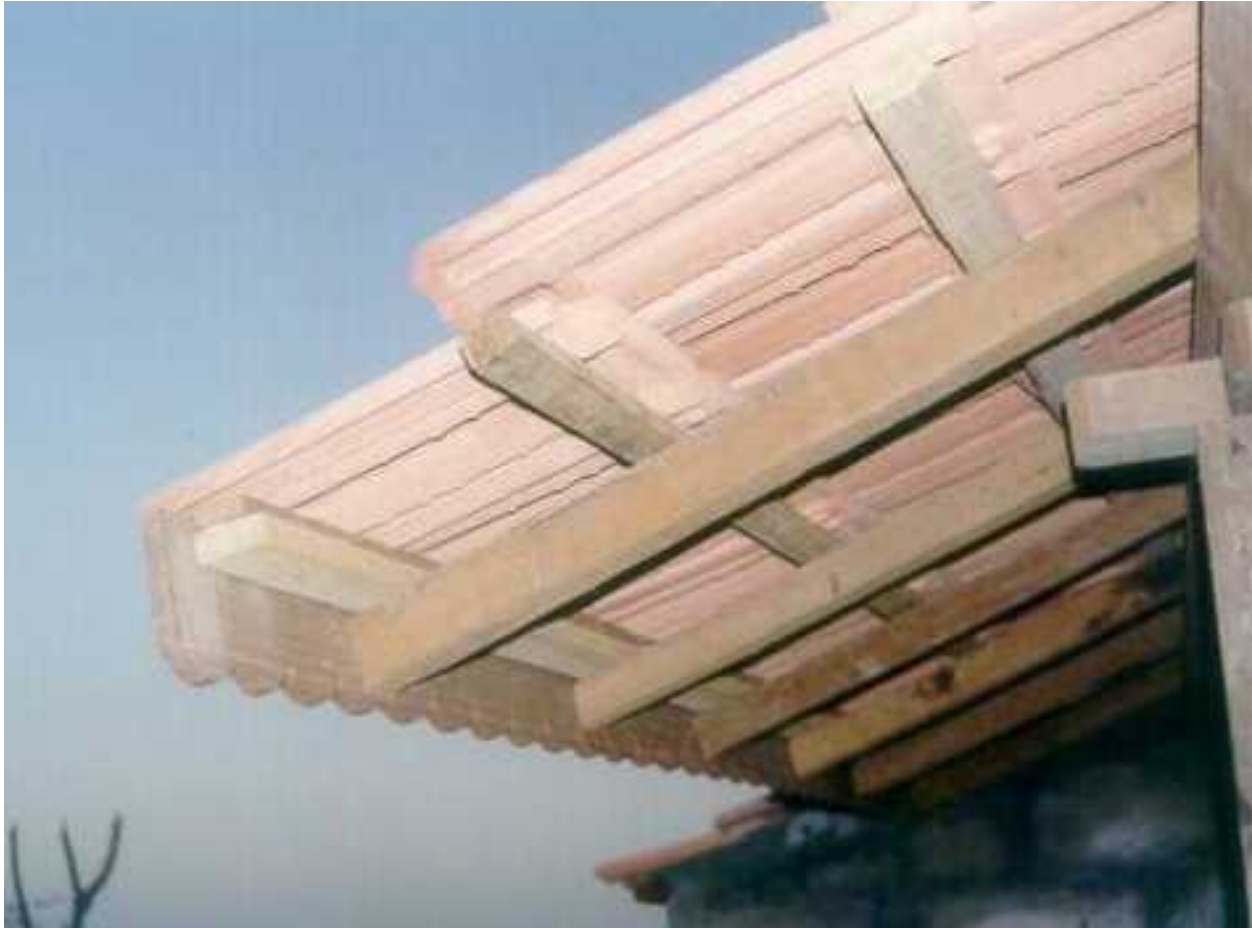
FIGURE 4B: Critical Structural Details - Mangalore Tile Roof Construction (Source: Sudhir K. Jain, IIT Kanpur)

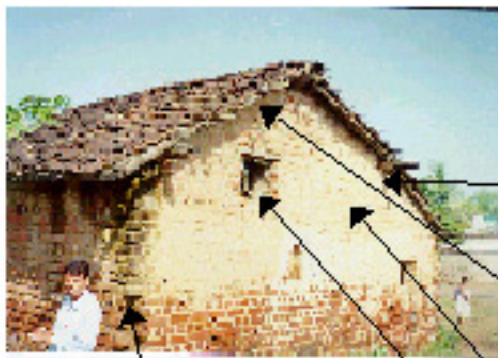
**Toothed joint at the corner**

Missing / Vertical  
Horizontal Reinforcement

Missing Bracing in Roofing  
Elements

No Lintel / Gable Band

No Opening at same level

FIGURE 5: An Illustration of Key Seismic Deficiencies

Structural Element	Seismic Deficiency	Earthquake-Resilient Features	Earthquake Damage Patterns
Wall	- Poor lateral resistance - Lintel band is absent - Openings are not properly proportioned - The distance between corner and opening is not as per recommended practice		
Frame (columns, beams)			
Roof and floors	- The roofing elements are not interconnected. - The roof structure is not anchored to the wall - Poor maintenance		
Other

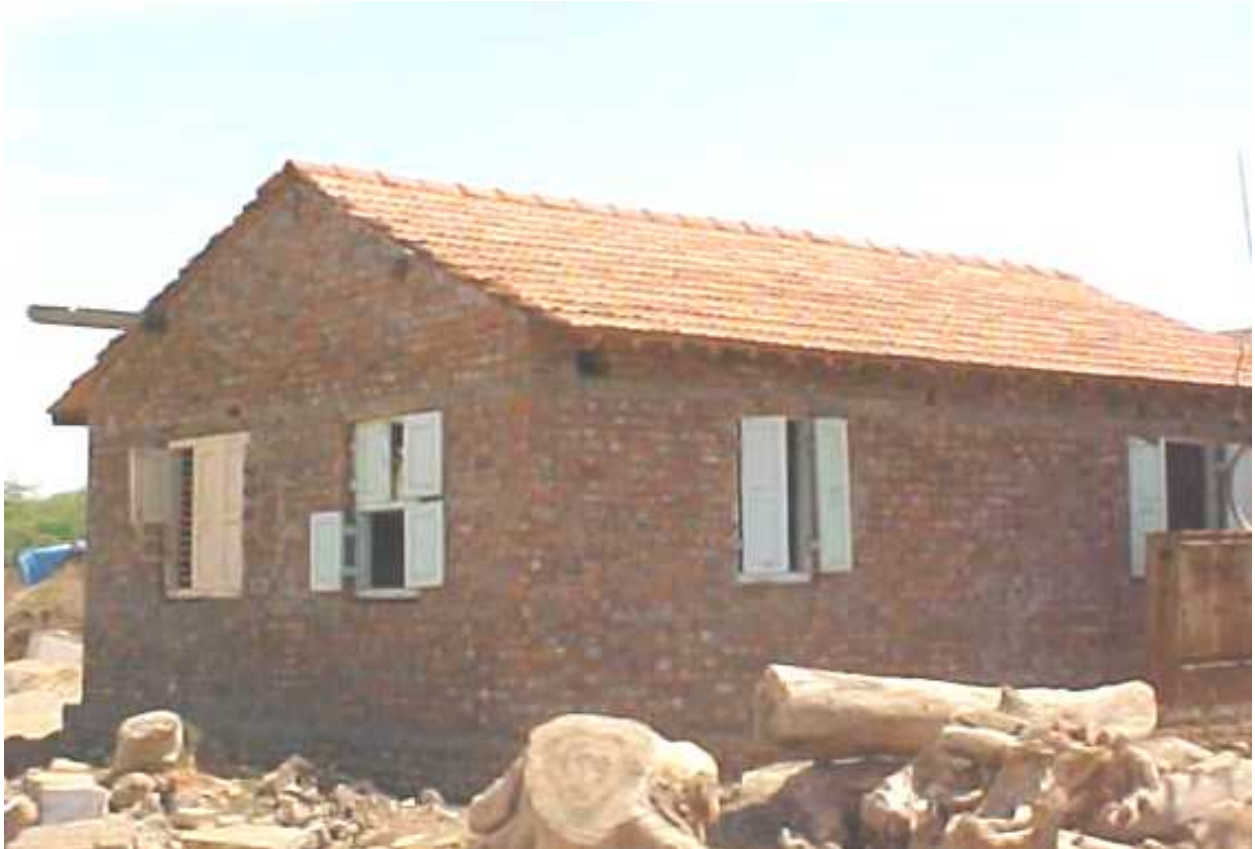
*FIGURE 5A: Key Seismic Resilient Features - RC Lintel Band and Good Quality Brick Masonry Construction (Source: Sudhir K. Jain, IIT Kanpur)*

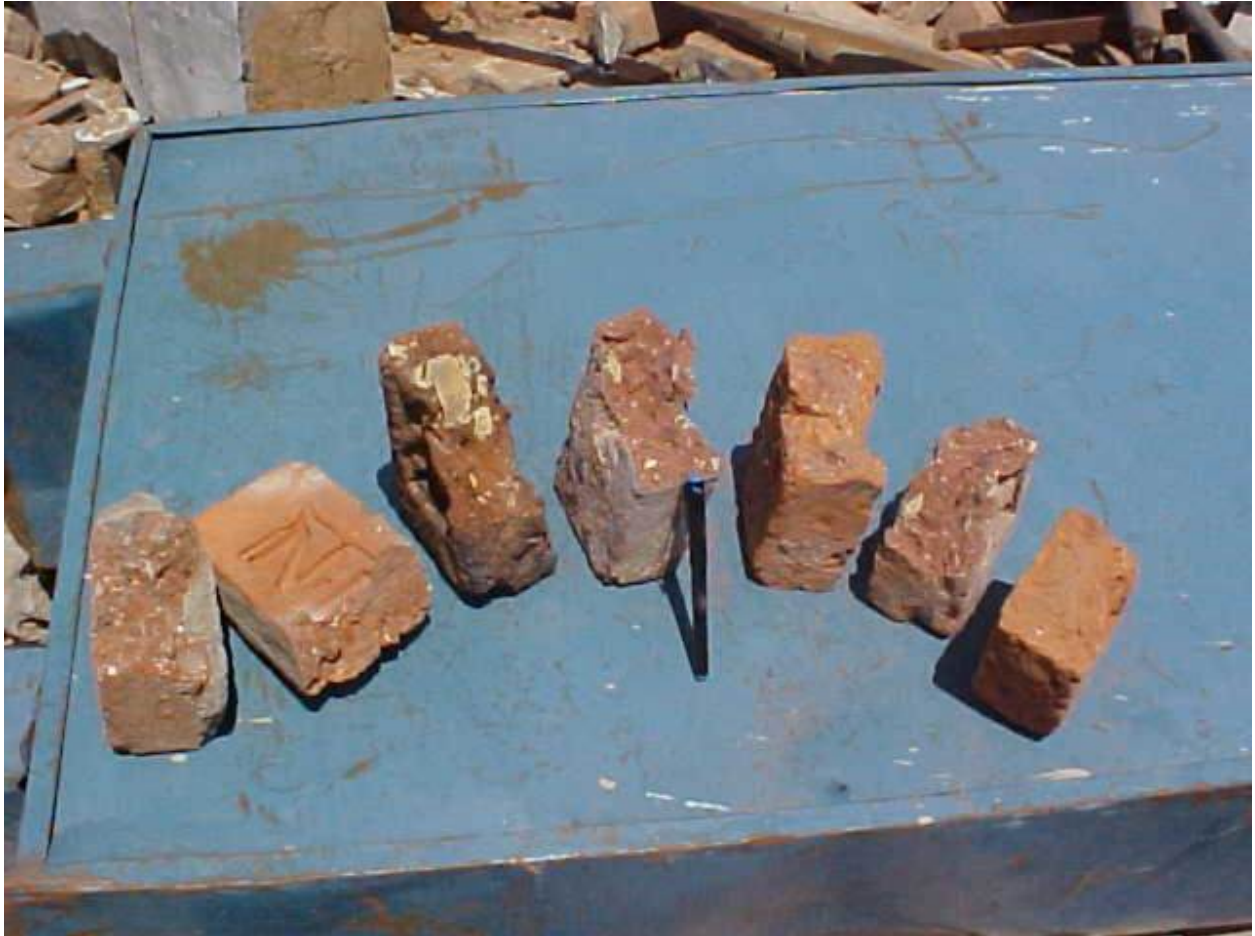
*FIGURE 5B: Construction Deficiency - Poor Quality Bricks (Source: Sudhir K. Jain, IIT Kanpur)*

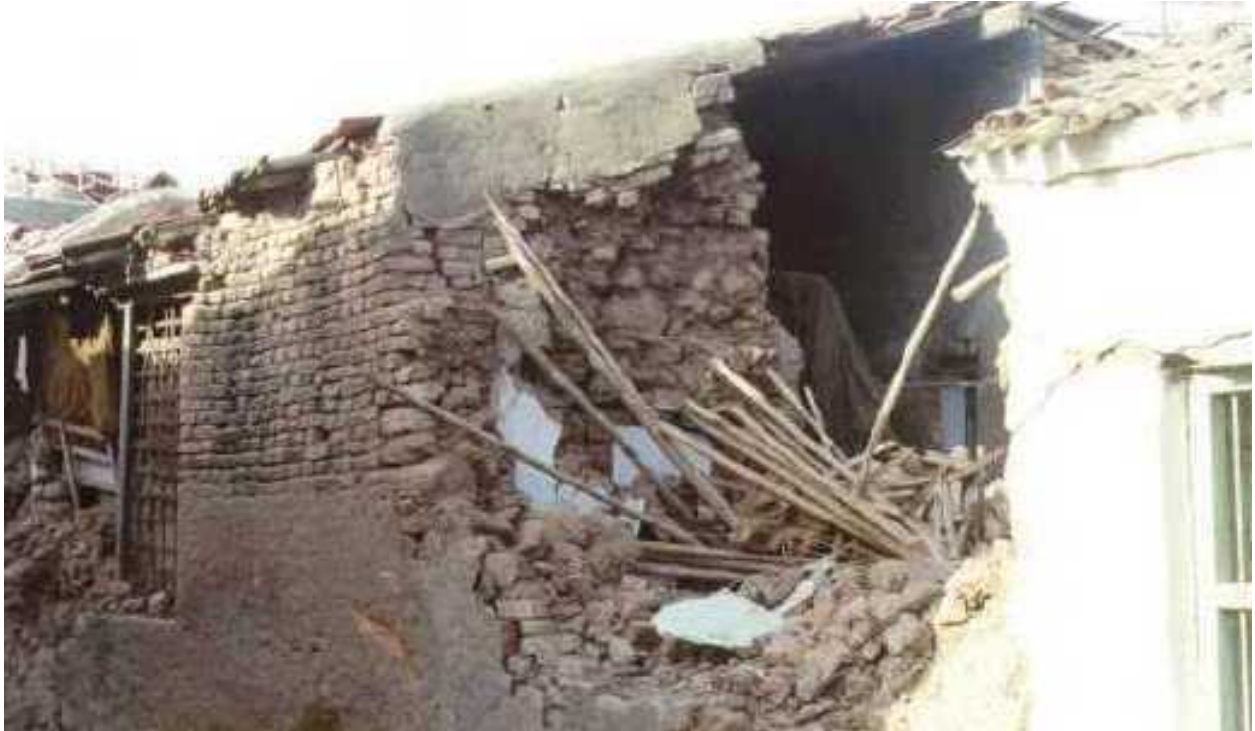
*FIGURE 6A: Typical Earthquake Damage - Wall Collapse due to Poor Quality Brick Construction and Poor Inadequate Wall Connections in the 2001 Bhuj earthquake (Source: IIT Powai 2001)*

*Additional Comments:* \*\*\*\* - Brick masonry buildings with pitched roofs and clay tiles were found in the area affected by the 2001 Bhuj (Gujarat) earthquake. In general, these structures performed poorly in the earthquake. In the epicentral region, several buildings of this type suffered total collapse of the walls resulting in the death and injury to large number of people. In masonry buildings with pitched roof, the roof tiles performed very poorly. In most cases, the roof tiles were damaged and in several instances, the tiles slid off the roof. Most of the dwellings have experienced failure of roofing tiles inside the house and rafters supporting the roof truss have also failed in some cases (Source: IIT Powai 2001).

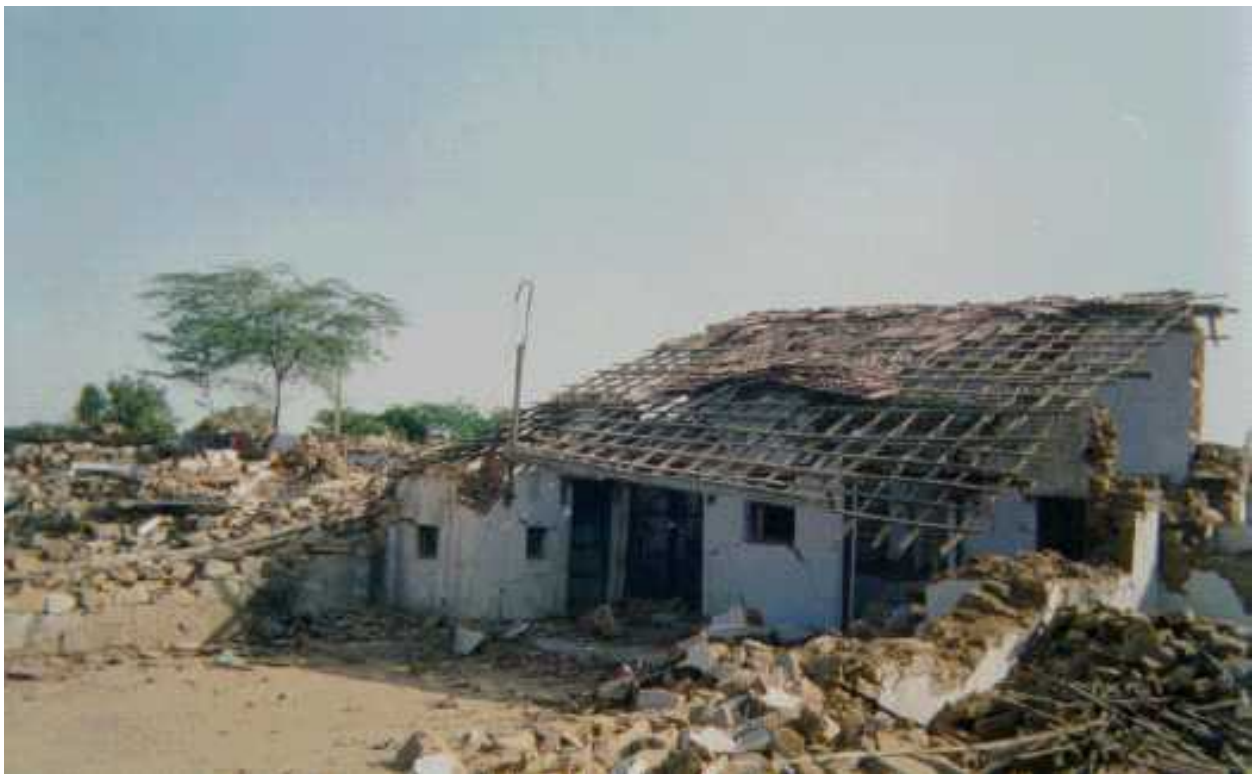
*FIGURE 6B: Failure of a residential building, Chobri Village near Bhachau, 2001 Bhuj earthquake (Source: IIT Powai 2001)*

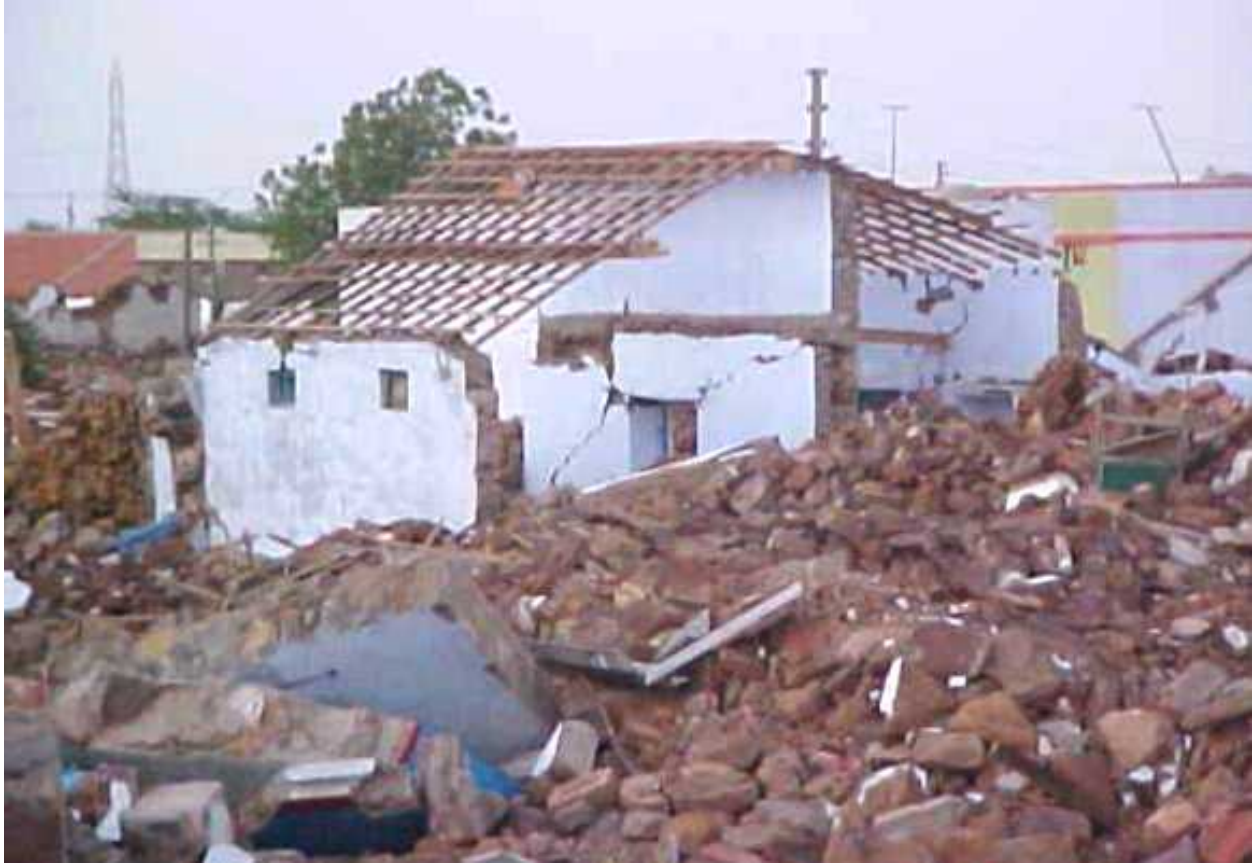
*FIGURE 6C: Typical Earthquake Damage: Collapse of roof and walls of a brick lime mortar house in the 2001 Bhuj earthquake (Source: Sudhir K. Jain, IIT Kanpur)*
