World Housing Encyclopedia Report

Country: Italy

Housing Type: Brick masonry farmhouse with a "dead door".

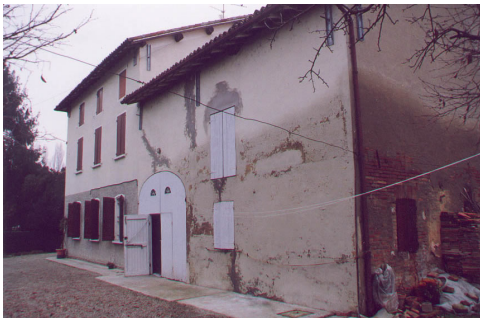
FIGURE 1: Typical Building

This is a single family farmhouse construction, found throughout the Padania Plain (Reggio Emilia Province). This housing type accounts for approximately 20% of the entire housing stock in the Reggio Emilia Municipality. This building practice is no longer followed. Most of the existing buildings were built in the 19th and 20th century. The residential and agricultural sections of the house are separated by a central area closed at one end and hence called a "dead door". The residential section usually has two floors (typical story height 2.5 - 3.0 m), and a sloping roof. The agricultural portion, usually larger than the residential section, also has two floor levels. The first floor height is on the order of 2.5 - 3.0 m whereas the second story floor height ranges from 5.0 - 9.0 m. As a result, roof in the agricultural part of the building is at the higher level as compared to the residential part. The first floor is used as a cowshed and the second as a hayloft. The load bearing structure consists of brick masonry walls in lime mortar. The walls are characterized with variable thickness, decreasing from 280 mm at the first floor level to 150 mm at the second floor level. There are brick masonry columns in the interior of the agricultural portion at the second floor level. The buttresses can be found in the exterior brick masonry walls. Both the residential and agricultural sections have wooden floors; there are vaulted floors in the central area. In some cases, composite floors made of steel beams and perforated bricks can be found. Although the building plan is very regular, the seismic performance of this building type is rather poor due to the vertical irregularity (offset of the floors in the residential and agricultural sections), the absence of connections between walls and between walls and floors, the thrusting of the roof, and the deterioration of materials.

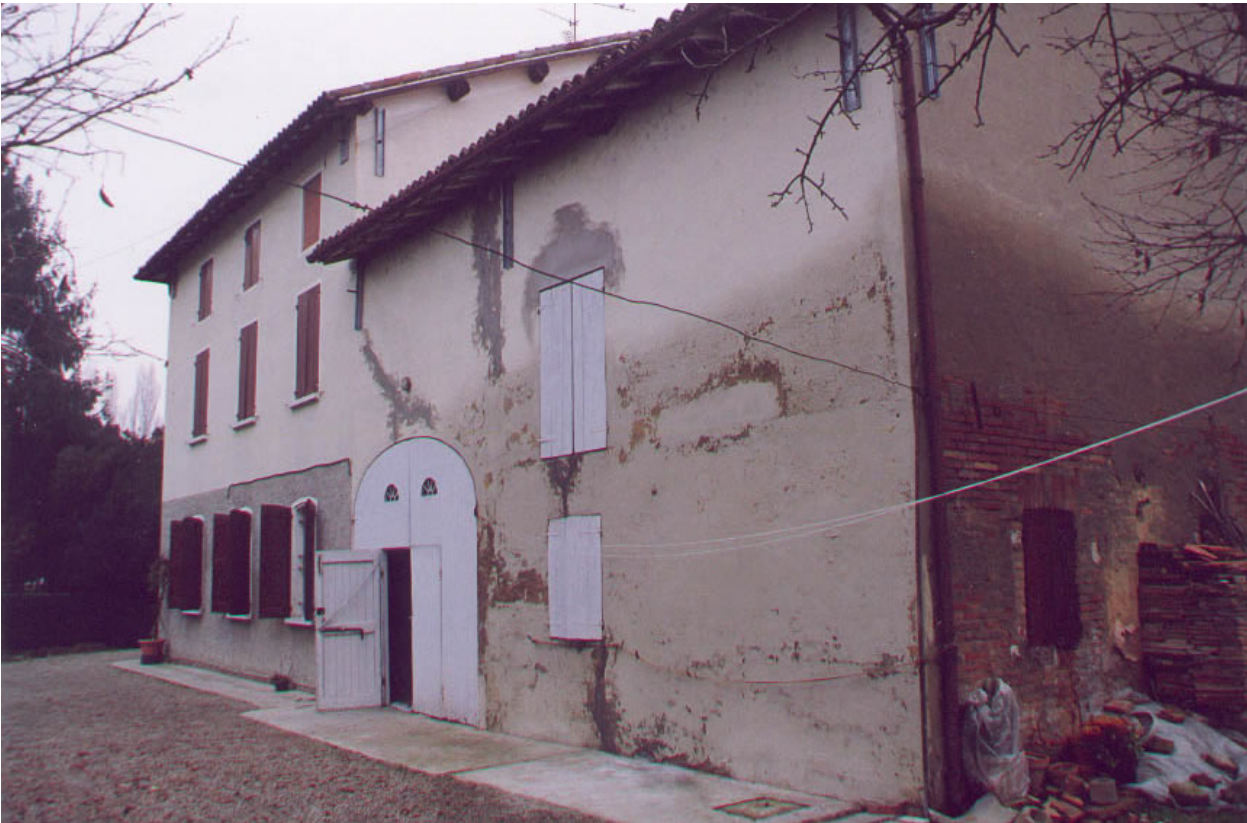
FIGURE 1: Typical Building

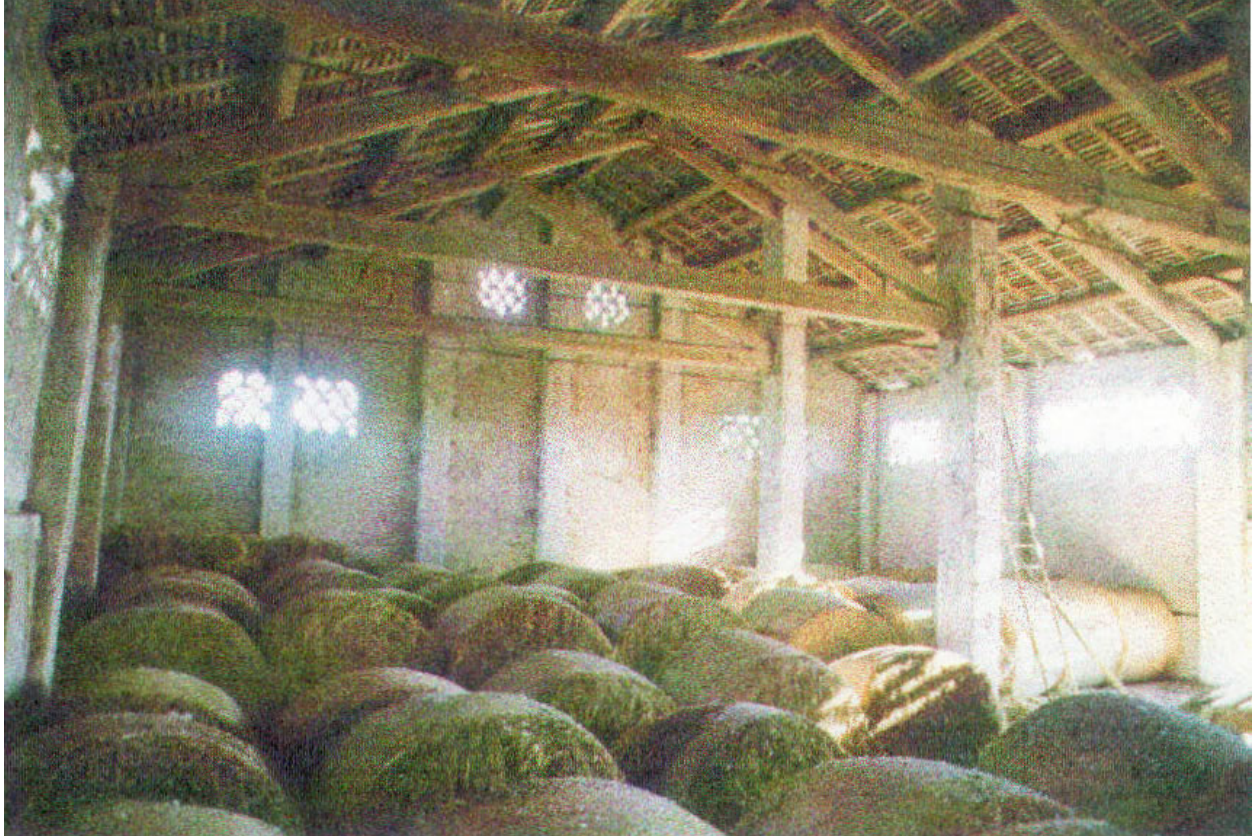
FIGURE 2: Key Load-Bearing Elements

The load bearing structure consists of brick masonry walls in lime mortar. The walls are characterized with a variable thickness, decreasing from 280 mm at the first floor to 150 mm at the second floor level. Brick masonry columns (560 mm depth) are present in the interior at the second floor level in the agricultural portion, and the buttresses can be found in the exterior walls. Both the residential and agricultural sections have wooden floors, while the vaults are present in the central area. In some cases, composite floors made of steel beams and perforated bricks can be found. On the second floor of the agricultural portion, diagonal bracing is present

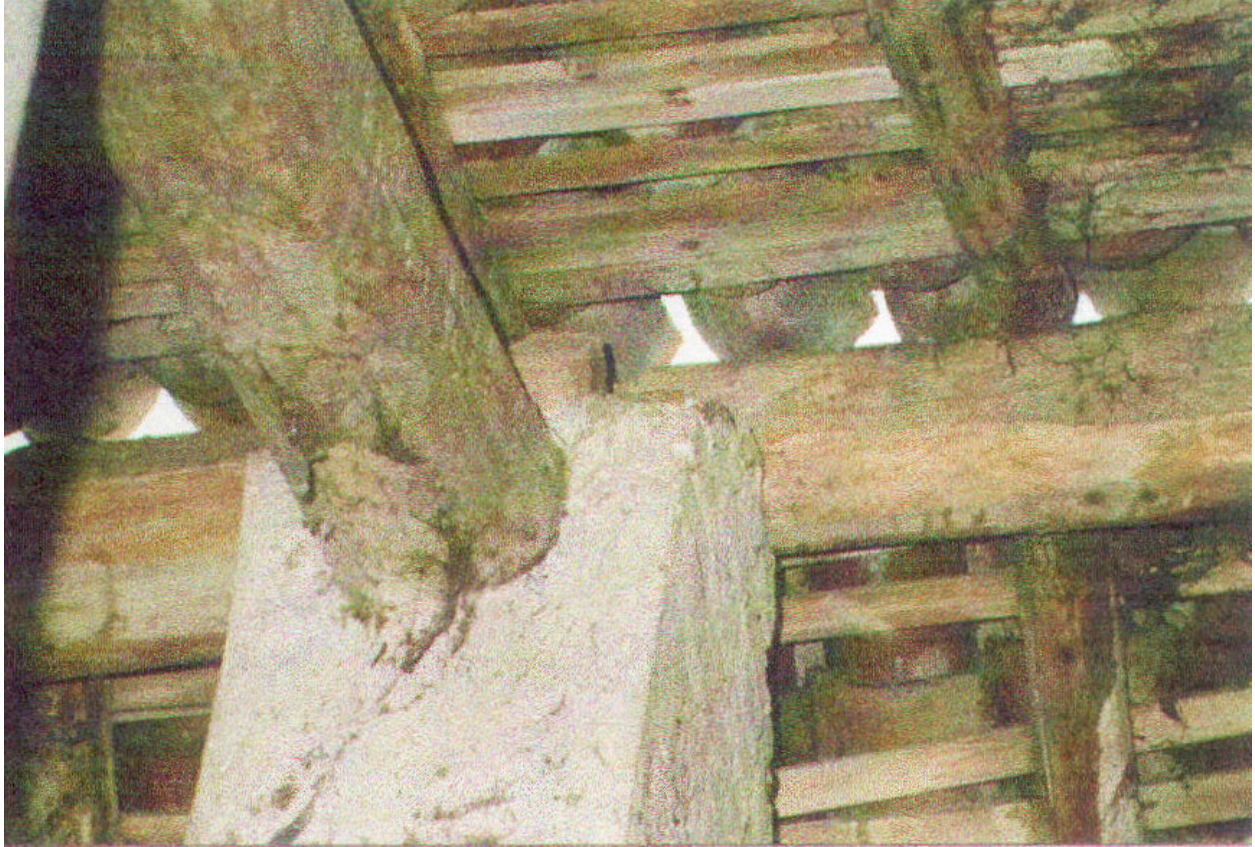
FIGURE 3: Critical Structural Detail - Roof Beam Support

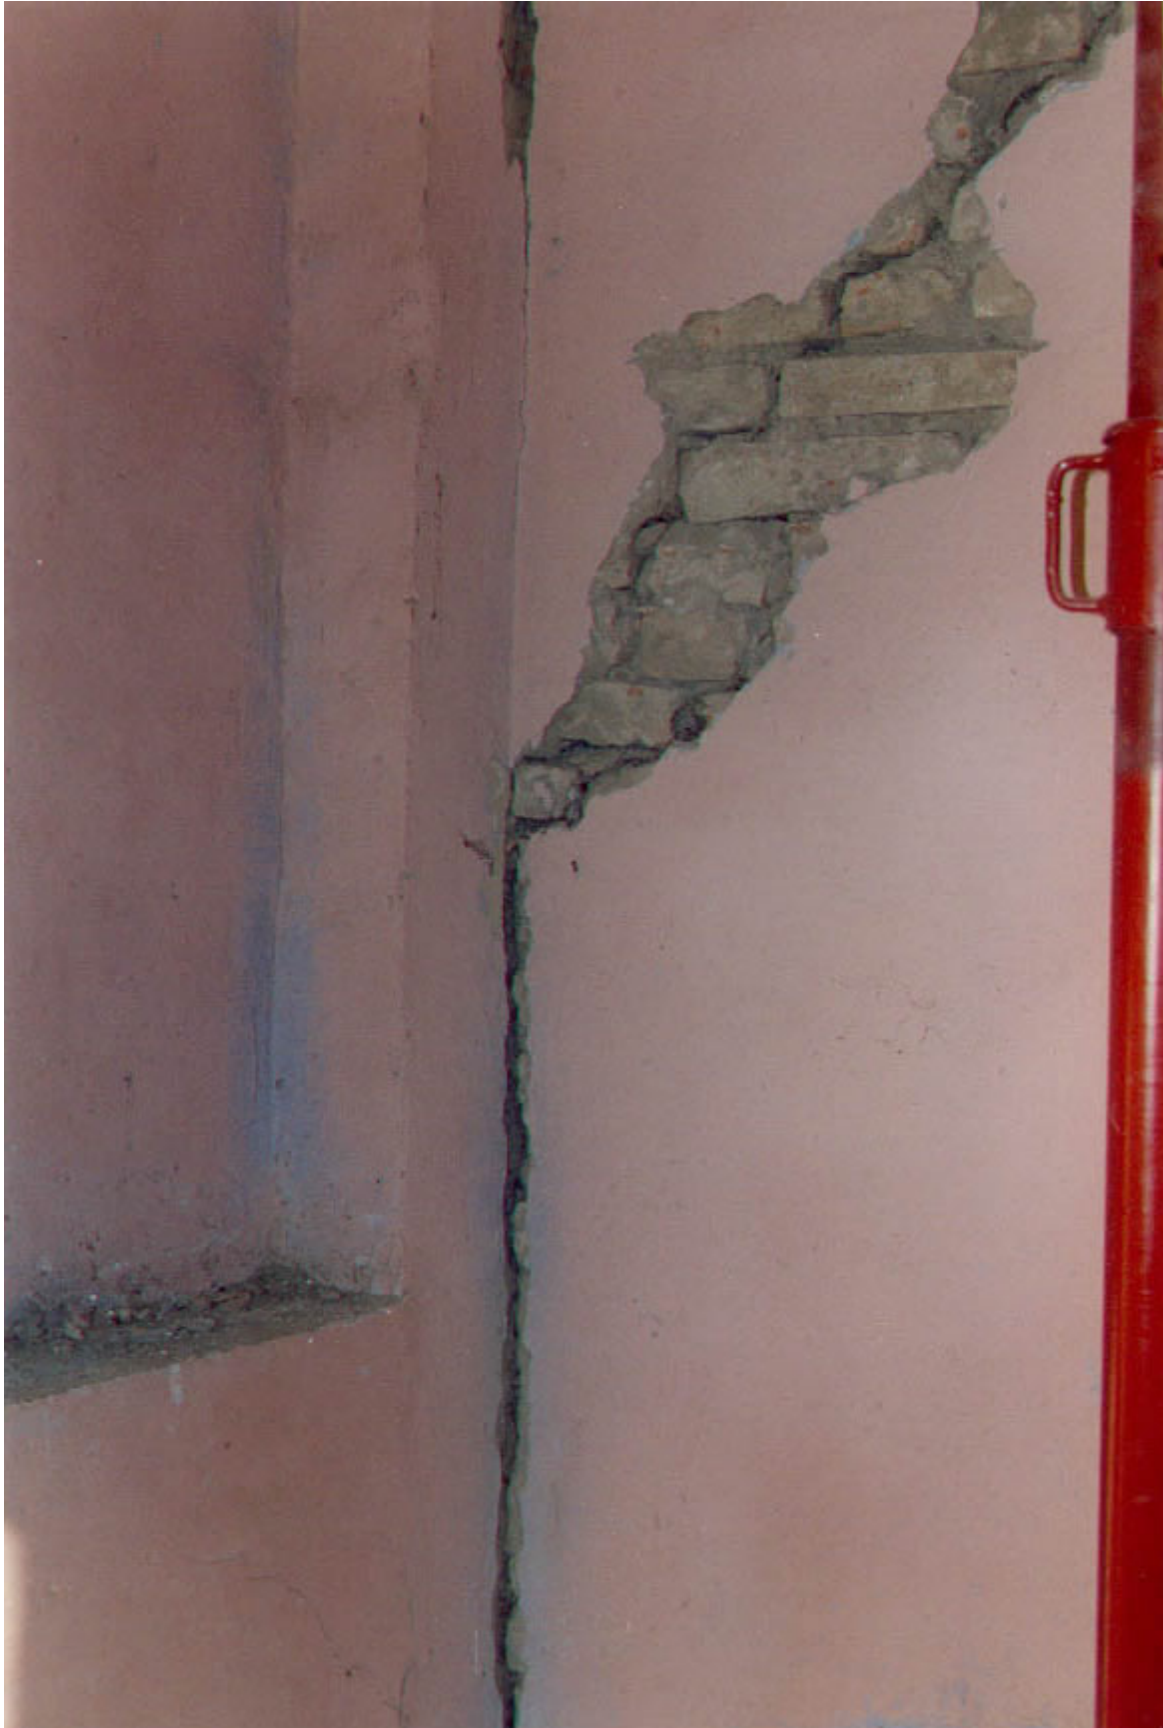
FIGURE 4: Seismic deficiency- inadequate wall connection

Structural Element	Seismic Deficiency	Earthquake-Resilient Features	Earthquake Damage Patterns
Wall	Absence of connections and/or iron ties able to prevent the out-of-plane wall overturning. At the second level, masonry wall is very slender with mortar often deteriorated.	Regular layout and solid bricks.	Separation of orthogonal walls, out of plane overturning, shear cracks, corner diagonal cracks due to the roof thrust
Columns	At the second level of the agricultural portion (hayloft) columns can be up to 9.0 m high		
Roof and floors	Flexible floors and roof are not effectively connected to walls. The vault in the central portion is usually very thin. The roof is often thrusting.	Floors and roof are light.	Separation of the floors and/or roof from the walls, beam hammering on walls

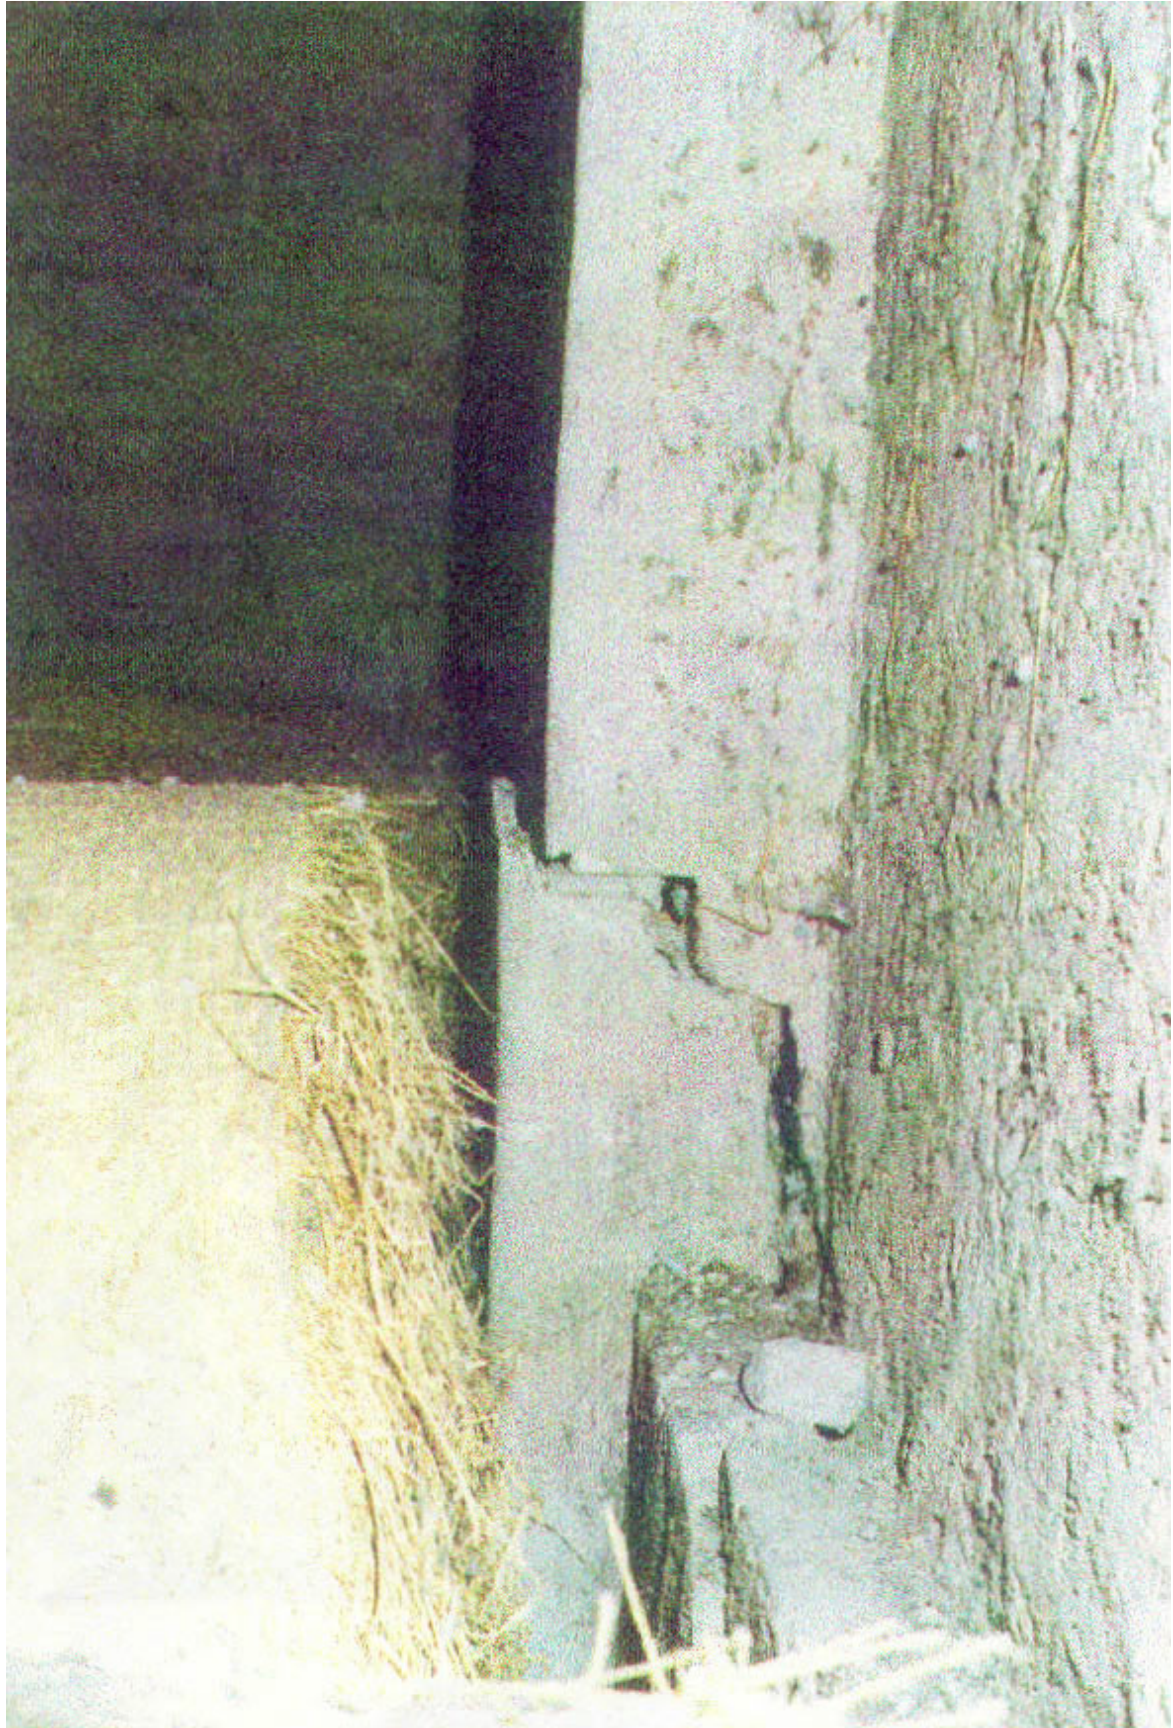
FIGURE 5A: Wall damage (1996 Bagnolo earthquake)

Year	Earthquake Epicenter	Richter magnitude(M)	Maximum Intensity (Indicate Scale e.g. MMI, MSK)
1996	Bagnolo in Piano, Reggio Emilia	4.5	VII MCS
1971	Parmense	5.5	VI MCS
1832	Reggiano	5.2	VII-VIII MCS
1547	Reggio Emilia	4.7	VI-VII MCS

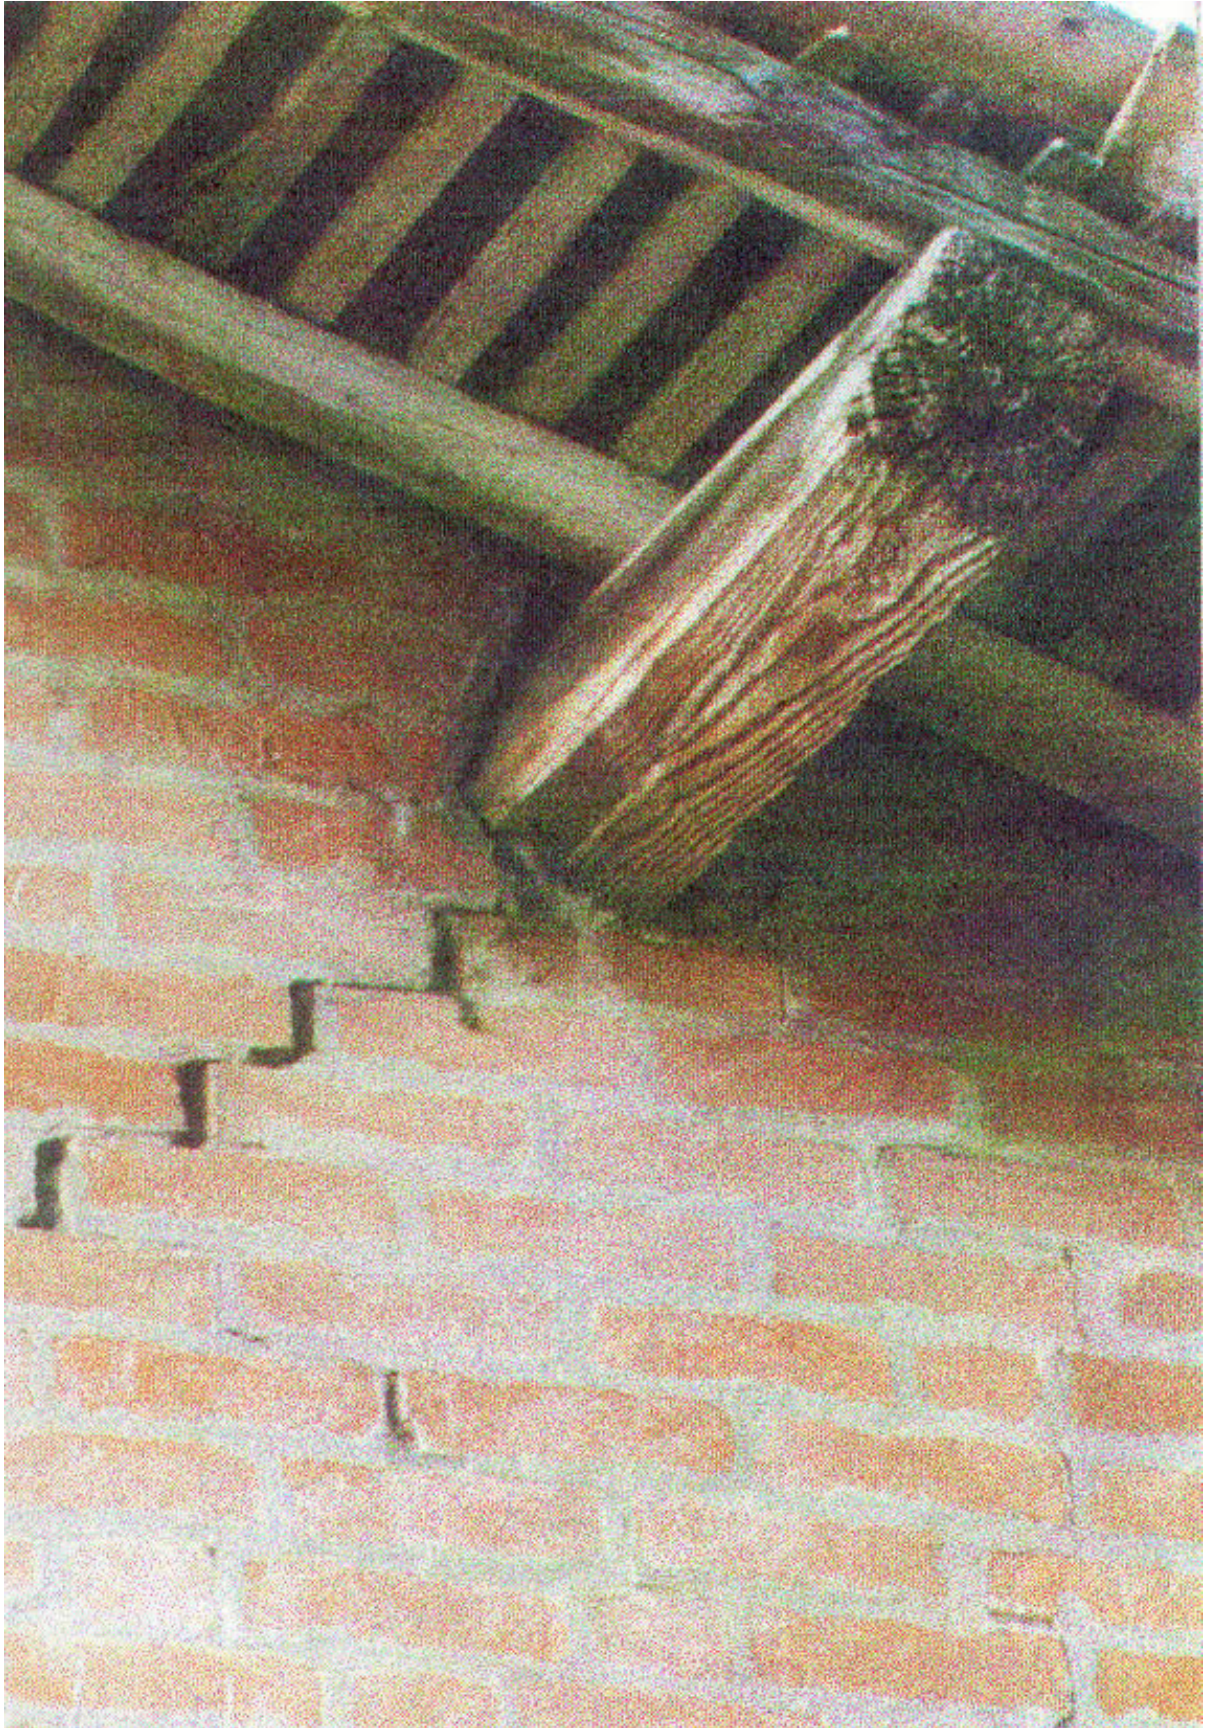
FIGURE 5B: Wall damage at the roof beam support (1996 Bagnolo earthquake)

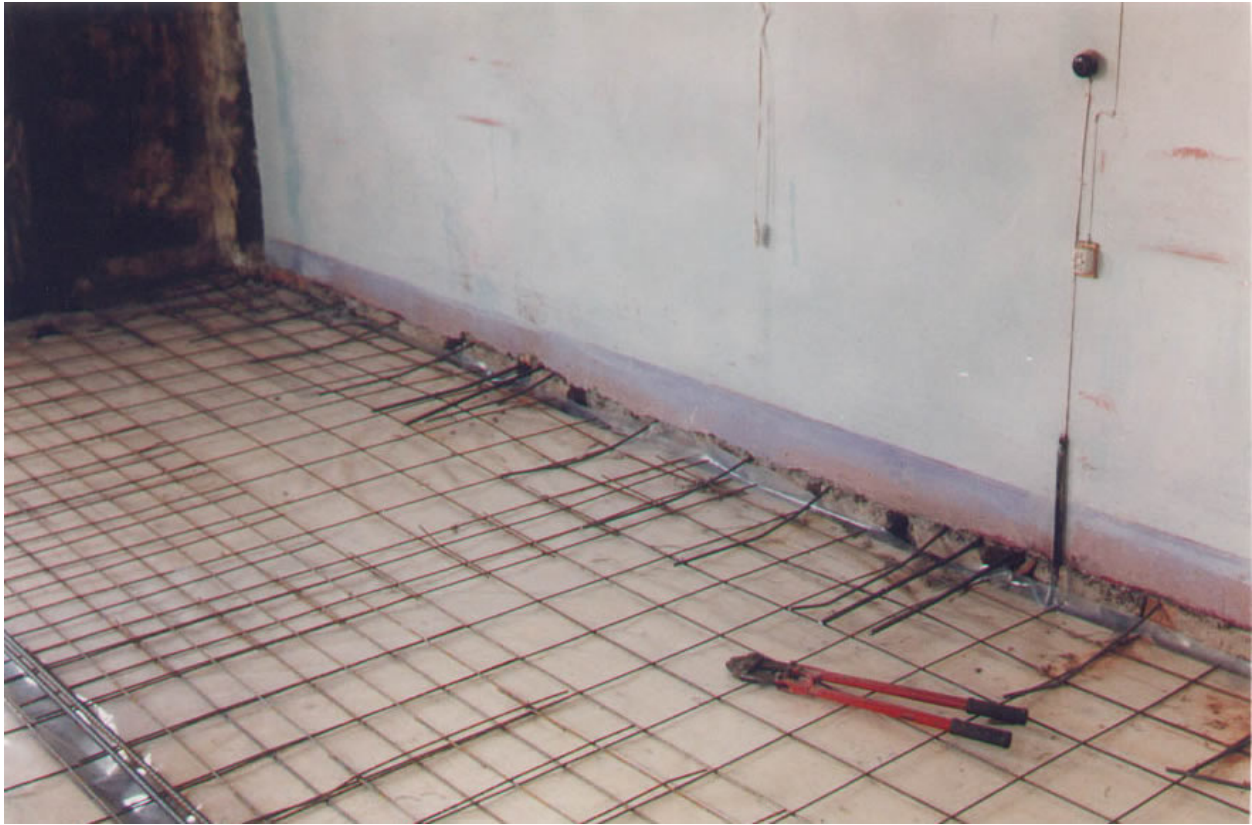
FIGURE 6A: Illustration of Seismic Strengthening Techniques

Type of intervention	Structural Deficiency	Description of seismic strengthening provision used
Retrofit (Strengthening)	Wall	-replacement of bricks with similar ones (sometimes with the insertion of horizontal steel rebars); -insertion of transverse connections made by bricks or steel bars into the wall; -tying of the orthogonal walls; -installation of iron ties; -Concrete jacketing is seldom performed.
	Floors	Construction of new RC slab atop existing beams, tying the floor to the walls, replacement of the existing floor with RC floor
	Roof	-replacement of existing wooden beams, -reinforcement (doubling) of the wooden boarding, -construction of RC ring beam
	Columns	-Confinement with steel elements
	Vaults	-RC slab on existing vaults

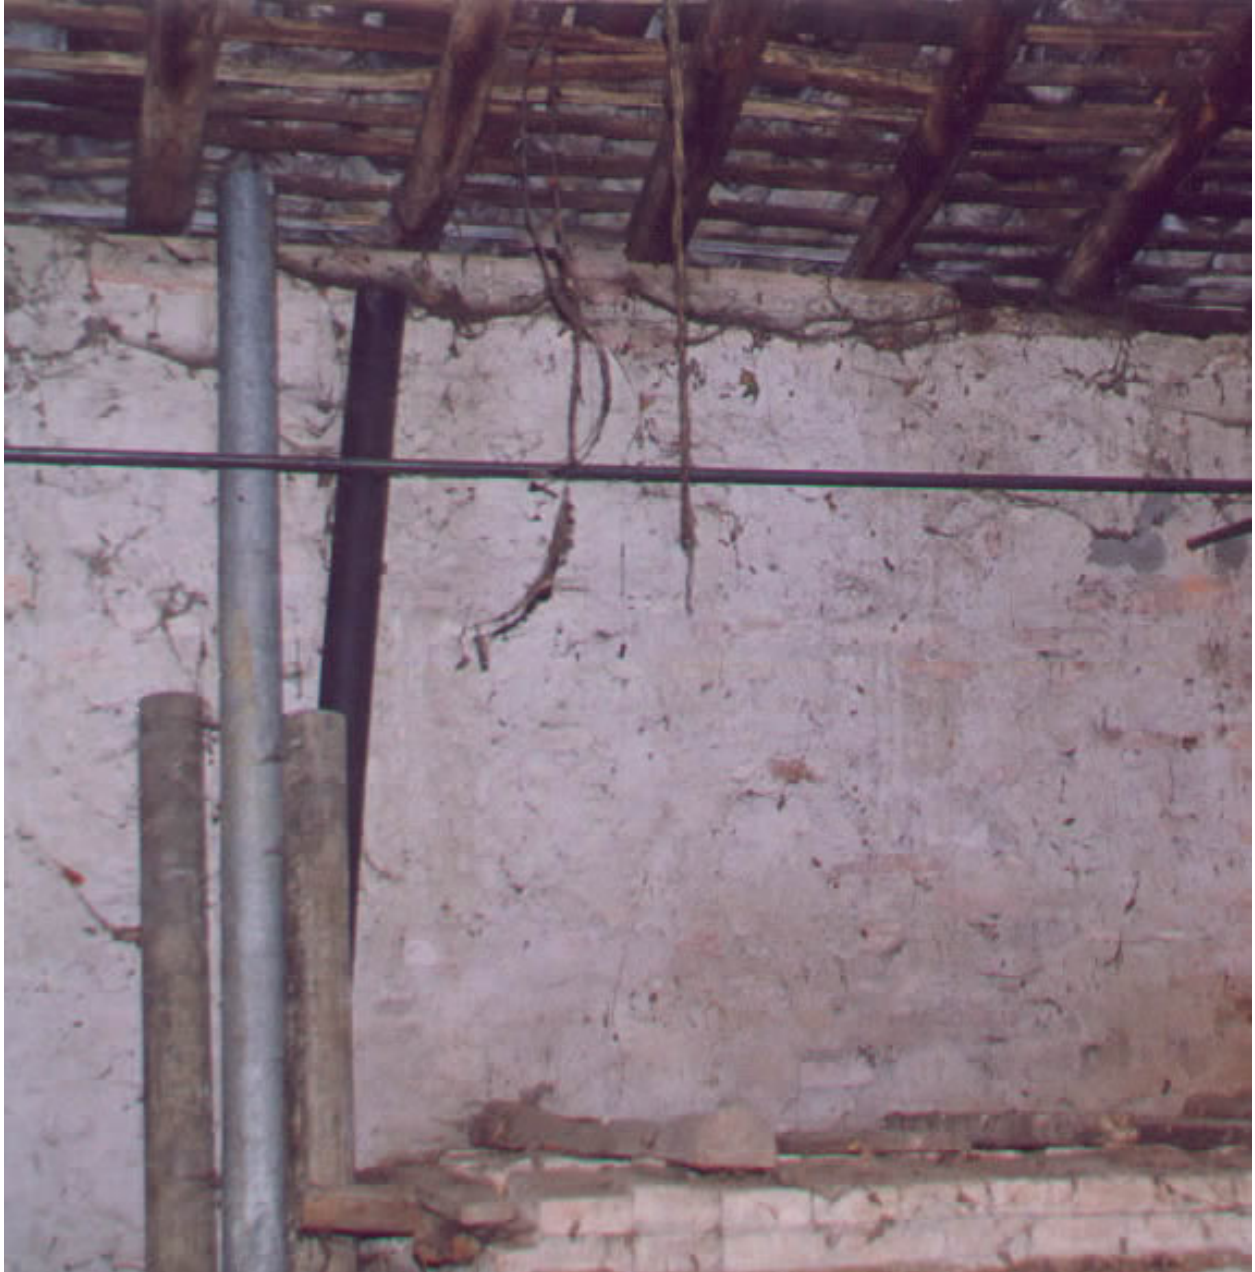
FIGURE 6B: Seismic strengthening technique - installation of the iron ties
