World Housing Encyclopedia Report

Country: Italy

Housing Type: Single-family historic brick masonry house (Casa unifamiliare in centro storico, Centro Italia)

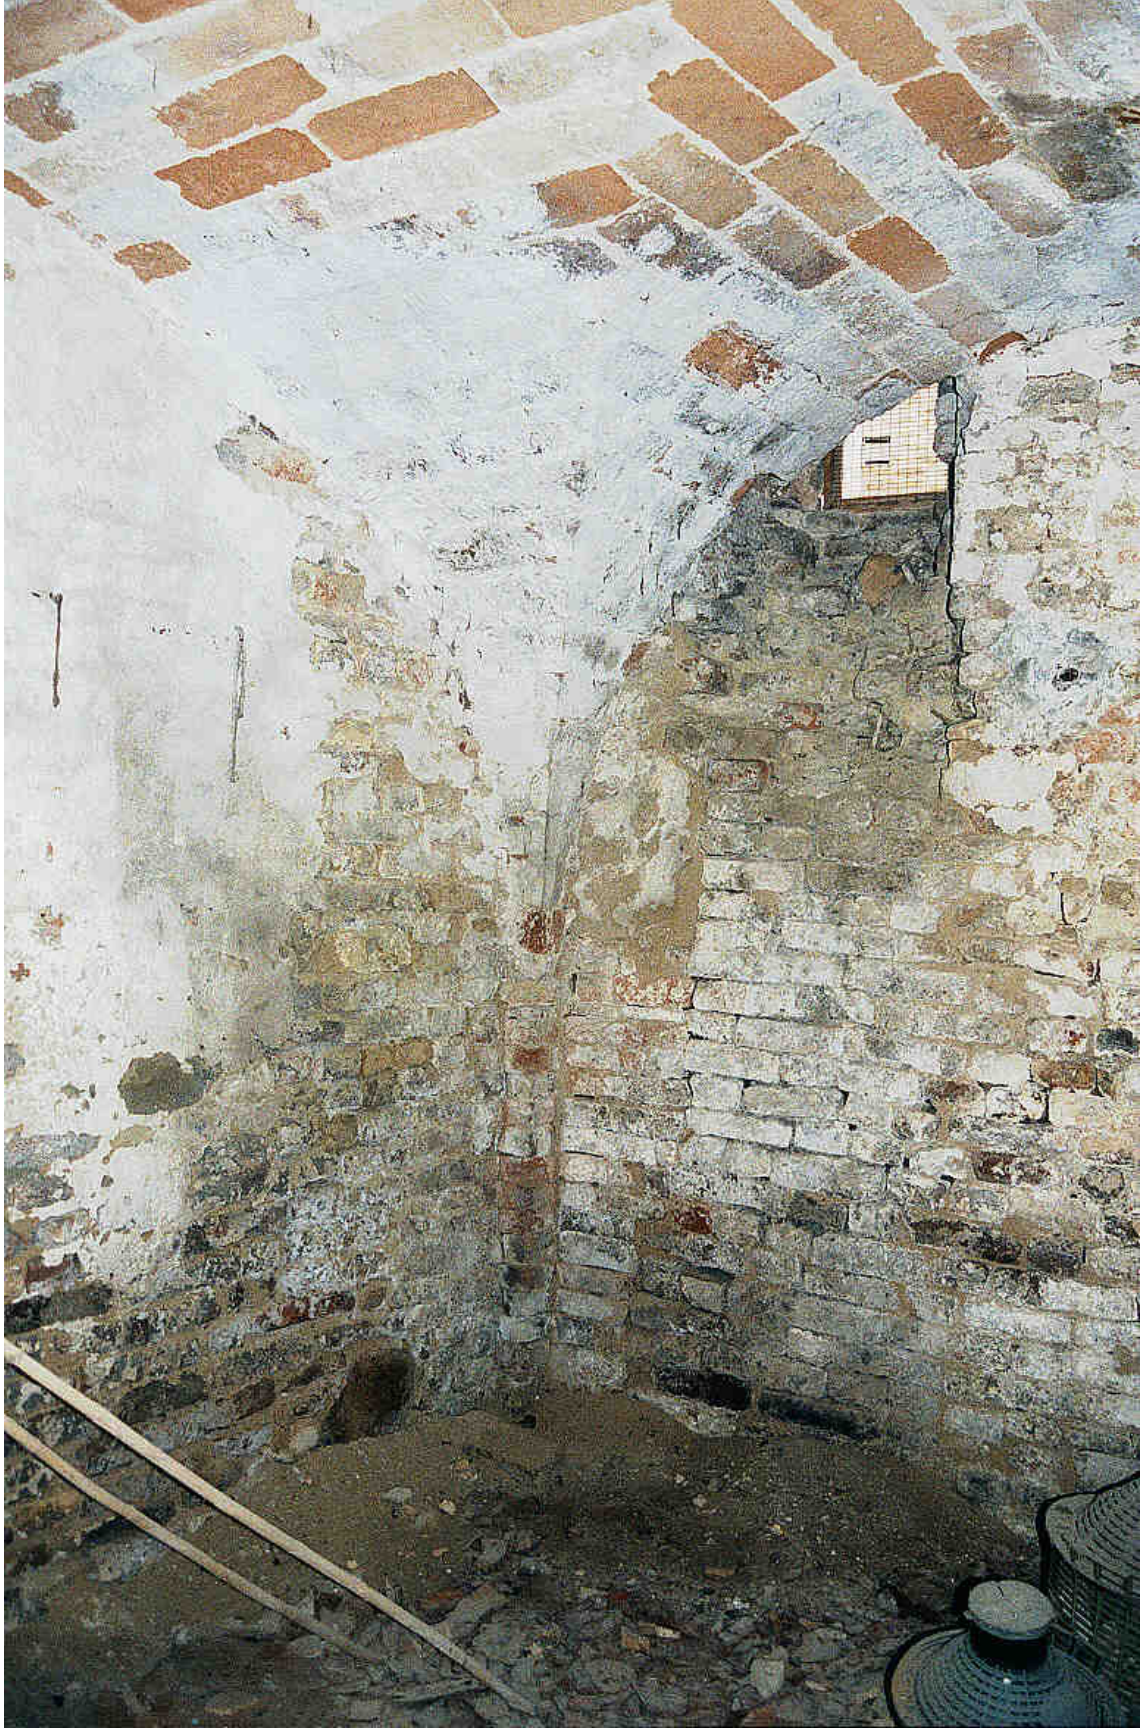
FIGURE 4B: Brick Walls Supporting the Cross-Vault System

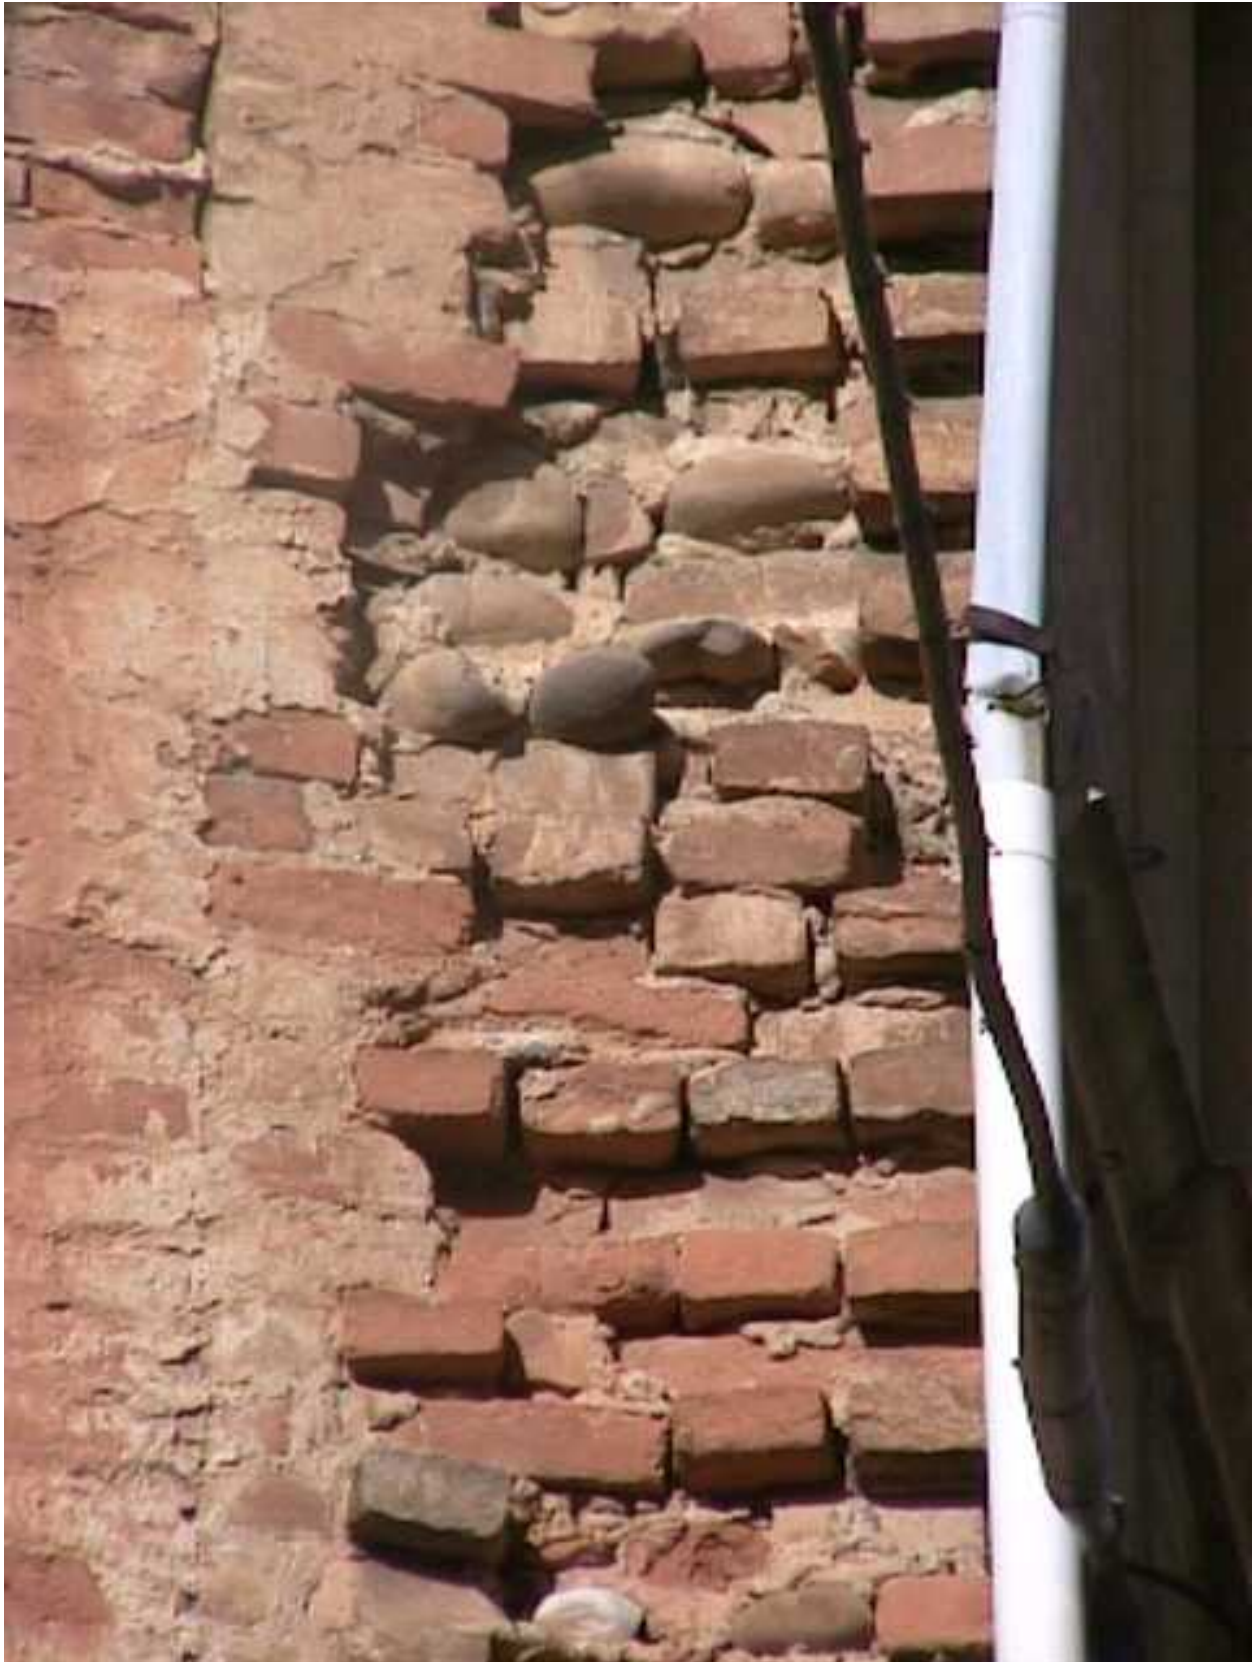
FIGURE 4C: Cross-Section of a Typical Brick Masonry Wall

Depending on the thickness, the walls are built either entirely in brick masonry or, in the case of walls of larger thickness, as multi-wythe walls with rubble infill in the middle portion.

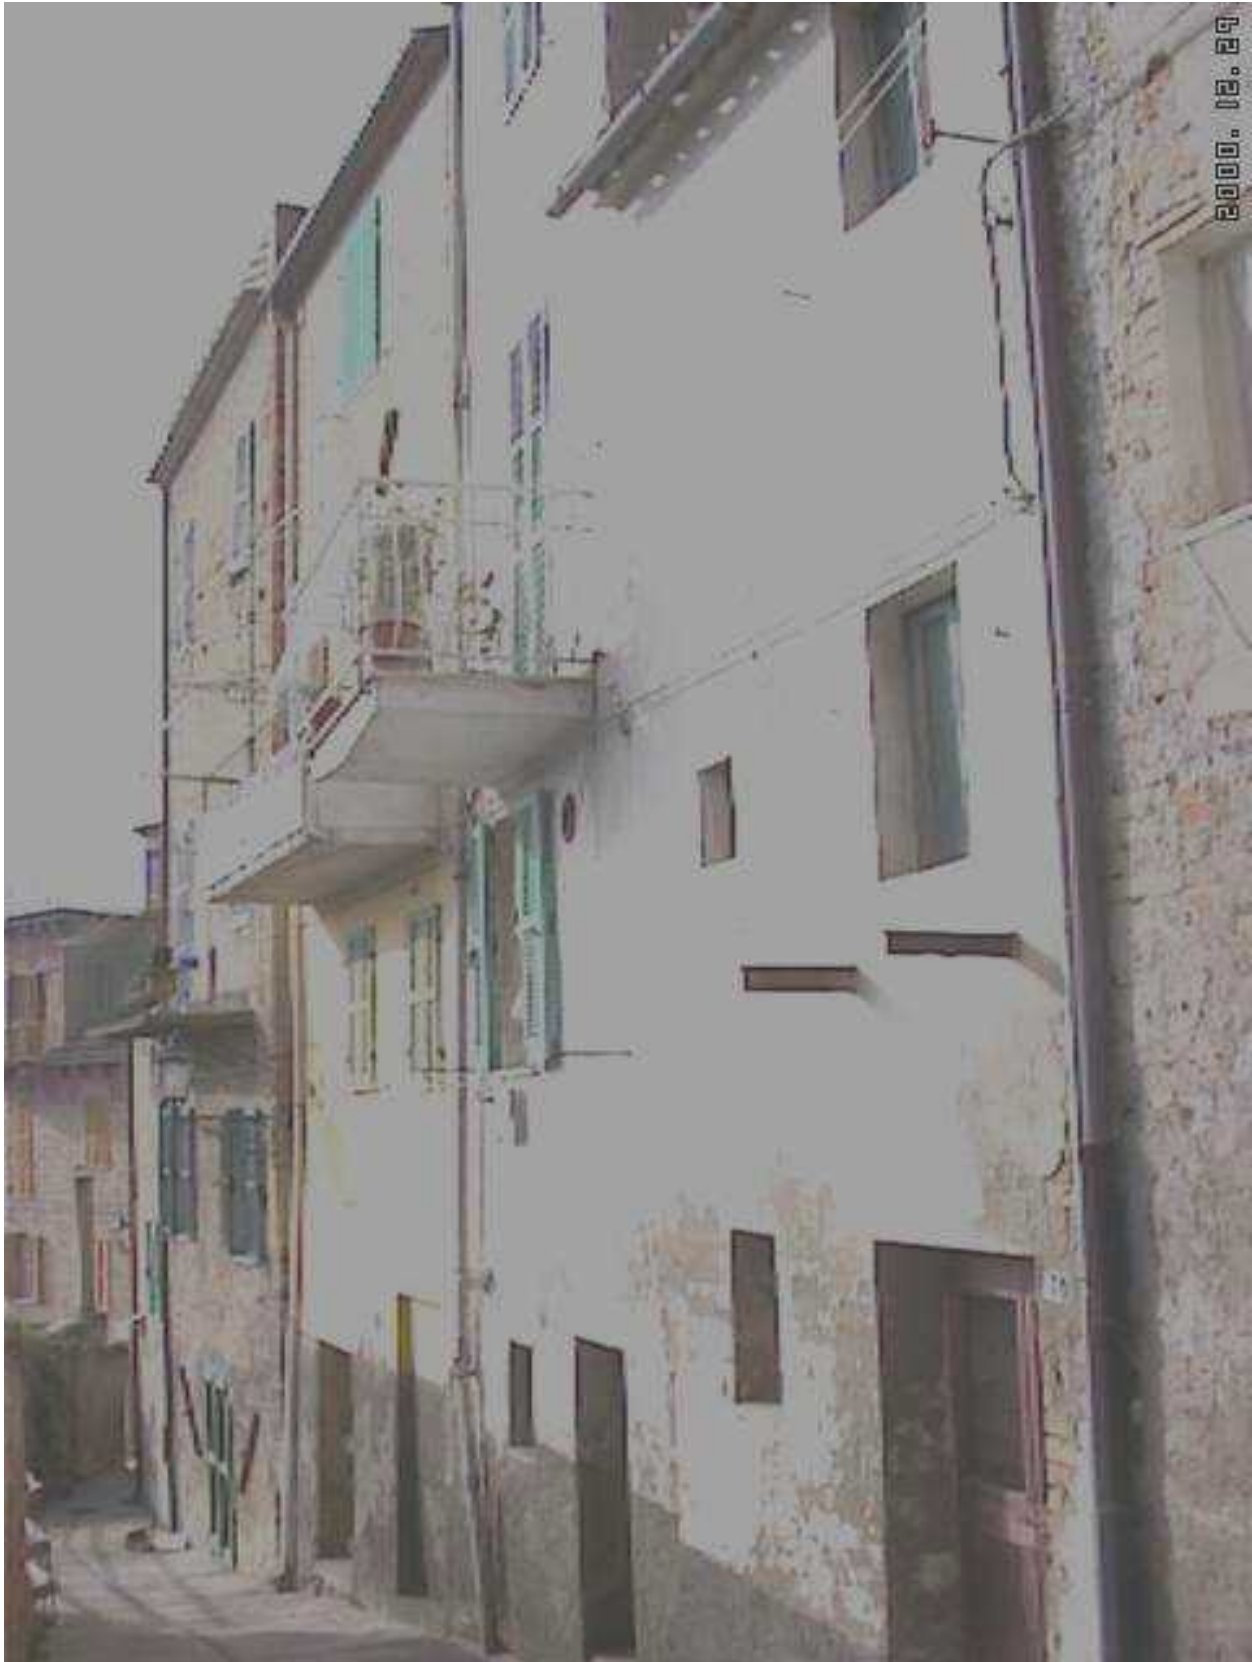
FIGURE 5A: Key Seismic Deficiencies-Proximity of Windows to the Corners and Vertical Extension of the Building (note also added balconies)

Structural Element	Seismic Deficiency	Earthquake-Resilient Features	Earthquake Damage Patterns
Wall	The perimeter walls are not sufficiently connected at the corners, and they behave as separate elements. This seismic deficiency is common for the buildings that were built later than the adjacent buildings. In this case, the side walls of the existing adjacent buildings were used to support the roof and floor structures of the new buildings, whereas the front and rear walls were built separately, without any connection to the existing side walls.	Presence of ties between the front walls and party walls. In some cases, metal ties perpendicular to the front wall are inserted for improving the wall connections and the global seismic performance of the building.	- Damage to the vertical addition of the building due to the out-of-plane wall failure. - Vertical cracks associated with horizontal arch effects.

Additional Comments: Seismic features characteristic for the buildings of this type are shown in Figures 5A and 5B. Seismic failure mechanisms are presented in Figure 5C.

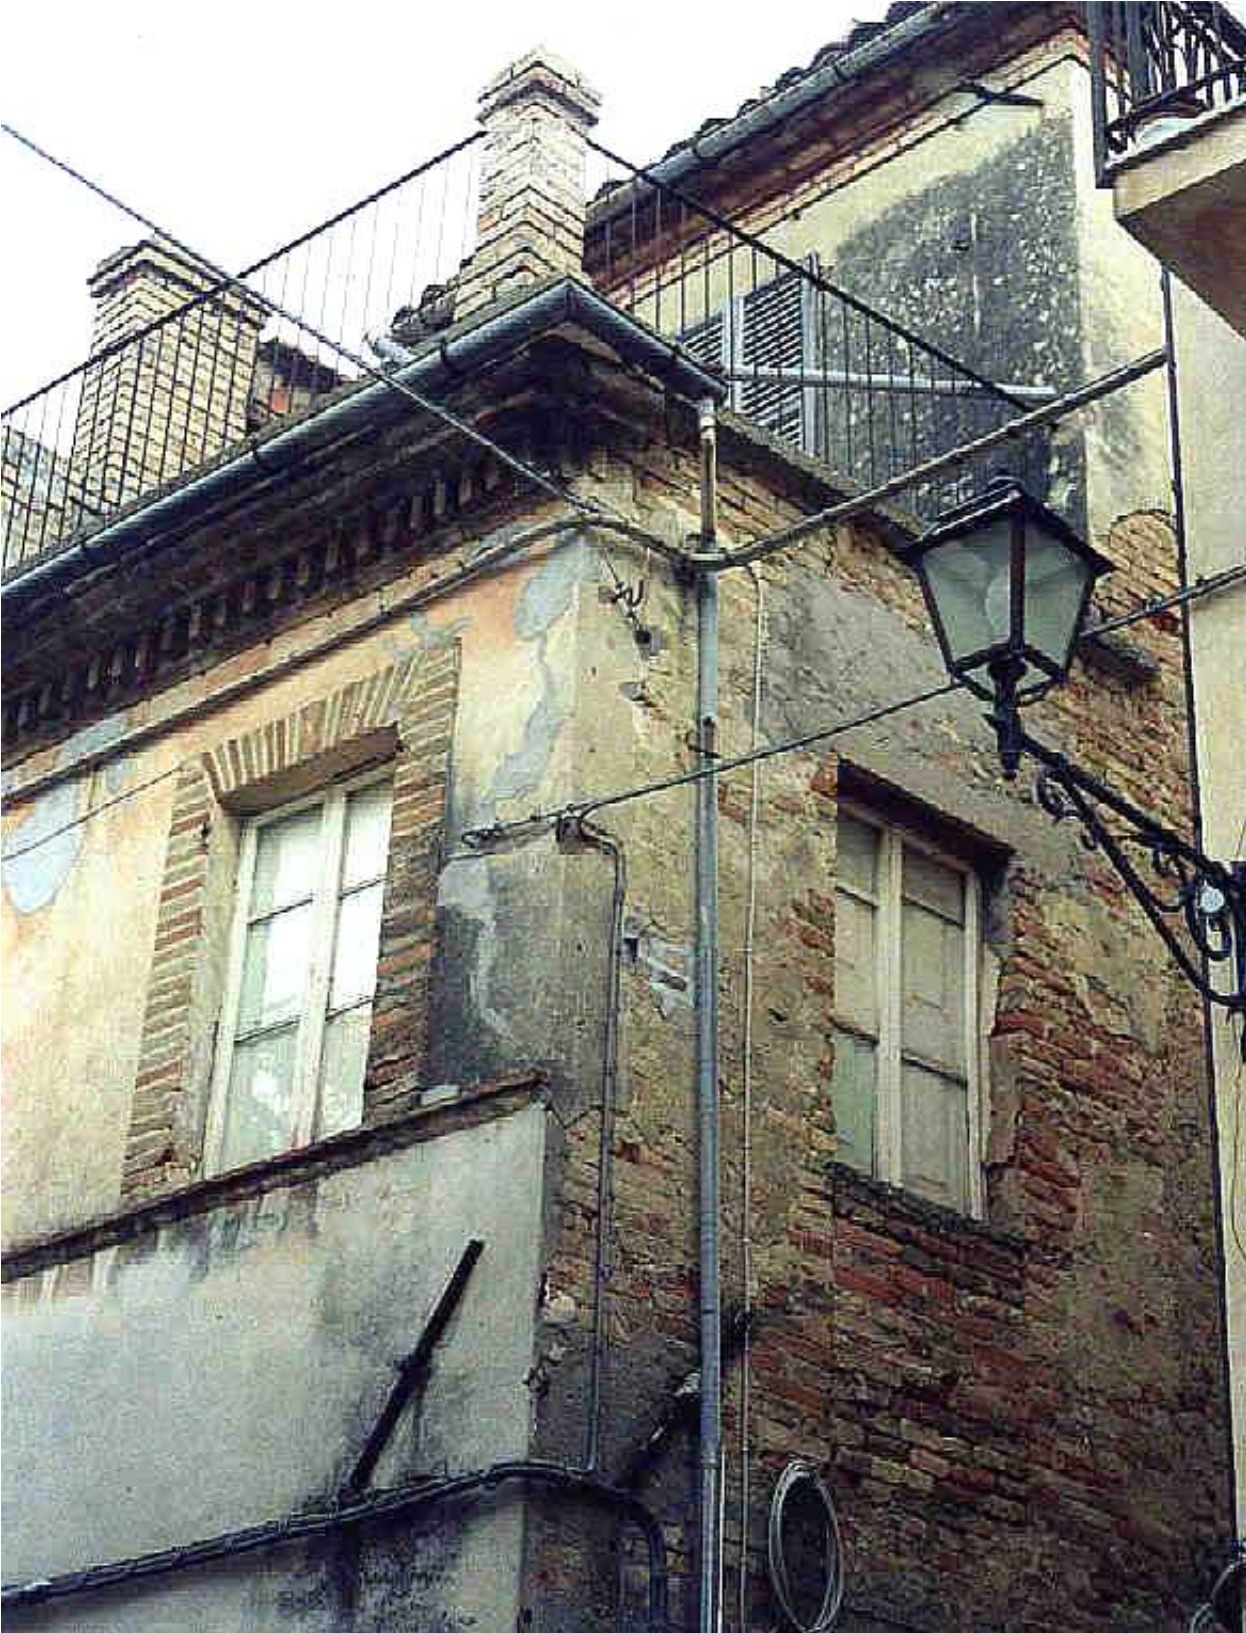
FIGURE 5B: Seismic-Resilient Features - Metal Ties in Two Orthogonal Direction and Brickwork Frame Around Windows

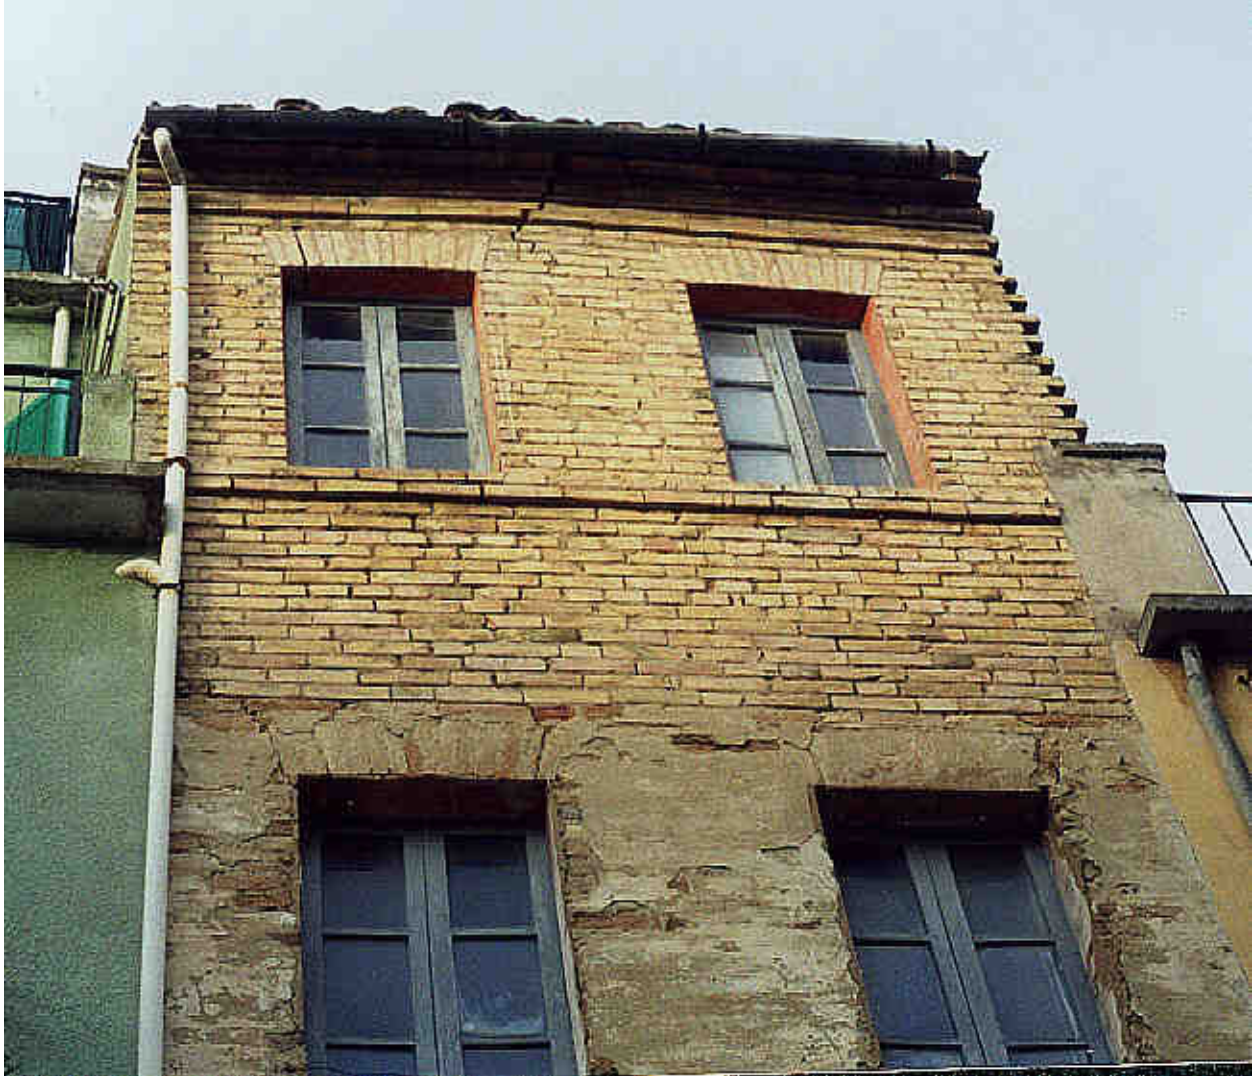
FIGURE 6: A Photograph Illustrating Typical Earthquake Damage (1997 Umbria-Marche earthquake)

Additional Comments: The most common earthquake damage was the collapse of interior floors. The original timber floors were replaced by concrete floors in the recent past and these concrete floors caused the damage. At present there are very few original timber floors; concrete floors are much more common. It was observed that the strengthening with concrete structures tends to substantially alter the stiffness ratio of wall-to-floor structures and if not implemented properly can cause serious damage to load-bearing walls. Also, earthquake damage in buildings of this type often occurs in the vertical addition to the building (a portion of more recent construction). Earthquake damage patterns include the flexural wall failure and the horizontal arch effect (see Figure 6).

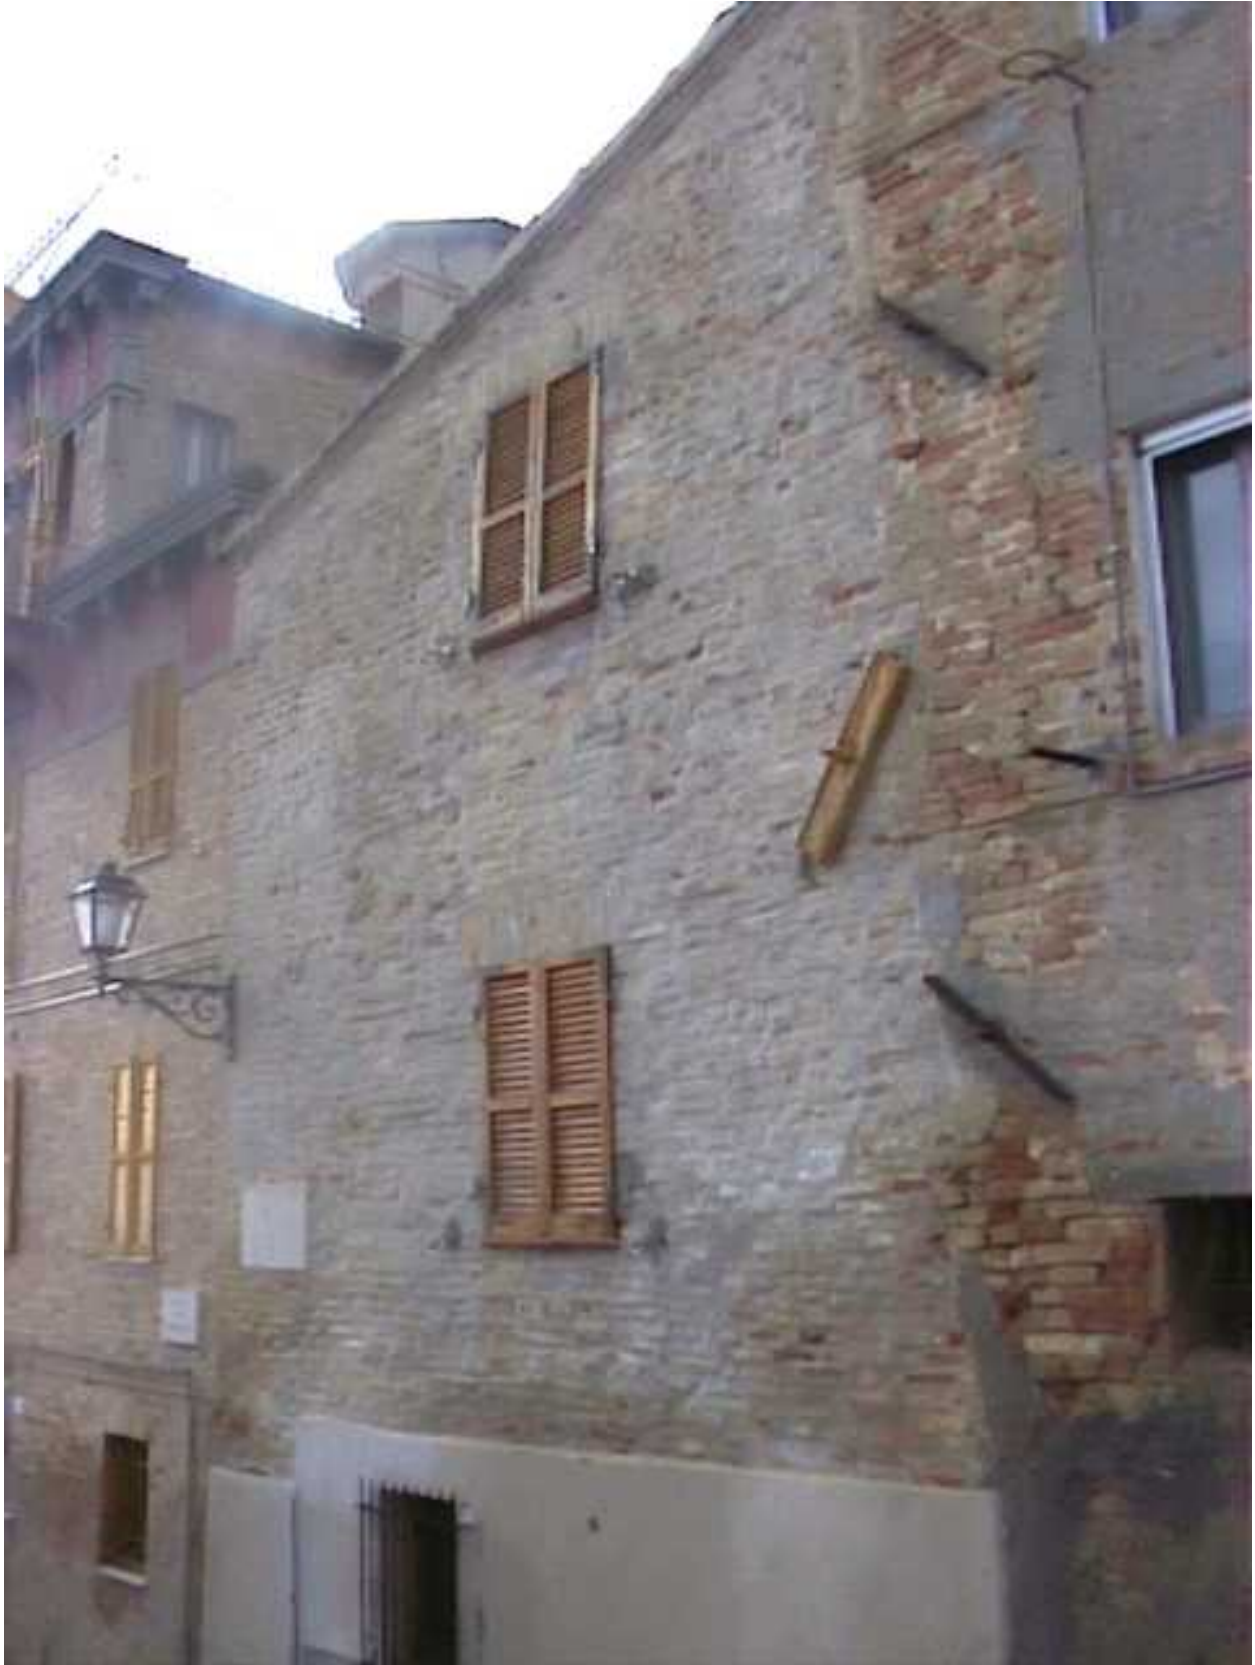
FIGURE 7A: Illustration of Seismic Strengthening Techniques

Type of intervention	Structural Deficiency	Description of seismic strengthening provision used
Retrofit (Strengthening)	Roof/floors	Reinforced concrete overlay; the effectiveness of strengthening depends on the roof -to-wall connections.
	Roof/floors- Lack of Integrity	Installation of new RC ring beam at the roof level. A procedure for the installation of a RC ring beam is presented in Figure 7B. Figure 7C shows a building strengthened with new RC ring beam at the roof level. It is very important to achieve the connection between the new RC ring beam and the existing masonry, otherwise the earthquake damage may be caused.
	Wall-Floor Connection	Installation of metallic ties. Figures 7D and 7E show two different details of ties with anchor plates at the exterior face of the wall. A building strengthened with the ties (similar to detail shown on Fig. 7E) is shown on Figure 7A. It is very important to accomplish a regular distribution of ties - irregular tie distribution may be a cause of earthquake damage.

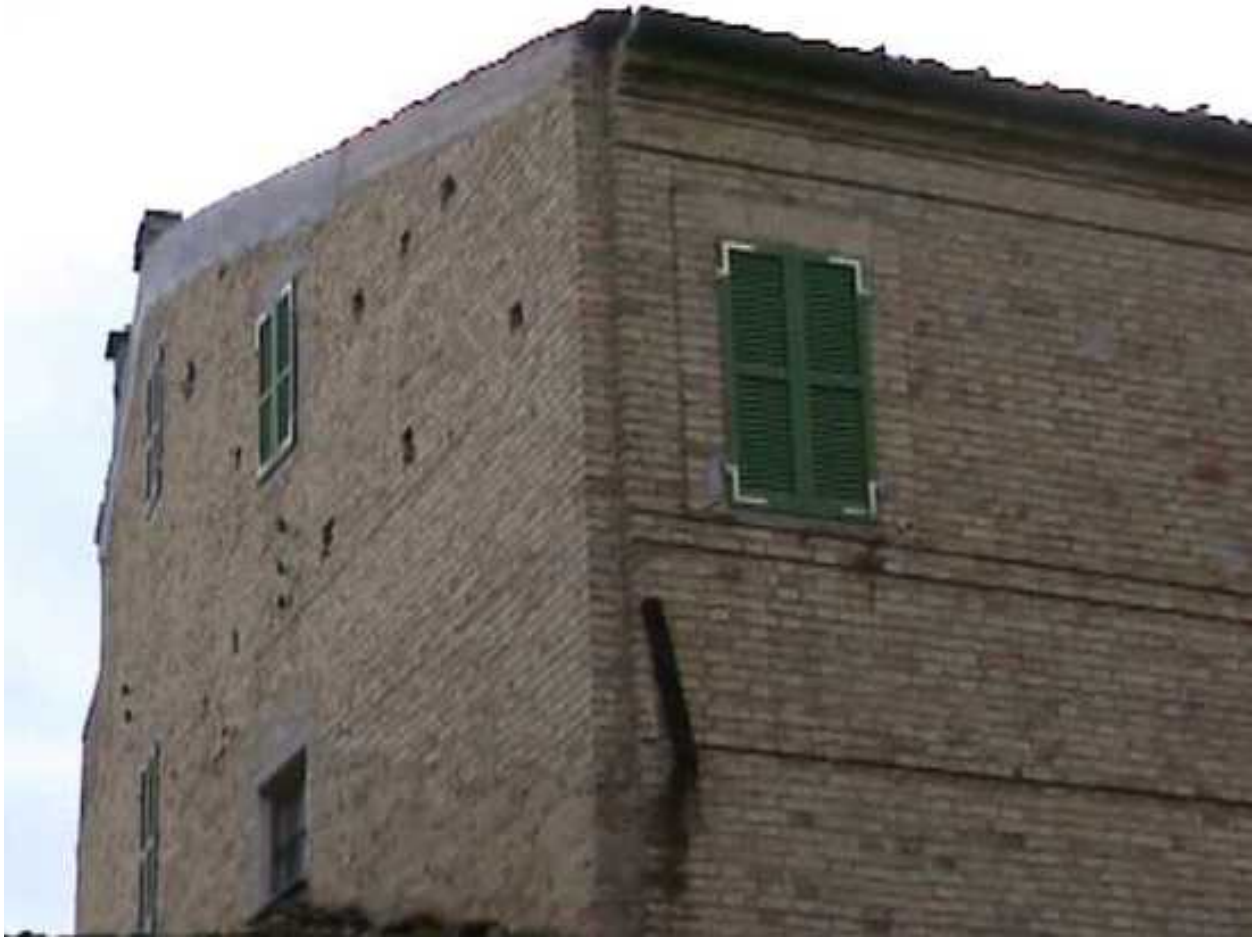
FIGURE 7C: Seismic Strengthening - Installation of a New RC Ring Beam at the Roof Level (Design Application)

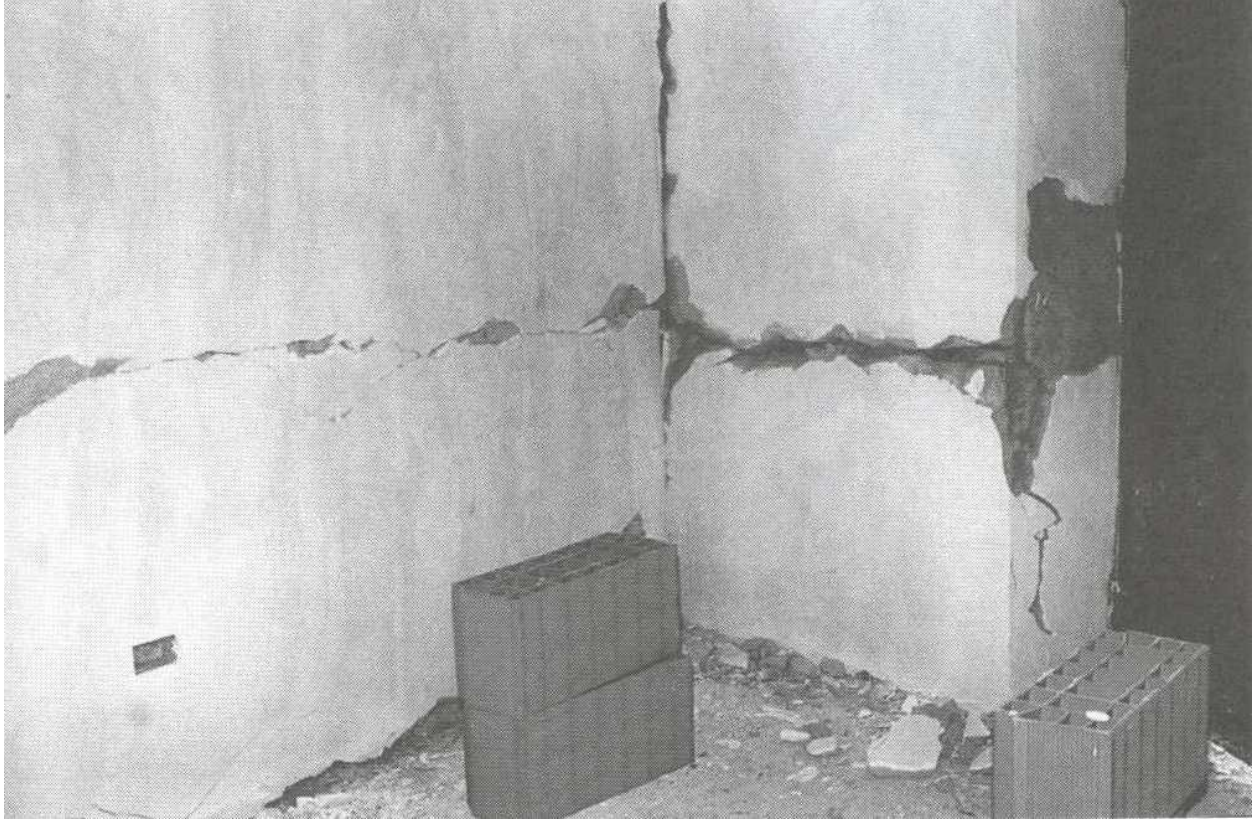
FIGURE 7G: Seismic Strengthening - Damage of Wall Strengthened by Shotcreting

Inadequate seismic resistance of masonry walls	Shotcreting- strengthening walls with shotcrete jackets. Figure 7F shows a masonry wall with shotcreting applied at both faces. The strengthening consists of installing new steel wire mesh and attaching it to the existing wall with through-wall ties or strips spaced at 500 mm on centre both horizontally and vertically. In case shotcreting is not properly applied, the wall can experience earthquake damage as illustrated in Figure 7G.
	Inadequate seismic resistance of masonry walls	Stitching and grouting - consists of drilling holes through the walls and installing steel bars; subsequently, the holes are grouted with cement grout, as illustrated in Figure 7H. A building strengthened using this technique is shown on Figure 7I.
