World Housing Encyclopedia Report

Country: Italy

Housing Type: Single-family stone masonry house

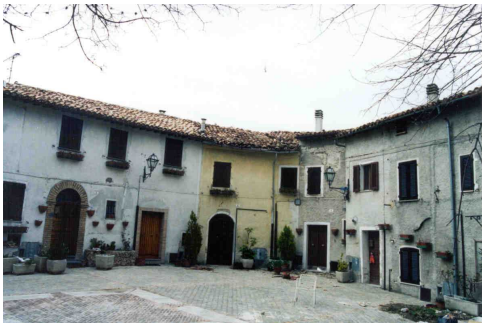
FIGURE 1: Typical Building

These buildings form the historic centers of most hilltop villages and towns in central Italy. They are arranged in long terraced arrays, with common party walls and variable number of stories on the hillside (up to 2 or 3) and valley side (usually 4 or 5, with a maximum of 6). The typical house is usually formed by one or two masonry cells, depending on the depth of the block, with a staircase running, usually but not necessarily, along the party walls. The masonry is made of roughly squared stone blocks set in lime mortar, and the walls are made of two leaves with a rubble core at the base, tapering at the upper floors. Limestone is used for the blocks, while a particular type of tuffa stone is used for the lintels above openings. At ground level there are sometimes vaulted structures, while the upper stories were originally spanned by timber beams, with joist and timber boards covered by tiles. The roof structure is usually original and made of timber trusses. In recent past, many of the original floors have been replaced either with iron "I" beams and jack arches (refurbishments occurred before the World War II) or more recently with weakly reinforced concrete slabs (last fifty years). Other alterations include vertical extensions, closing and opening of windows, introduction of hygienic services. A high proportion of these houses show traditional iron ties introduced in the 18th Century to tie together orthogonal walls and floors, to ensure better seismic performance. After the introduction of modern seismic codes in 1980s many buildings have undergone further strengthening, represented by RC ring beams and concrete jacketing of walls.

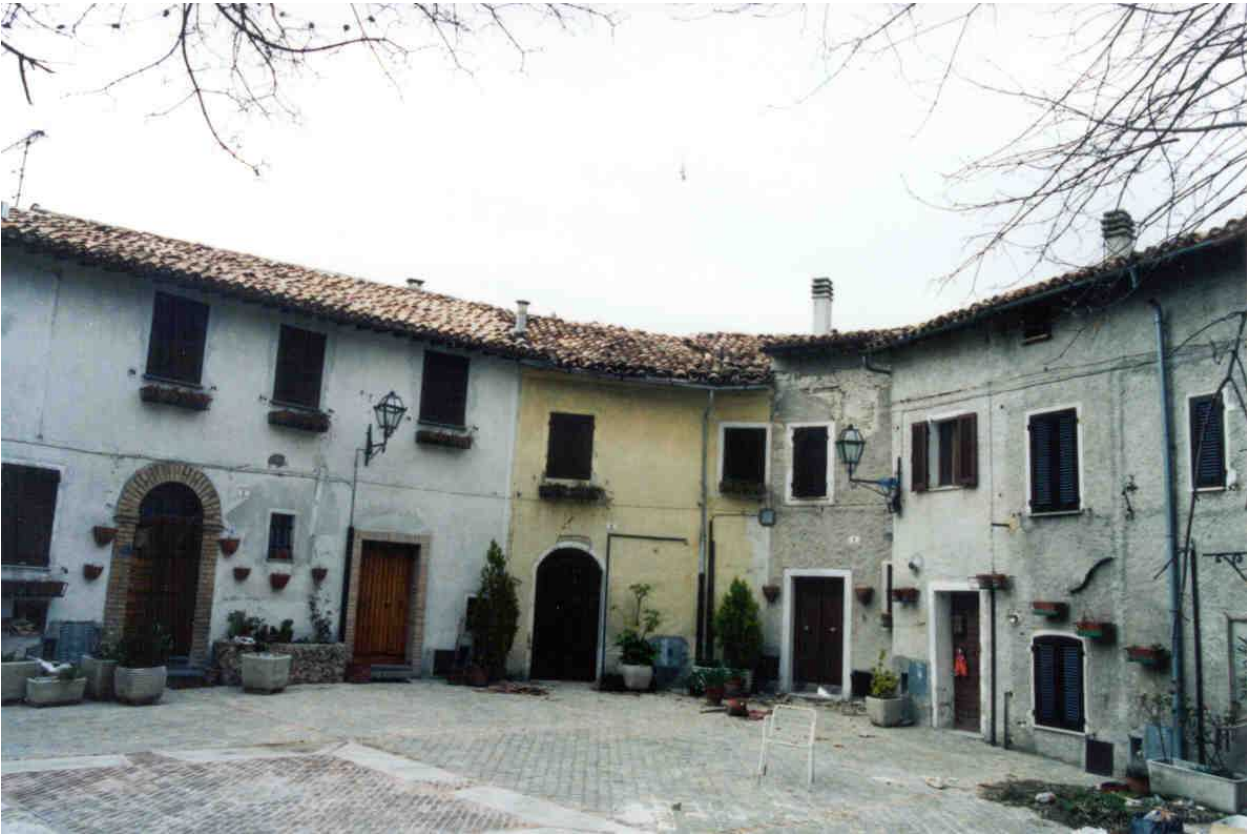
FIGURE 1: Typical Building

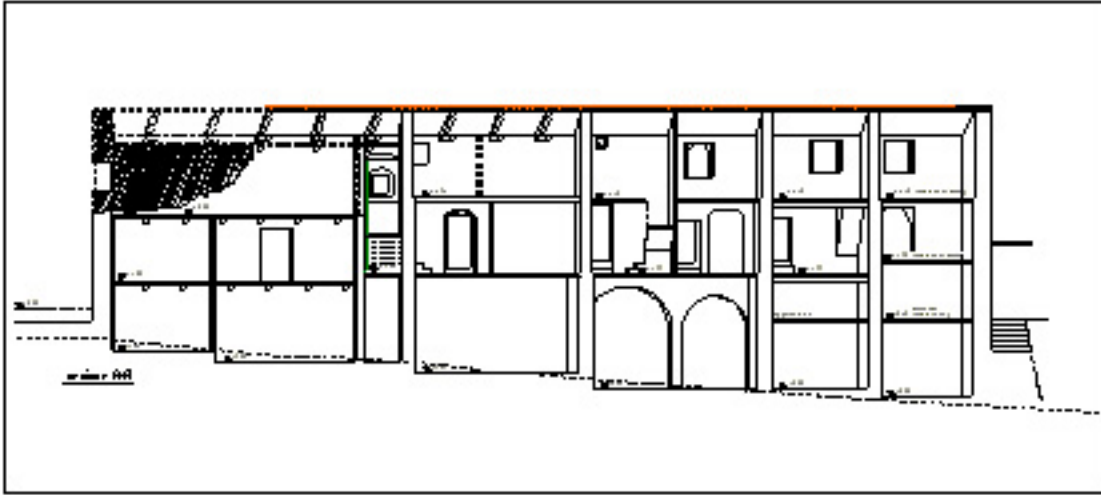
FIGURE 2B: An Elevation of a Typical Building

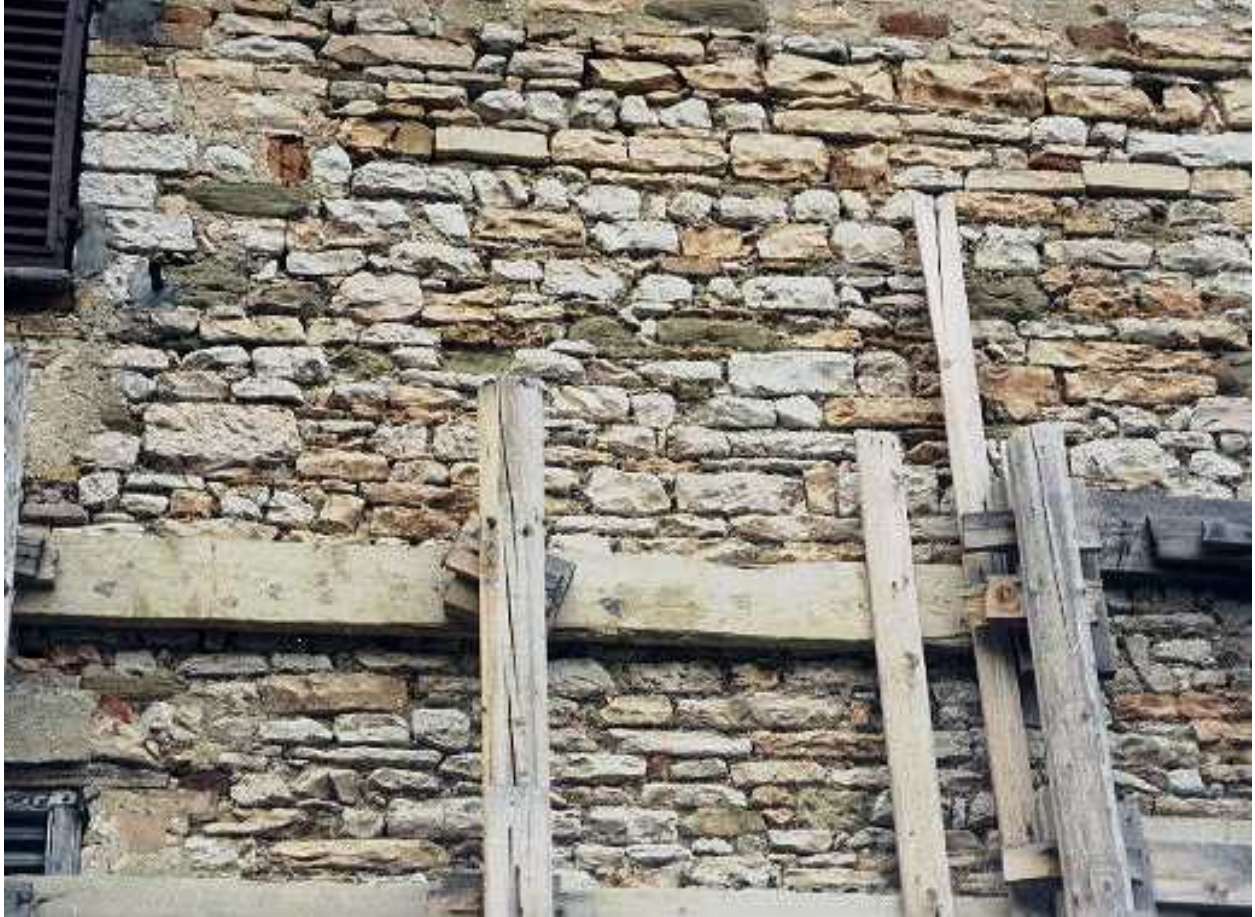
FIGURE 4A: Critical Structural Details Stone Masonry Wall With Irregular Roughly Dressed Stone Blocks of Varying Dimensions Embedded into Thick Lime Mortar Joints (not properly repointed)

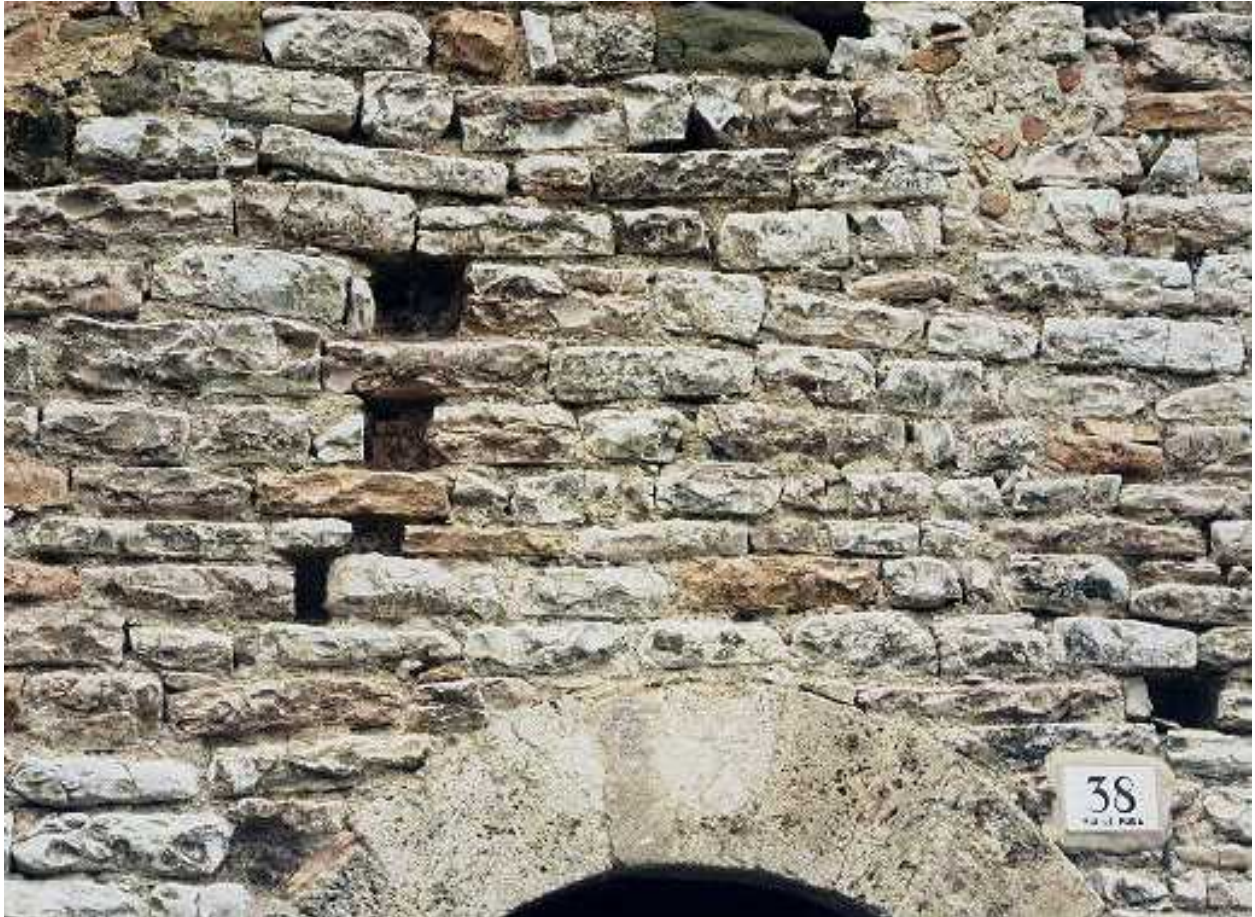
FIGURE 4B: Critical Structural Details-Movement Between the Blocks, Probably as a Result of Damage in Previous Earthquakes and Visible Loose Stones Around the Arch

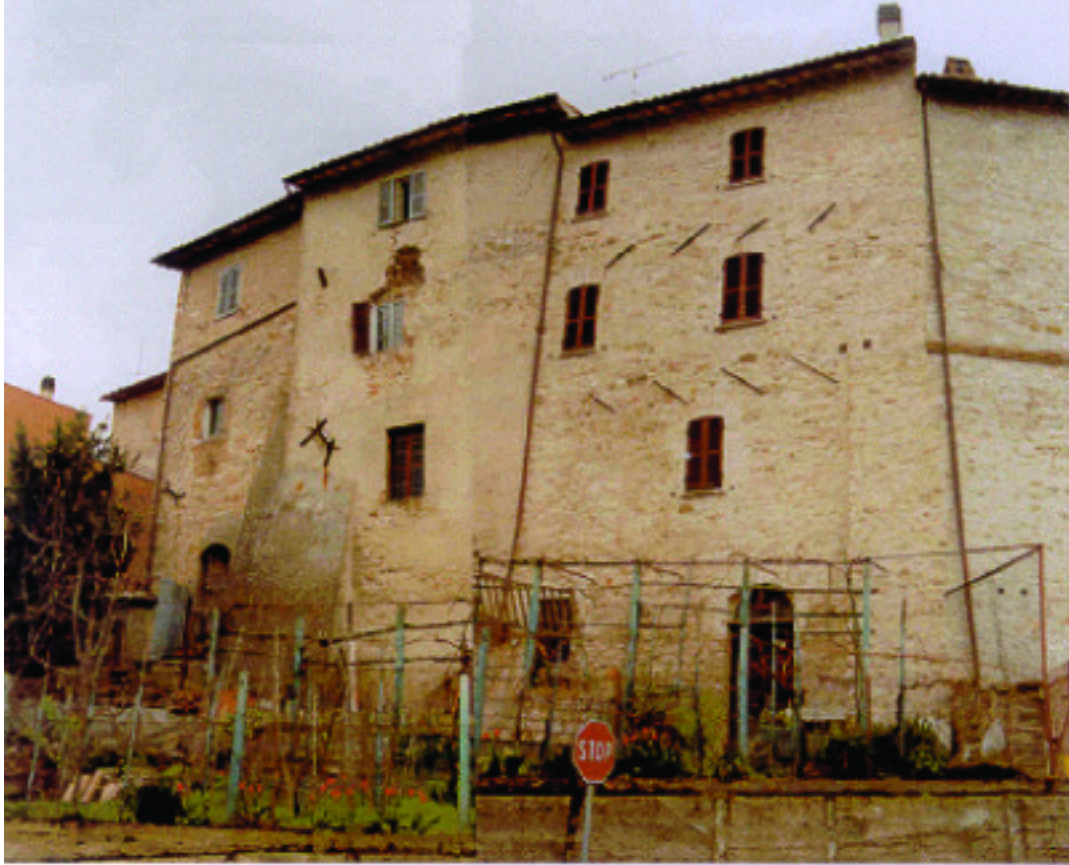
FIGURE 5A: Key Seismic Features and Deficiencies Showing the Regular Arrays of Floor Ties in One Unit, Irregular Distribution of Wall Ties in the Next One, and Corner Return Stones in the Third Unit.

Additional Comments: Seismic features for a typical building of this type are illustrated in Figure 5A. Note the regular arrays of floor ties in one of the units, irregular distribution of wall ties in the next one, and corner return stones in the third unit. Due to the absence of adequate connections between internal and

external leaves of masonry, a partial collapse of the area above the window opening took place.

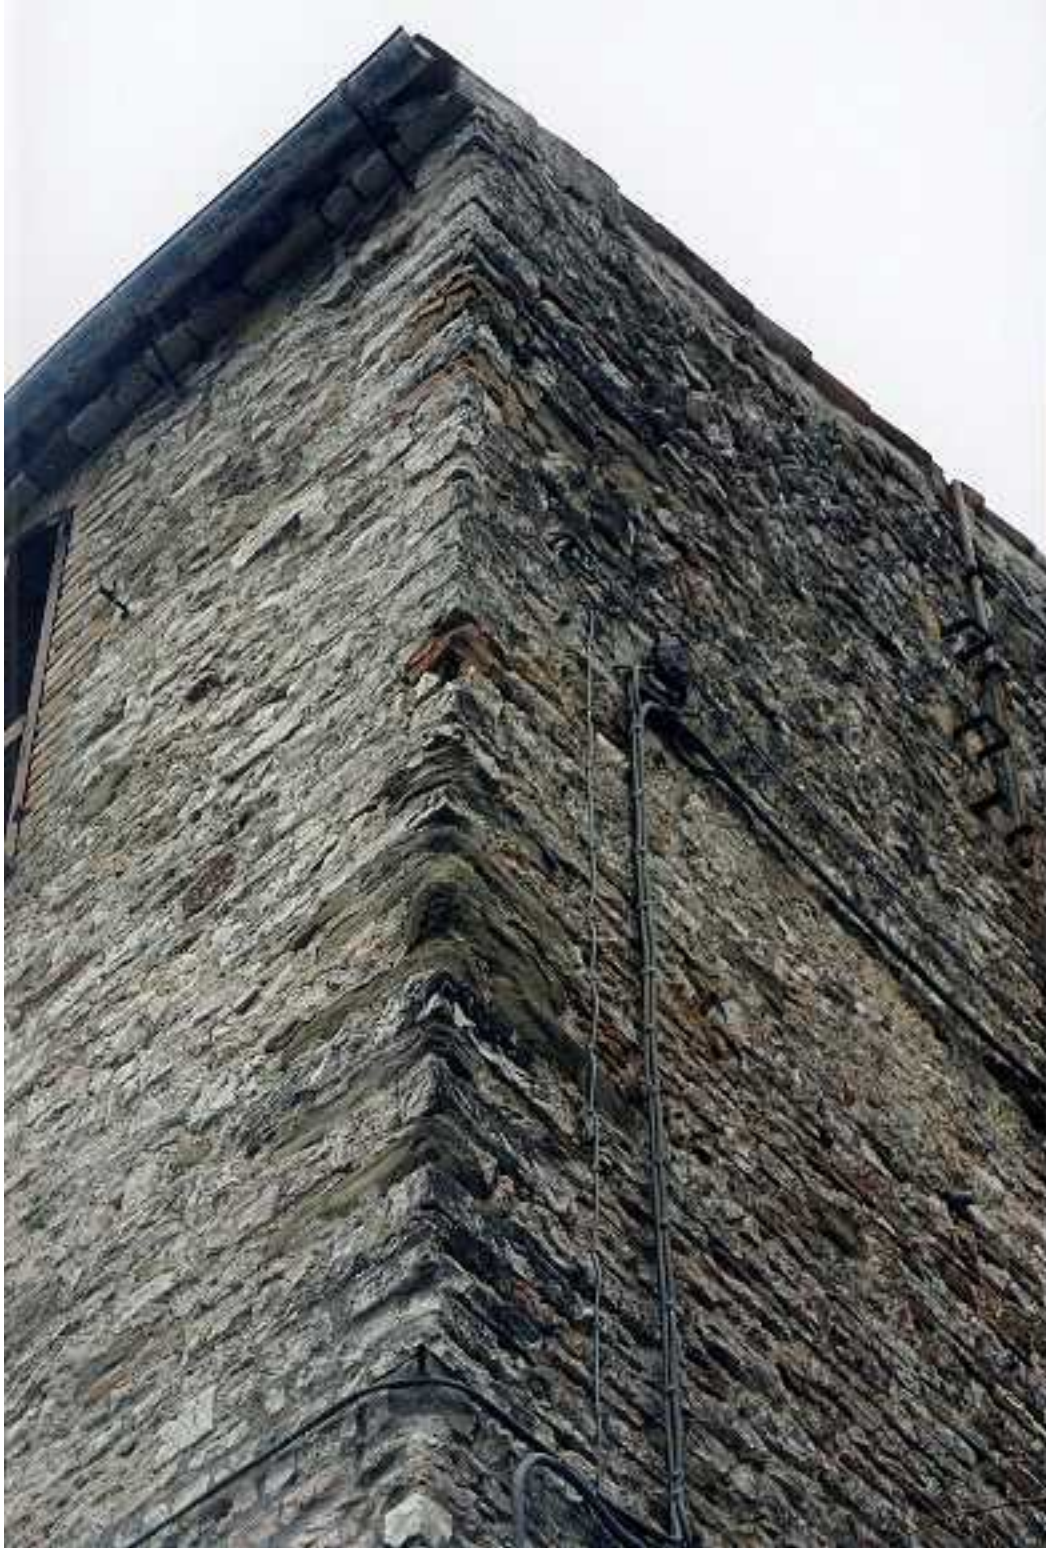
FIGURE 5B: Earthquake-Resilient Feature - Corner Returns between the Perpendicular Walls Made of Larger Stone Blocks

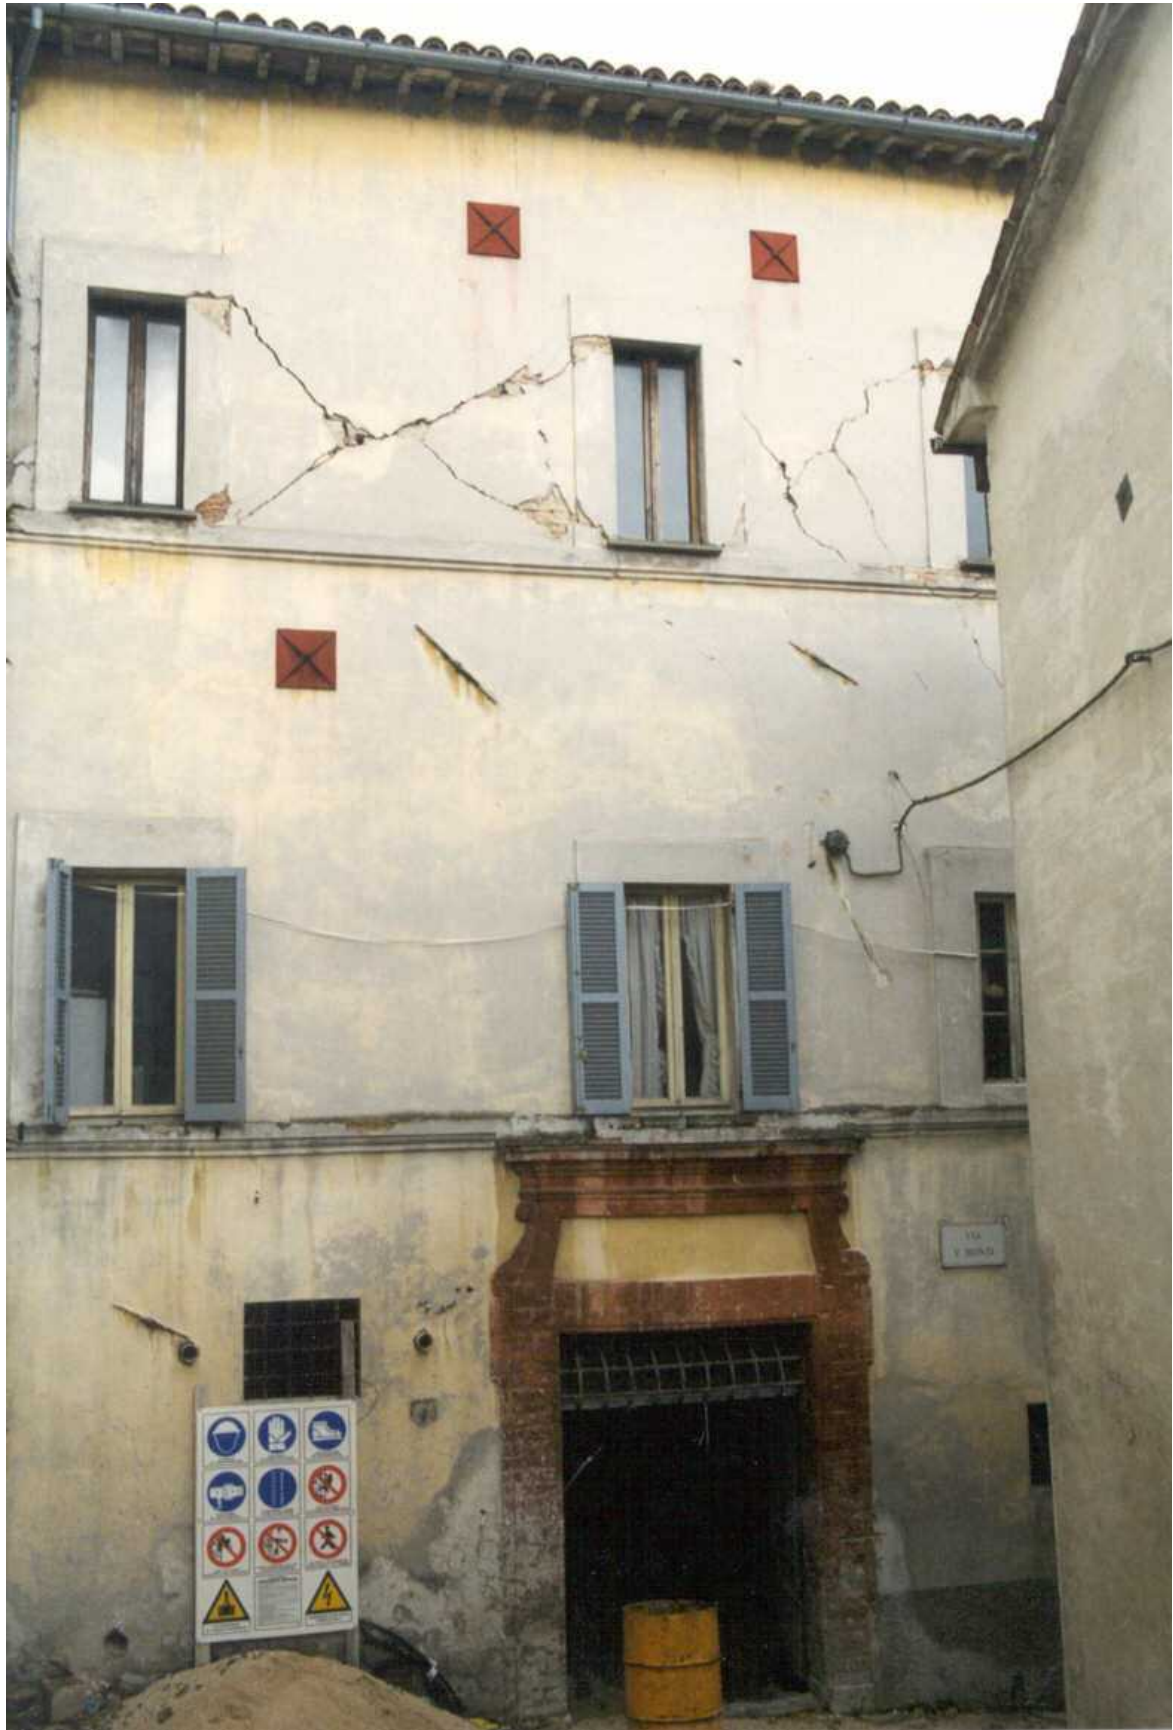
FIGURE 6A: Typical Earthquake Damage-"X" cracking of walls (1997 Umbria-Marche earthquake)

Structural Element	Seismic Deficiency	Earthquake-Resilient Features	Earthquake Damage Patterns
Wall	-Level of bond in the geometric thickness of the multi-leaf walls. -Extent of connection between façade and party walls, depending on alteration and position of windows. -Level of bond between mortar and units depending on decay of original material and regular repointing.	-Corner returns between the perpendicular walls made of larger stone blocks are an original feature in many buildings, see Figure 5B. -In some buildings built in the last 100 years iron anchors connecting the floor timber structure to the wall are an as-built feature, see Figure 5A.	- In cases of poor bond between leaves, disintegration of the masonry fabric is the most common damage. - In cases of poor connection between facades and party walls, out-of-plane mechanism will take place resulting in partial or total collapse of one or more walls. - In cases of good connections between orthogonal walls, in-plane mechanism will take place resulting in diagonal cracking ("X" cracks), see Figure 6A.

Type of intervention	Structural Deficiency	Description of seismic strengthening provision used
Retrofit (Strengthening)	Lack of Structural Integrity	Installation of new RC ring beams with or without concrete slab. A procedure for the installation of a new RC ring beam in an existing stone masonry building is presented in Figure 7F. Note the dowels anchored into the existing walls and the new concrete slab atop the existing wood floor. Figure 7E shows an alternative solution, which includes the installation of steel anchors grouted into the existing walls and the installation of new concrete floor slab atop the existing wood floor. Figure 7A shows a building strengthened with new RC ring beams. It is very important to achieve the connection between the new RC ring beam and the existing masonry, otherwise the earthquake damage may be caused, as illustrated in Figure 6B.
	Inadequate Wall-Floor Connection	Installation of new steel ties. Figure 7C shows a steel strap detail connecting an existing stone masonry wall to a timber floor joists. Figure 7D shows a detail of ties with an anchor plate at the exterior face of the wall. A building with the installed ties is shown on Figure 5A. It is very important to accomplish a regular distribution of ties - irregular tie distribution may be a cause of earthquake damage, as illustrated in Figure 6A.

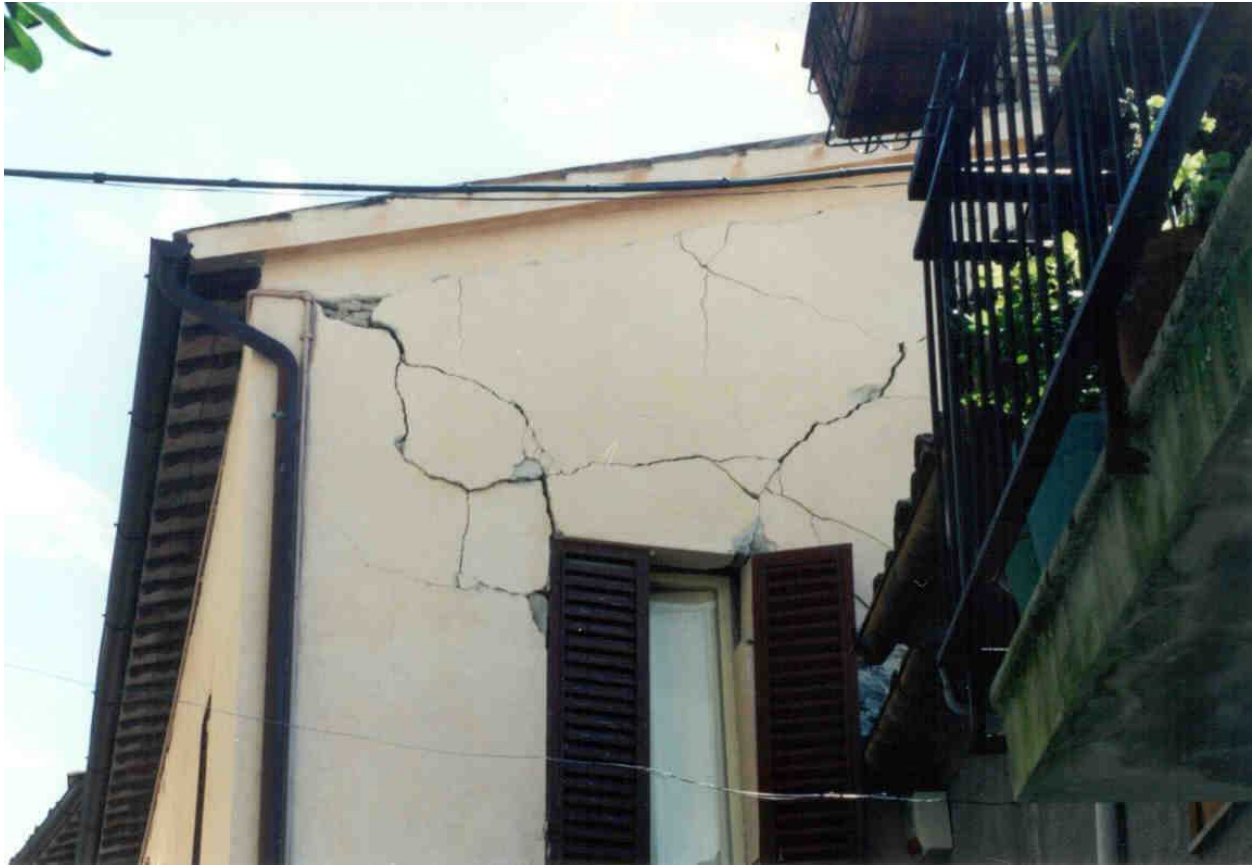
FIGURE 6B: Earthquake Damage to a Retrofitted Building Due to the Inadequate RC Ring Beam-Wall Connection

Additional Comments: A small proportion of these buildings collapsed in the town centers and usually these had very poor maintenance record, i.e. the buildings had not been occupied for a number of years. A greater proportion of similar buildings (still within 25% of the total number) collapsed in the smaller mountain villages closer to the epicenter. Two main factors can be considered as possible causes of this disparity, assuming a similar level of seismic excitation: worse construction quality, and the fact that the houses in the villages are isolated, whereas in the towns they are built in the rows. Figure 6A shows a house in the historic centre of Nocera Umbra, subjected to the 1997 Umbria-Marche earthquake. Typical "X" cracks developed in masonry walls, in this case caused by the increased stiffness of roof structure that had been replaced by reinforced concrete slab with ring-beam. Figure 6B illustrates the earthquake damage associated with the inadequate ring beam-wall connection. The roof had slipped on the masonry and caused the wall damage.

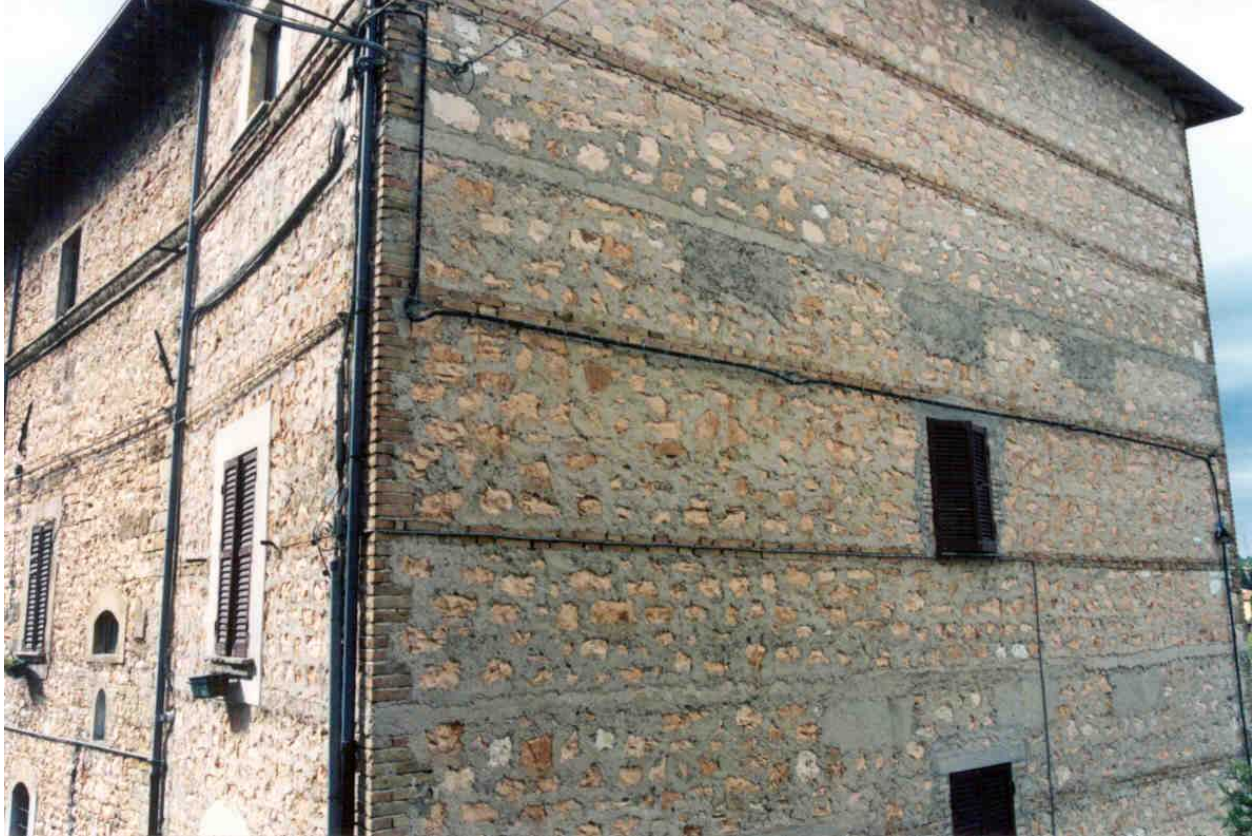
FIGURE 7A: Illustration of Seismic Strengthening Techniques

Low Lateral-Load Resistance of the Walls	Grouting, see Figure 7A.

Additional Comments: Figure 7A illustrates the following seismic strengthening provisions: RC ring beams and anchorage of floor beams to the wall, repointing and grouting using cement-based grout, corner return in brickwork, and the installation of concrete window frame. Figure 7B illustrates modern anchors with anchorage plates and concrete lintels over openings.

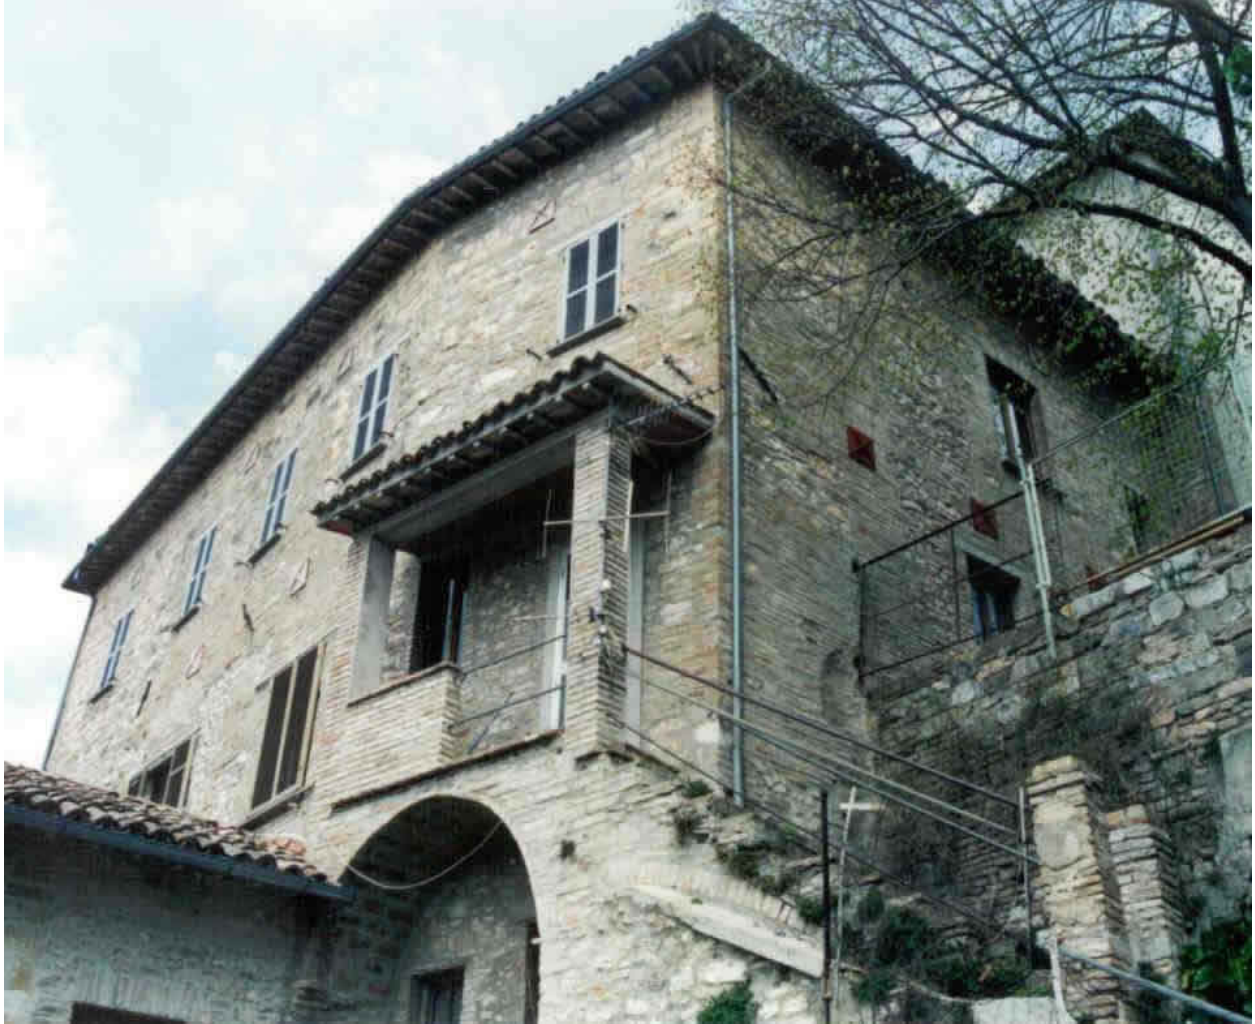
FIGURE 7B: Seismic Strengthening Techniques- Installation of modern anchors with anchorage plates and concrete lintels over openings
