World Housing Encyclopedia Report

Country: Malawi

Housing Type: Rammed earth house with pitched roof (Nyumba yo dinda OR Nyumba ya mdindo)

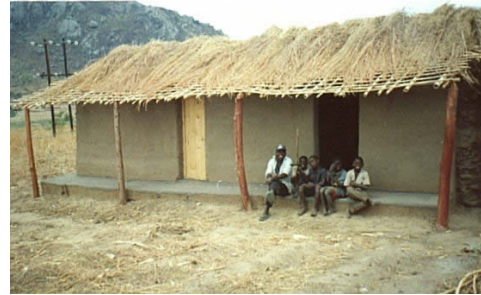
FIGURE 1: Typical "nyumba yo dinda" house

This type of construction is used for residential purposes only. The building technique consists of in situ ramming of moist soil in a carefully aligned/placed mould. The mould dimensions are between (250 mm - 300 mm) wide X (400 mm - 450 mm) long X (200 - 300) mm height. The plan of the house is rectangular. The roof is either grass thatch or iron sheets supported on timber poles. This type is found in all three regions of Malawi. The strength of the wall is low and depends on the compacting effort applied. The expected seismic performance is poor. There are no vertical or horizontal reinforcements.

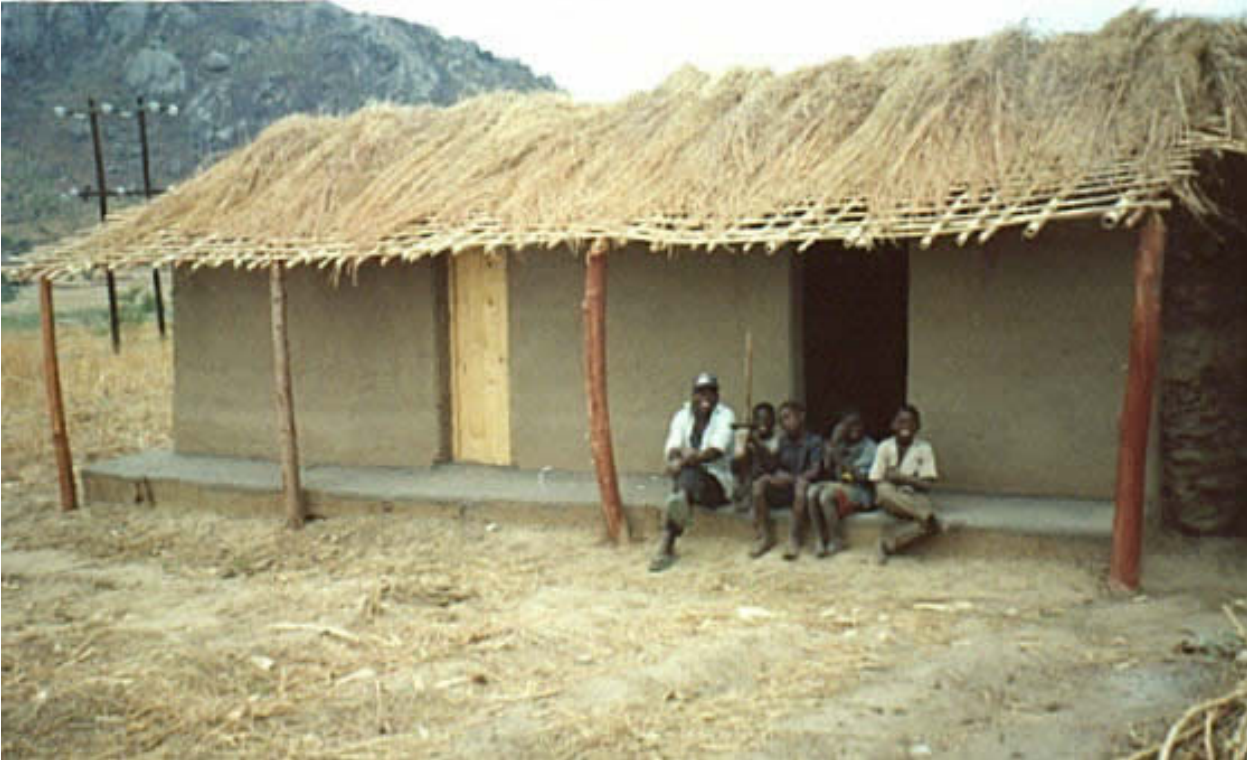
FIGURE 1: Typical "nyumba yo dinda" house

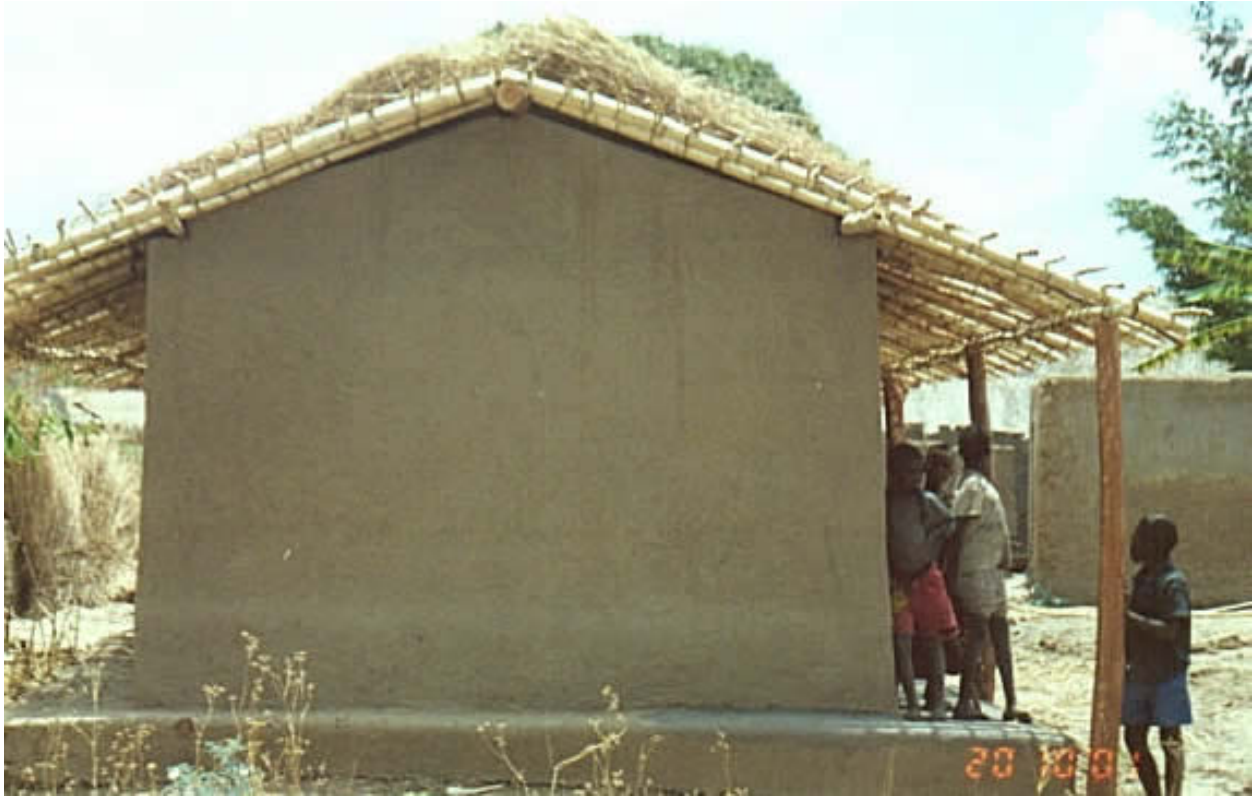
FIGURE 2: Typical Building

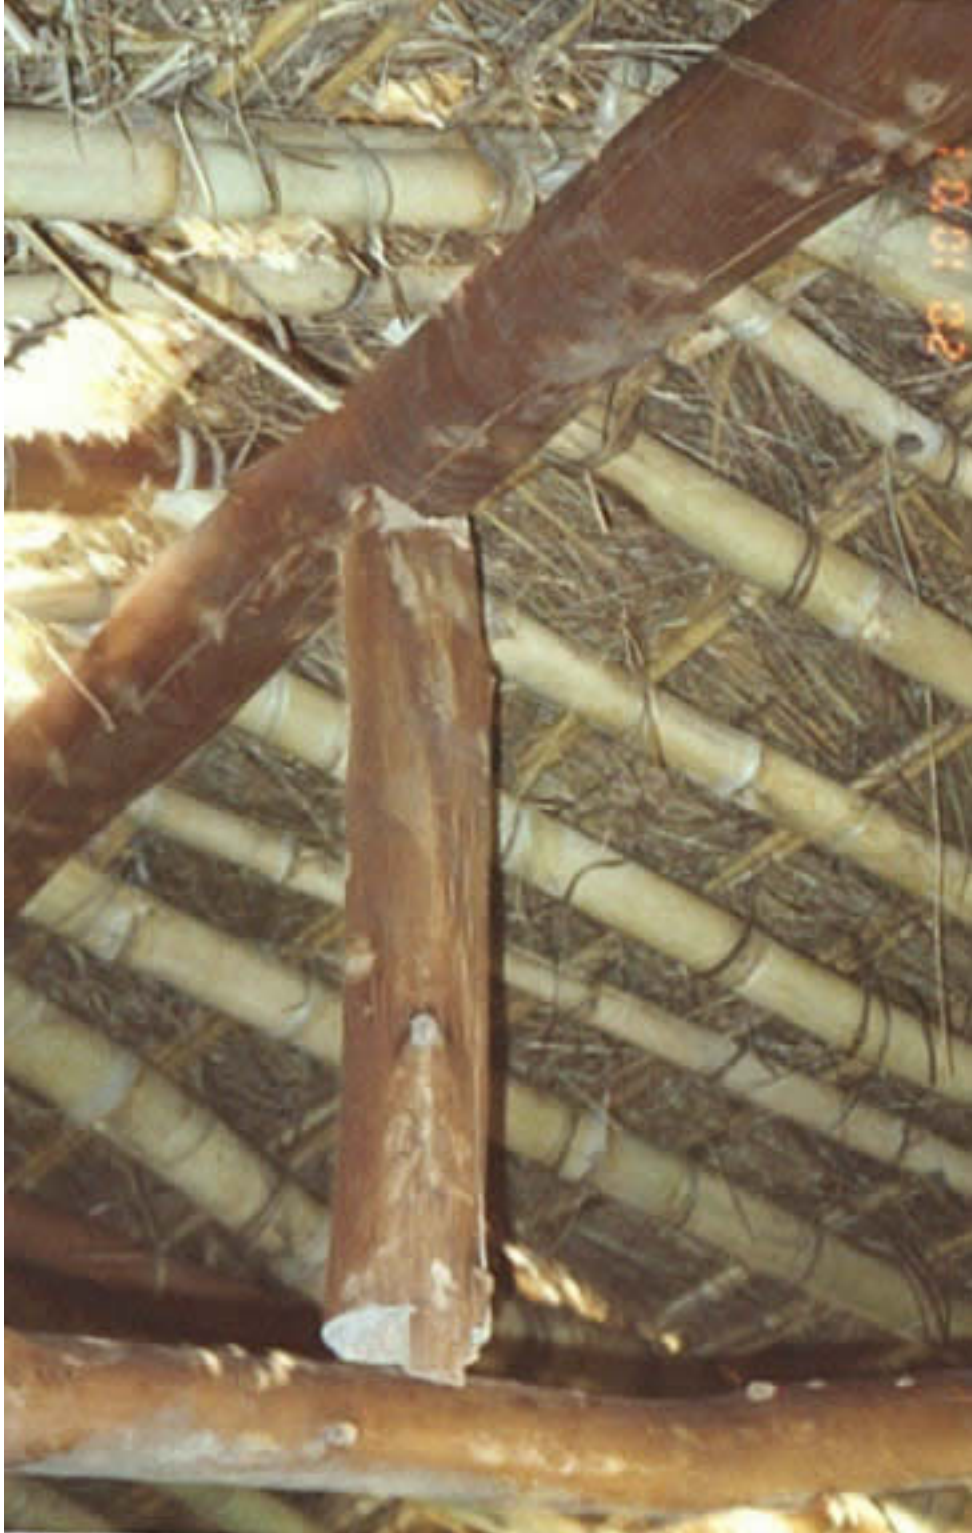
FIGURE 4: Critical Structural Detail

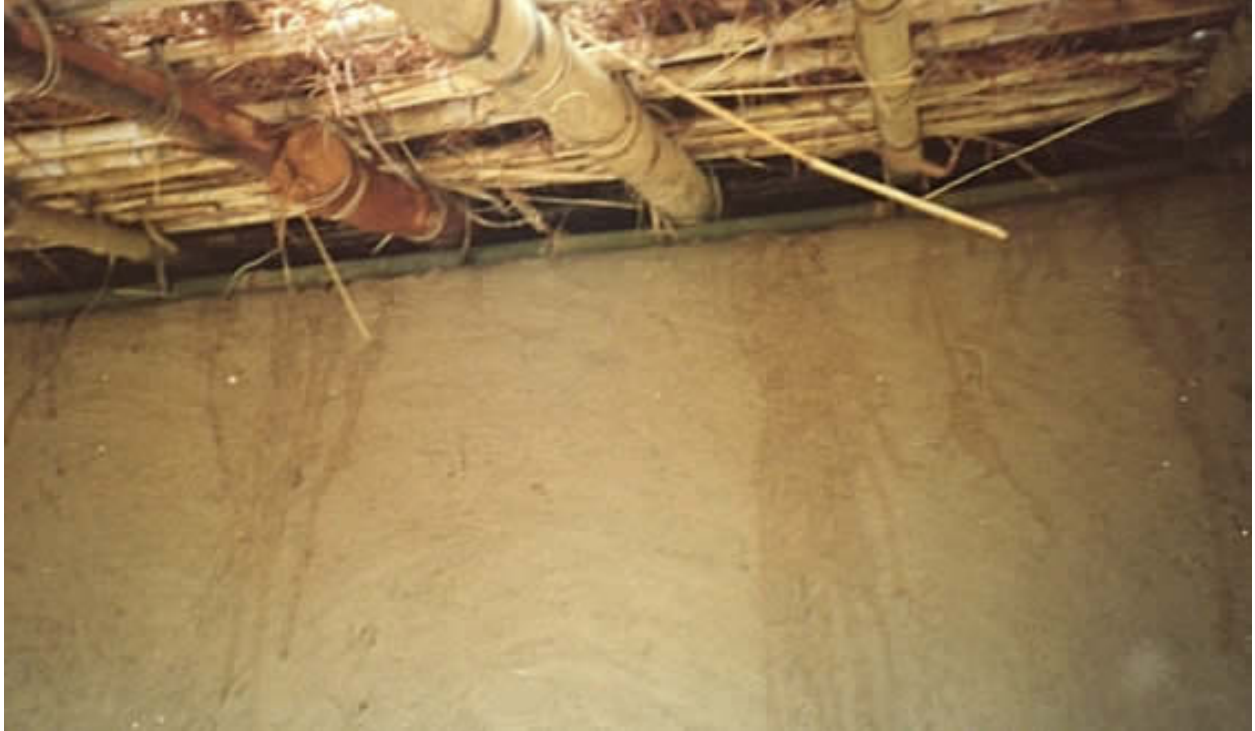
FIGURE 5: An Illustration of Key Seismic Features and/or Deficiencies

| Structural Element | Seismic Deficiency | Earthquake-Resilient Features | Earthquake Damage Patterns |
|---|---|---|---|
| Wall | Very poor lateral resistance; lintels provided are very weak; soil structure is brittle and prone to crumbling. | Built in situ | |
| Roof and floors | No ties between roof and wall; weak joining of roof members; and floor is made up of rammed earth. | Wide bearing area at roof support | |
