World Housing Encyclopedia Report

Country: Malawi

Housing Type: Unburnt brick wall building with pitched roof (nyumba ya zidina)

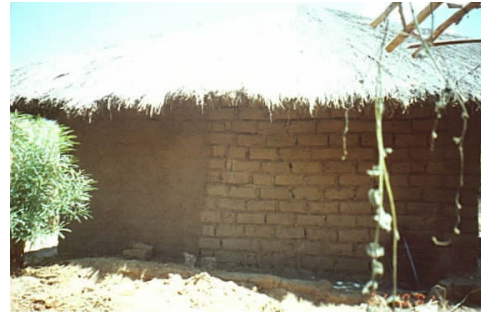
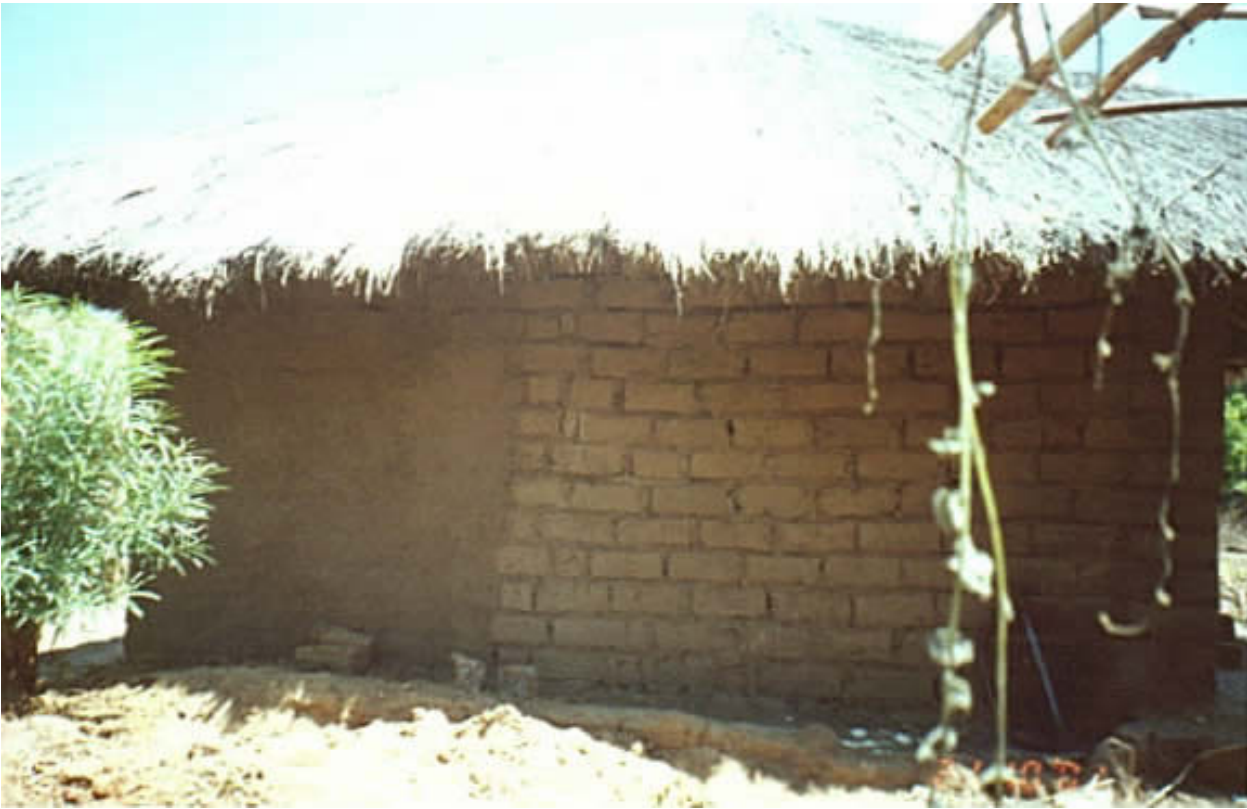
FIGURE 1: Typical Building

This type of building is found both in urban and rural areas throughout Malawi. It is a construction type that is gaining popularity at the moment; it is estimated that it constitutes 45% of the country's housing stock. The thatched roof is supported by unburnt mud brick walls built in mud mortar. The walls are built on a stone platform raised above ground for the purpose of protection from floods. These buildings are built without any horizontal and vertical reinforcement. The strength of the building is very low. This type of construction is considered to be very vulnerable to earthquake effects. In the 1989 Salima earthquake (magnitude 6), 9 people died and over 50,000 people were left homeless. Many buildings of this type suffered extensive damage or collapsed.

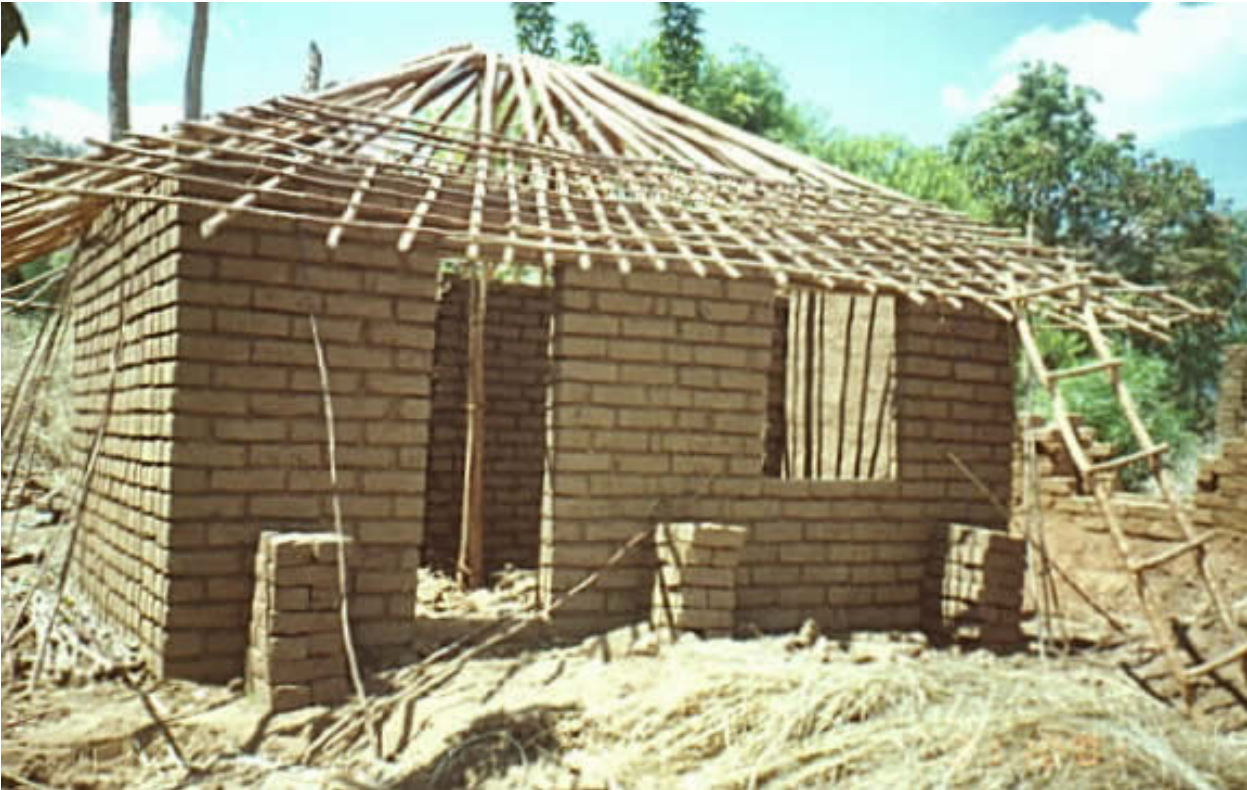
FIGURE 2: Key Load-Bearing Elements

The wall takes the load from the roof and wall elements. The walls are placed on a raised platform as a way of keeping above ground/surface water levels during the rainy season. This platform may be considered as a foundation because it projects outside the wall thickness and is generally constructed of stone. However, the connection between the wall and the raised platform is not structural, so there is no transfer of lateral forces at this point. The connection between the roof and the wall does not provide lateral transfer of forces.

The roof loads are supported on the timber members which are supported on walls. Generally gable walls are used both internally as room partitions and at the extreme ends of the building.

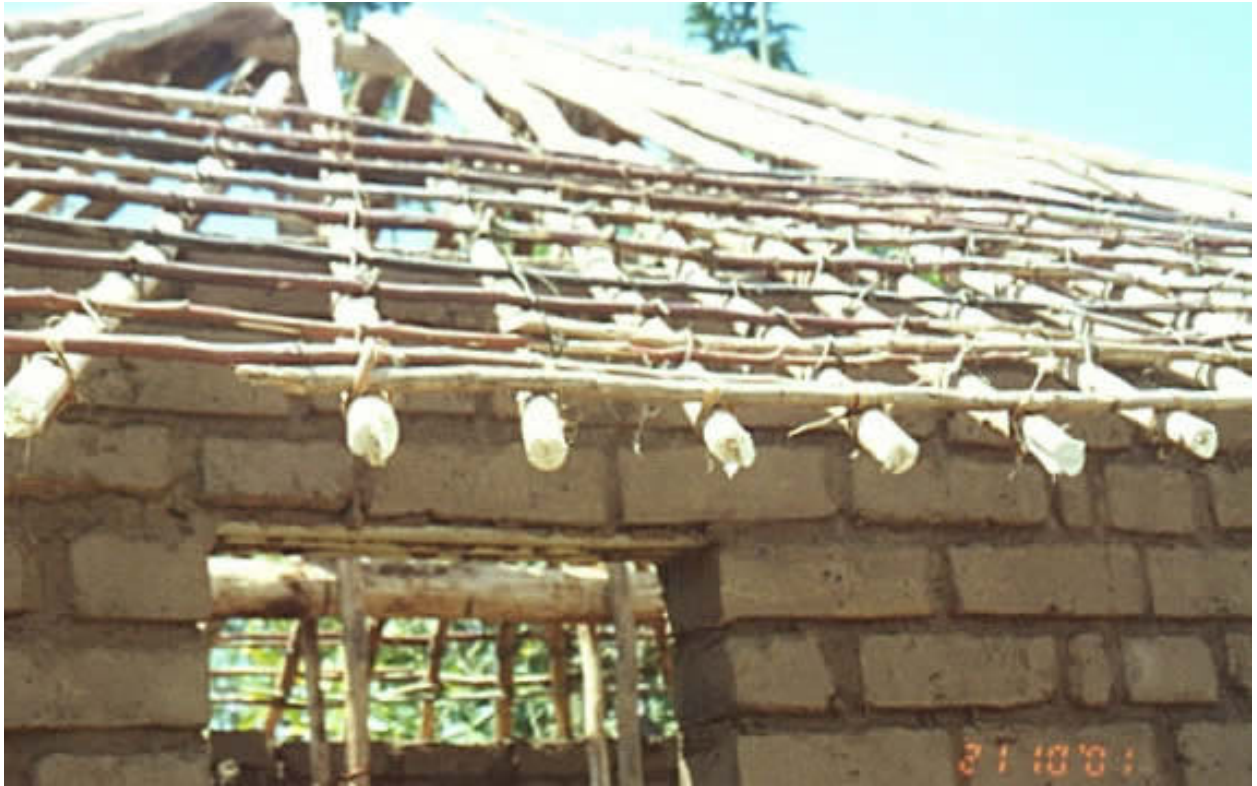
FIGURE 3A: Critical Structural Details

FOUNDATION: The ground is leveled. Stone wall 0.4 m wide is built along the wall perimeter from ground level in mud mortar to a height of 0.4 m.

WALL CONSTRUCTION: The dry clay/mud blocks form the masonry units with mud mortar as the joining medium. The procedure is like any masonry wall construction. The mortar thickness is 10 mm - 15 mm. At the roofing level of the wall, a wall plate is introduced which is generally of timber poles.

ROOFING: Grass thatch or iron sheets supported by timber purlins (generally poles) which run over the gable walls. Truss construction is also used.

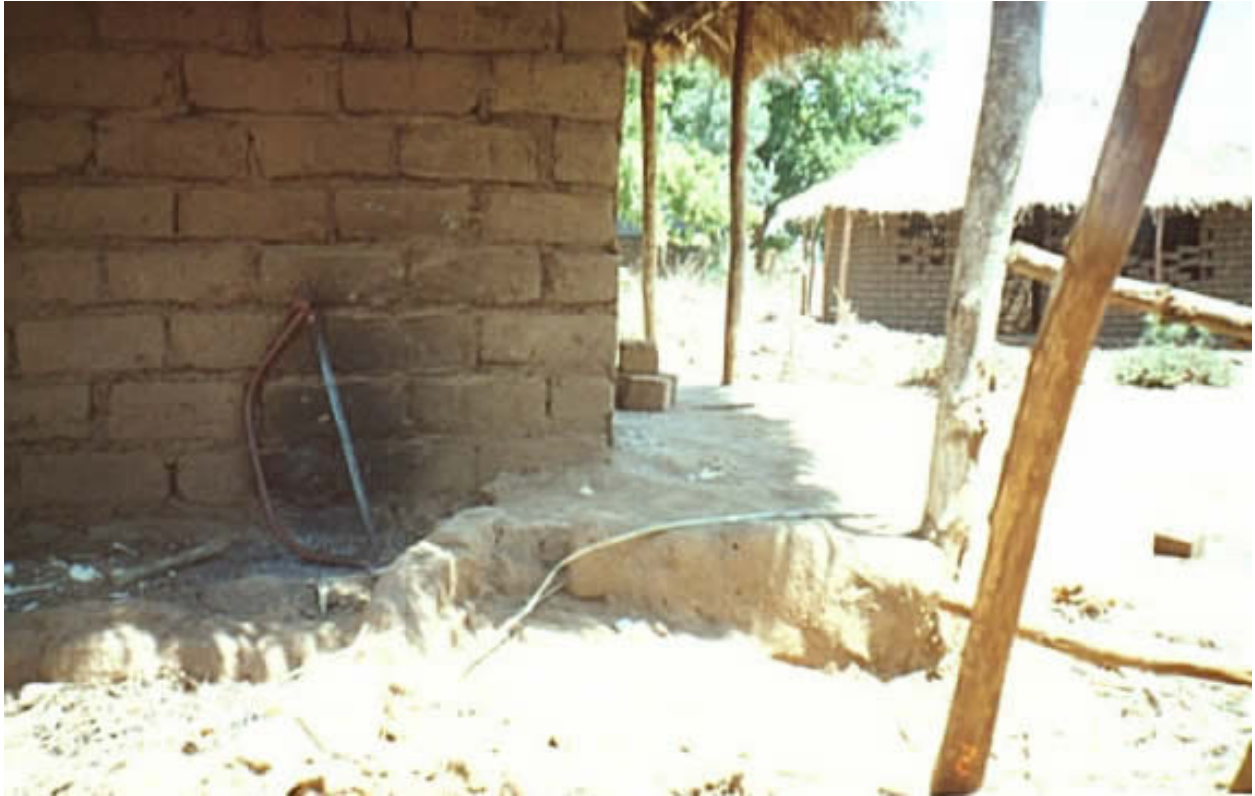
FIGURE 4: An Illustration of Key Seismic Features and/or Deficiencies

Structural Element	Seismic Deficiency	Earthquake-Resilient Features	Earthquake Damage Patterns
Wall	Poor lateral resistance, weak timber lintels.	Gable construction	
Frame (columns, beams)			
Roof and floors	Roofing timber embedded in wall	Light roof system

Additional Comments: The construction practice is not based on engineering expertise. The tying of the wall girder to the roofing structure contributes somehow to the seismic resistance.
