World Housing Encyclopedia Report

Country: Nepal

Housing Type: Uncoursed rubble stone masonry walls with timber floor and roof

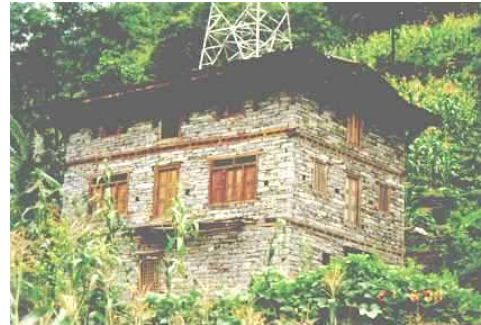
FIGURE 1: Typical Building

This is a typical rural housing construction spread in Nepal from east to west throughout the hills and mountains. It is a traditional construction practice followed for over 200 years. These buildings are basically loose fit loadbearing structures constructed of uncoursed rubble stone walls in mud mortar and timber floors and roof. These buildings are expected to be extremely vulnerable to earthquake effects due to the lack of integrity.

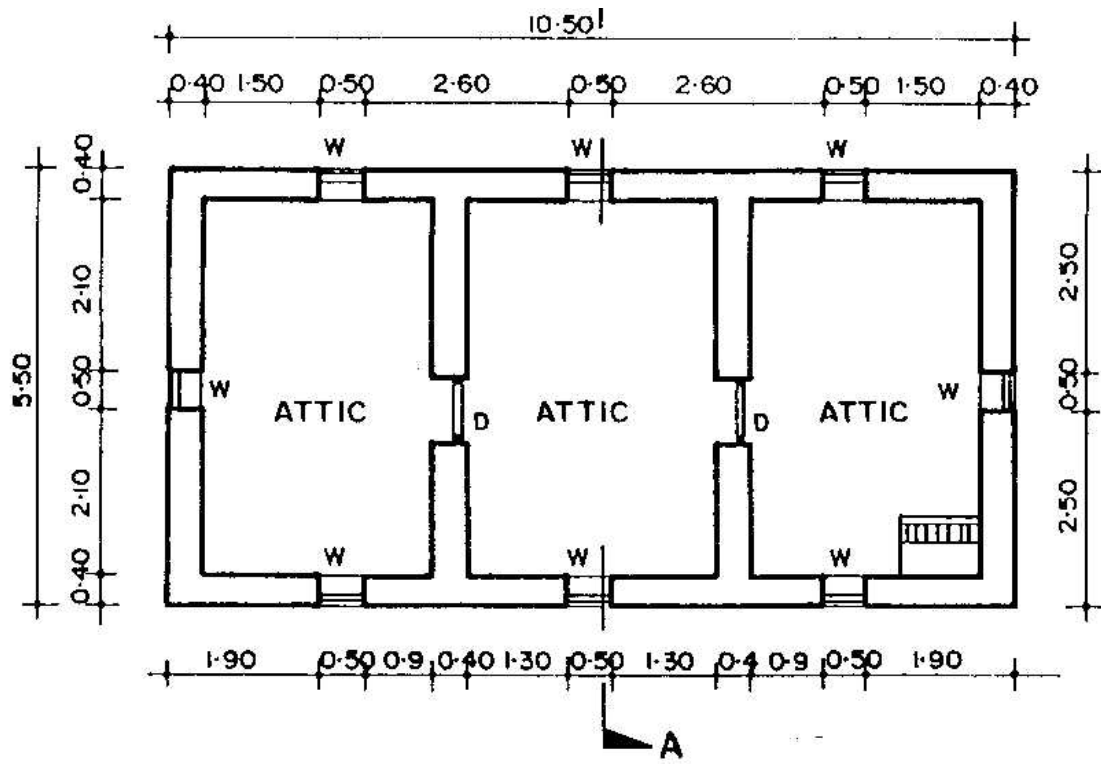
SECOND FLOOR PLAN

FIGURE 3B: Second Floor Plan

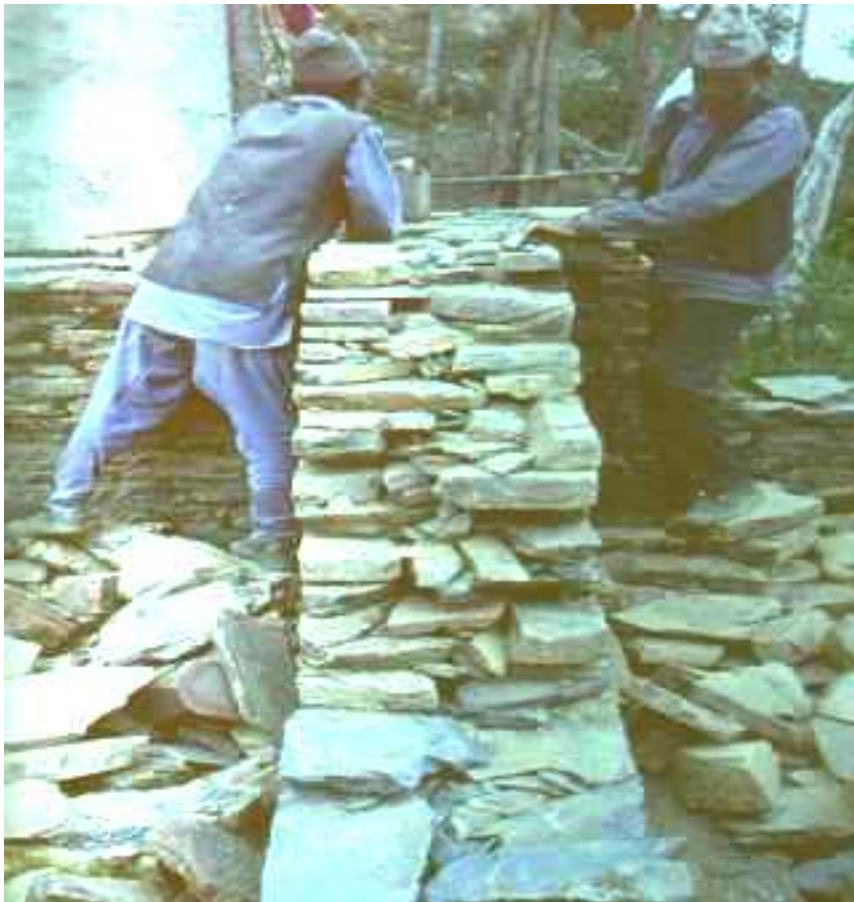
FIGURE 5: Key Seismic Deficiencies-Lack of Connection Between the Wall Wythes (note loose stone rubble)

Structural Element	Seismic Deficiency	Earthquake-Resilient Features	Earthquake Damage Patterns
Wall	-Binding material (mortar) for walling is too weak (mud mortar) or there is no binding material at all (dry stone masonry). -Stone units (boulders) are irregular; -Absence of header stones at wall junctions and corners. -Absence of through stones.	In some cases, bond stones or timber bands are provided.	-Separation of the walls at the junctions, in-plane and out-of-plane wall failure.
Timber Frame (verandah)	-Inadequate beam-column and beam-wall connections. -Lack of anchorage between timber posts and foundation.		
Roof and floors	-Flexible -Lack of integrity (connections) between different structural elements -Absence of wall-floor and wall-roof connection (in general) -Heavy floors		-Total disintegration of roof/ floor structure, separation of floor/ roof structure from walls due to the absence of wall-floor anchorage (ties).

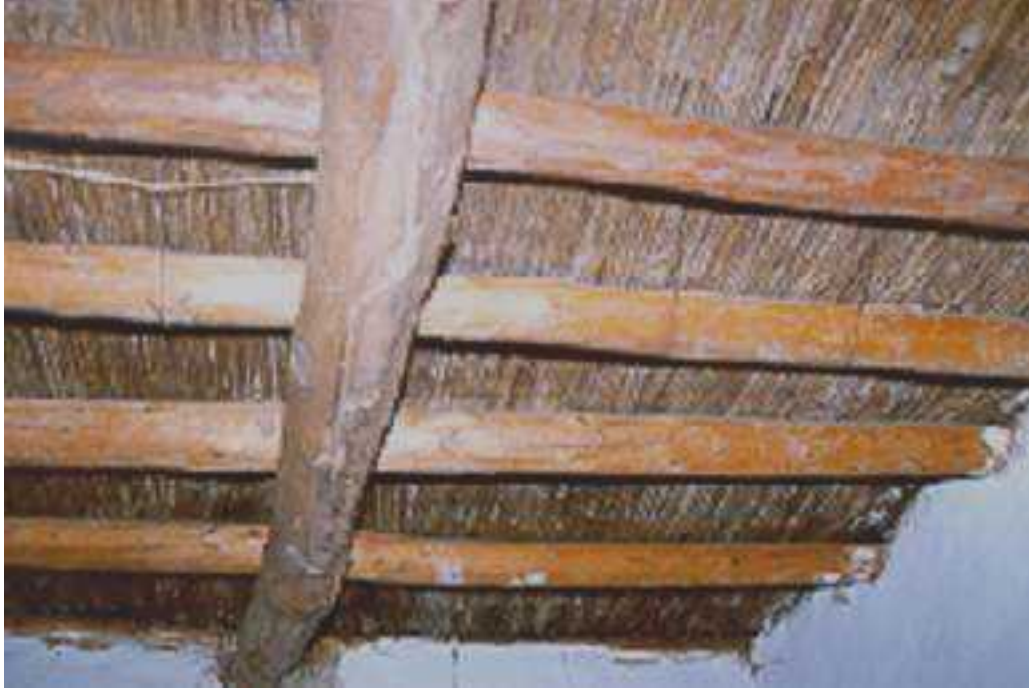
FIGURE 5A: Seismic Deficiencies - Inadequate Wall-Roof Connections

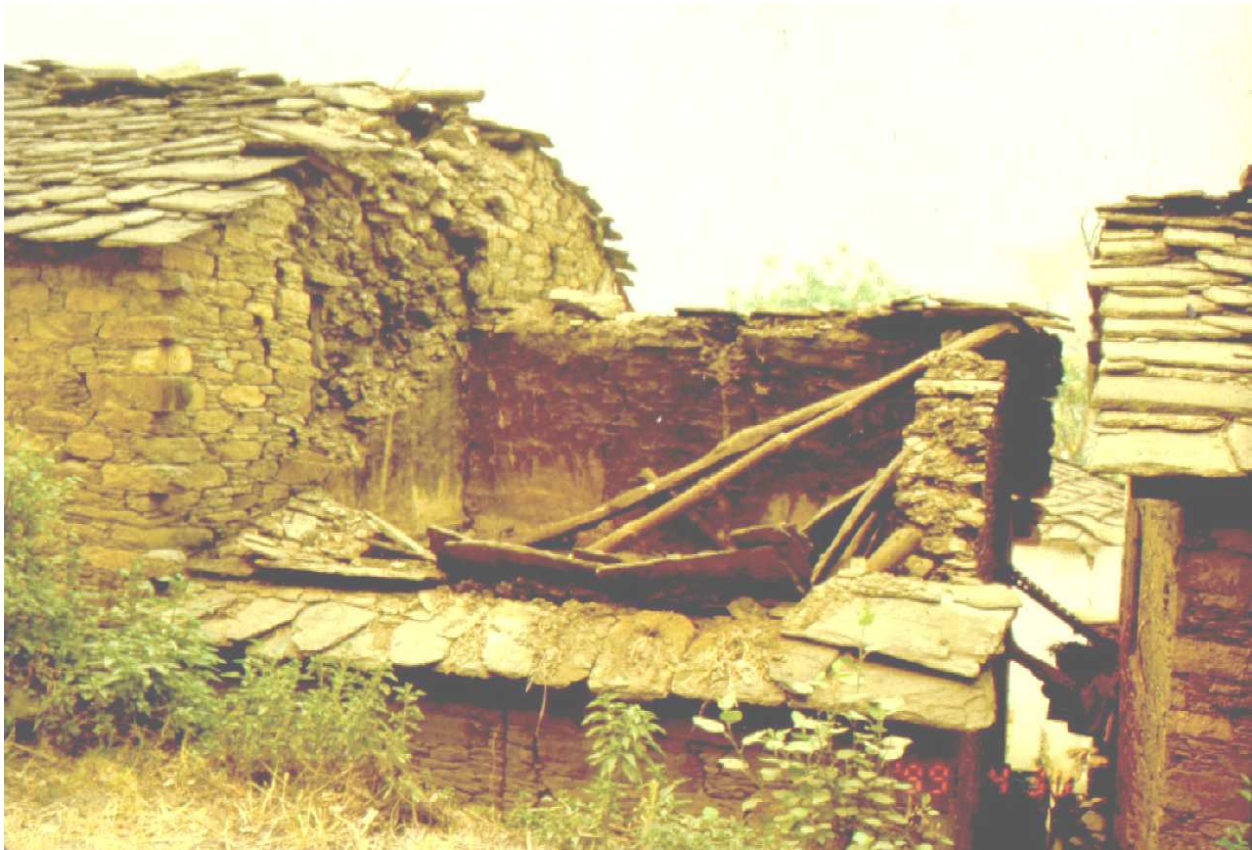
FIGURE 6: Typical Earthquake Damage-Roof Collapse Due to the Absence of Wall-Roof Connection

Additional Comments: This building type is among the most vulnerable to earthquake effects, as it suffers fatal damage in even minor shaking. Many building in Nepal suffered severe damage in the 1999 Chamoli Eartquake, although the epicentre was approximately 140 km away. The main source of damage is loss of integrity of building components, dislodging of rubble stones, delamination of walls etc. skata

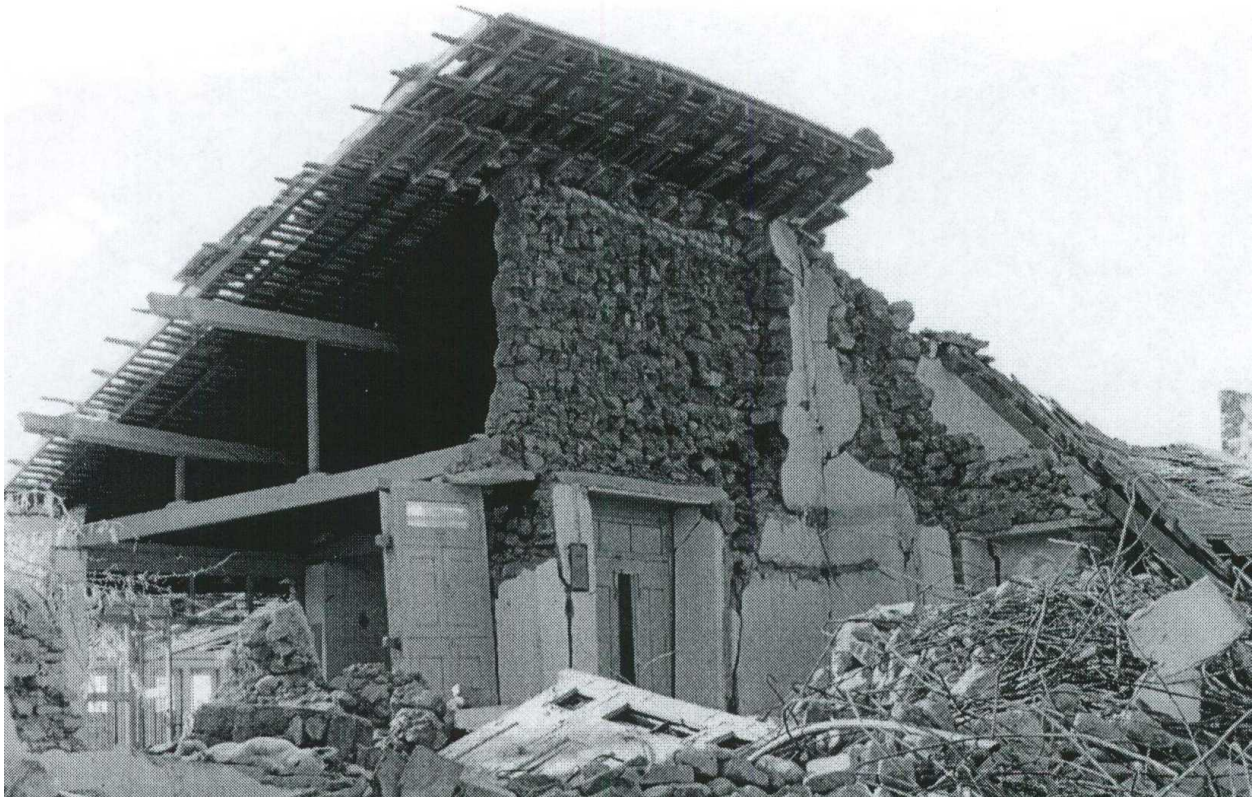
FIGURE 6A: Typical Earthquake Damage - Delamination of Stone Walls due to Absence of Bond Stones (through-stones)

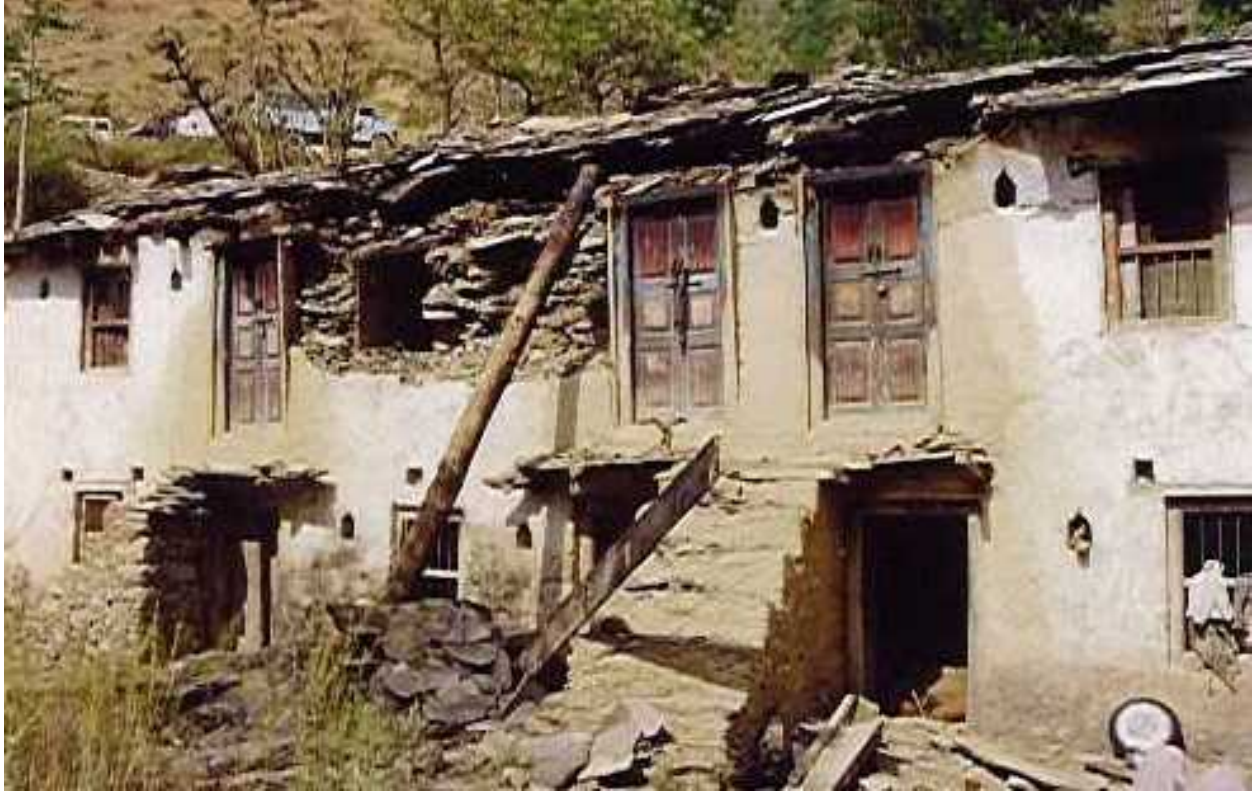
FIGURE 6B: Typical Earthquake Damage to Stone Masonry Buildings

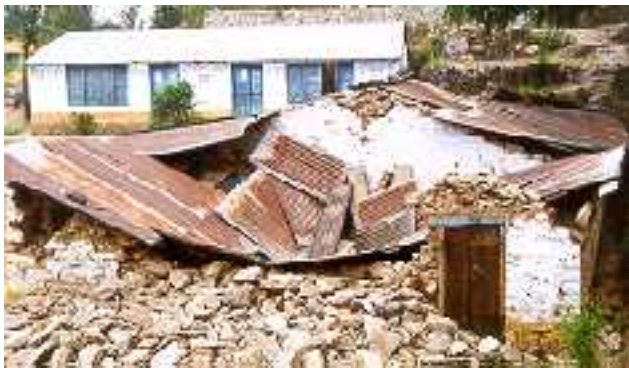
FIGURE 6C: Complete Collapse of a Stone Building in an Earthquake

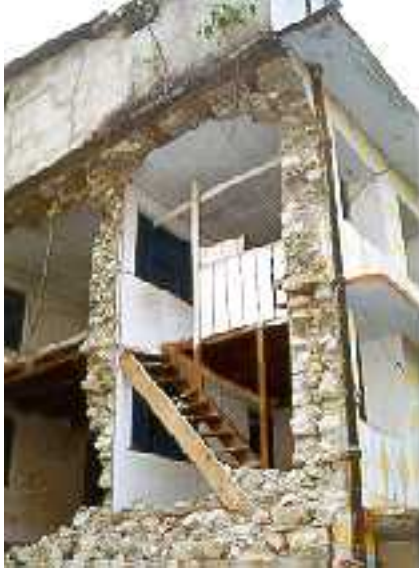
FIGURE 6D: Typical Earthquake Damage -Out-of-plane Wall Collapse Due to Lack of Anchorage

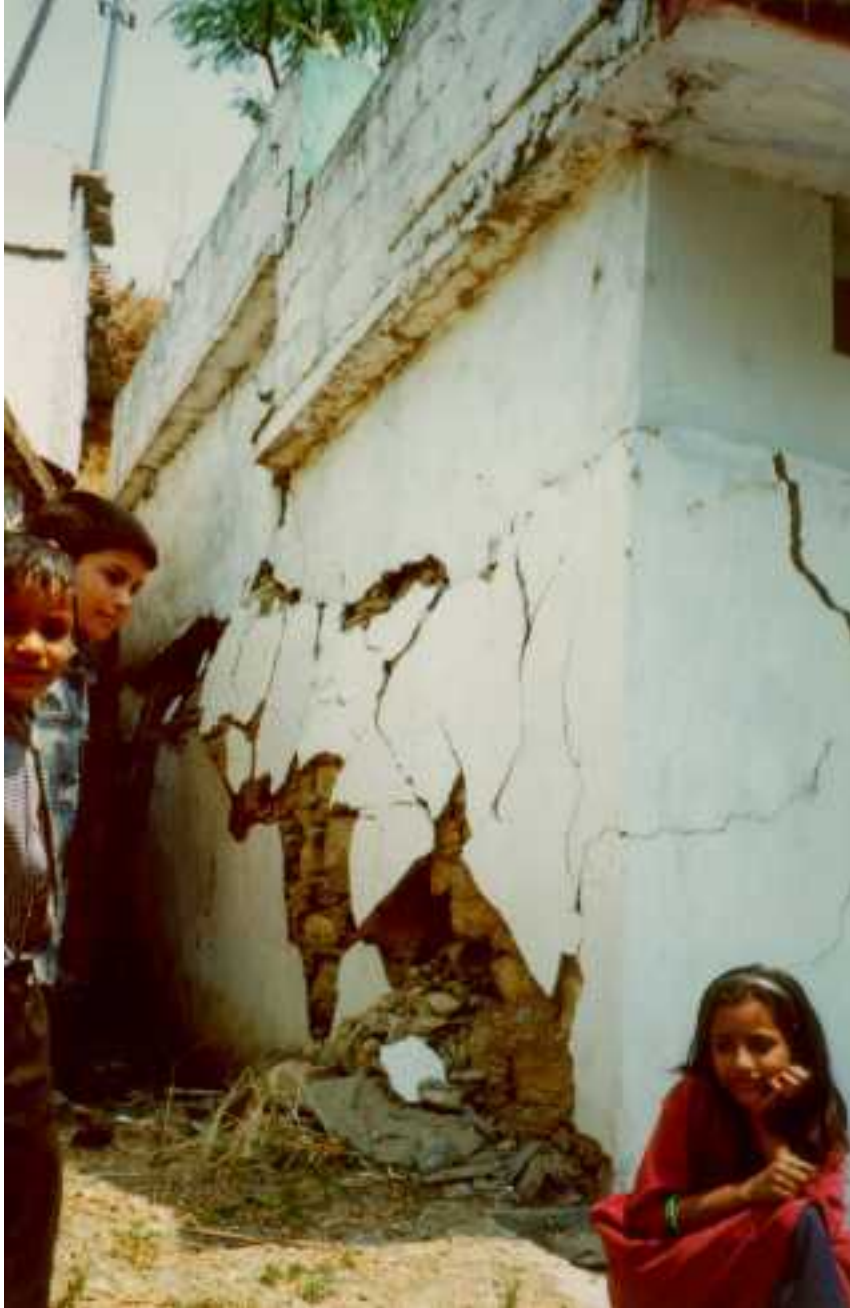
FIGURE 6E: Typical Earthquake Damage -Wall Bulging due to Delamination

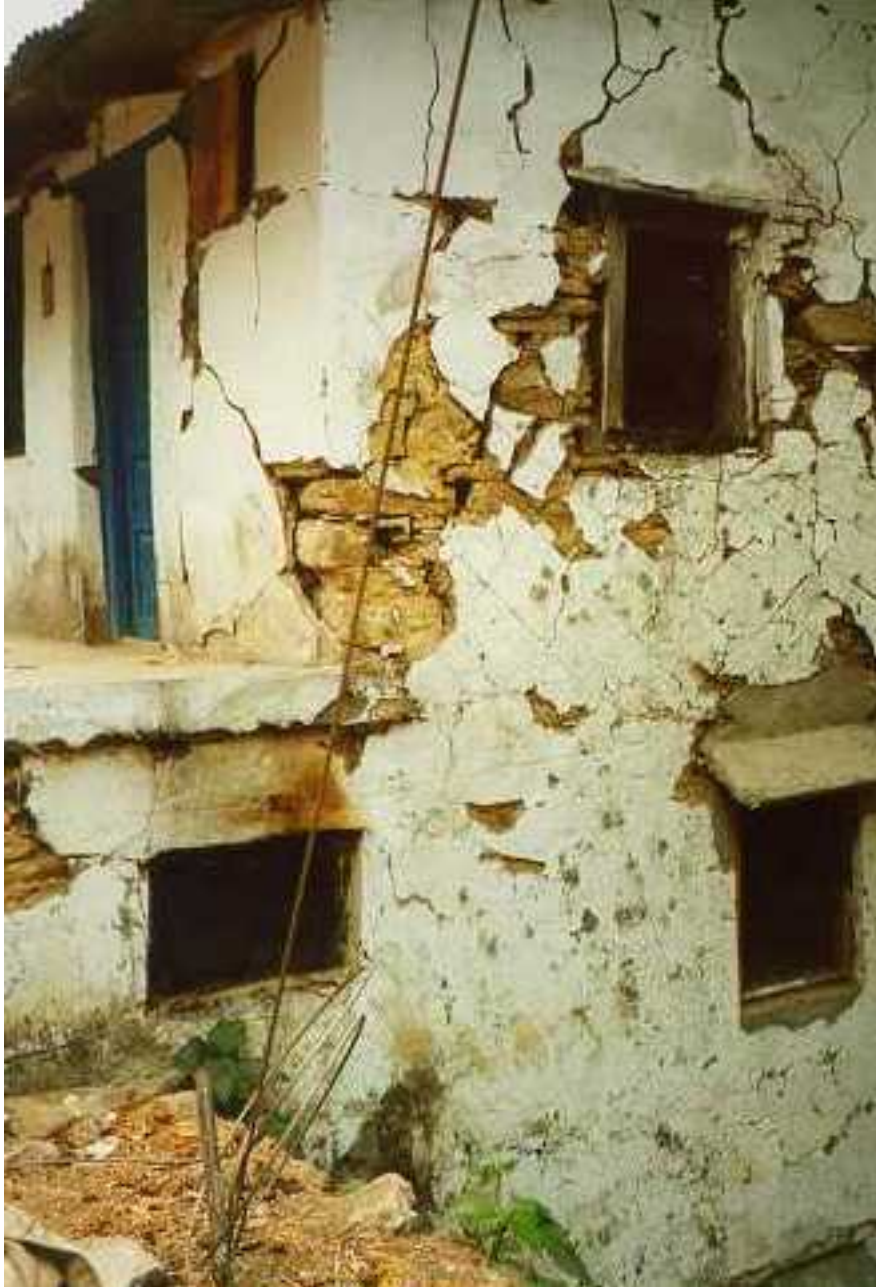
FIGURE 6F: Typical Earthquake Damage - In-plane Failure of a Stone Masonry Wall

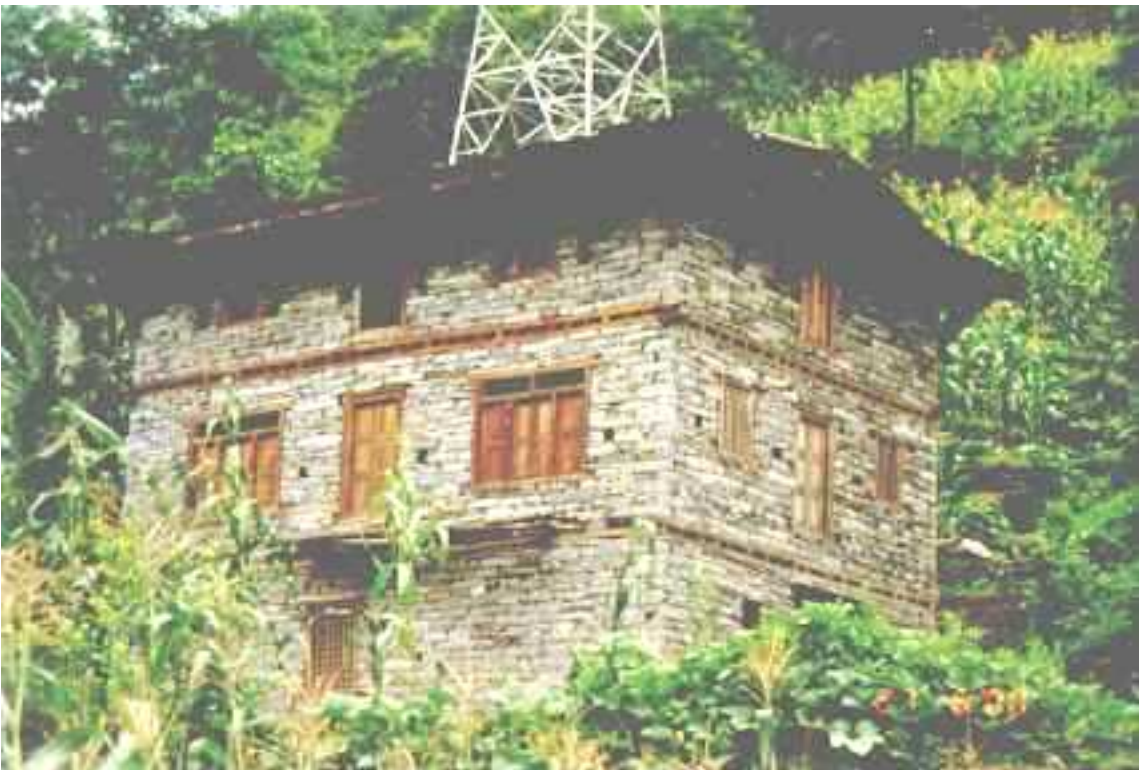
FIGURE 1: Typical Building
