# World Housing Encyclopedia Report

Country: Peru

Housing Type: Adobe house

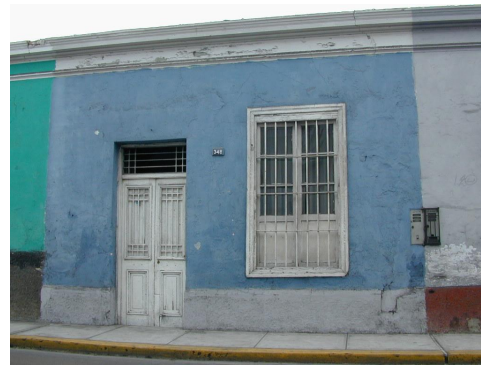
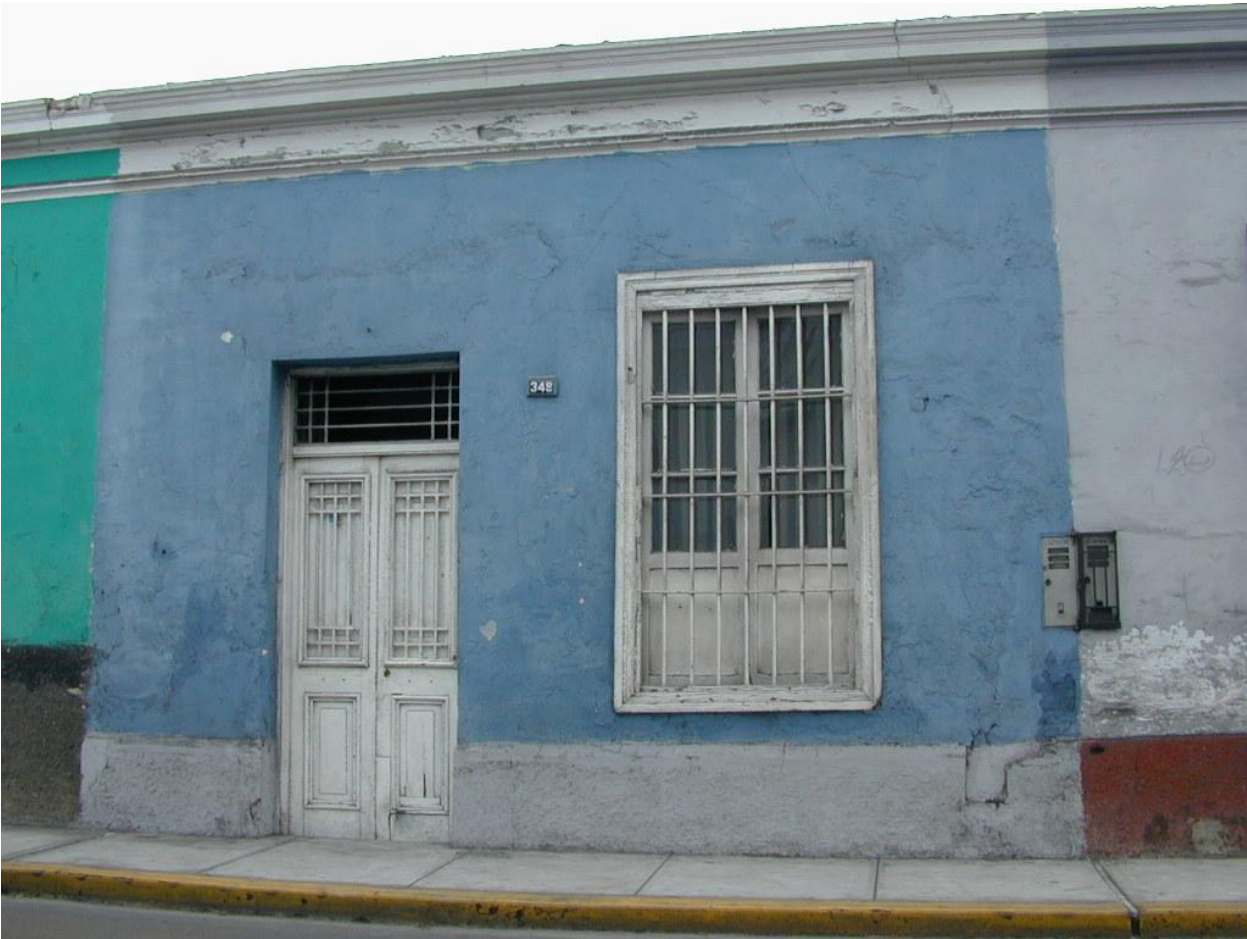
FIGURE 1: Typical Building

This is a traditional construction practice followed for over 200 years. Houses of this type can be found both in urban and rural areas in the coastal and highlands regions of Peru. Walls are made of adobe blocks laid in mud mortar. The roof structure is made of wood; it usually consists of timber beams with timber planks covered with a mud mortar overlay or with clay tiles or metal sheets. Houses of this type are mainly occupied by poor people. This construction is considered to be very vulnerable to earthquake effects.

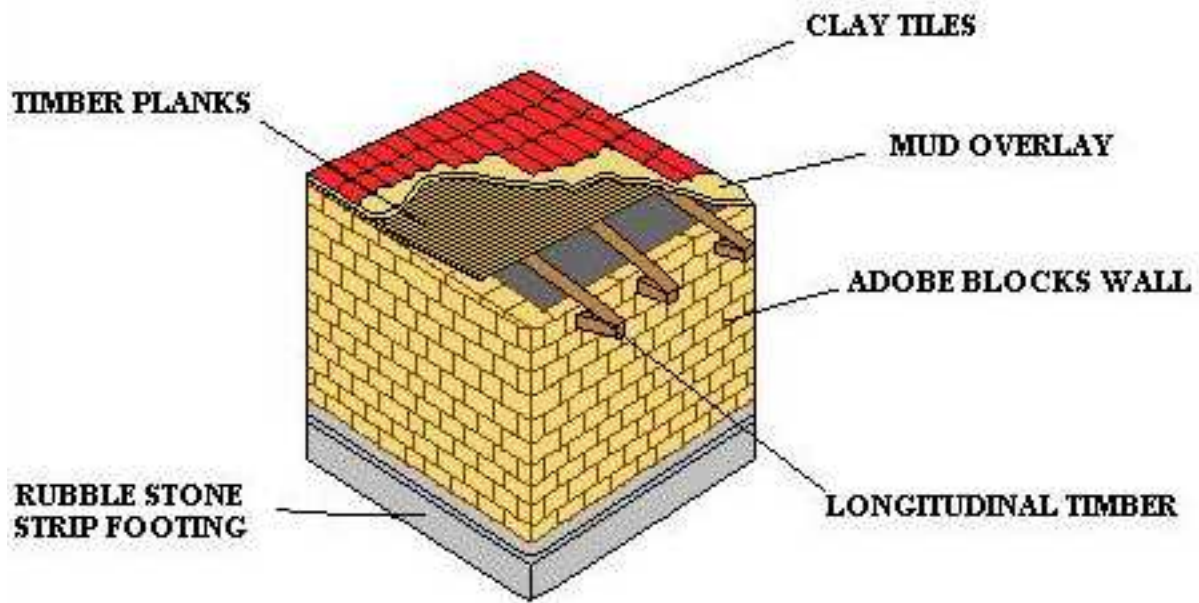
**FOR HOUSES AT THE HIGHLANDS REGION**

*FIGURE 2A: Key Load-Bearing Elements*

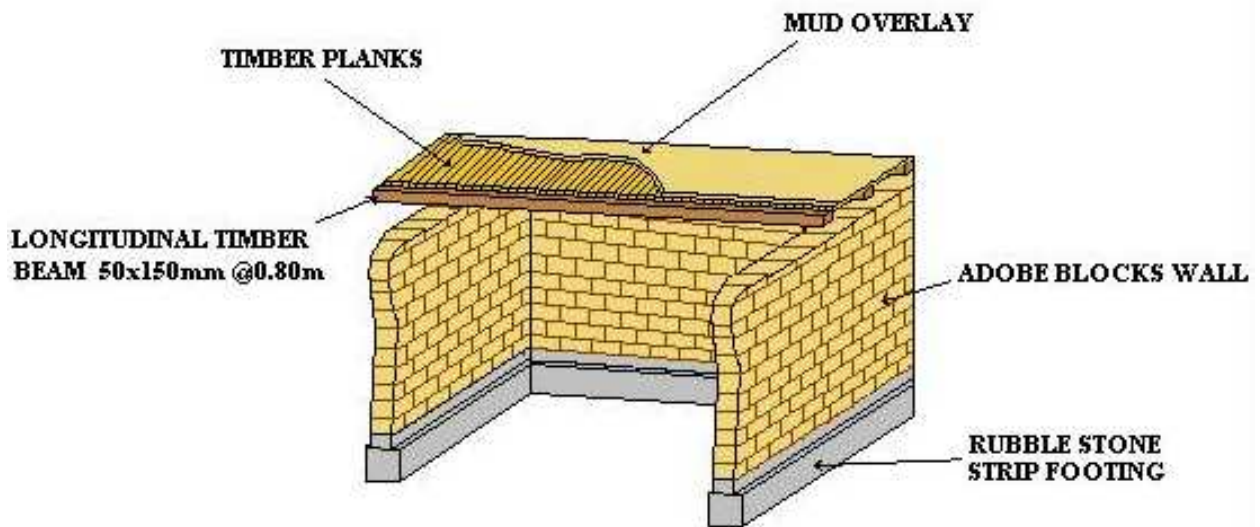
**FOR HOUSES AT THE COAST REGION**

*FIGURE 2B: Key Load-Bearing Elements for Houses in the Coastal Region*

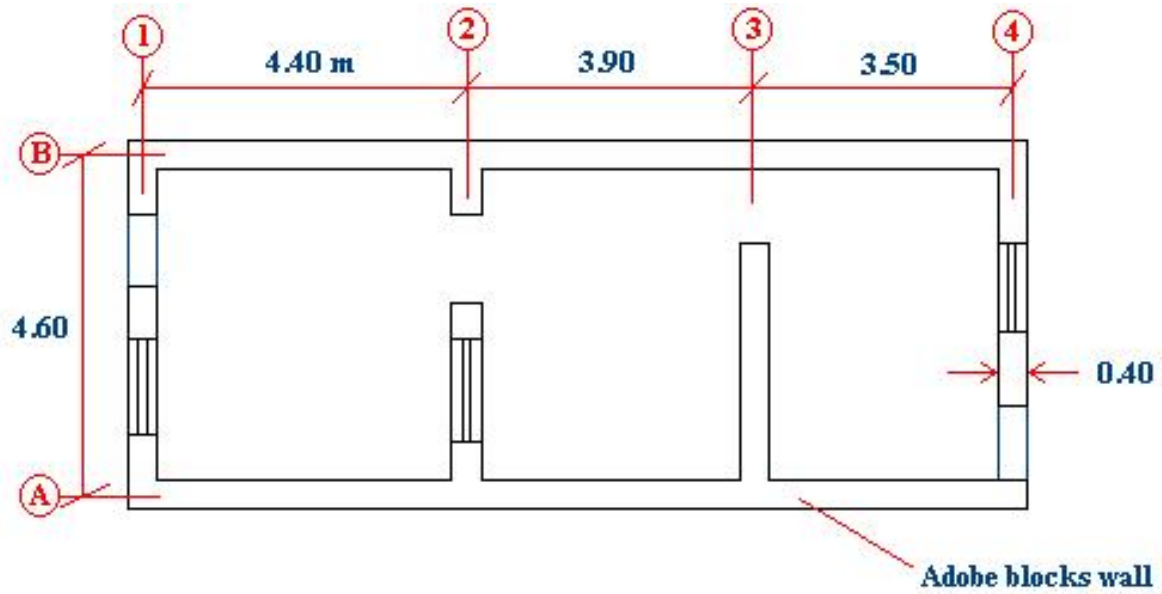
**Typical House Plan**

*FIGURE 3: Plan of a Typical Building*

Building plan is typically of a regular shape, usually rectangular or square.

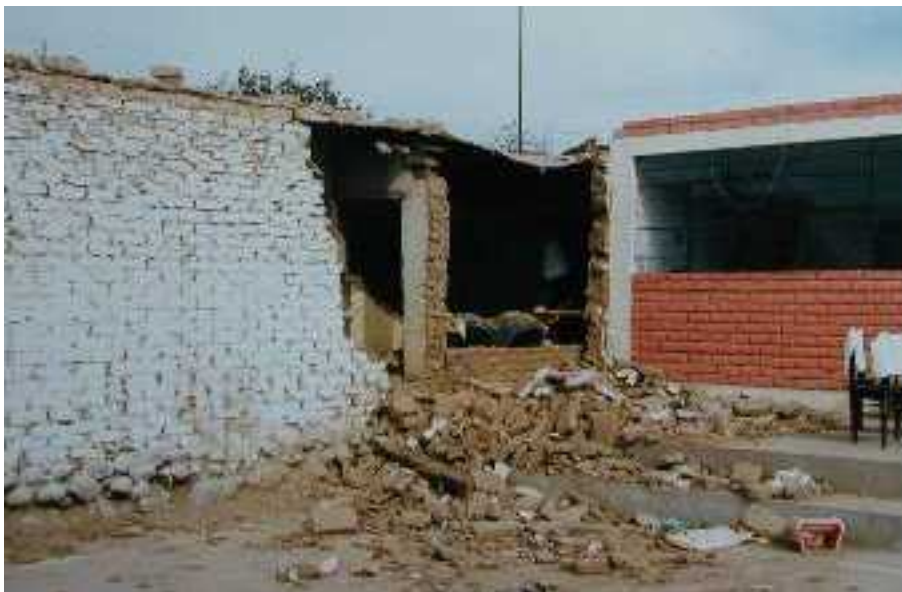
FIGURE 5A: Key Seismic Deficiencies - Adobe Wall Failure Due to Out-of-Plane Seismic Forces

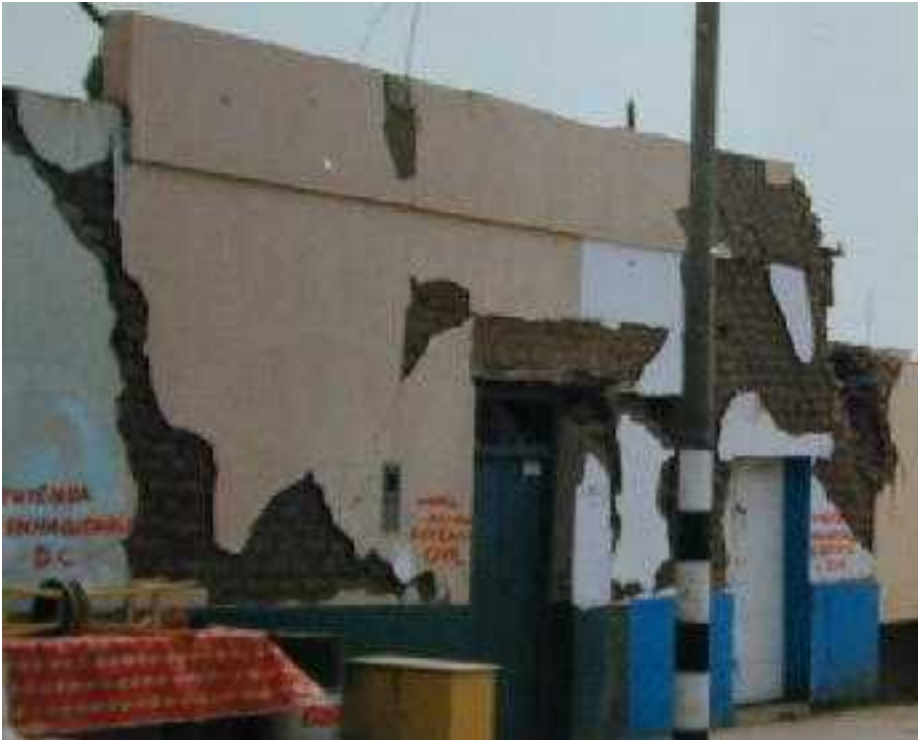
FIGURE 5B: Key Seismic Deficiencies - Wall Damage Due to Inadequate In-Plane Seismic Resistance

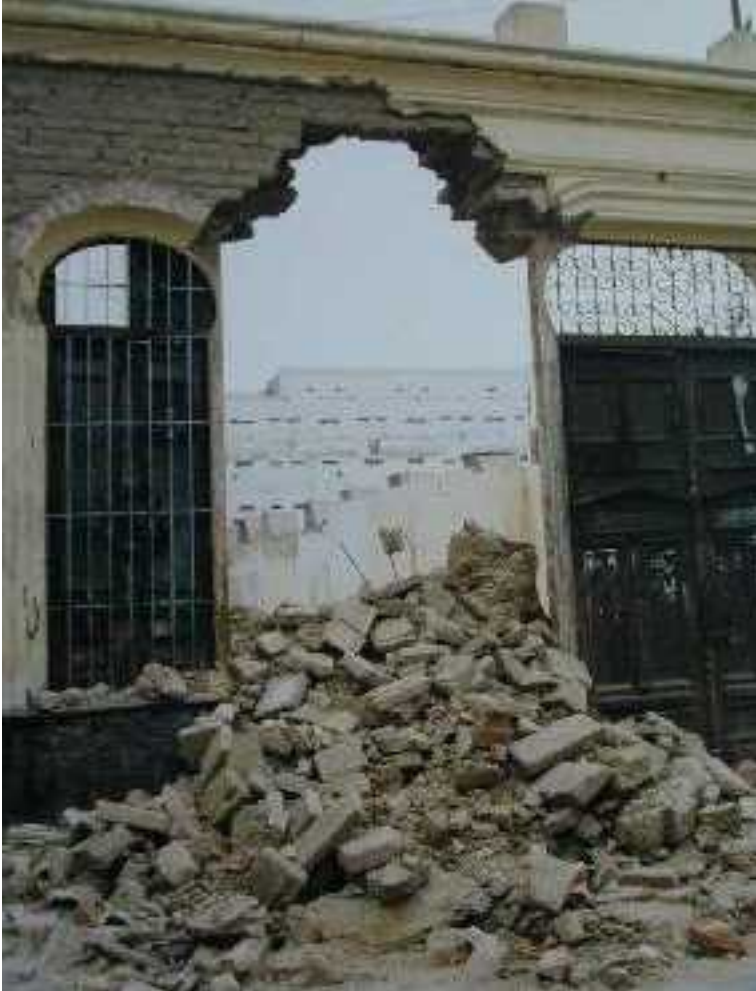
*FIGURE 6A: A Photograph Illustrating Typical Earthquake Damage (November 1996 Nasca Earthquake)*

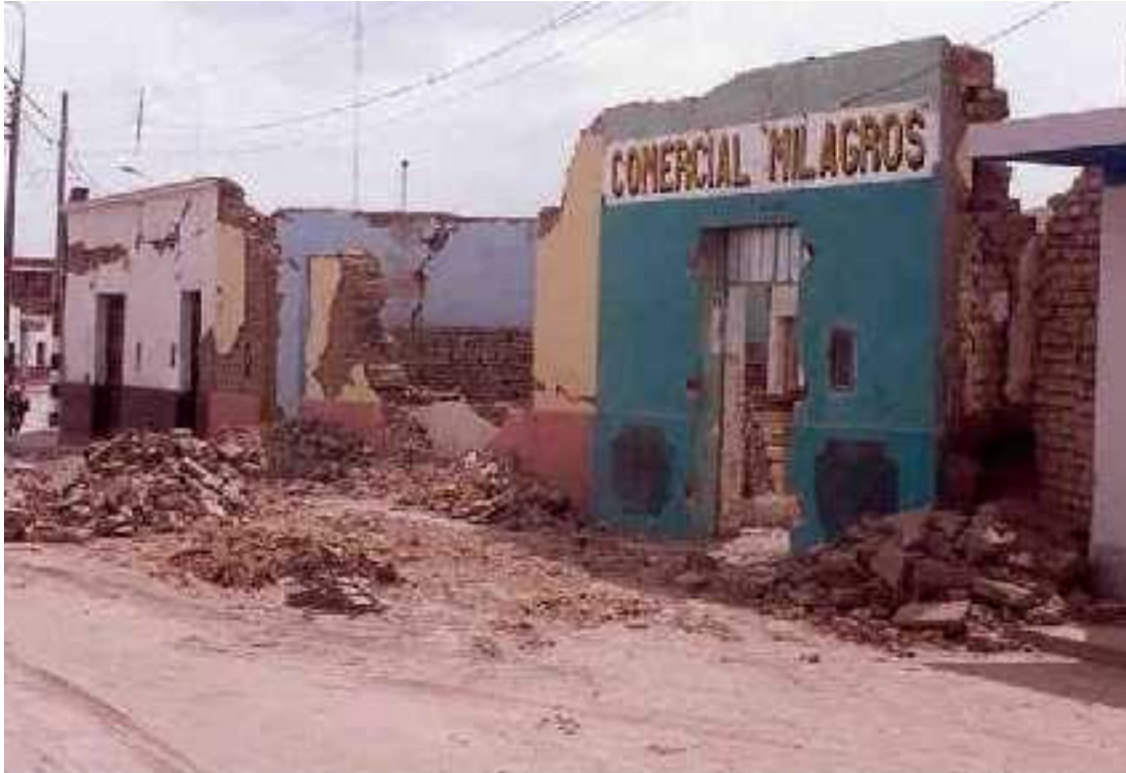
FIGURE 6B: A Photograph Illustrating Typical Earthquake Damage (November 1996 Nasca Earthquake)

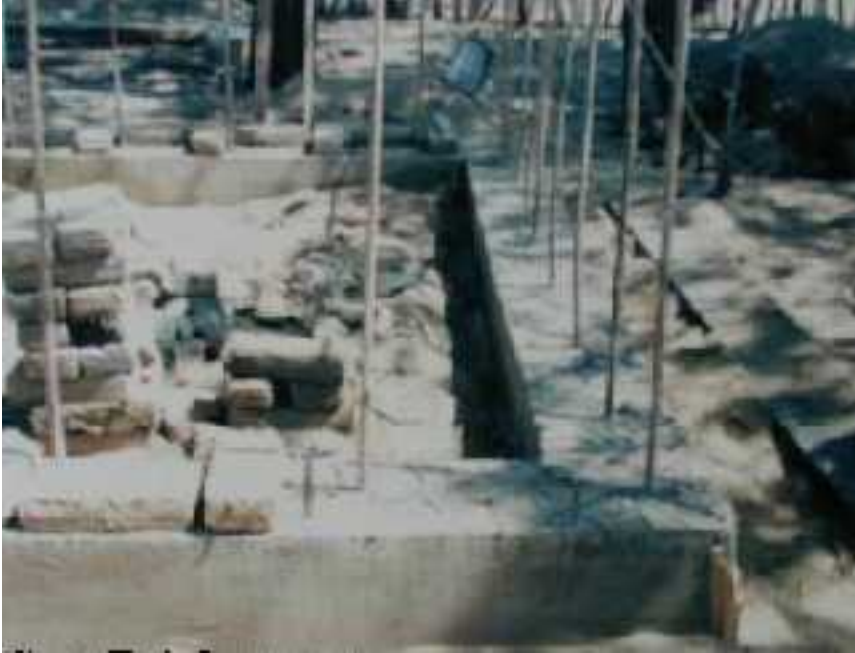
*FIGURE 7B: Seismic Strengthening- Cane Reinforcement for Adobe Walls*

Reinforcing of walls with bamboo cane reinforcement	Bamboo cane is used in adobe walls to provide ductility and improve tensile resistance. This is a very effective and inexpensive strengthening system. Cane does not increase significantly the lateral resistance, however lateral drifts are reduced (see FIGURE 7B).

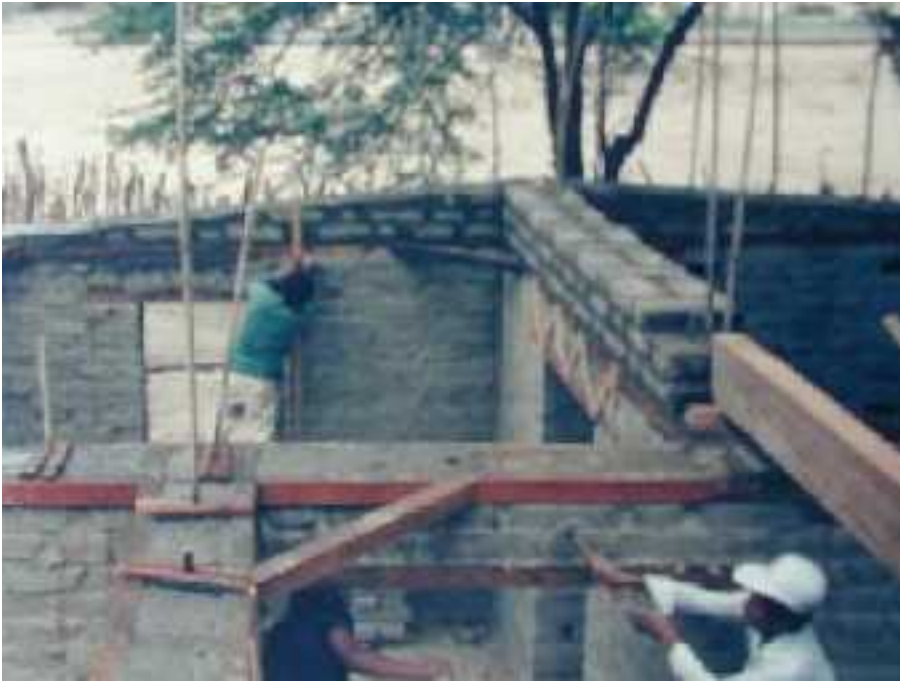
*FIGURE 7C: Seismic Strengthening - Construction of Wooden Beams atop the Adobe Walls*

Type of intervention	Structural Deficiency	Description of seismic strengthening provision used
Retrofit (Strengthening)	Adobe walls- Lack of confinement	Adobe walls are confined with reinforced concrete tie columns and beams. Concrete columns are cast against the serrated endings of adobe walls. This is a very good seismic strengthening system, however it could be expensive for owners.
	Lack of integrity- adobe walls	A wood beam is cast atop the walls, keeping them united during an earthquake. It is an inexpensive system (see FIGURE 7C).
	Adobe walls-poor in-plane and out-of-plane resistance	A steel mesh fixed with metal plates is installed to strengthen the adobe walls. The mesh is applied on both wall surfaces and at the wall corners. This is a very effective and inexpensive strengthening system, developed at the Catholic University of Lima
New Construction	Improved integrity of adobe walls	A wooden beam is cast atop the walls, keeping them united during an earthquake. Rectangular wood beams are used as lintels (see FIGURE 7C).
