Learning from Earthquakes

The February 21, 1996 Chimbote Tsunamis in Peru

This report was prepared and submitted by Catherine Petroff, Jody Bourgeois, and Harry Yeh of the University of Washington.

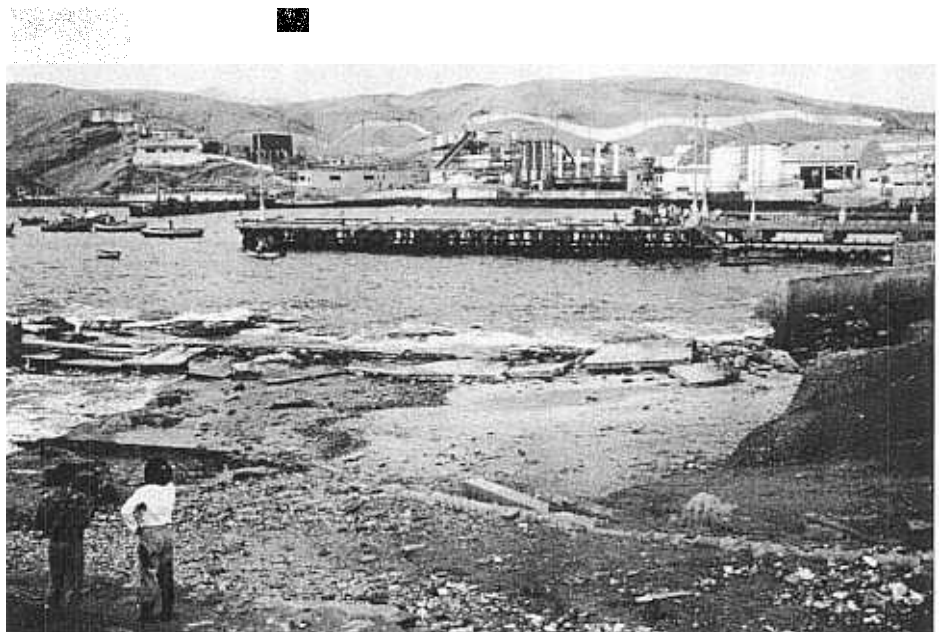
at Campo Santa. In the town of Coishco (approximately 10 km north of Chimbote), a 30-m long brick wall framed by reinforced concrete columns was destroyed by the tsunami impact, and similar destruction was also observed at the port of Culebras, approximately 15 km north of Huarney (Figure 1).

Figure 1 - Destruction of the wall at the Port of Culebras. The maximum runup of more than 5 m was measured at the nearby ravine.

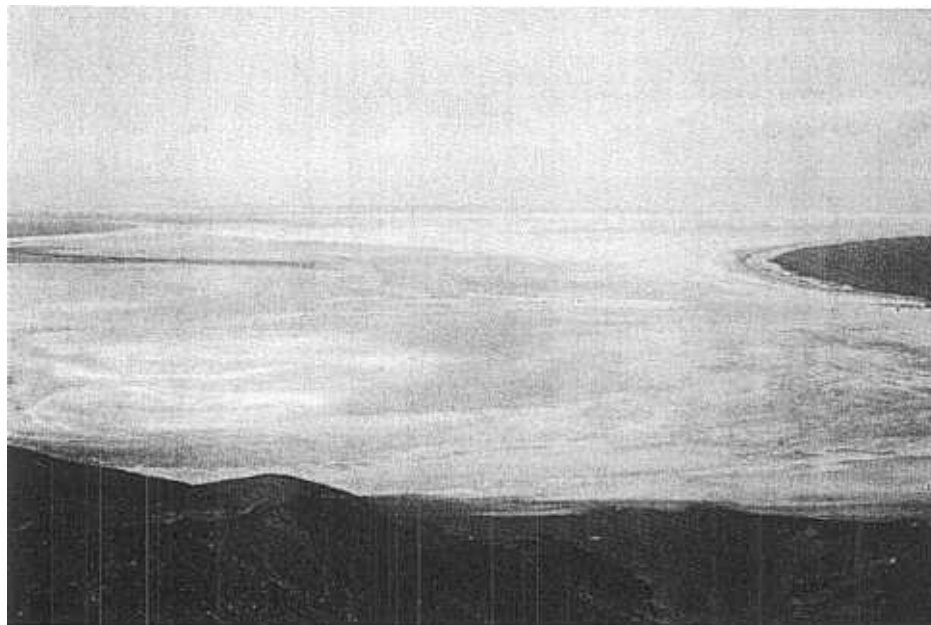
Although runup heights were not extremely high, inundation distances were often quite large because of the flat beach slopes. Several of the inundation distances were well over 200 m. In one case the tsunami inundated an entire isthmus (near Chimbote), approaching from both sides to cover a distance of 1500 m and carrying fishing boats 300 m onshore (Figure 2). In Campo Santa, tsunamis evidently penetrated onto a very flat sandy beach to a distance of more than 450 m. Very long penetration distance on mild-slope beaches implies that the tsunami period was long.

Figure 2 - A scene of the 1,500 km wide isthmus between Chimbote and Samanco Bays. Several boats, that appear as small dots in the middle of the photo, were carried 300 m from the beach by tsunamis. The tsunami inundated the entire isthmus connecting Chimbote and Samanco Bays.
