# The Great Sumatra Earthquake and Indian Ocean Tsunami of December 26, 2004

## Report #5

### Tsunami Survey in Sri Lanka

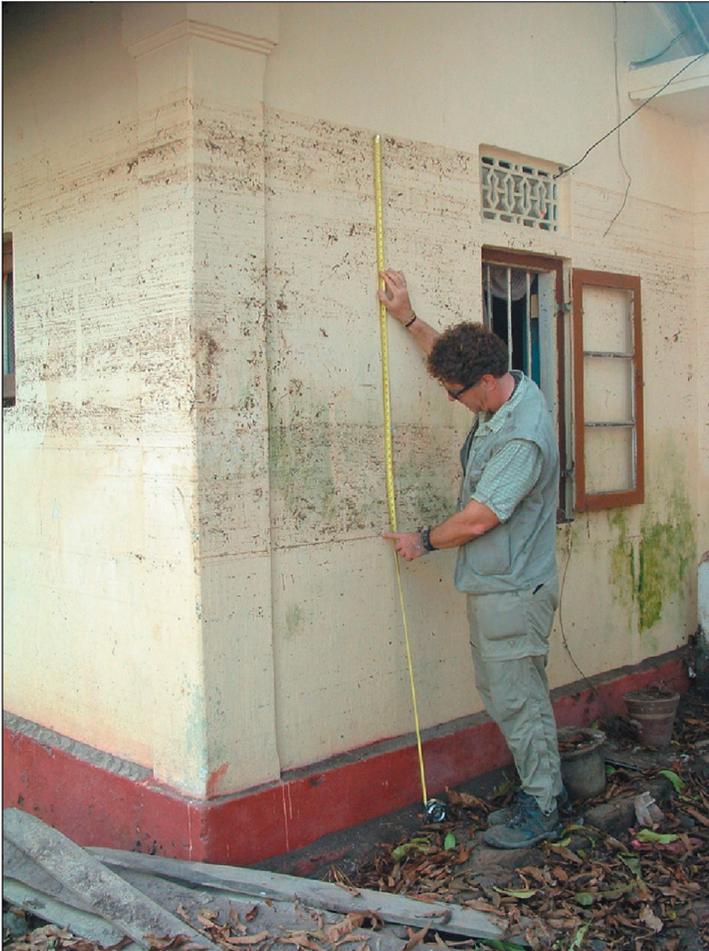
**Figure 2.** Water marks on buildings were measured for tsunami elevations.

The team measured maximum tsunami heights, maximum runup heights, inundation distances, and areas of inundation in the villages indicated on Figure 1. Team members also collected soil samples from tsunami deposits, did a limited aerial inspection along the southwestern coast, and recorded eyewitness accounts. The elevations of water marks on buildings (see Figure 2), scars on

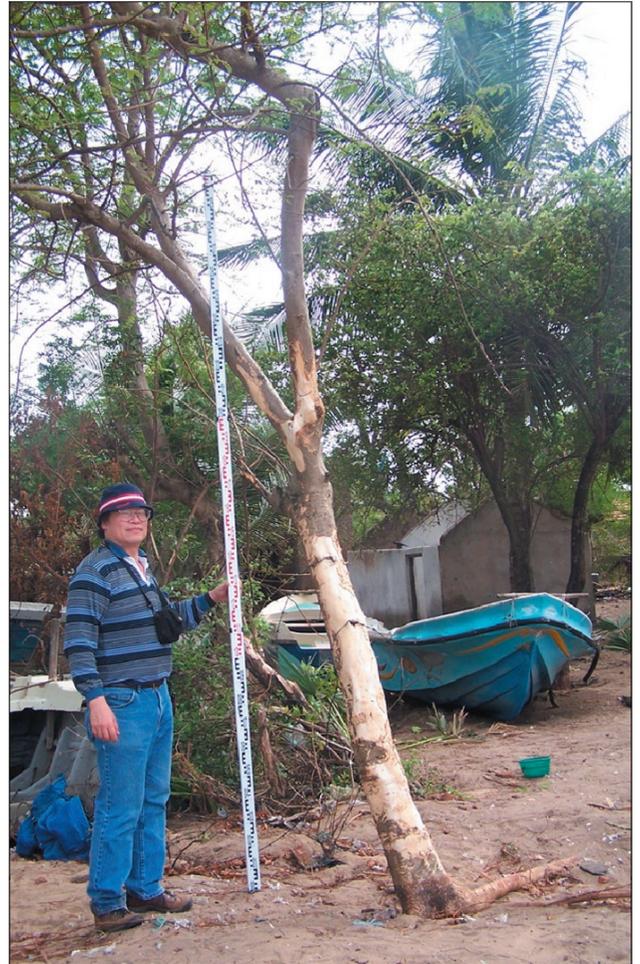
**Figure 3.** Scars on trees were measured for tsunami elevations.

trees (see Figure 3), and rafted debris were measured as indicators of the maximum tsunami height, defined relative to sea level. Maximum runup height is the elevation at the inundation distance, as depicted in Figure 4. Inundation distance is the distance from the shoreline to the inland limit of tsunami flooding.

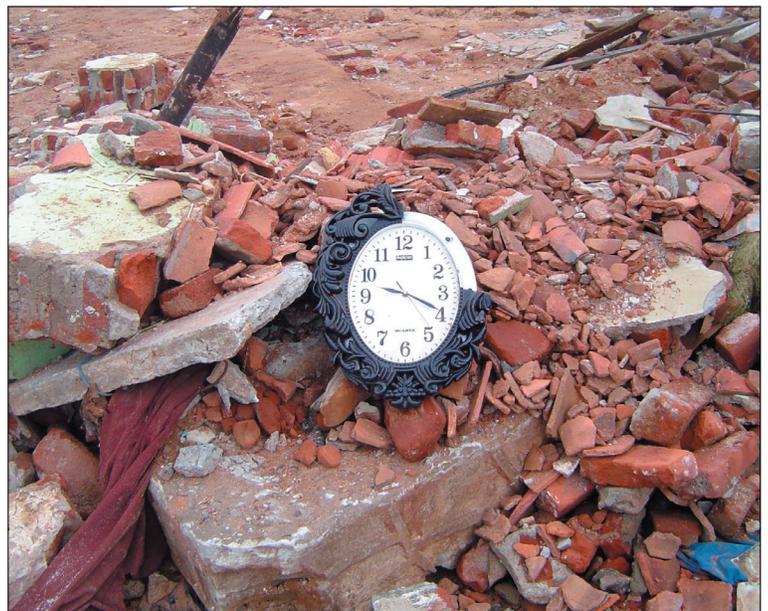
Eyewitnesses described one to three waves, depending on their locations. From the southern tip of Matara to about Galle, the first wave arrived around 9:10 a.m. local time, with a wave height of less than a meter. It was followed by a second large wave at about 9:20 a.m. (see Figure 6), with wave height of up to 10 m. On the southwest coast north of Galle, up to Kalmunai, a third wave several meters high arrived near noon, possibly reflected from the coast of India or from the Maldives. Tide gauge rec-

**Figure 6.**  
A clock stopped at 9:20 was found near Galle.

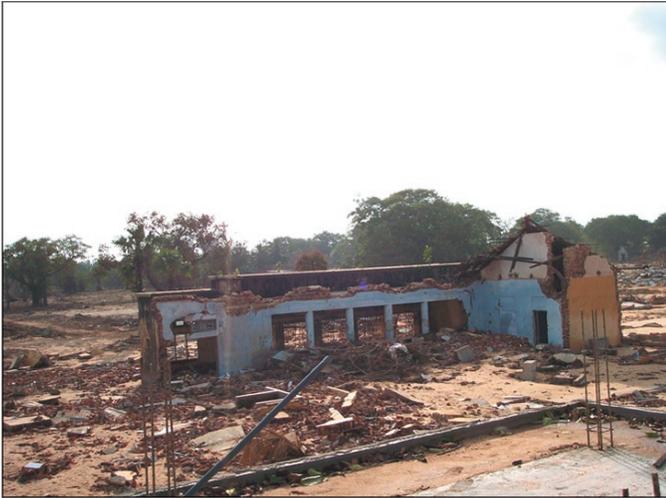
**Figure 7.** A damaged building near Kalmunai.

Most of buildings on the east coast of Sri Lanka are made of bricks. Damage to these buildings was most apparent in regions where part of the building was left standing (see Figure 7). However, in most cases, the only indication of a pre-existing building was a remnant of a foundation. In some areas, there was a zone near the coast where all structures were completely destroyed; however, the damage to structures varied over short stretches of coast. In one part of Kalmunai, the zone of destruction extended about 0.5 km inland, but less than 2 km from there, most of the structures were standing and relatively undamaged at distances greater than 100 m from the shoreline.

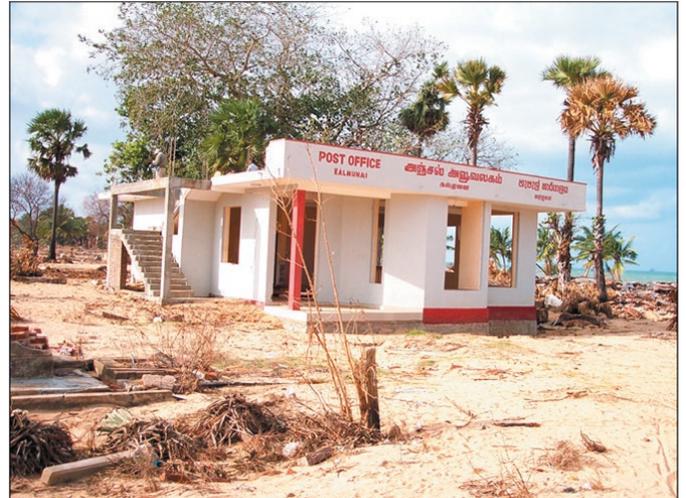
**Figure 8.** The post office at Kalmunai was not structurally damaged.

This variability may have resulted from differences in both the tsunami heights and the quality of construction (see Figure 8). Large scour was noted in most areas (see Figure 9), which appeared to result from both the incoming and returning flow, undermining the foundations of many structures.

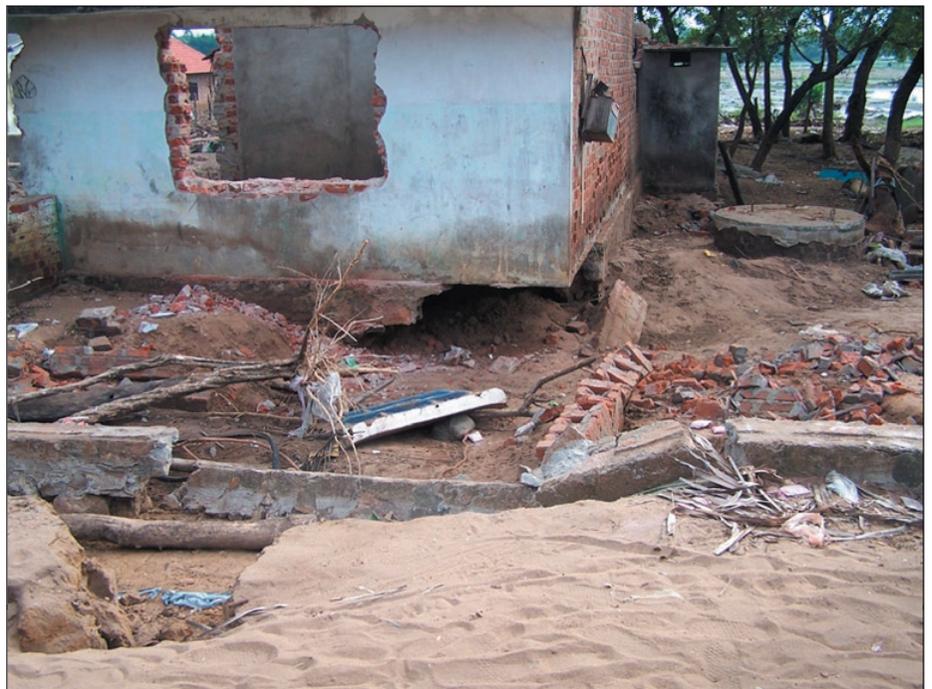
**Figure 9.** Typical scour damage at the foundation of a building.
