World Housing Encyclopedia Report

Country: Venezuela

Housing Type: Urban non-engineered popular housing on flat terrain

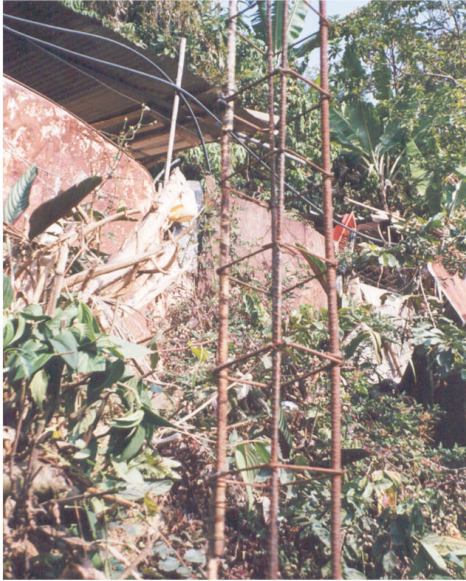
Ties and Stirrups widely spaced, 90 ° Anchorage hooks

Reinforced concrete frames generally provide an acceptable lateral load resistance depending on adequate quality and detailing of structural elements (columns and beams). In this case, the detailing of reinforced concrete columns and beams is inadequate e.g. there is excessive stirrup spacing (same distance of element's section base), inadequate tie anchorage (angle of anchorage is 90° instead of 135° as recommended in seismic codes), and inadequate location of laps in longitudinal reinforcement for columns (laps are provided at bottom of columns in successive stories). Roof structure consists of lightweight roofing (zinc and/or acclimatized galvanized sheets) supported by I-shaped steel beams.

Additional Comments: See Figures 4 and 5

FIGURE 5: An Illustration of Key Seismic Features and/or Deficiencies

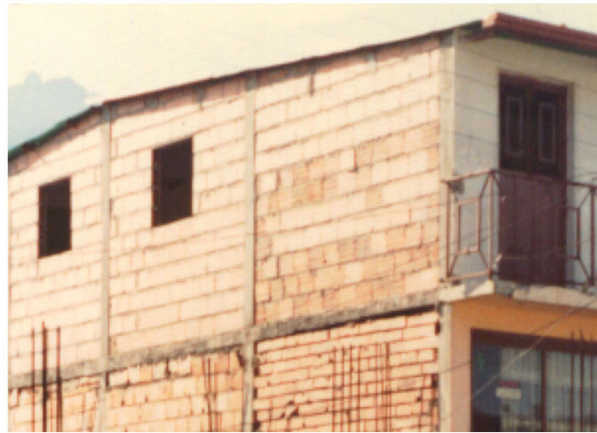
Inexistent Collar Beam

Additional Comments: Floors may be considered as rigid diaphragms. Special inspection must be performed on floor connection with beams, to guarantee transmission of lateral loads. Roof may not be considered as a rigid diaphragm, due to the reduced sections (at most IPN 80), the low connectivity between joists and the lack of connection with the rest of the structure (absence of a collar beam on top of walls in roof level).

Roof and floors	Roof may not be considered as a rigid diaphragm due to the lack of adequate connectivity within its elements and with the walls (absence of a collar beam on top of walls at this level).Connections between floor and frames must be inspected to guarantee adequate linking and load transmission.		Roof: great movements may be generated in roofs, total dismantelation and consequent collapse may occur. Floors: great movements may inflict damage in confinement and walls.
Other	Risk of pounding effect. Not enough gap between adjacent buildings, distance is not greater than 10.0 cm.		Column failure at level where slabs of neighboring construction pounds.

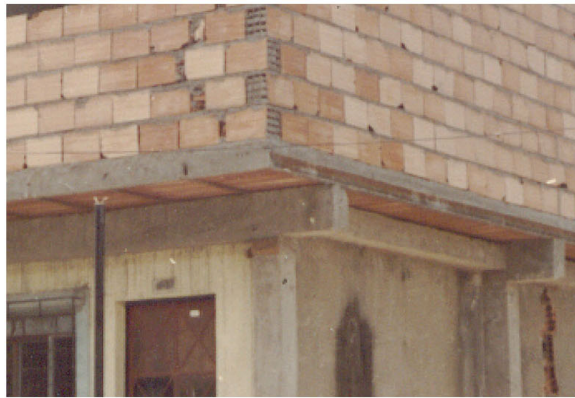
Inadequate connection between floor and frames

Inexistent seismic detailing features in reinforced concrete works. Connections between floors and structural frames do not guarantee lateral force transmission and may induce displacement of slabs with respect to the frames generating damage to columns. Parapets in uppermost levels represent a dangerous collapsible feature. The absence of collar beams and horizontal reinforcement in uppermost walls may produce out-of-plane inertial loads. Gap between adjacent buildings (not greater than 10.0 cm.) identifies risk of pounding effect.

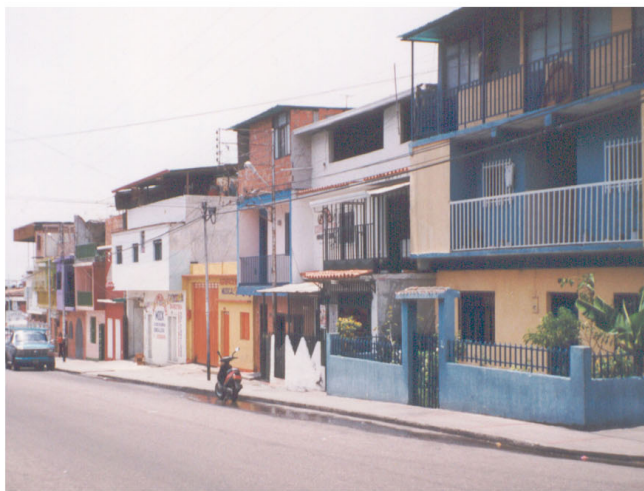
Adjacency and height differences

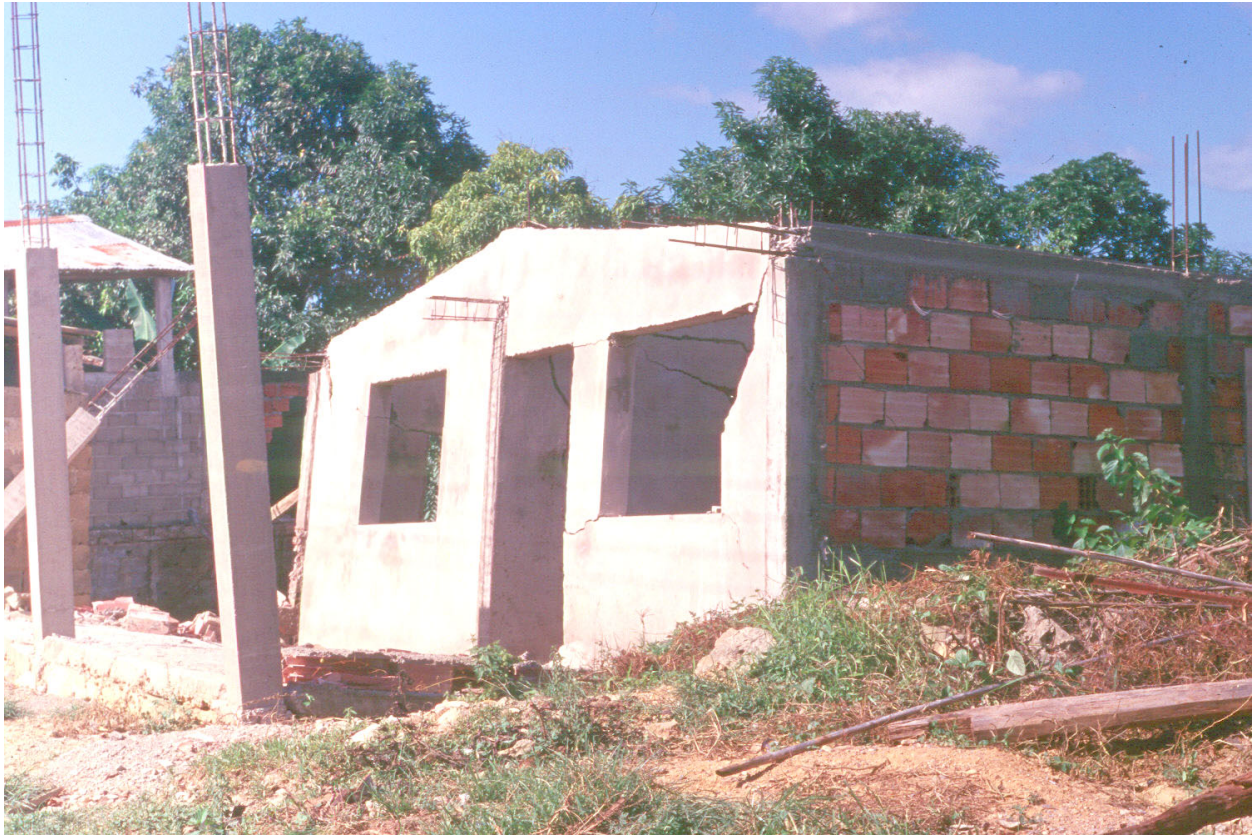
FIGURE 6: A Photograph Illustrating Typical Earthquake Damage (1997 Cariaco earthquake)

Year	Earthquake Epicenter	Richter magnitude(M)	Maximum Intensity (Indicate Scale e.g. MMI, MSK)
1997	10.5N 5.3°W Depth 9.4 km(Cariaco, Venezuela)	6.8	VIII (MMI)

Additional Comments: See Figure 6
