EARTHQUAKE AND TSUNAMI LIFELINE PERFORMANCE INVESTIGATION INDIA TEAM

Overview

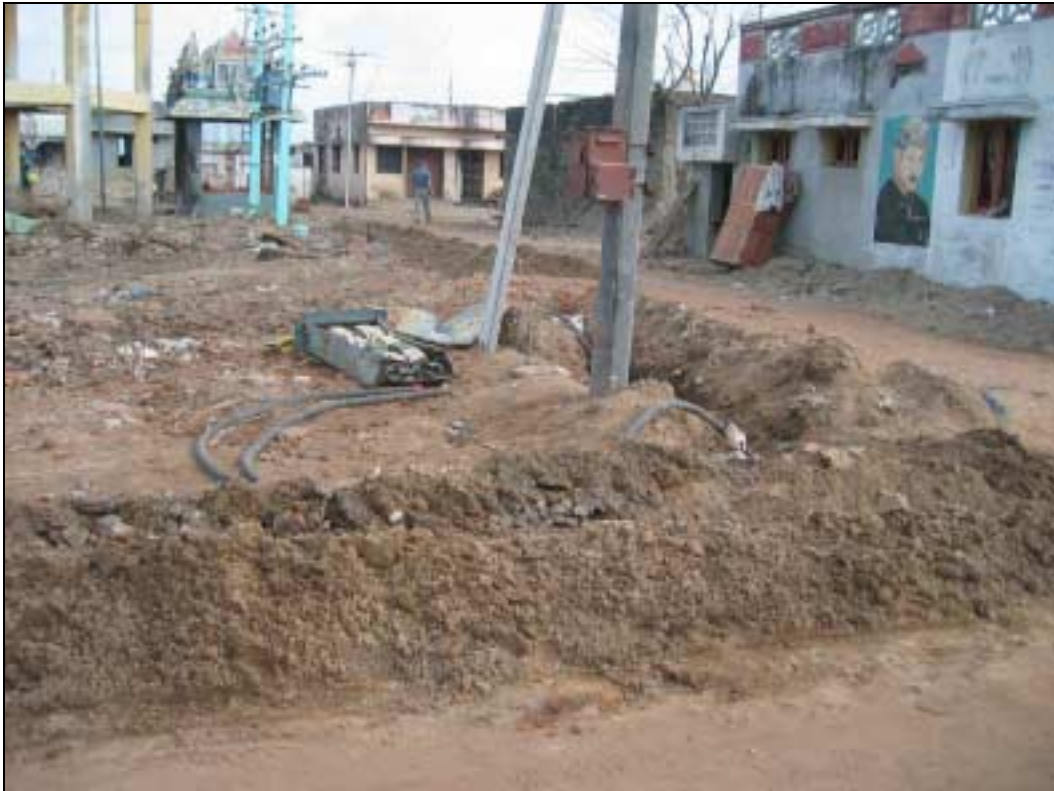
Figure 2. Damaged telephone cross connect box for the village. (Tang)

Telecommunication went down due to Central Offices inundated and had to turn power off to protect digital equipment. Power room of the Central Office, which is in the lower floor, was under water. It took Bharat Sanchar Nigam Limited (equivalent to North America Bell Company) 3 days to remove and re-install equipment from spares to bring telecommunication back to normal. During the process of removing and replacing water-damaged equipment, a fibre optics cable of SONET was severed that brought down several Central Offices from the intra office connection.

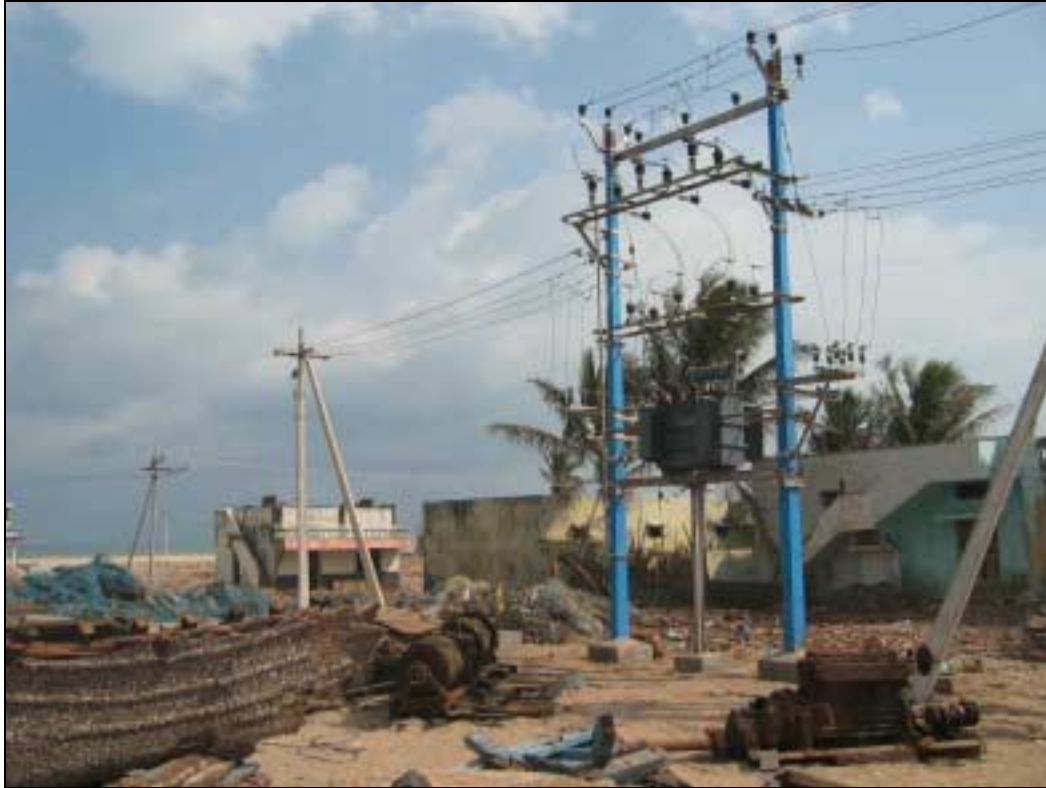
Figure 3. New transformer and new poles for power distribution (Tang)

Downed power poles mainly caused electric power outage. In the Cuddalore district, there were more than 300 poles had to be replaced. The recovery of power took three days after the tsunami.

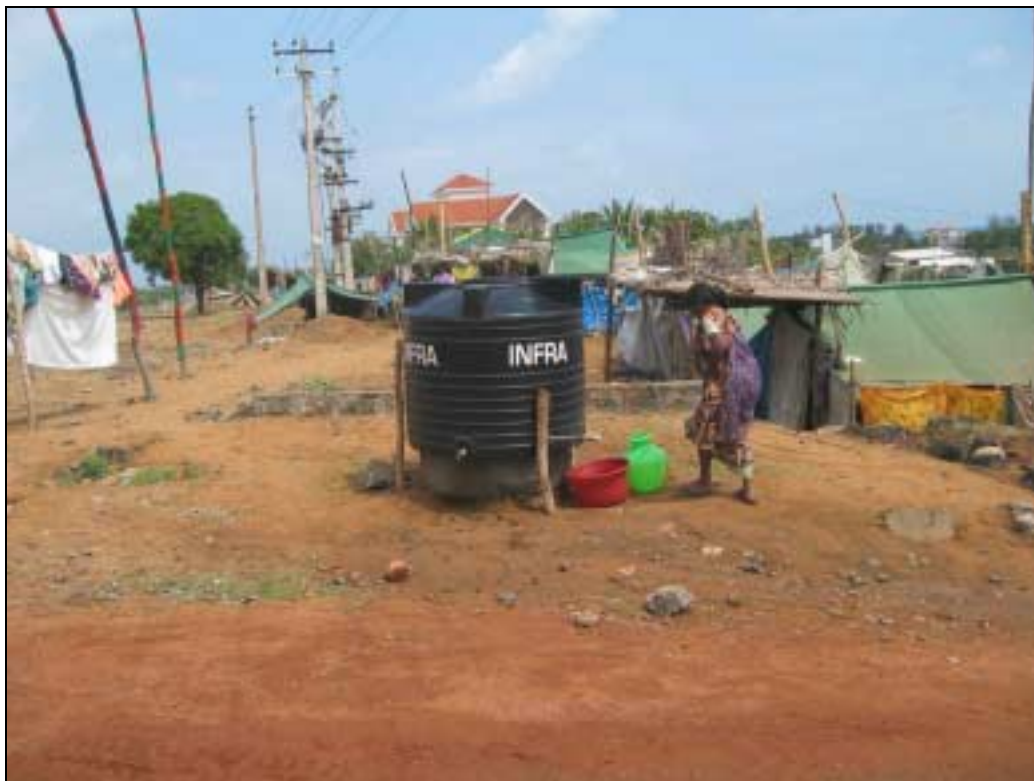
Figure 4. Water Tanks for temporary shelters for victims (Tang)

Ground water is the main source of water supply in this State; new taps were installed almost immediately. However water tanks were also supplied for the villages, particularly in the temporary shelters areas.

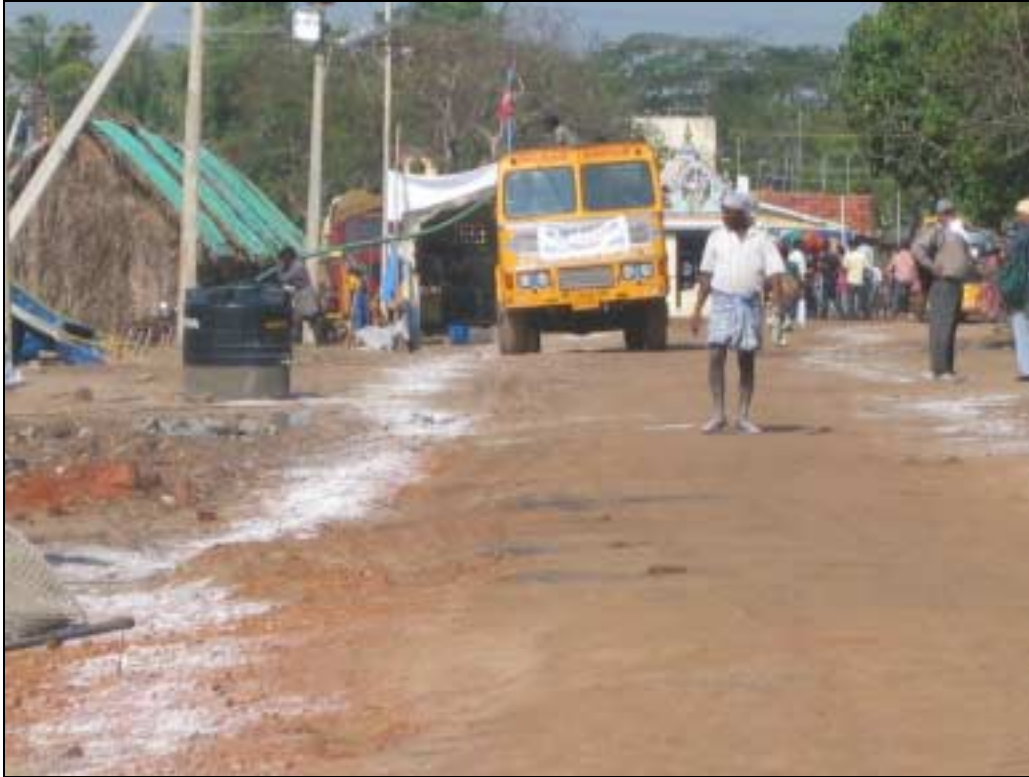
Figure 5. Water truck filling water tanks, the white powder on either side of the road is bleach used to control infection. (Tang)

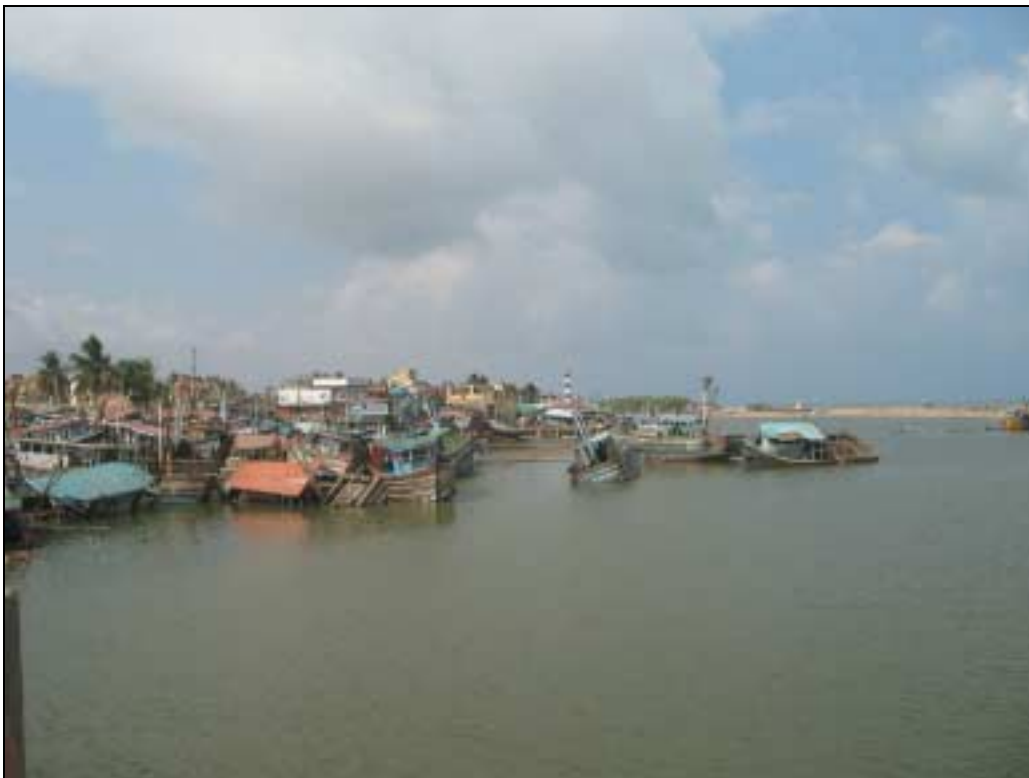
Figure 6. Fishing boats damaged by tsunami (Ames)

Due to factors such as fear, cost of fishing boat and fishing net repair during our visit, no fisherman is going out to the sea. Almost all wholesale fish markets were damaged by the tsunami. The Central Government through the Relief and Rehabilitation Office is taking applications from the victims to help them to finance repairs (loan and grant).

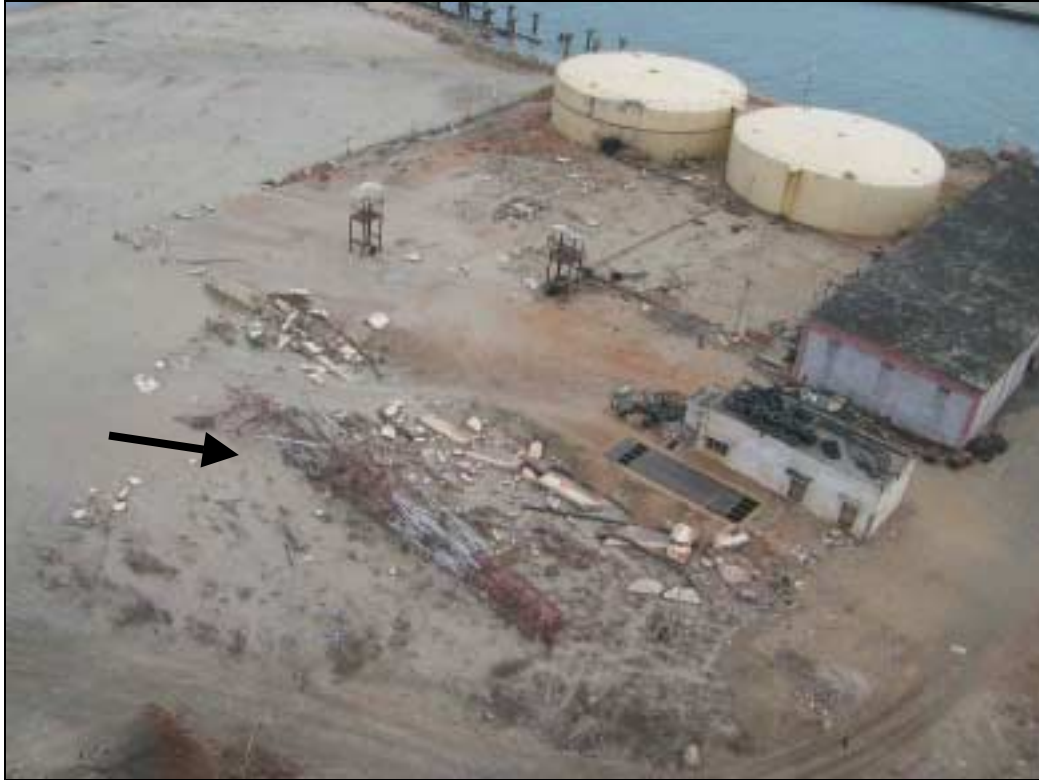
The damage structures of small port in Nagapattinam for cooking oil storage and fishing boats were quite extensive. A telecommunication tower was collapsed by the tsunami; it also took down the electric power cable and poles.

Figure 7. Collapsed telecommunication tower as a result of tsunami (Tang)

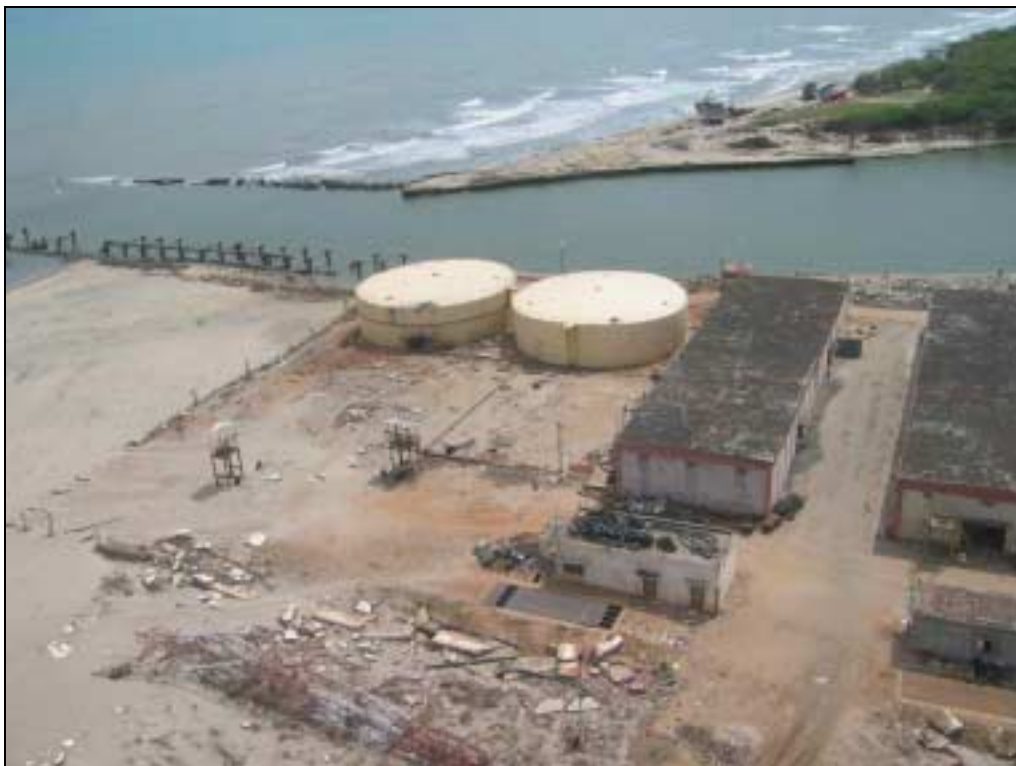
Figure 8. Damaged pier – for loading cooking oil to the tanks (Tang)

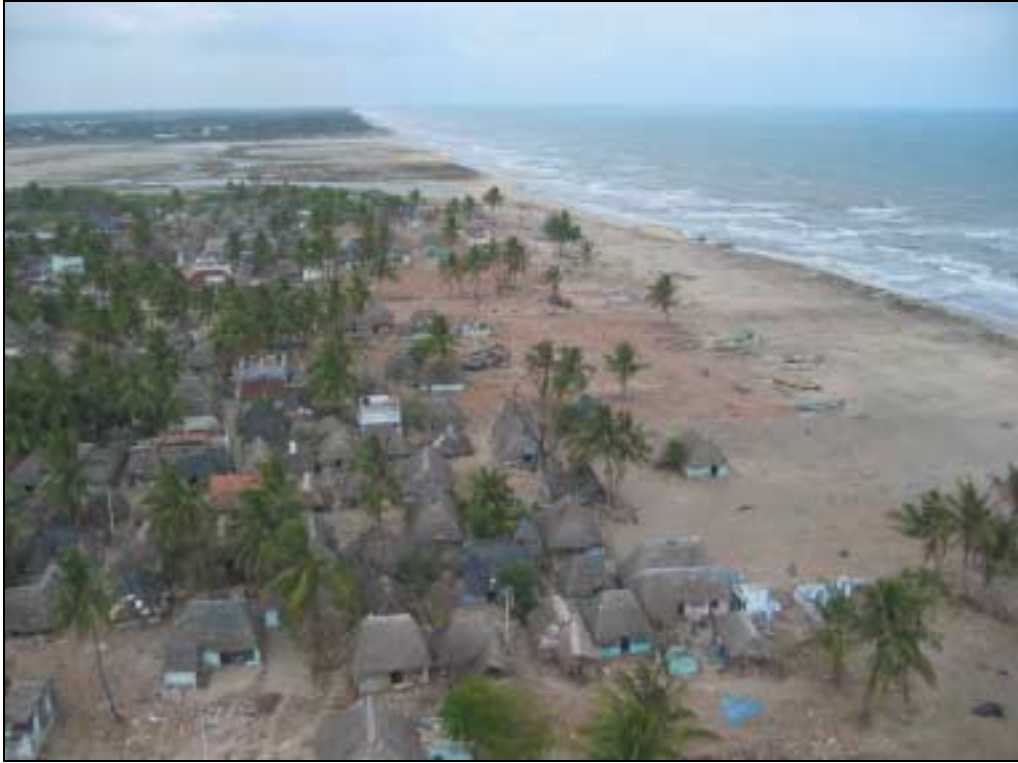
Figure 9. The village in Nagapattinam – the houses/huts close to the waterfront were wiped out by the tsunami (Tang)

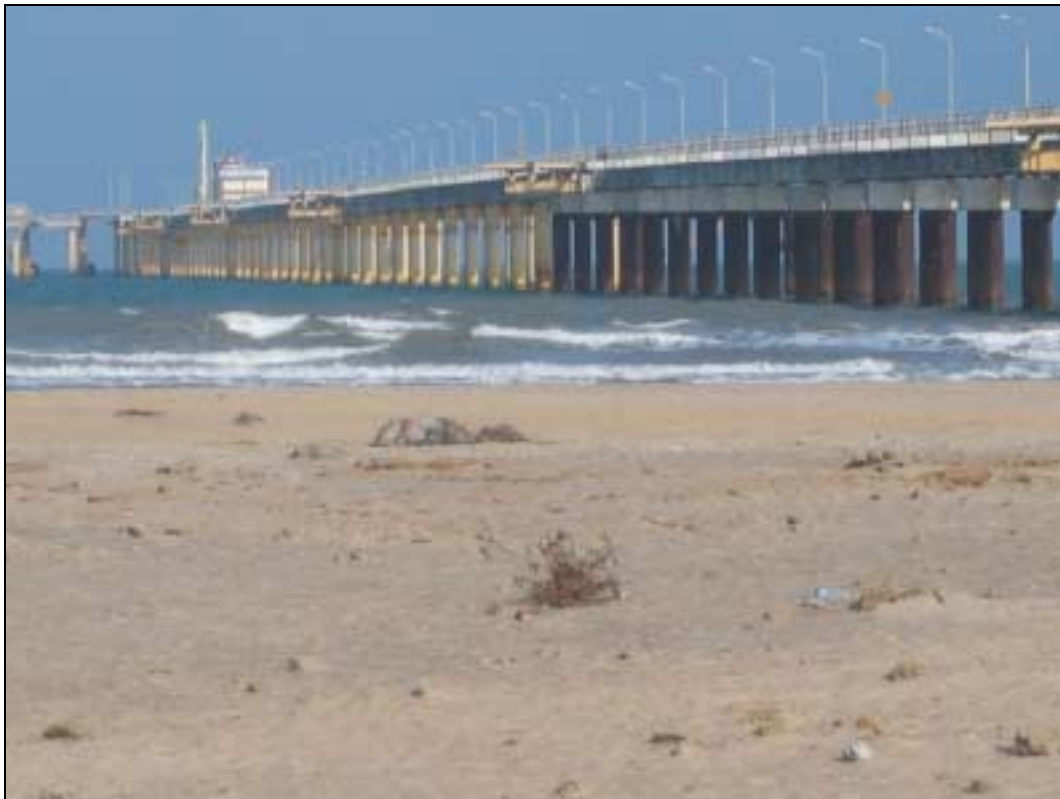
Figure 10. A well-built pier for unloading oil and gas from tankers. (Ames)
