Dr. Gerhard Berz,* Geophysicist
Ekkehard Hettler, Engineer

Munich, March 1981

Earthquakes in Greece, February/March 1981

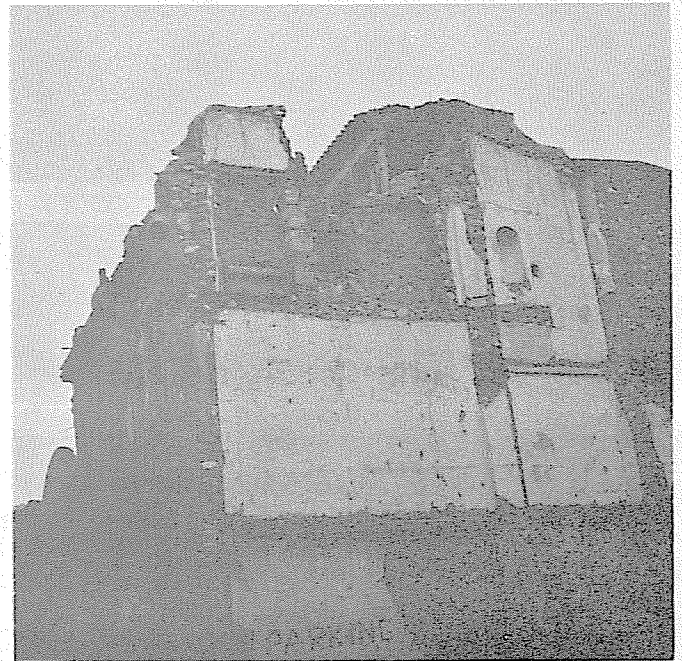
3: Earthquake damage in Athens was only slight.

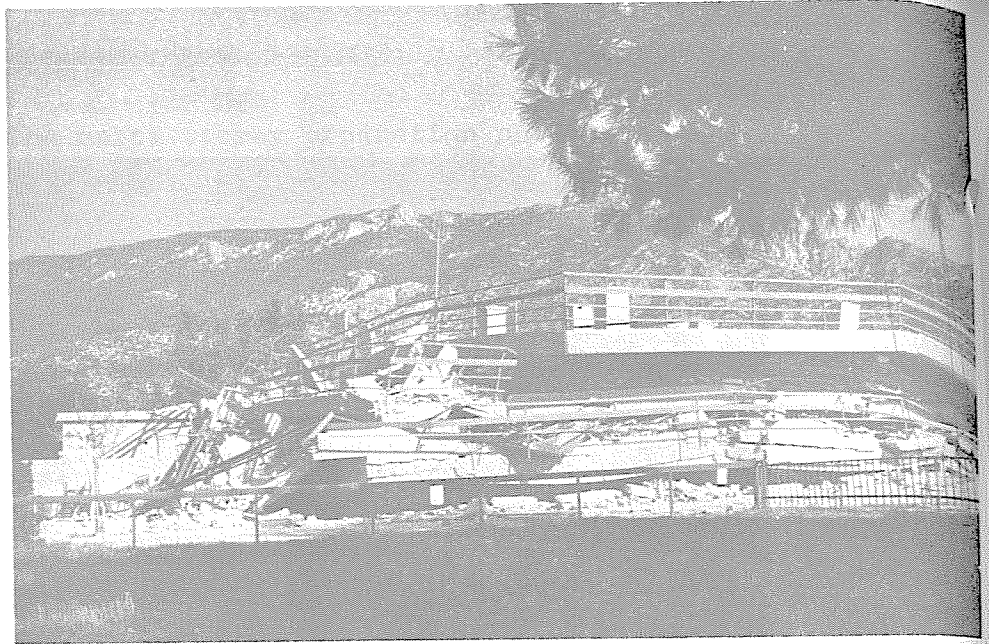
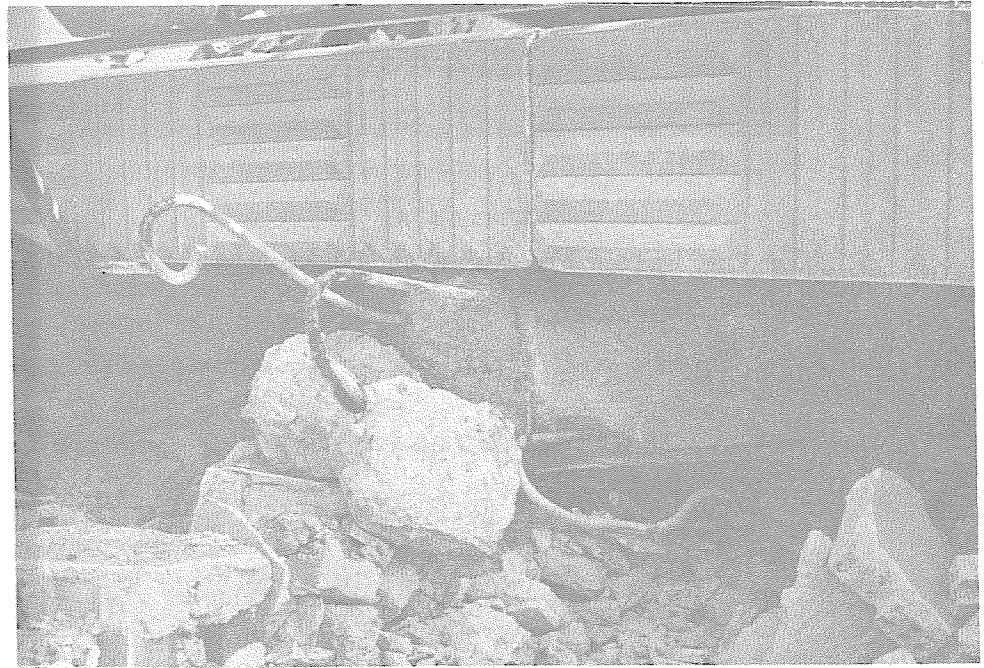
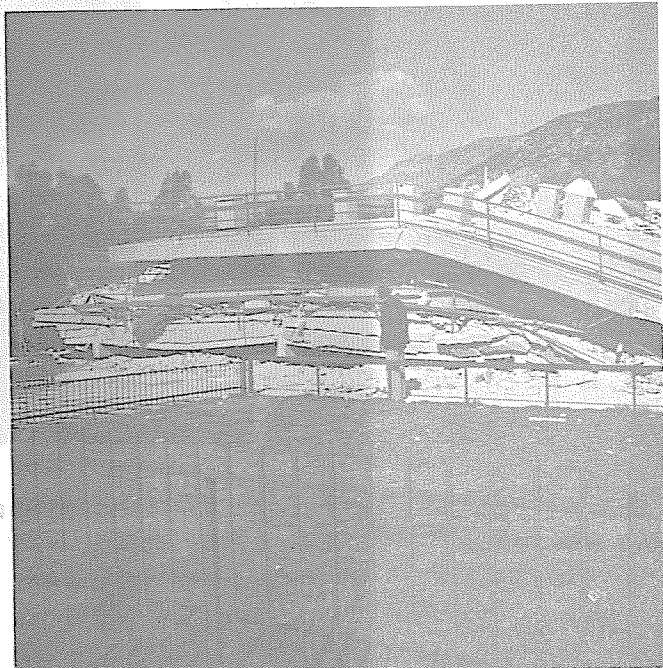
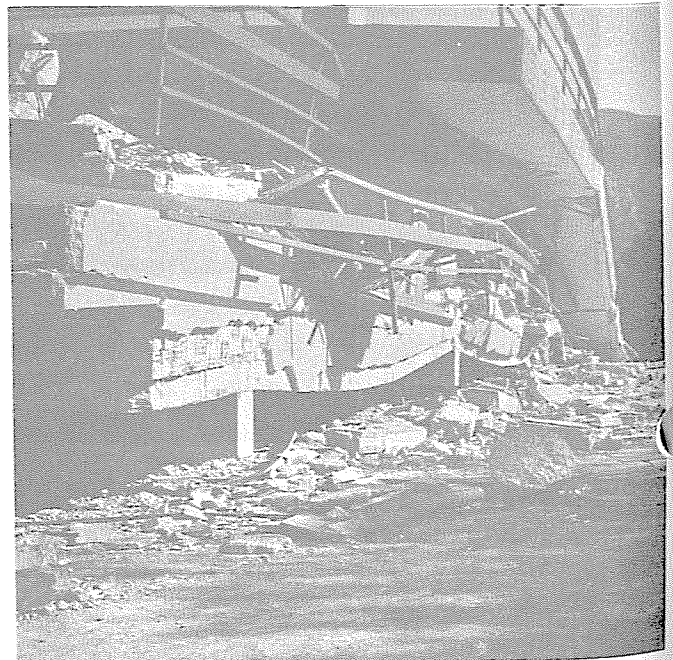
4 - 7:

This picture shows a collapsed hotel approximately 40 km west of Athens. The two upper storeys had been built onto the ground floor after its completion.

In view of the weight of the ceiling, the number of columns was too small. The soft sediment subsoil probably strengthened the seismic movements.

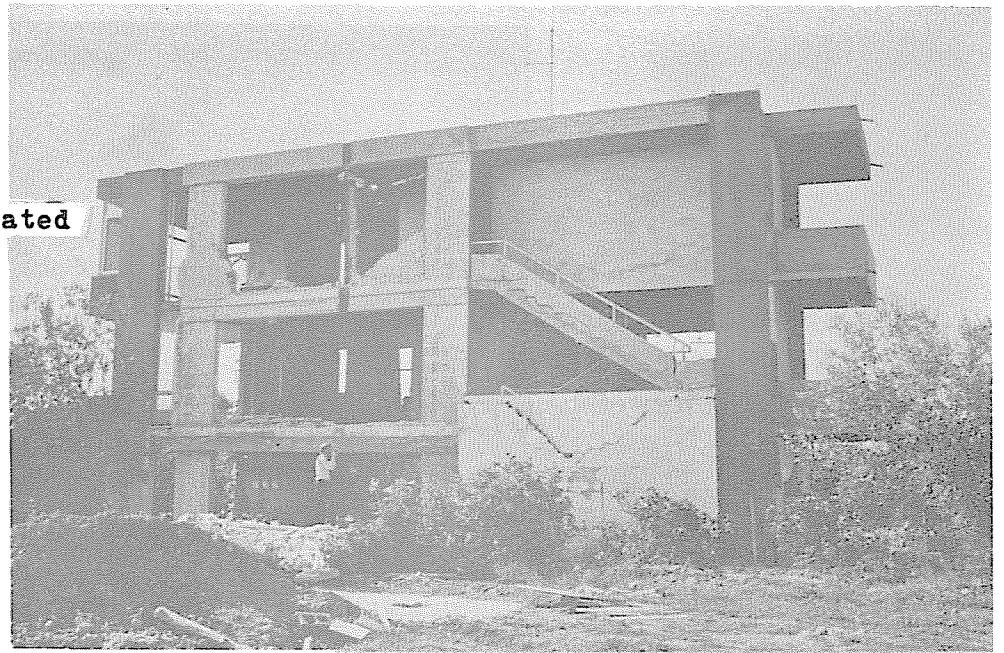
8: This reinforced-concrete frame construction oscillated strongly, causing serious damage to the non-load-bearing walls and to the stairs.

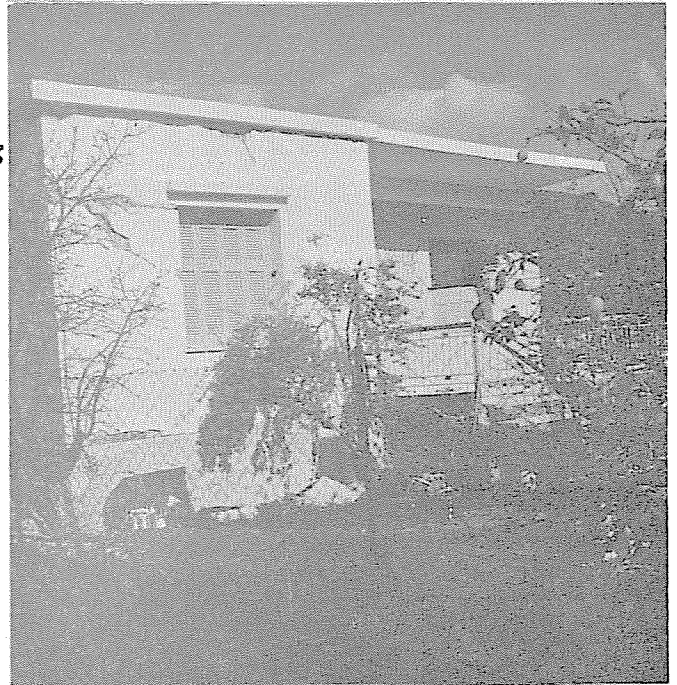
9: This brick building without frame construction cracked in many places.

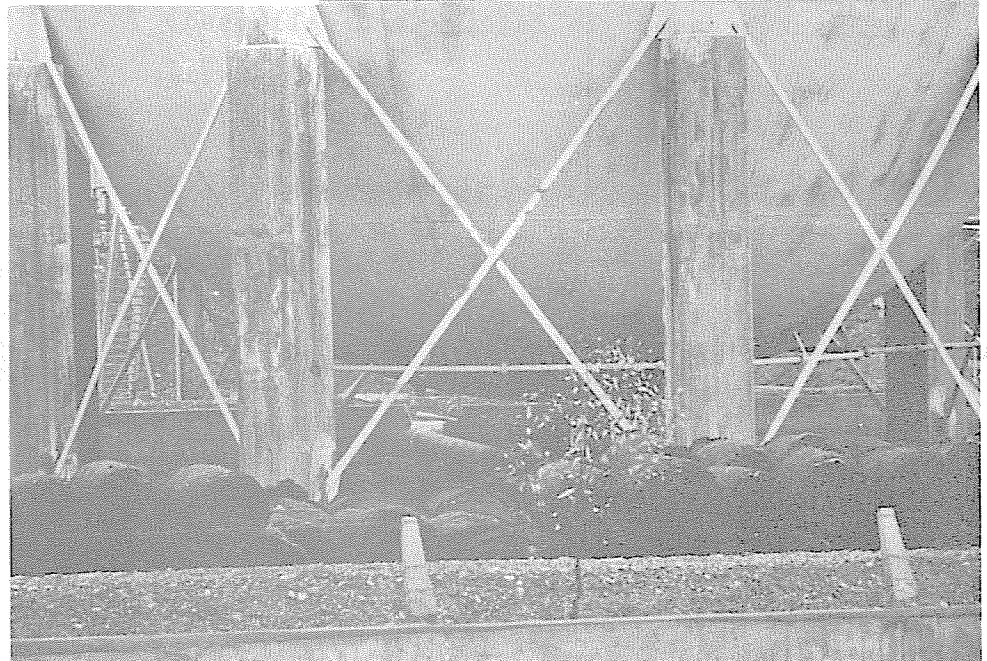
10: In the "Motor Oil Hellas" refinery near St. Theodori, the foundations and supporting columns of two spherical LPG tanks were damaged.

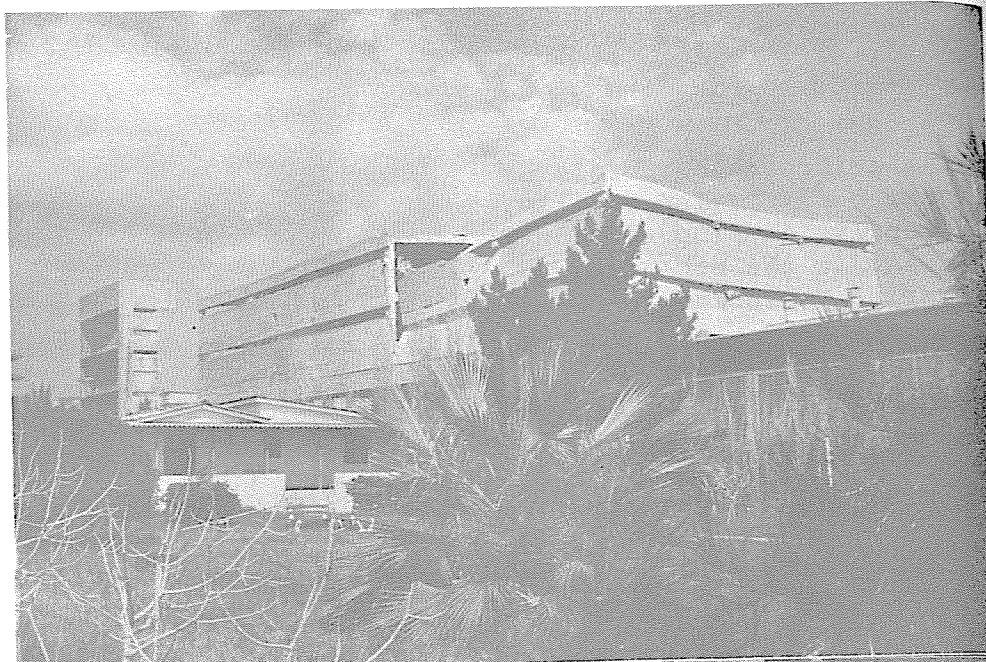
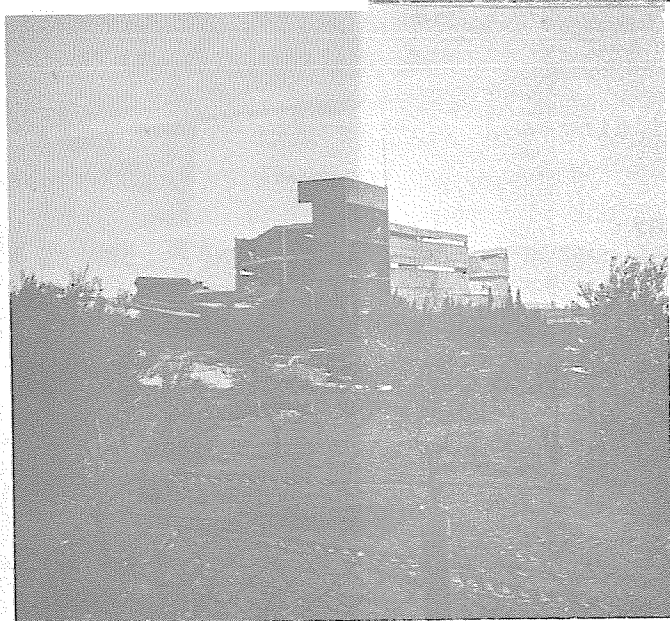
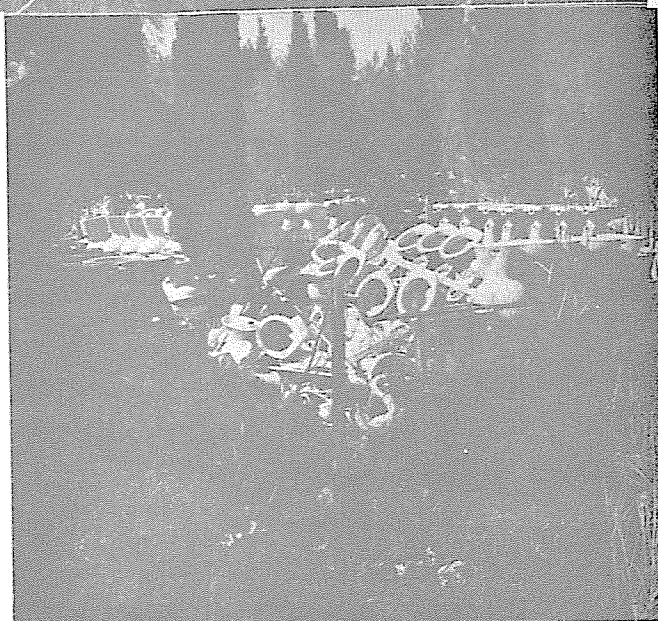
11 - 13: Large parts of the production shed and the open-air store of a ceramics factory near the Isthmus had collapsed.

substantially greater: The multi-storey production shed of a factory that manufactures ceramics for sanitary purposes collapsed; the open-air store was also heavily hit. One plant belonging to Landis & Gyr, a Swiss enterprise that manufactures counting, metering, regulation and control equipment, suffered much damage, especially in the non-loadbearing masonry and in a double-wall facade built for insulation purposes, whereas a newly built reinforced-concrete shed with walls filled with concrete hollow tiles, bonded wooden beams and an insulated plate roof survived the quake more or less unscathed.

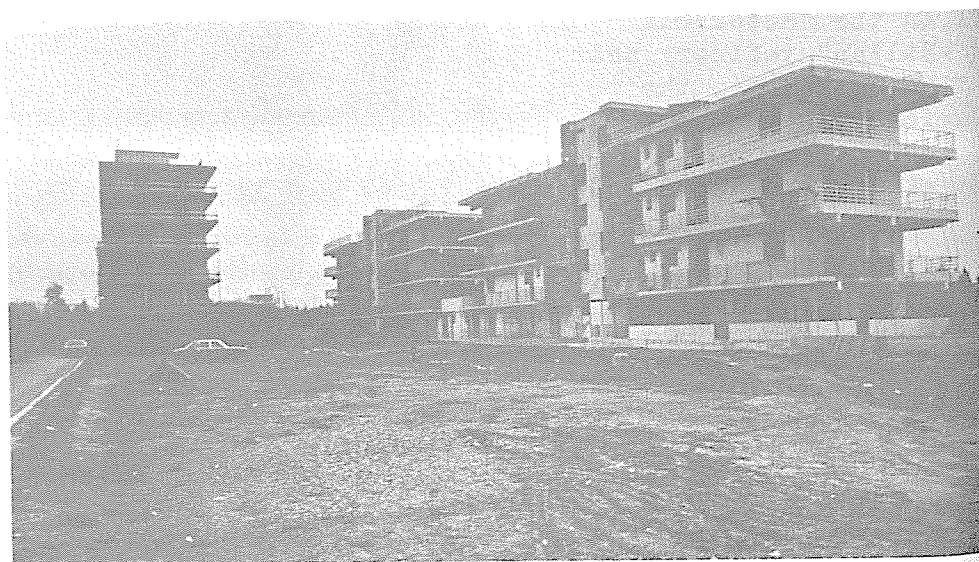
14: This building with holiday flats on the Bay of Loutraki was severely damaged but could still be lived in.

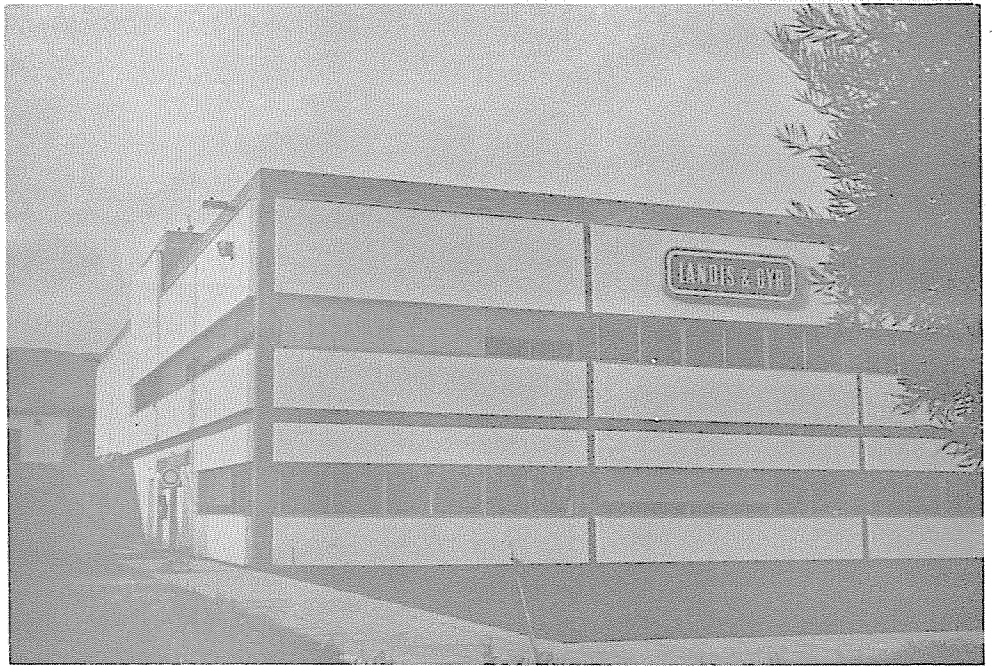
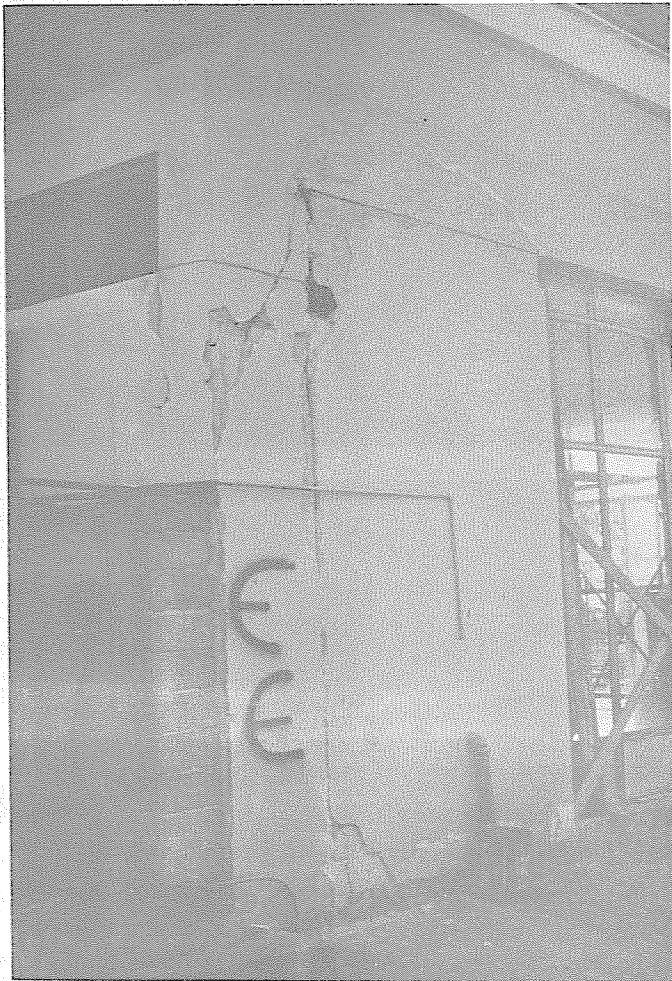
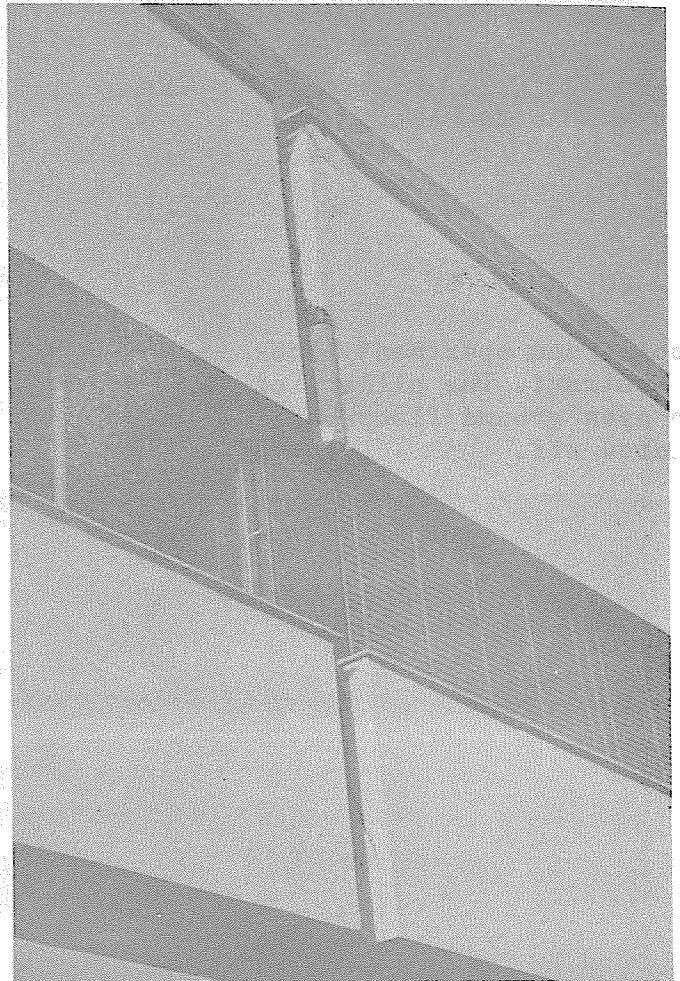
15 - 17: The reinforced-concrete frame, its brick filling, and the brick façade of this building belonging to Landis & Gyr, manufacturers of counting, metering, control or regulation equipment, were severely damaged.

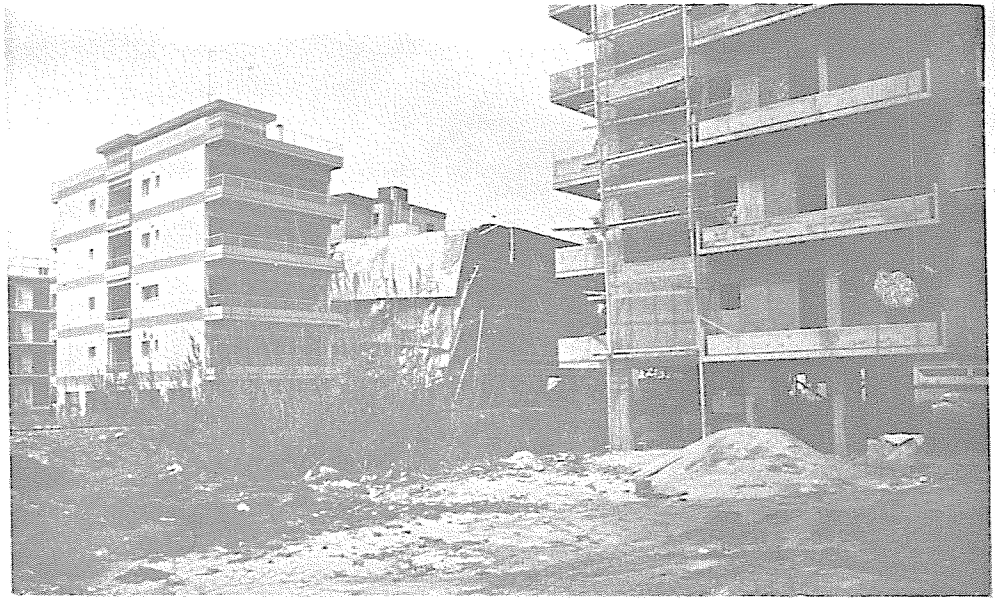
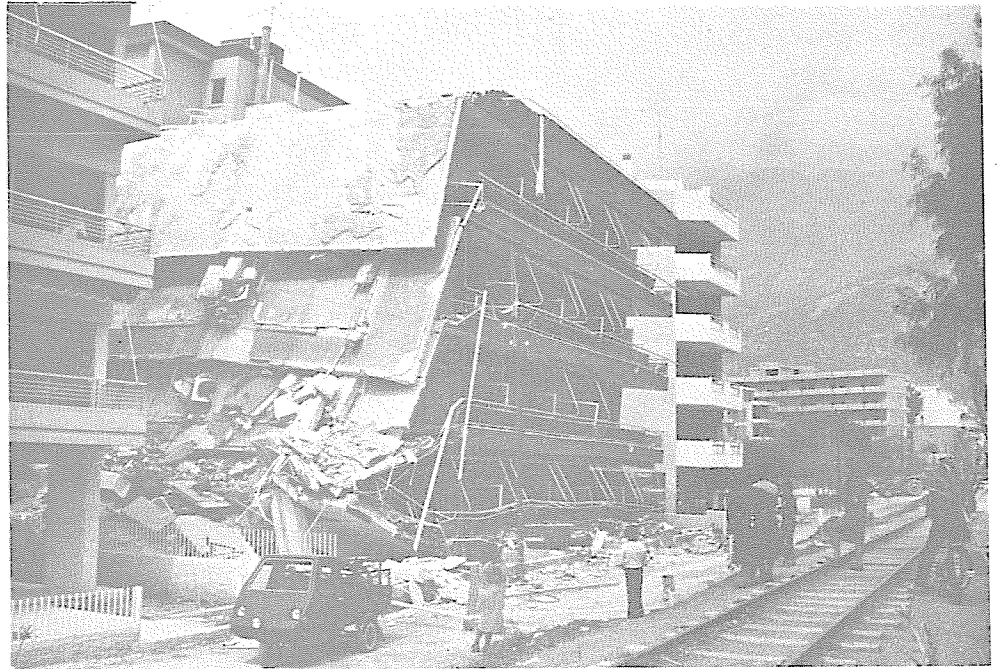
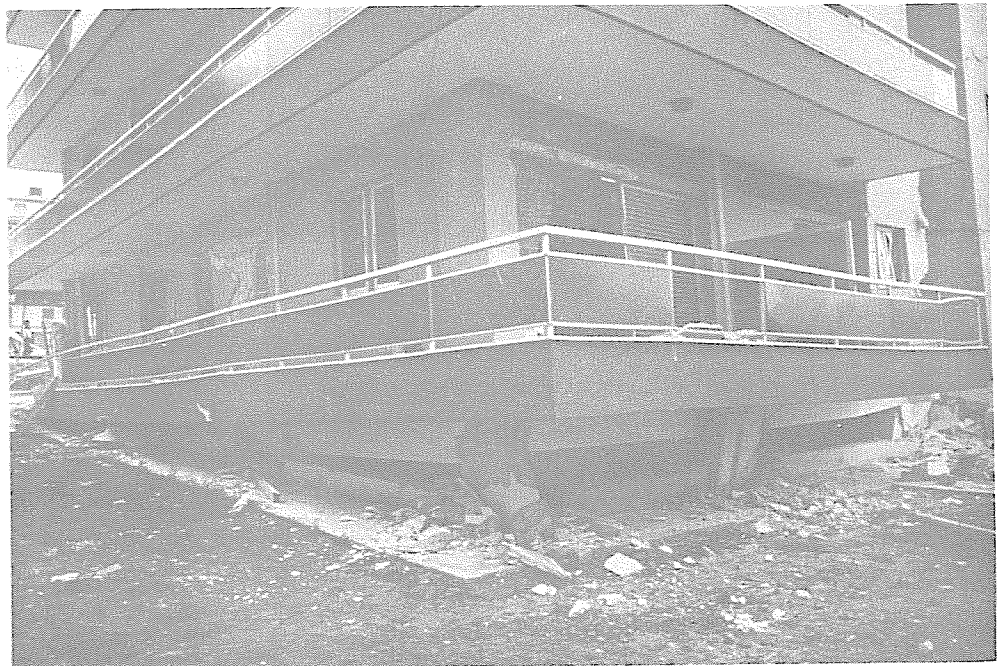
18 - 20:

A collapsed apartment block in Loutraki. The pillars of the open ground floor had snapped off.

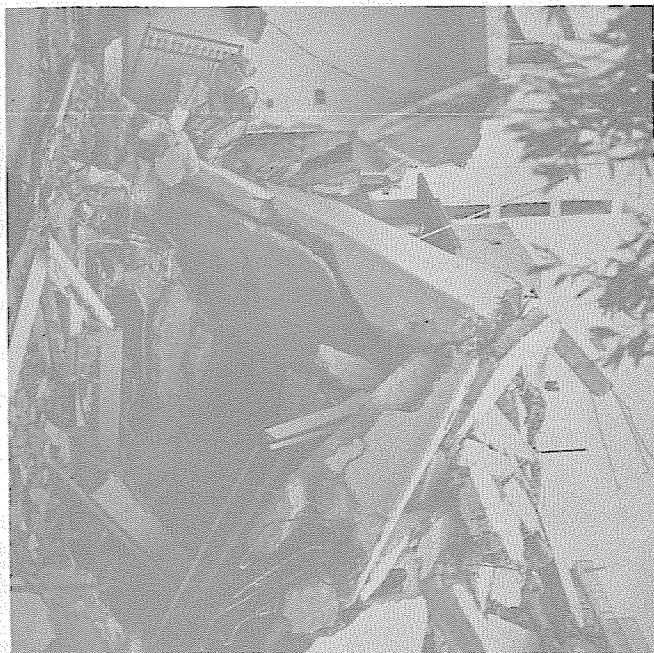
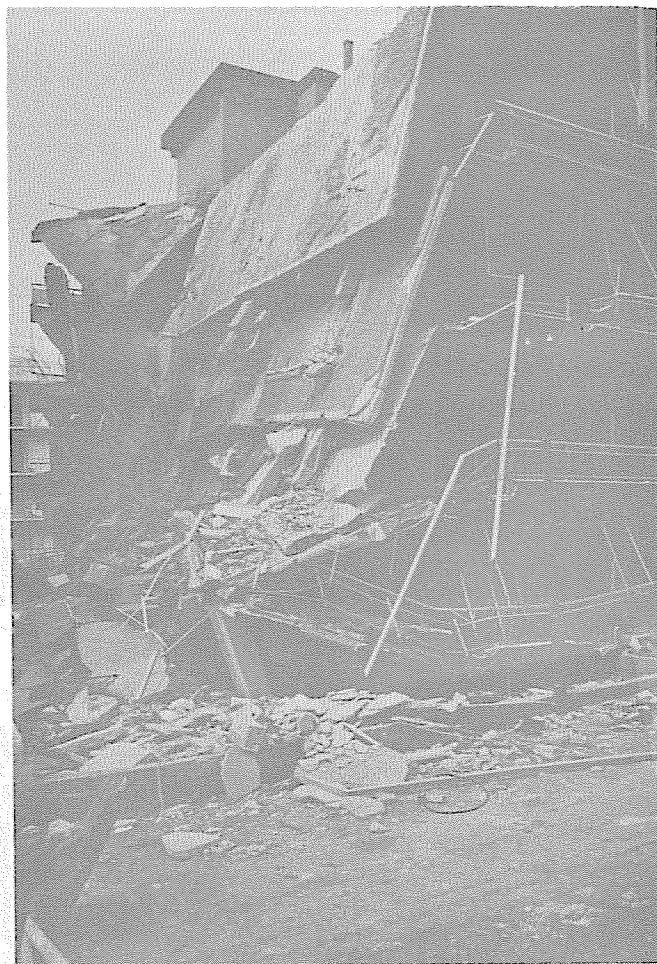
22 . 23:

21: One section of the building
had collapsed completely.

The collapsed hotel 'Contis'
in Loutraki.

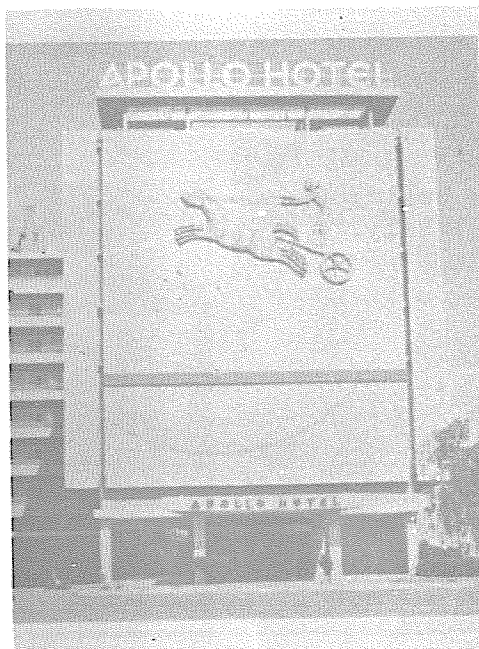
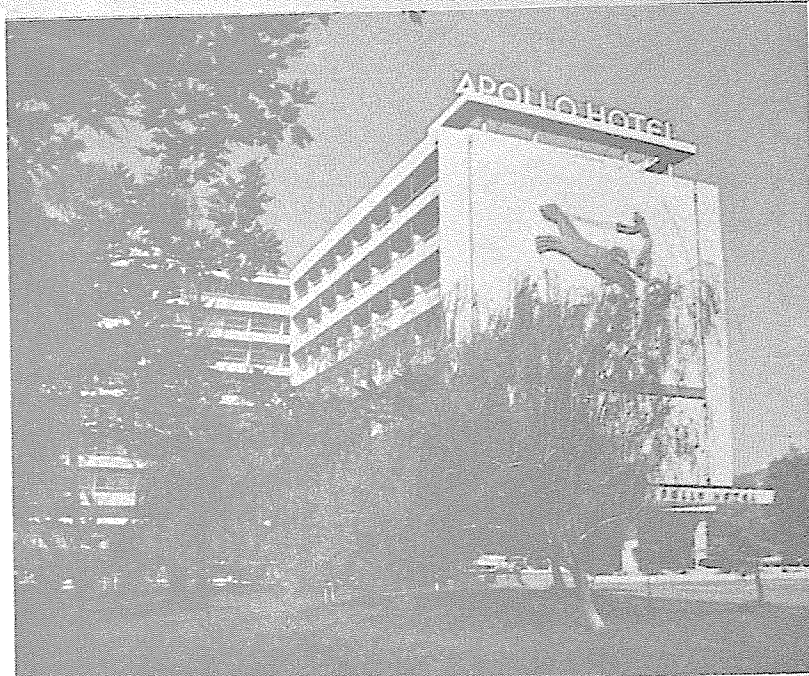
24 - 26:

The 8-storey "Apollo" hotel in Loutraki was razed to the ground.

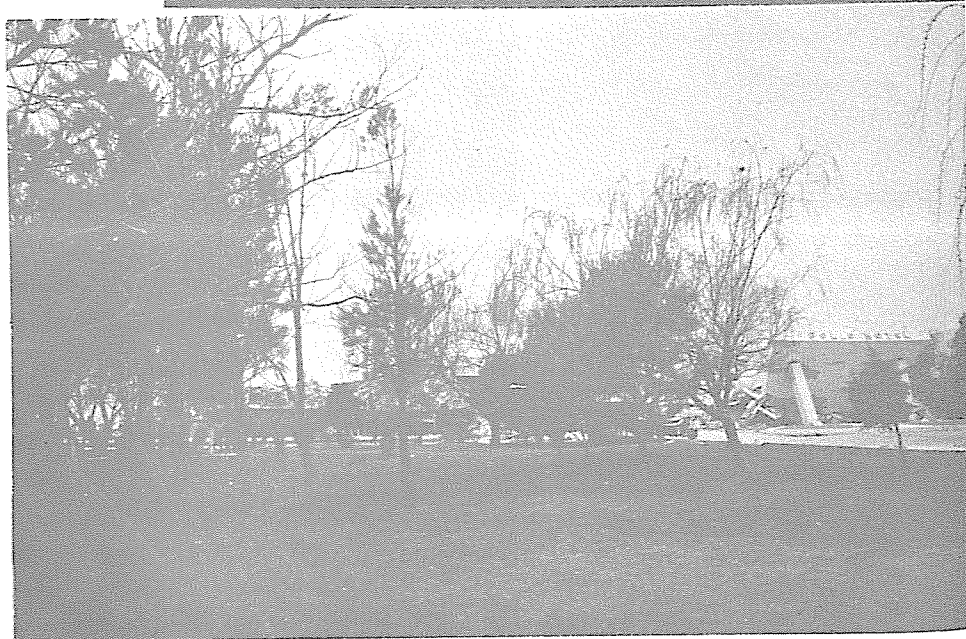
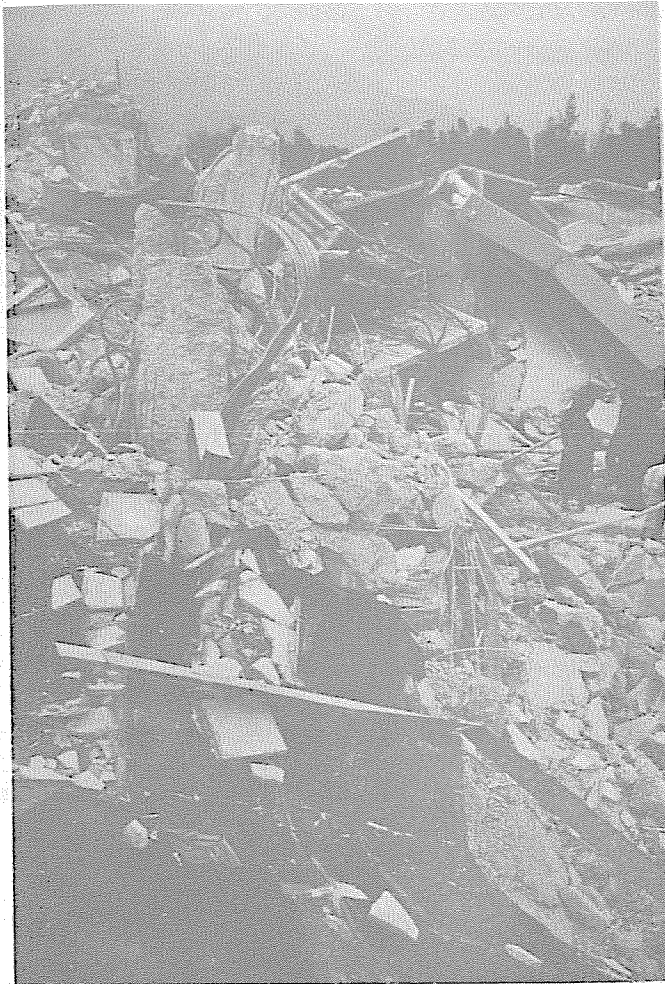
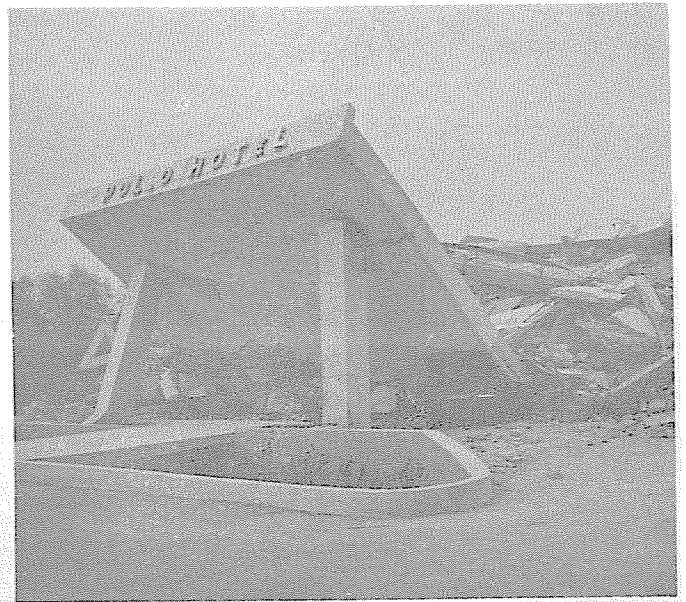
27 - 29:

All that was left of the "Apollo" hotel.

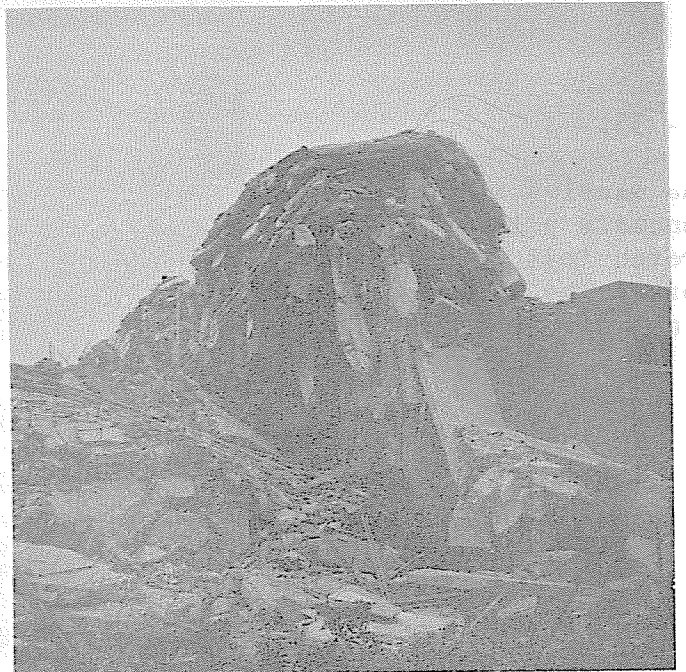
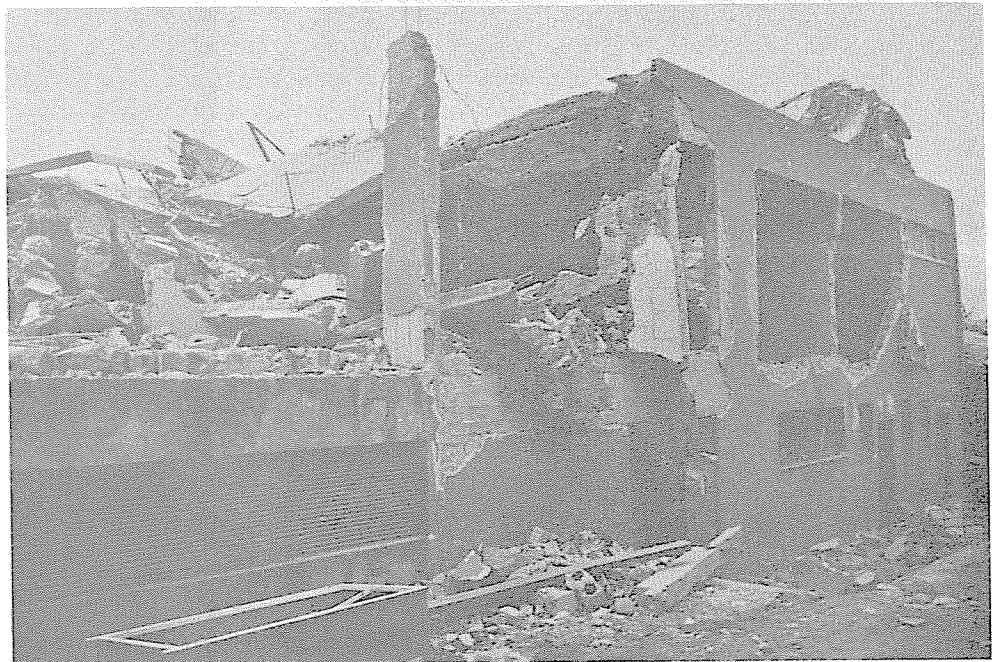
30: The design of the reinforced-concrete pillars is in some cases completely inadequate.

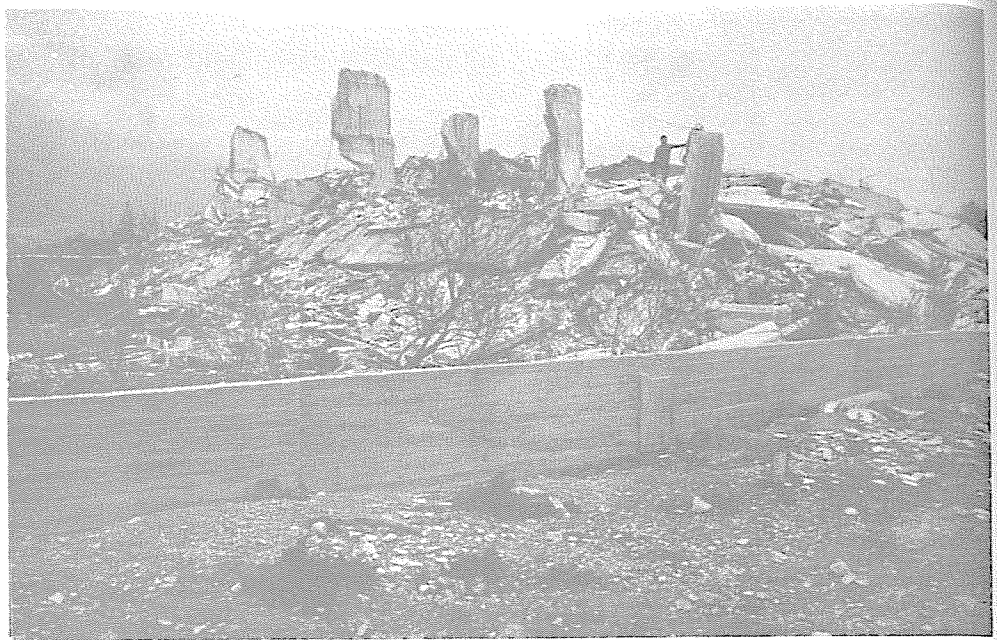
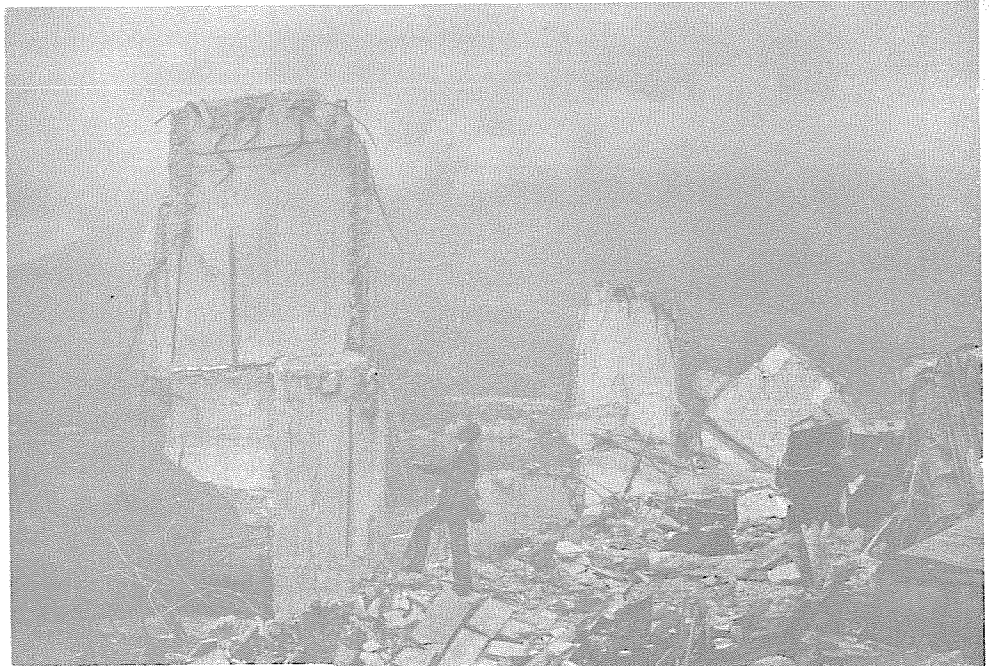
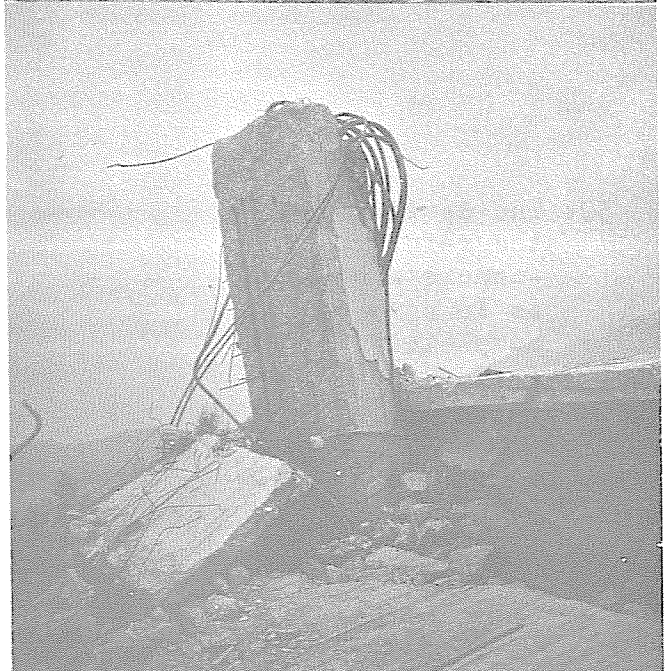
31 - 33:

Some massive reinforced-concrete pillars only stretch into the second storey. The reinforcement is not tied properly.

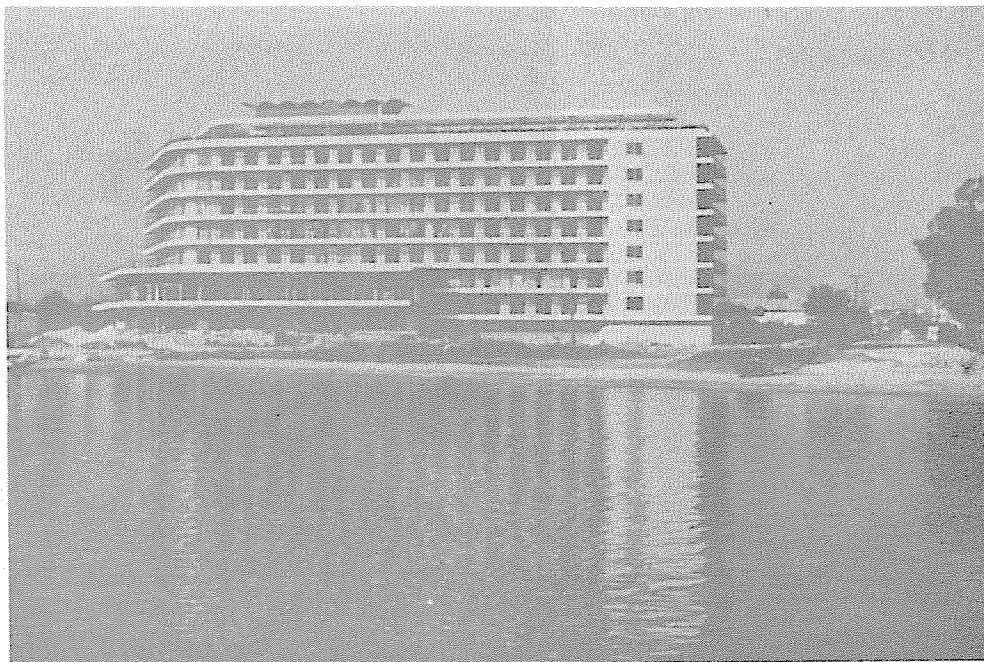
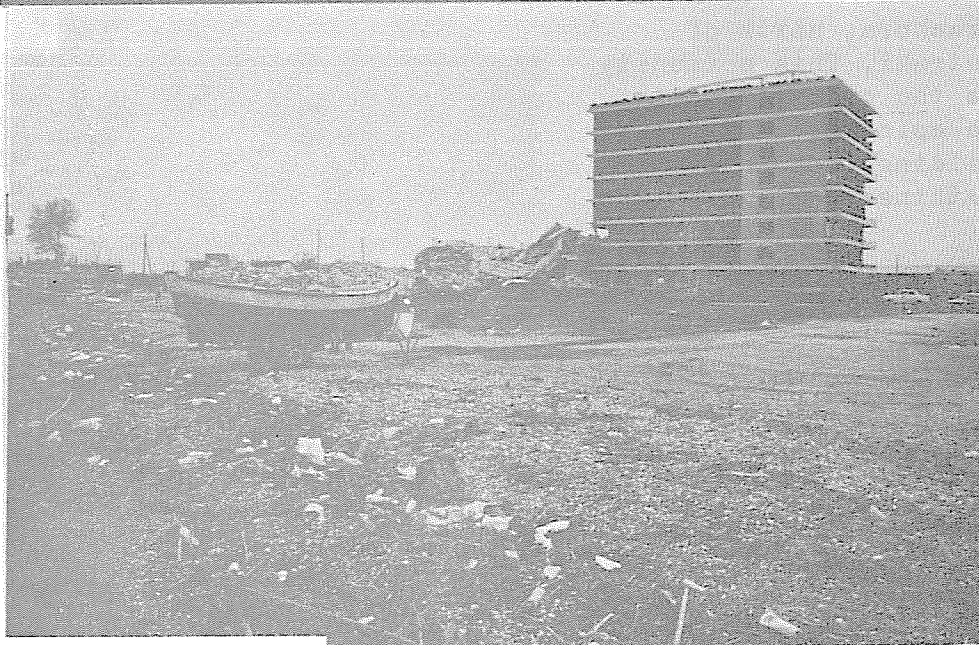
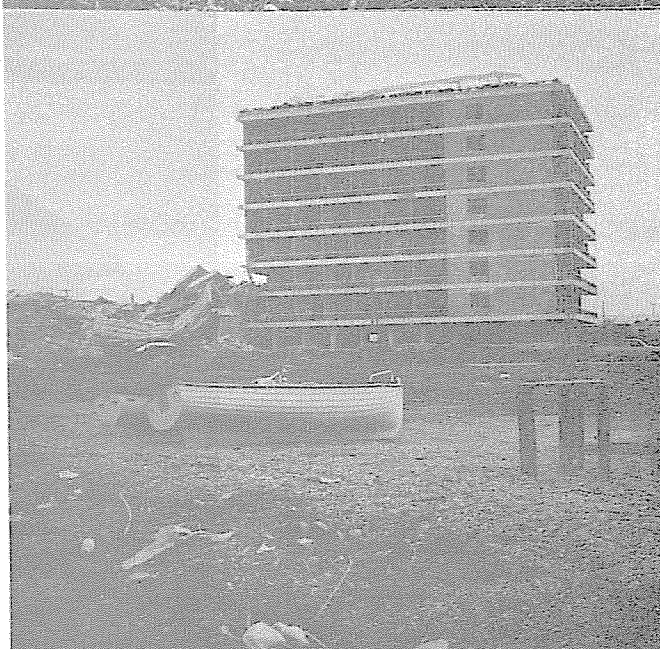
34 - 36:

Half of this hotel west of Corinth, which had only just been completed, collapsed. Shops and restaurants were situated in the first two storeys of this section.

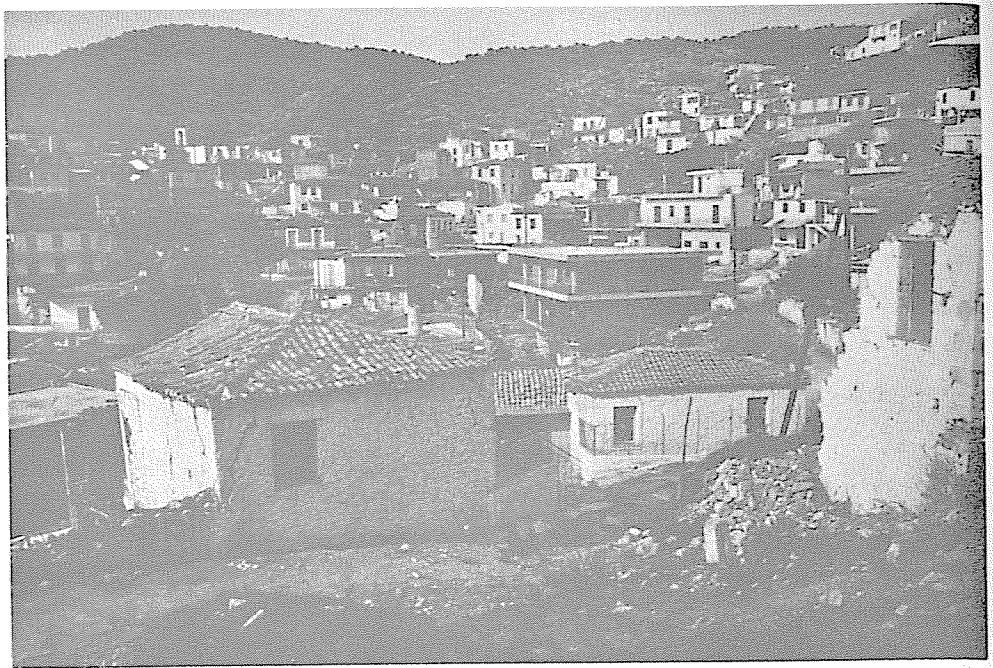
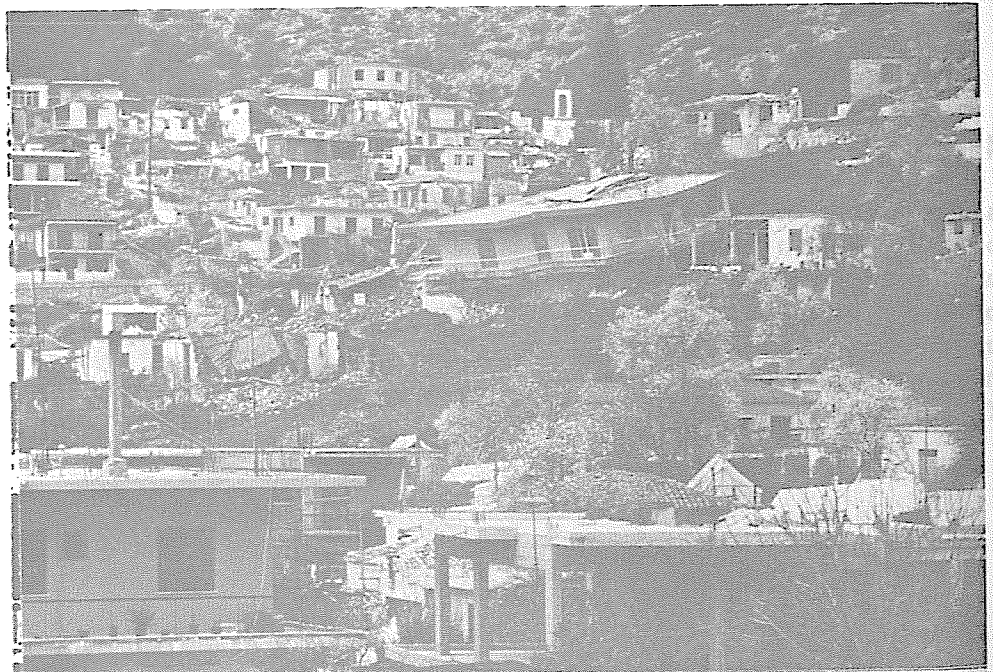
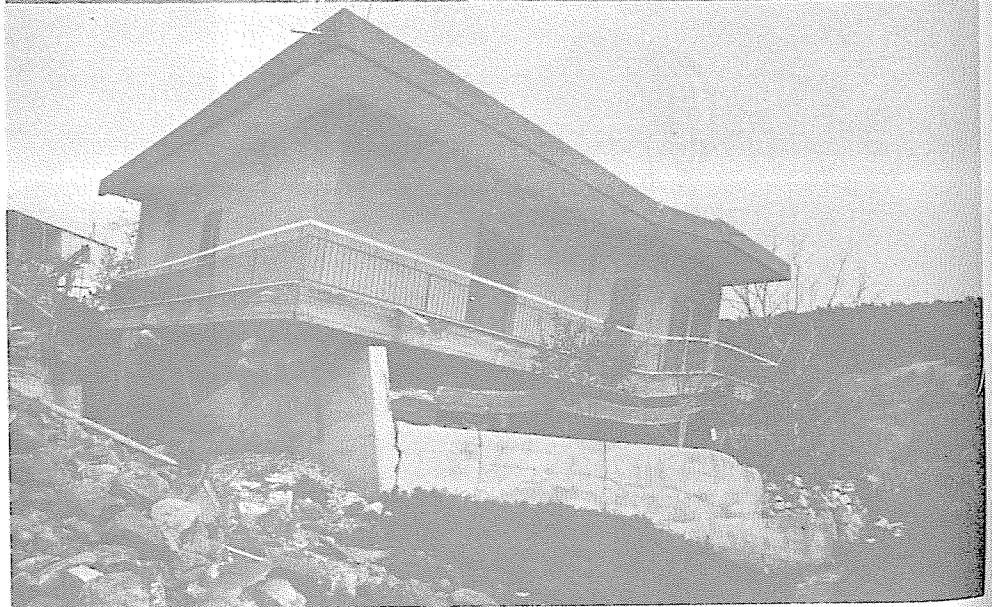
37 - 39:

Perachora, north of I utraki. This community was the one nearest to the epicentre. Numerous buildings collapsed or sustained serious damage.

No liquefaction was observed, but there was settlement in reclaimed land, and the quake also caused landslides. The latter led to fairly severe damage to buildings, particularly in Perachora, which is situated in mountainous terrain.

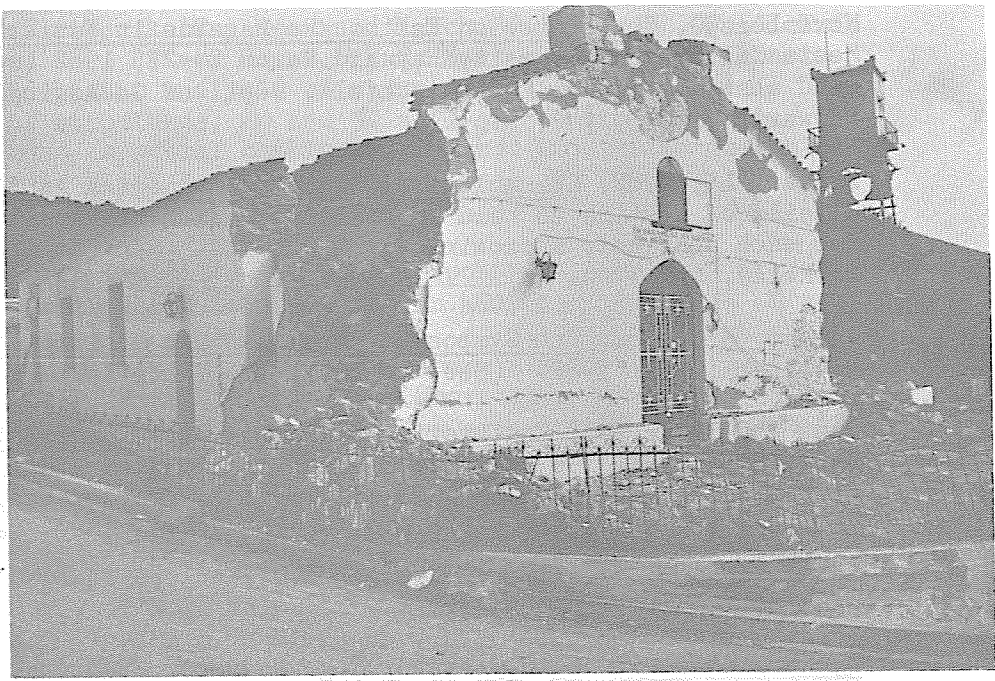
40: Again Perachora.
This church of quarry
stone collapsed.
