# World Housing Encyclopedia Report

Country: Argentina

Housing Type: Traditional adobe house with reinforcement

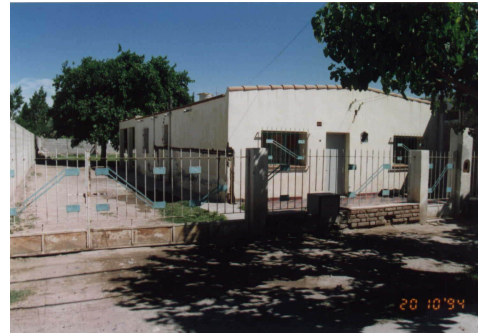
FIGURE 1: Typical Building

This construction type is a single-family house. In general, it is a single-story building, an isolated construction found in the rural areas of San Juan and Mendoza. The traditional adobe block masonry walls are reinforced with foundations and plinth structure, which provide structural strength. A deficiency in this type of construction is that the adobe blocks deteriorate due to prolonged exposure to humidity.

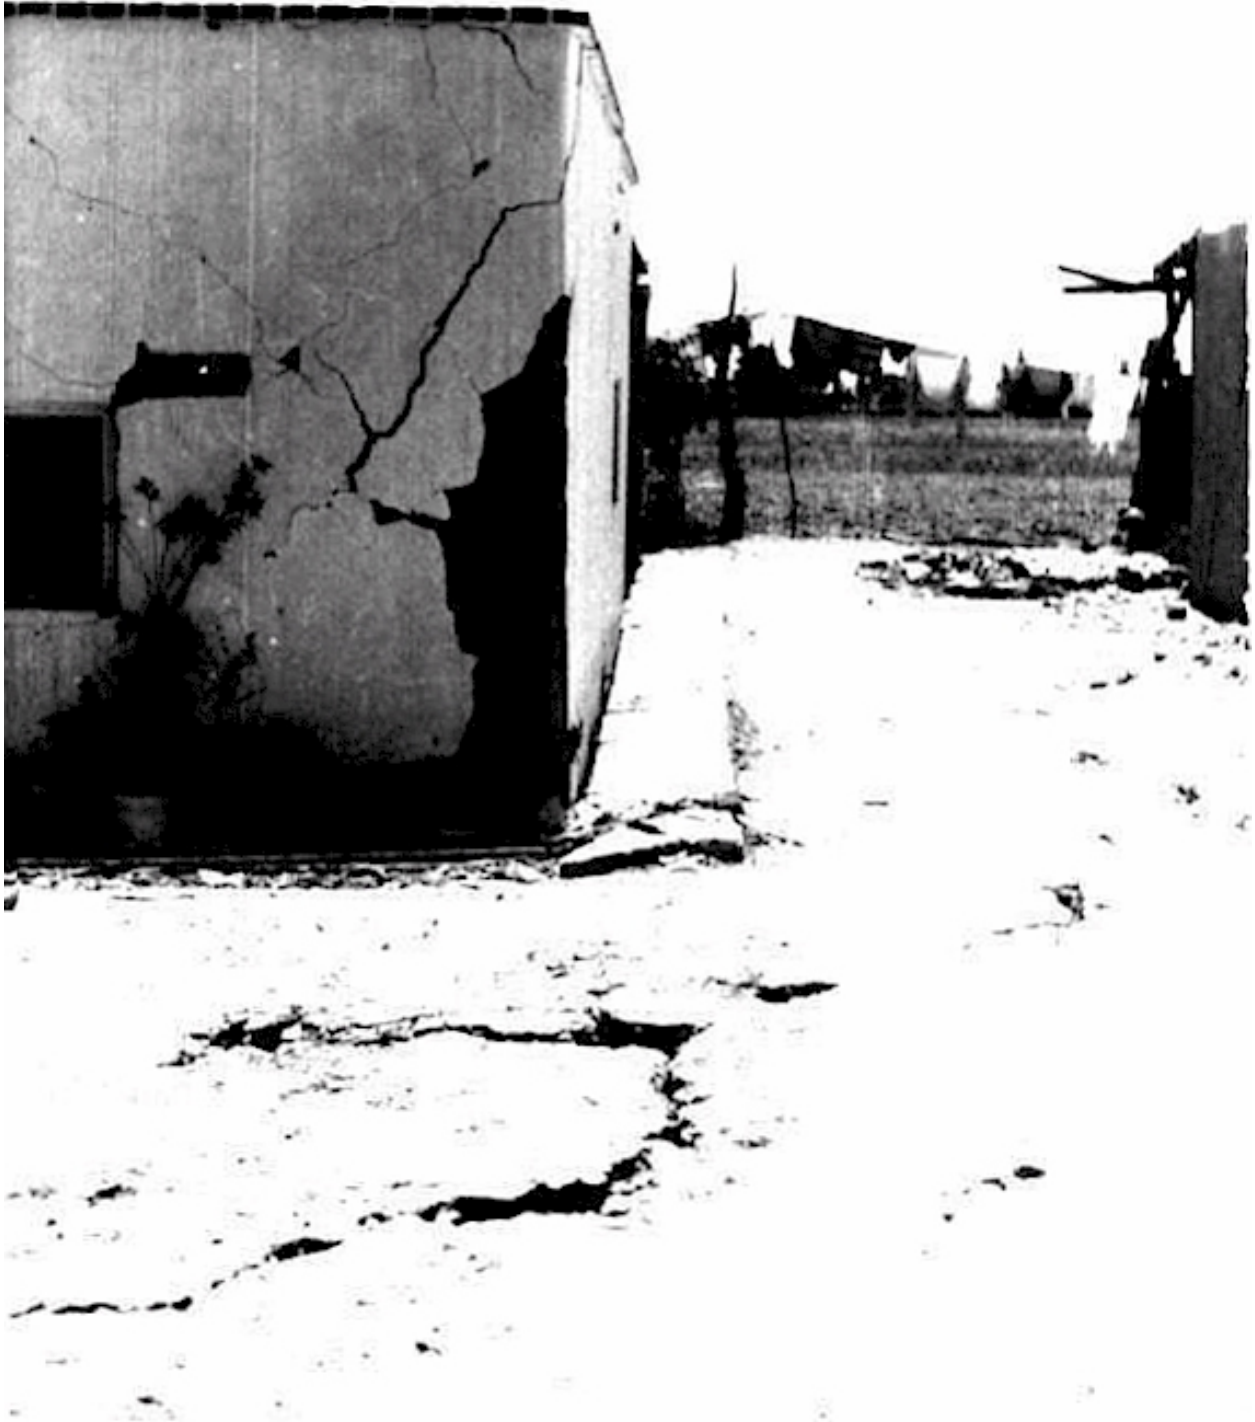
*FIGURE 6A: Photograph Illustrating Typical Earthquake Damage*

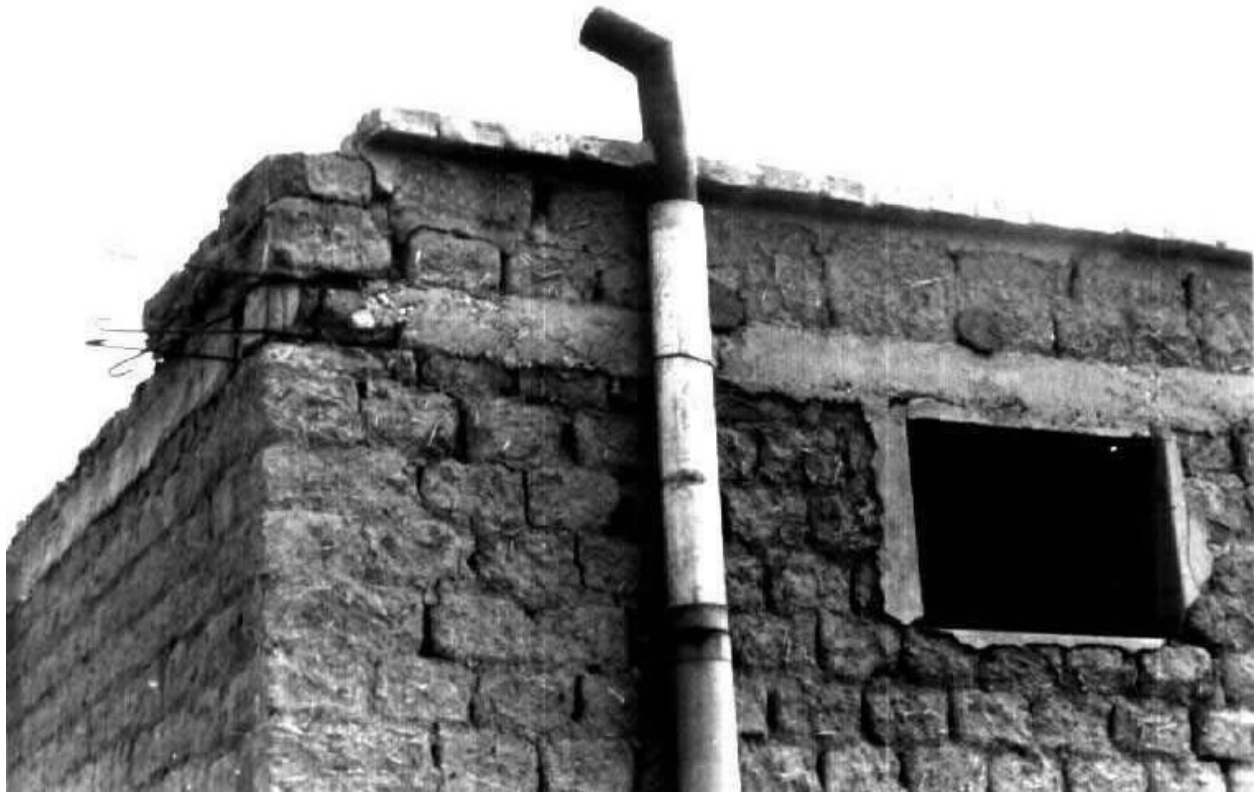
*FIGURE 6B: A Photograph Illustrating Typical Earthquake Damage*
