# Costa Rica Earthquake of April 22, 1991

REPORT RECEIVED APRIL 30.

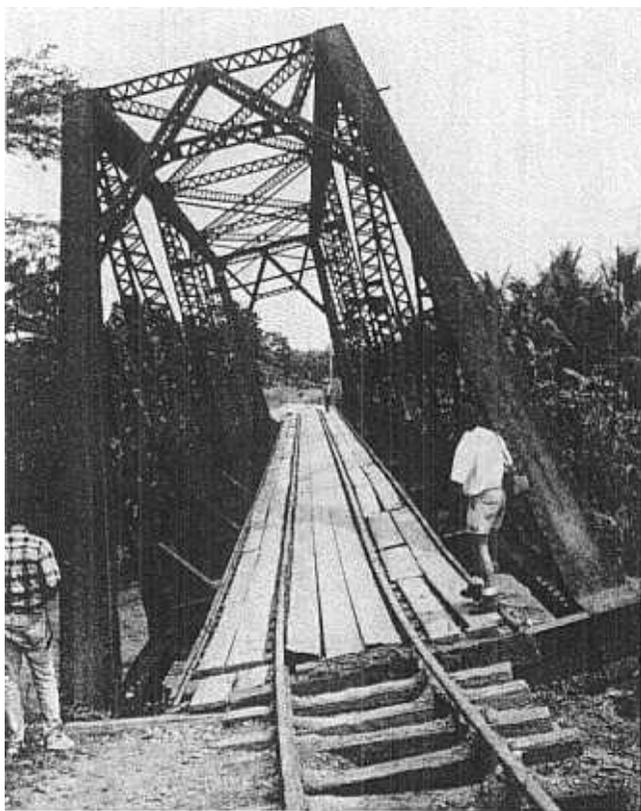
Rail bridge over Rio Bananito Sur showing partial collapse as a result of failure of caissons and support blocks.

The railroad line is a mess, due to settlement and liquefaction

beneath rails, and compression buckling.

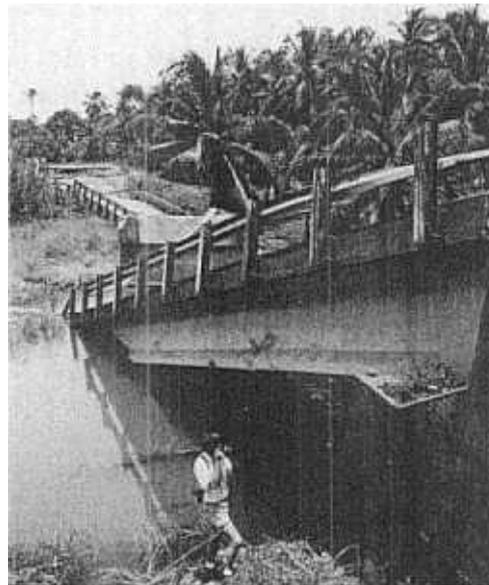
Automobile bridge over Rio Bananito showing two spans which have fallen from center abutment.
