# World Housing Encyclopedia Report

Country: Greece

Housing Type: Multi-story reinforced concrete frame building

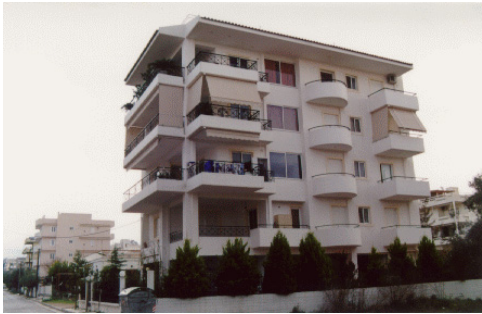
These buildings represent a typical multi-family residential construction, mainly found in the suburbs of Greek cities. This housing type is very common and it constitutes approximately 30% on the entire housing stock in Greece. Buildings are generally medium-rise, typically 4 to 5 stories high. The main lateral load-resisting structure is a dual system, consisting of reinforced concrete columns and shear walls. A relatively small-size reinforced concrete core usually exists, serving as an elevator shaft. The roof and floor structures consist of rigid concrete slabs supported by the beams. Seismic performance of these buildings is generally good, provided that the seismic design takes into account the soft ground floor effects e.g. by installing strong RC shear walls. Failure of the soft ground floor is the most common type of damage for this type of structure. Some buildings of this type were damaged in the 1999 Athens earthquake.

FIGURE 1: Typical Building

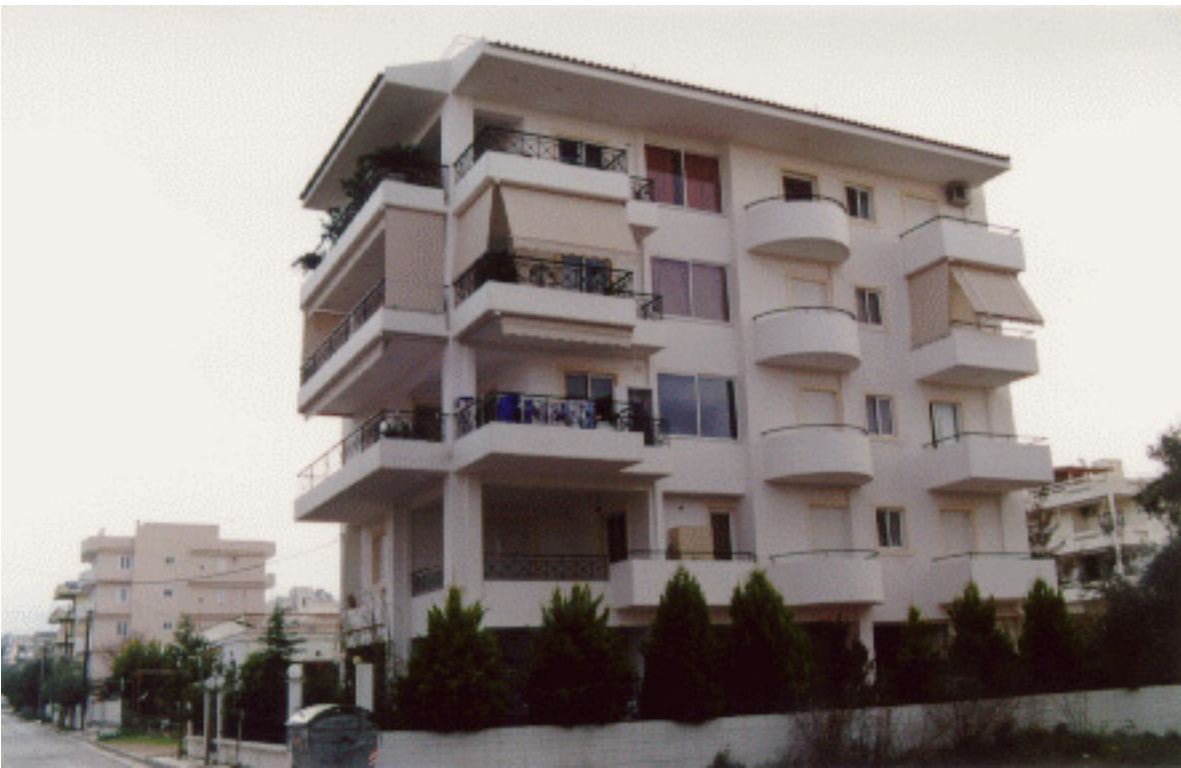
*FIGURE 1: Typical Building*

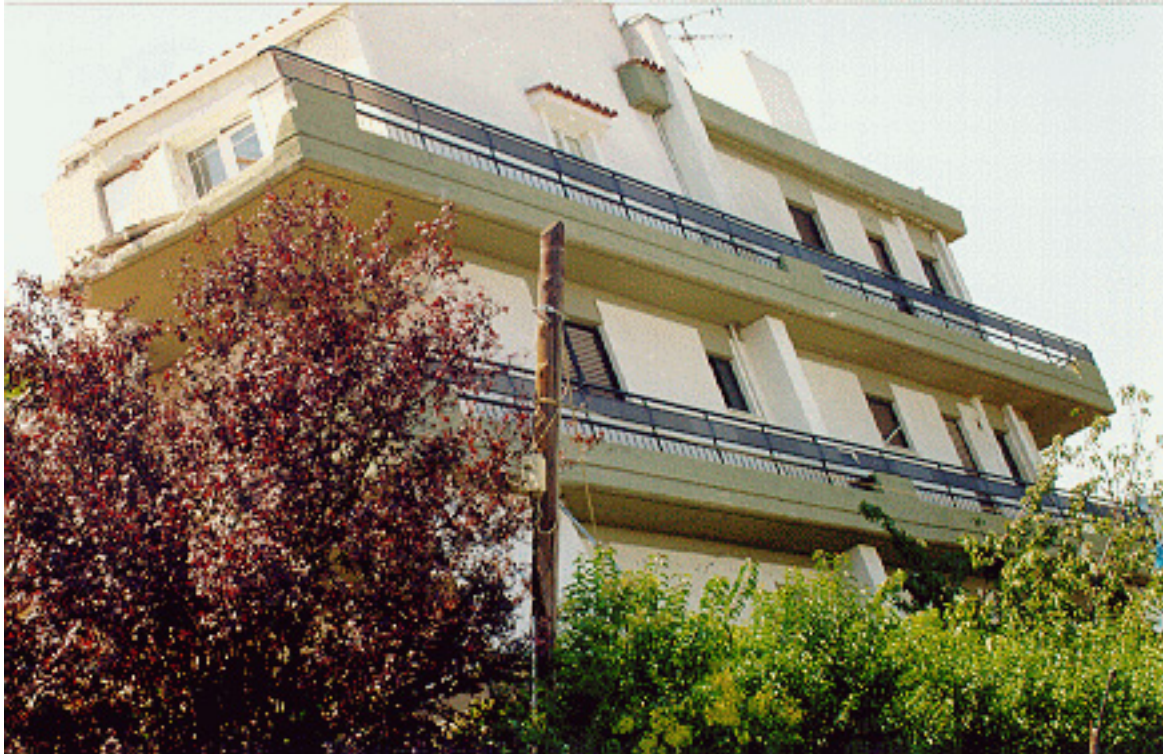
*FIGURE 5A: Typical Earthquake Damage (1999 Athens earthquake)*

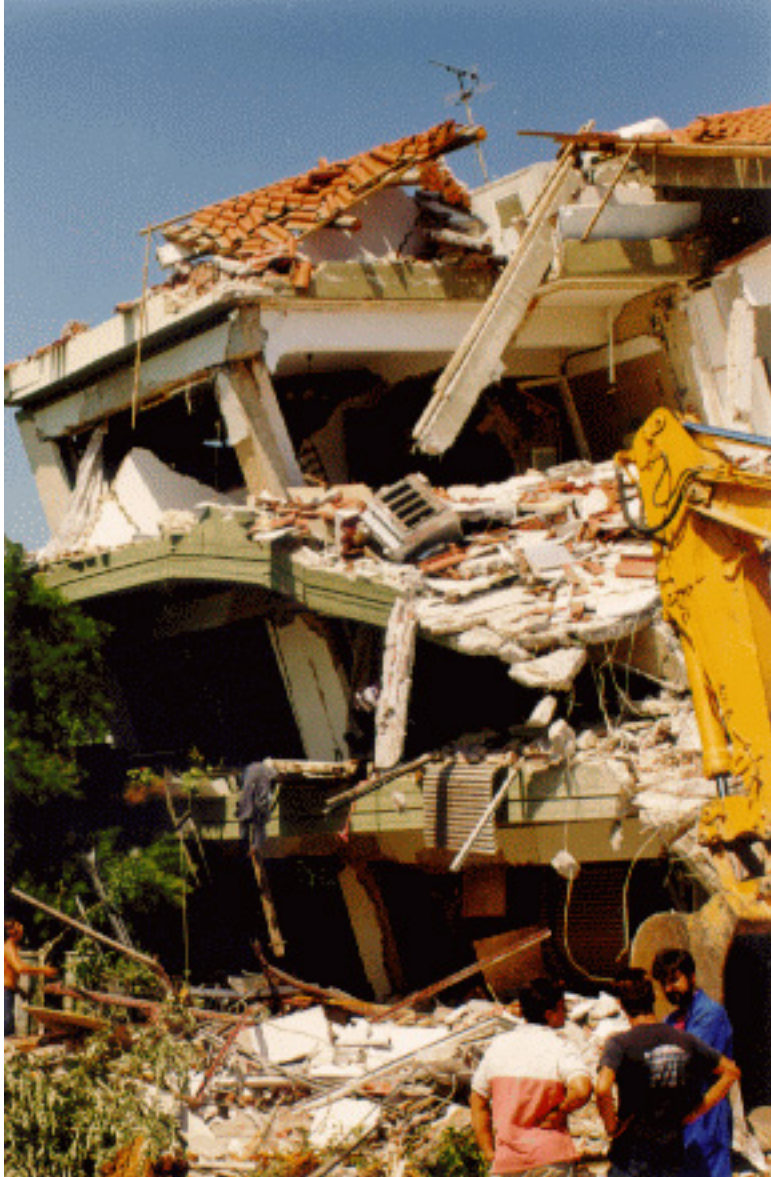
*FIGURE 5B: Building Collapse in the 1999 Athens earthquake*

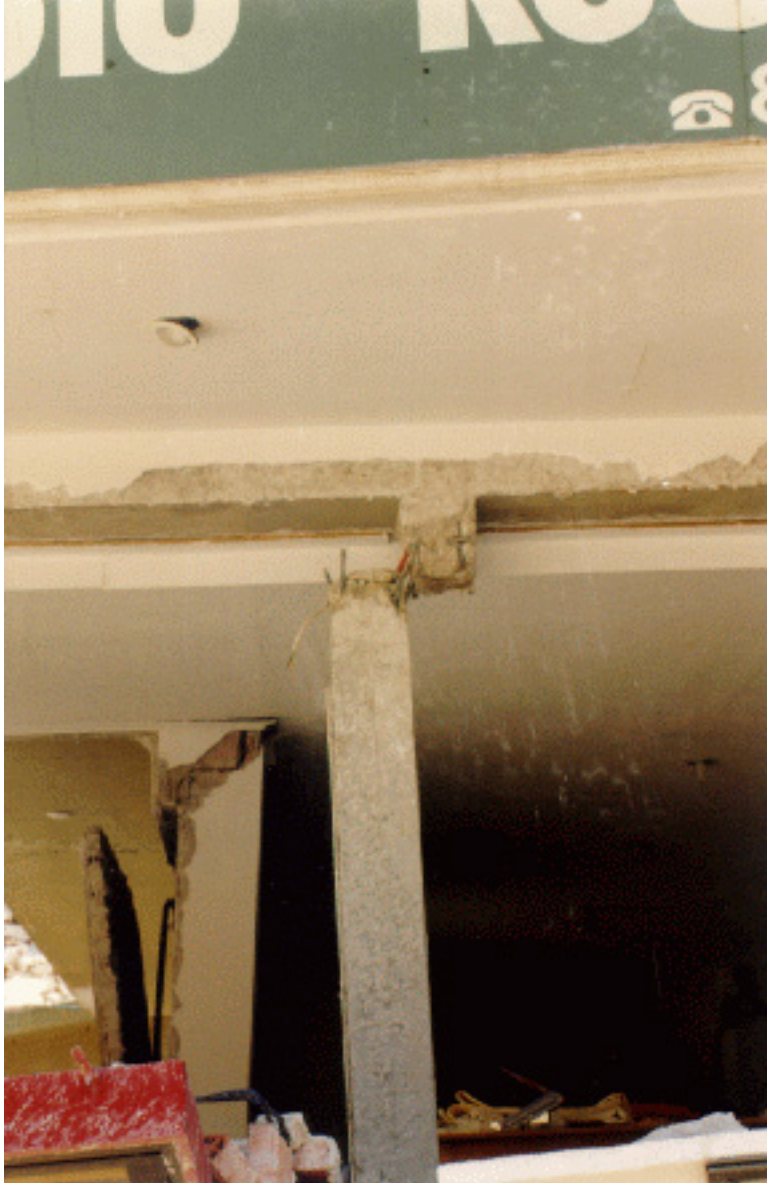
*FIGURE 5C: Earthquake Damage- Dislodged Column due to Soft Ground Floor Effect (1999 Athens earthquake)*

Roof and floors		Rigid diaphragms (insignificant relative in-plane displacements).	
Irregular Stiffness Distribution - Soft Ground Floor	Soft story at the ground floor level. Buildings with a soft ground floor are a common practice in Greece. Significantly less rigidity in this floor, compared to the rest of the building, leads to large deformations of the soft story (EERI).	In the 1999 Athens earthquake, the soft-story effect was more pronounced in buildings without shear walls (EERI).	Soft ground floor (where there is an absence of infill walls at the ground floor) may cause damage, leading to the development of collapse mechanisms. In the 1999 Athens earthquake, the damage occurred mainly to the joints, which were totally destroyed in a number of cases. As a result, the structural system became a mechanism, and large permanent horizontal displacements were observed. In some cases, collapse of the soft story was occasioned by P-d effect, combined with high vertical accelerations (EERI).

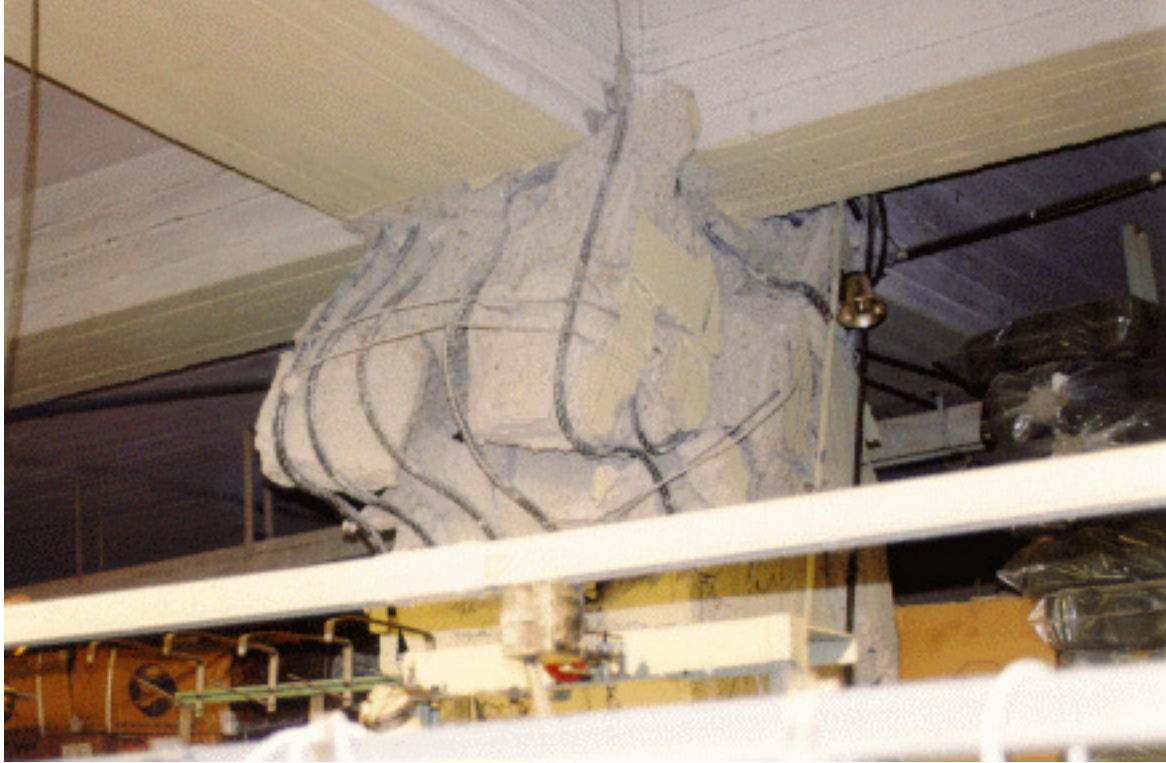
*FIGURE 5D: Typical Earthquake Damage-Column Failure (1999 Athens Earthquake)*

Structural Element	Seismic Deficiency	Earthquake-Resilient Features	Earthquake Damage Patterns
Wall	Clay brick infill with low tensile strength. Non-uniform wall distribution (in elevation or in plan) may create problems related to seismic performance.	The presence of minimum RC shear walls (a Code requirement) led to an improved structural performance	Cracking in shear walls of the elevator shaft (1999 Athens earthquake), see Figure 5F.
Frame (columns, beams)	Lack of lateral confinement (stirrups) in the columns.	-Capacity design of beam-column joints ensures ductile behavior of the structure -Good seismic performance on condition of careful detailing during design and construction after the application of the 1985 Code.	Joint failure in poorly constructed structures. Damage to column-beam joints due to bad concrete quality and insufficient reinforcement was observed in the 1999 Athens earthquake (EERI). In many cases, stirrup reinforcement was almost nonexistent (see Figures 5D and 5E).

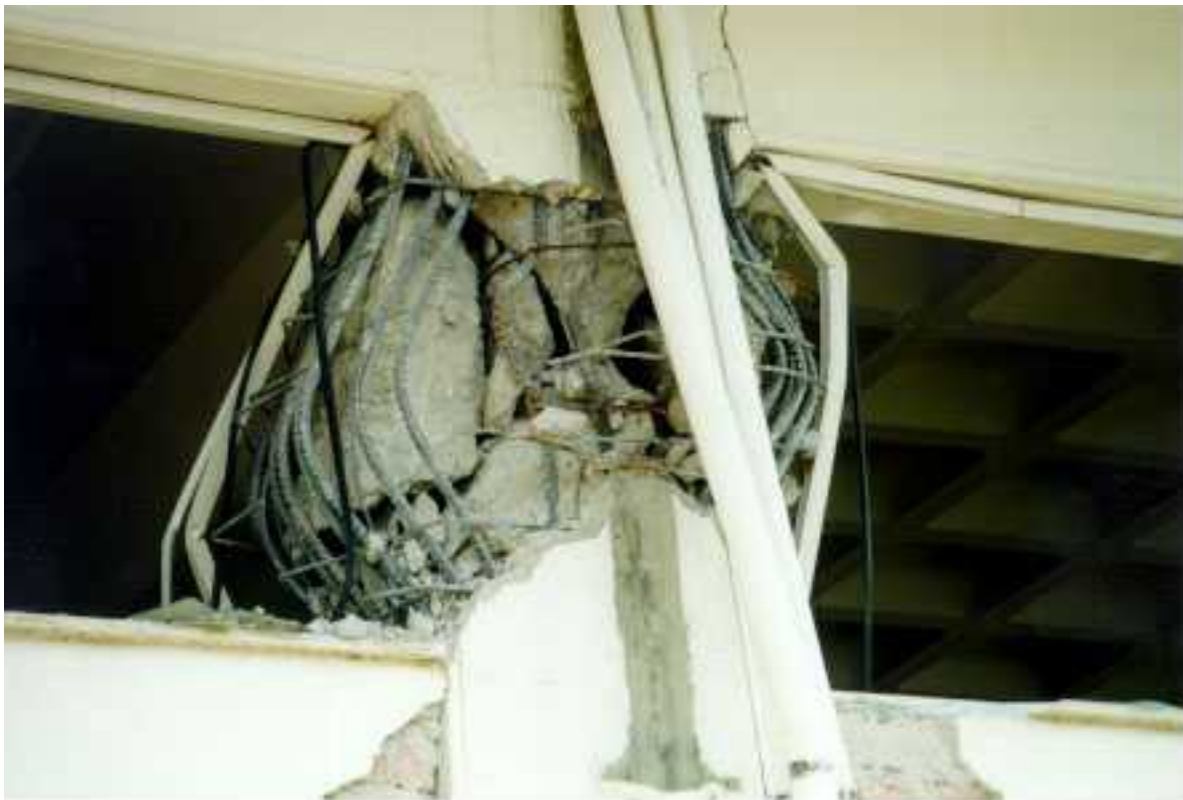
*FIGURE 5E: Failure of column, due to short column effect, of a 5-storey building in Ano Liosia, which was built in 1997 according to the new Greek Seismic Code (1999 Athens earthquake); Source: ITSAK*

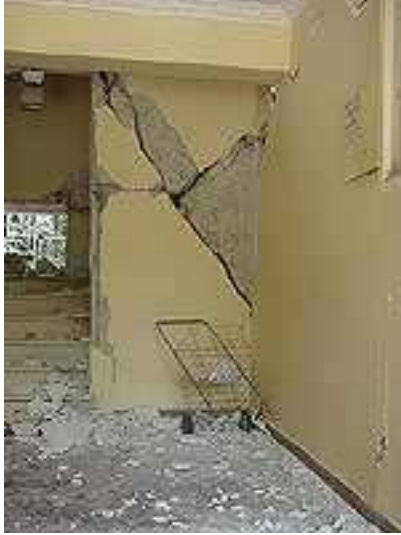
FIGURE 5F: Typical damage to the shear wall surrounding the stairwell in an apartment block in the 1999 Athens earthquake (Source: EQE)
