Learning from Earthquakes

The Great Sumatra Earthquake and Indian Ocean Tsunami of December 26, 2004

Report #1

Field Survey of Northern Sumatra

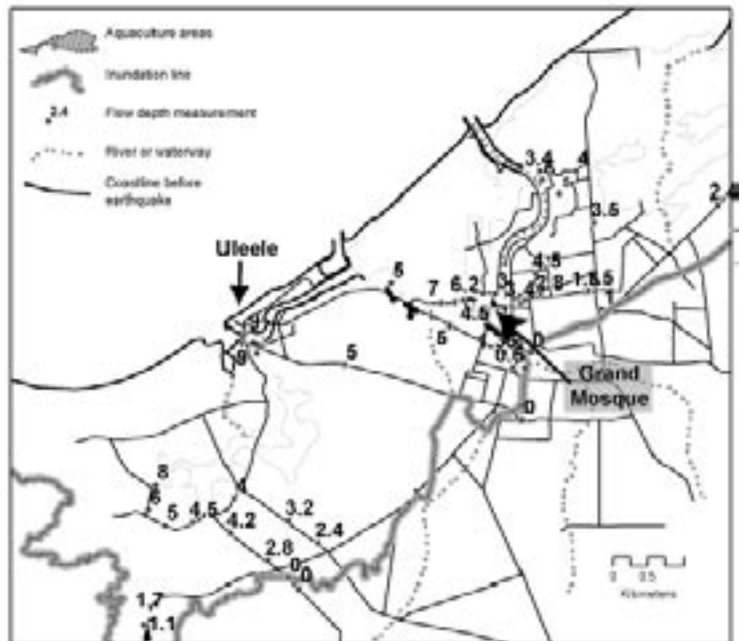
Figure 2. Map of Banda Aceh with flow depths as measured in the field.

Banda Aceh: Banda Aceh lies on a river delta created by the Aceh River reaching the Andaman Sea. Two large forks of the river split the city, with the main one one running through the center of town and the other lying 15 km to the east. The central area of Banda Aceh was separated from the open sea by nearly 2 km of low-lying wetland, probably used for aquaculture. Only on the sand spit of Uleele were there significant structures built on the shoreline (Figure 2).

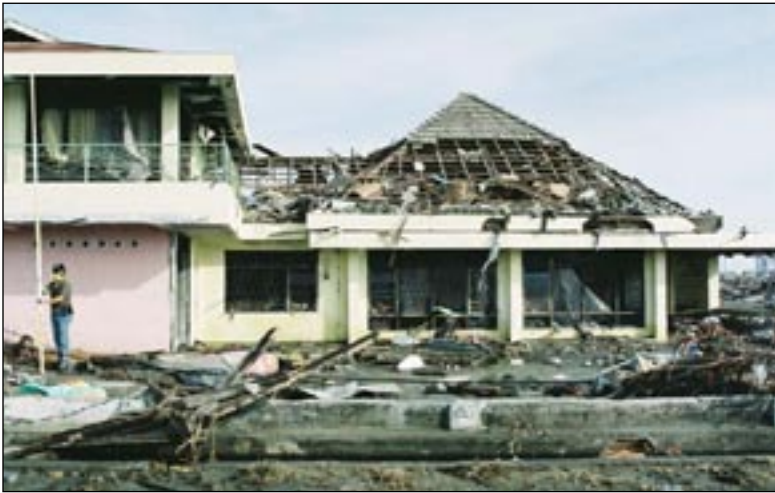
Figure 3. Roof tiles were removed by the flooding wave in Banda Aceh.

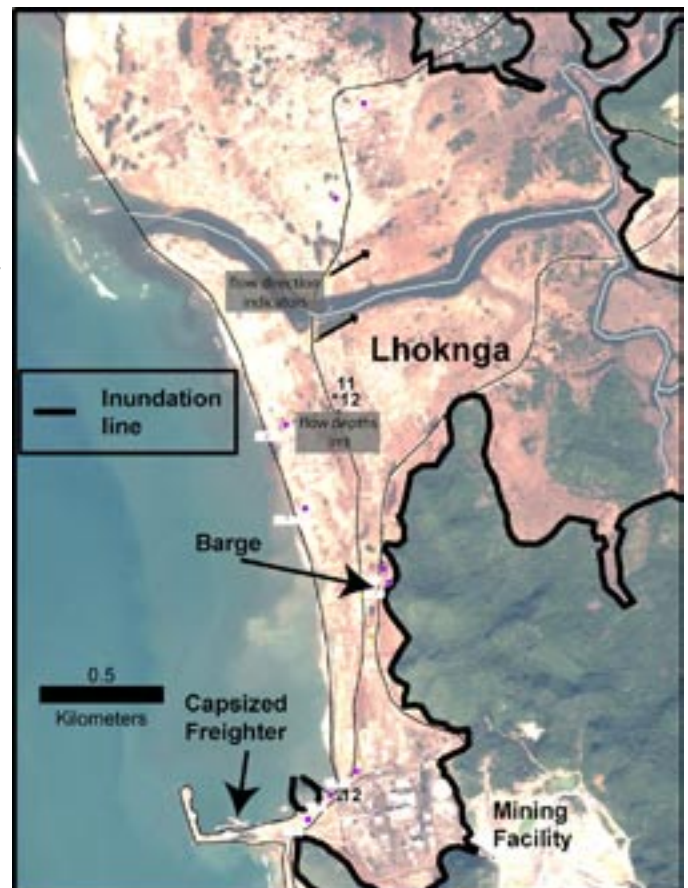
Figure 4. Satellite view of Lhoknga. The estimated runup at the trim line above the barge was 25 m.

trees indicated a sustained flow depth of over 13 m at the shoreline. A mining facility at the south end of the beach was severely damaged by the tsunami, and two large ships were affected. A 90-m long coal barge was moved from the shore more than 160 m to the base of a hill with its tugboat still attached. At the jetty in front of the mining facility, a 100-m freighter was capsized at its moorings (see Figure 4).

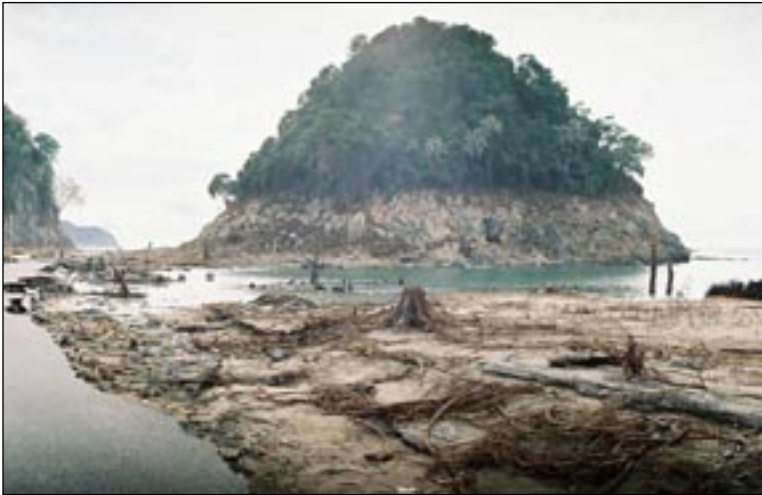
Figure 5. The trim line at a small headland at Lhoknga. This hill was previously covered by dense jungle to the waterline.

A clearly defined trim line was visible all along a steep hill that backed the beach 300 m from the shoreline. The height of this trim line was estimated to be 25 m high, but it was not measured precisely in the field during this survey. That value was later confirmed by comparing a satellite photograph of the inundated region to a 90-m digital elevation model, which gave a value of 23 m at that location. Later surveys by Tsuji et al. (2005) reported runup heights at that location to be 22 and 32 meters (see Figure 5).

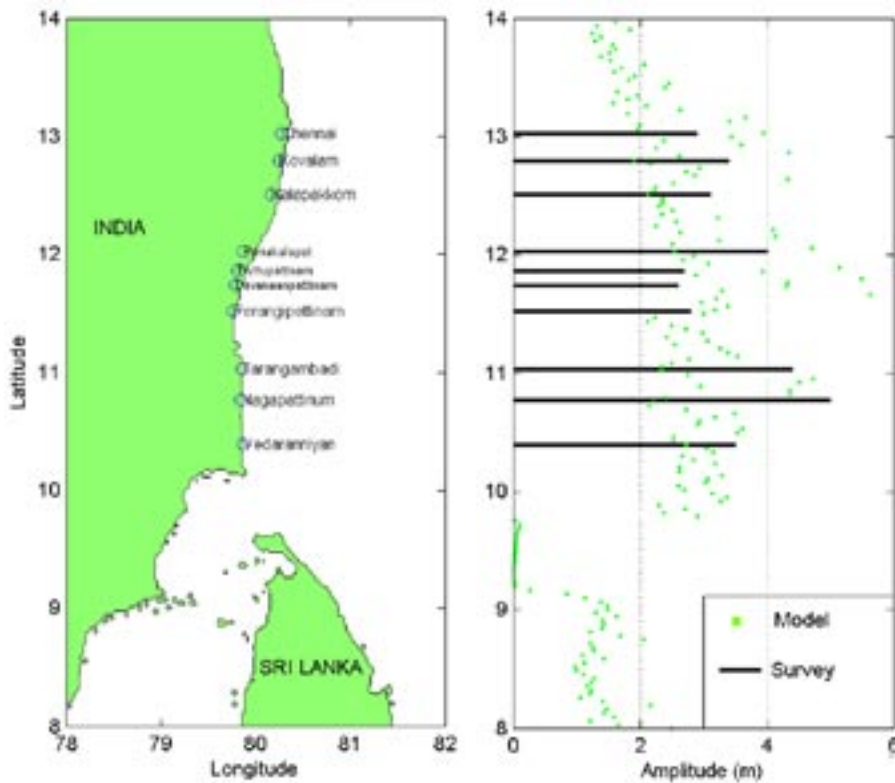
Figure 2. Comparison of the numerical predictions (provided by Philip Liu) with the measured tsunami runup heights.

The measured runup heights are plotted with the numerical predictions (discussed earlier) in Figure 2, and they are fairly consistent. The numerical prediction model is based on a 3.7 km x 3.7 km grid system,

which does not take into account the detailed local bathymetry and inland topography. The prediction does not include final shoaling effects of tsunami because the model assumes fictitious vertical walls (no flux condition) near the shore where the depth is less than 5 m. In spite of the simplifications in computation, the agreements are excellent. The good agreements are mainly attributed to advances in the numerical technique, as well as the bathymetry dataset made available during the last decade through the work of the General Bathymetric Chart of the Oceans (GEBCO): <http://www.ngdc.noaa.gov/mgg/gebco/gebco.html>.

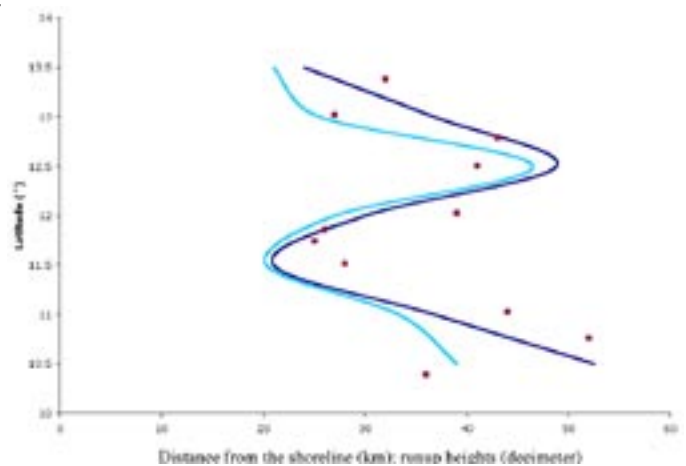
Figure 3. The breadth of the continental shelf in the survey region, presented by the 100m and tsunami runup heights in decimeters.

The edge of the continental shelf in this region can be represented by the 100 ~ 200 m depth contour line shown in Figure 3. Also plotted on the figure are the tsunami runup heights. There appears to be some correlation between the tsunami runup height and the width of the continental shelf: the wider the shelf, the higher the runup.

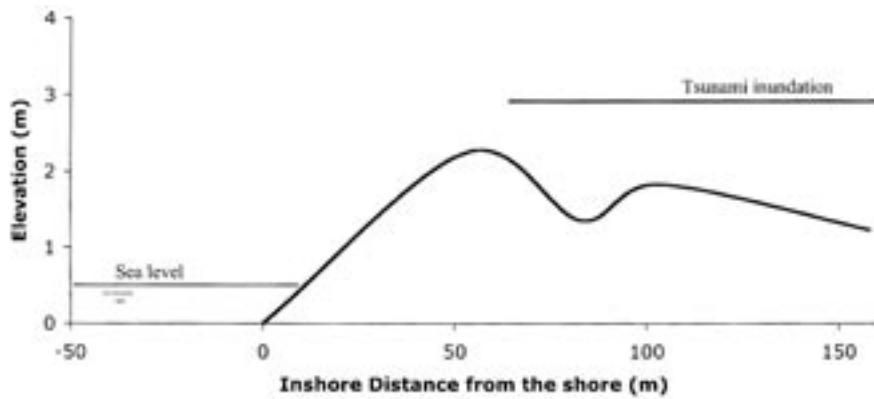
Figure 4. A typical beach profile taken at Devanaanpattinam.

We observed that most of the victims drowned in tsunami flows with a depth of ~1.5-2.0 m. Figure 4, showing a typical beach profile at Devanaanpattinam, indicates that the tsunami flow speed could have been enhanced behind the beach berm. Thus, even a 1.5 m-deep flow had more than enough force to kill adult human beings. Because a tsunami wave period is much longer than cyclone-generated waves of the equivalent height, the tsunami's wave has very long and sustained penetration.

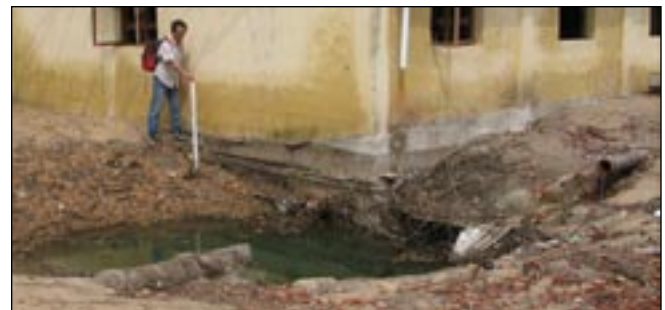
Figure 5. Tsunami scour and failure of a wastewater pipe at a schoolhouse at Kalapakkom.

sive scours around their foundations. The scour patterns were not consistent: on some buildings, the damage was found on the sea side, while on others it was on the land side. Figure 5 shows scour damage at the seaward corner of the schoolhouse at Kalapakkom, where the runup height was 4.1 m; the building was inundated to 0.95 m above the floor level. The scour depth is approximately 1.5 m with a horizontal span of 5 m.

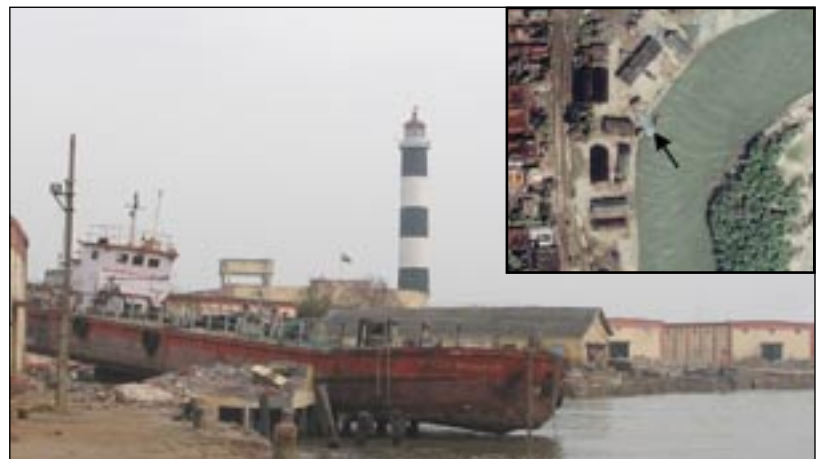
Figure 6. A ship pushed up by the tsunami at Nagappattinam Port, seen in the satellite image by the arrow mark (IKONOS Image by Space Imaging).

preting ground level observations, and vice versa. Figure 6 shows a comparison of satellite image with the ground-level survey. The washed up ship on the quay can be identified in the satellite image. The small anomaly next to the ship in the satellite image was found to be a damaged concrete block of the quay wall. In the same area, we observed many damaged boats stacked on the quay, while no such boats were observed in the satellite image that was taken after the tsunami. This discrepancy indicates that the boats were not moved by the tsunami but rather were transported after the event to that location as part of the clean-up process.
