World Housing Encyclopedia Report

Country: Indonesia

Housing Type: Unreinforced clay brick masonry house

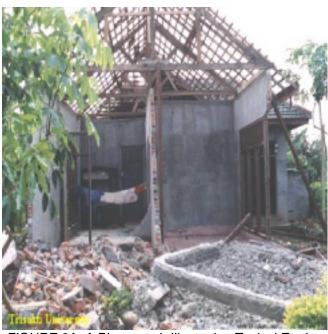
FIGURE 5C: The recommended connection between foundation and tie beam

<u>Additional Comments:</u> It is rather difficult to convince the community to do seismic strengthening on the existing undamaged houses to the local community. One of the best ways is by disseminating recommended earthquake resistant construction to the local community under supervised an engineer by applying local material condition which are easy to obtain in the neighborhood. Recommended seismic strengthening provisions for the new construction of this type are illustrated in Figures 5A, 5B and 5C.

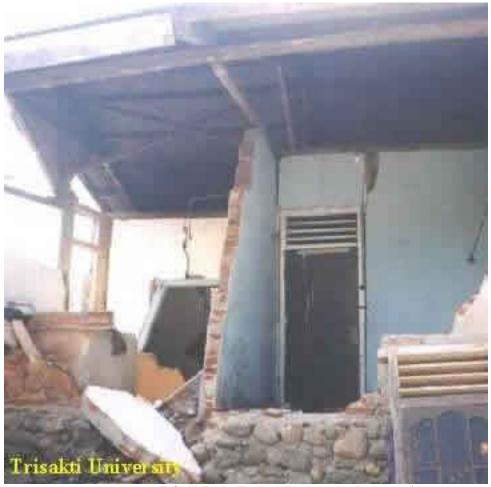
FIGURE 6A: A Photograph Illustrating Typical Earthquake Damage (June 4, 2000 Bengkulu Earthquake)

<u>Additional Comments:</u> Typical damage features on non-engineered buildings: 1. Failure on corners of the walls and the openings like doors and windows. 2. Roof structure was usually sliding off from its base 3. Diagonal cracks on the clay-brick walls 4. Fail in connection between: - foundation and walls, - walls and walls - walls and roof structure. 5. low construction quality (the quality of building material and labor).

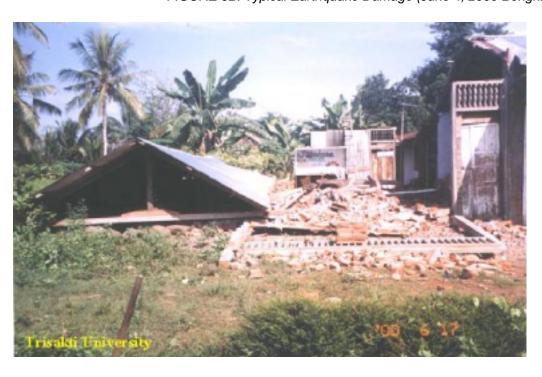
FIGURE 6B: Typical Earthquake Damage (June 4, 2000 Bengkulu Earthquake)
