Dead Sea Earthquake of 11 February 2004, Mb 5.1

A Preliminary Report

An-Najah National University
Earth Sciences and Seismic Engineering Center (ESSEC),
Nablus, P.O. Box 707, Palestine

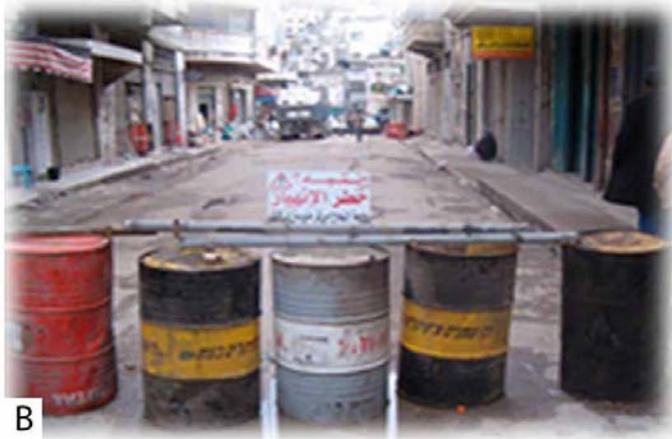
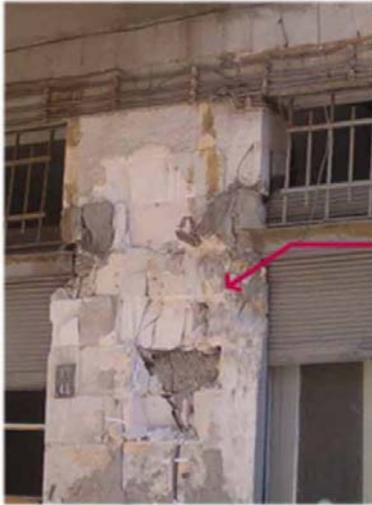
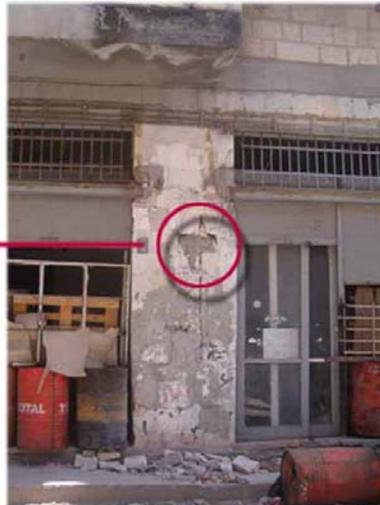
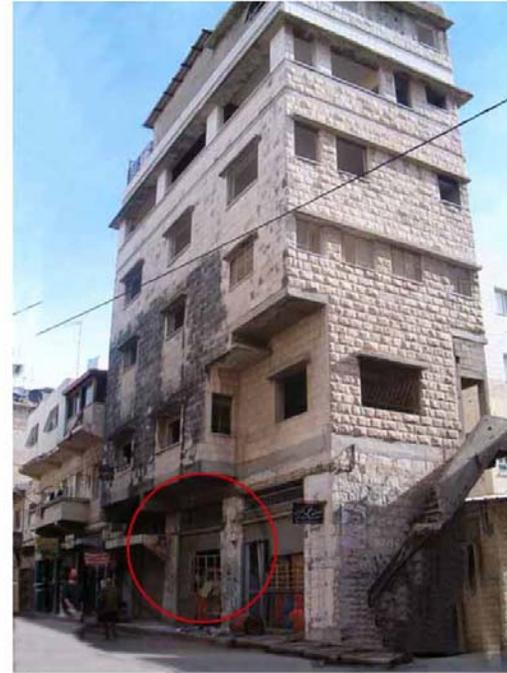
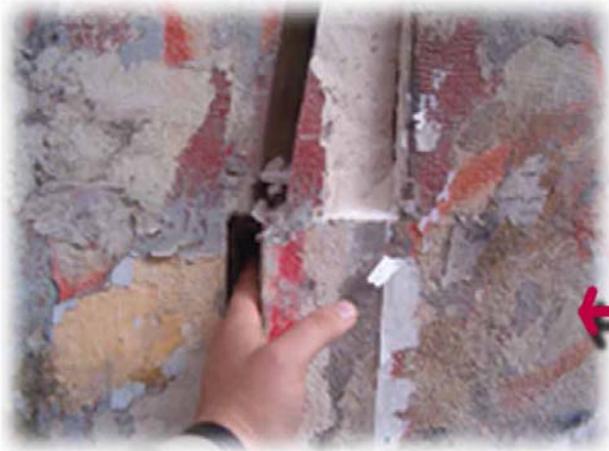
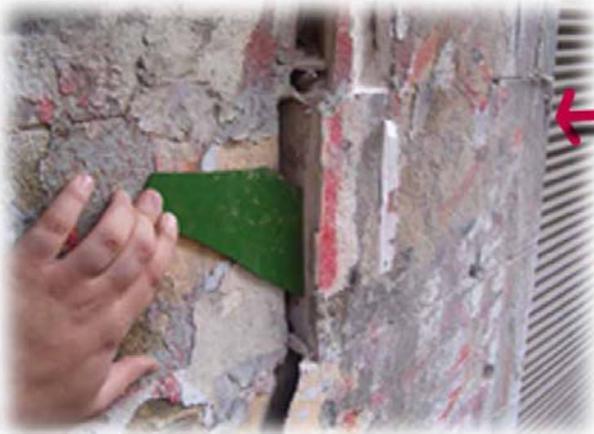
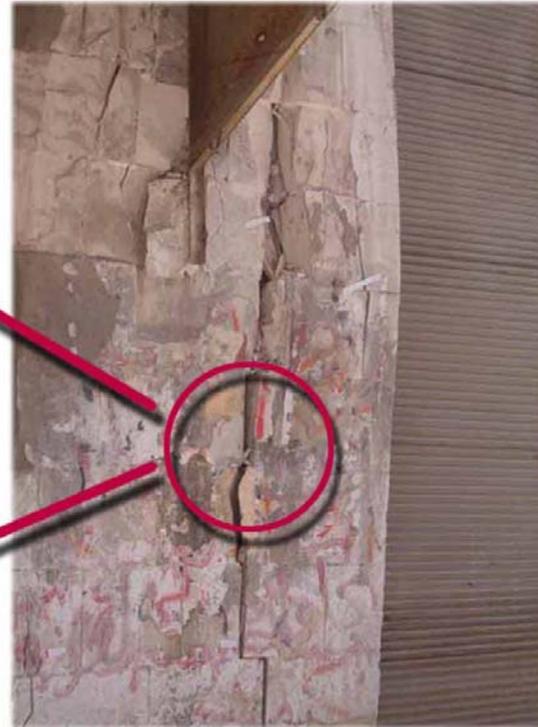
fig. 1
Crack Patterns, Crushing
and Large permanent
deformation in the
Masonry Pillars.
see more details page no. (4/8)
page 3/ 8

Five Storey Masonry Building- NABLUS City

B
Expulsion of blocks in poor mortar stone

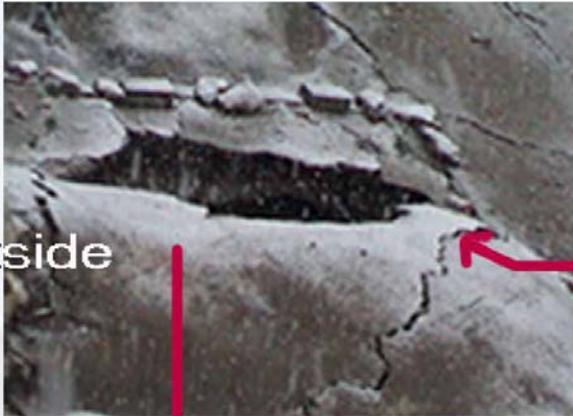
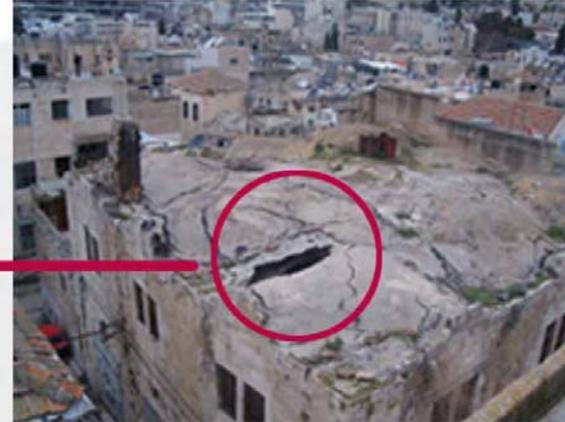
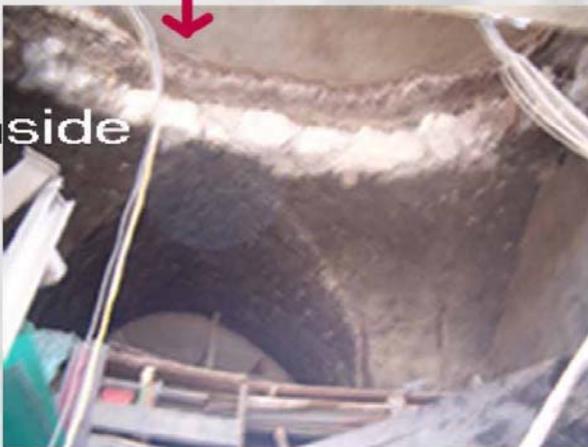
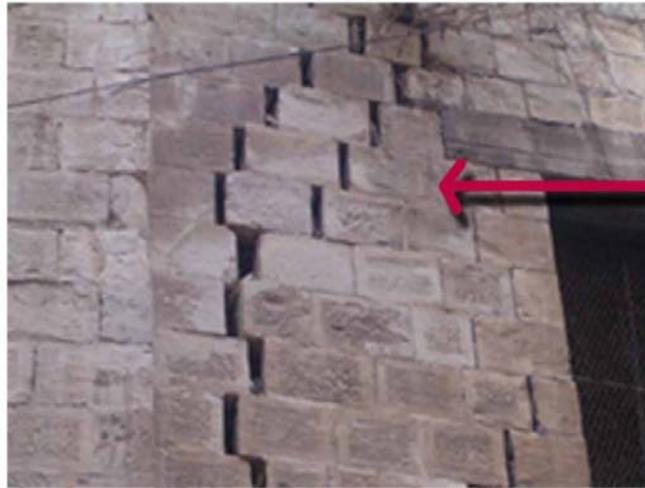
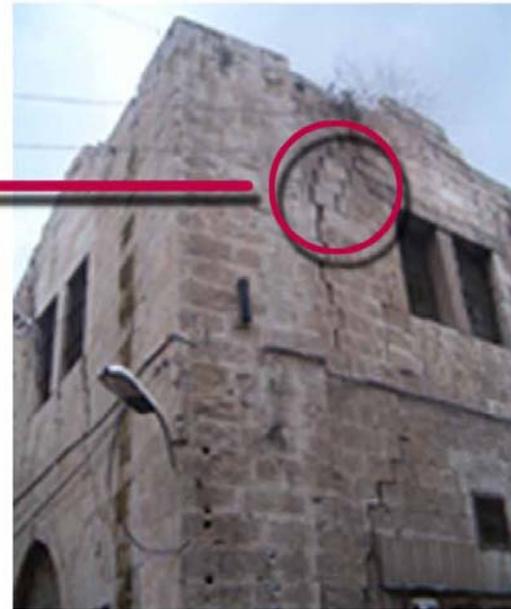
fig. 2

A flat vault's collapse

Old Masonry Building

Location: Old town of NABLUS city

Structural System: Cross Vault's

Use: Soap Factory

Corner Detachment of Building

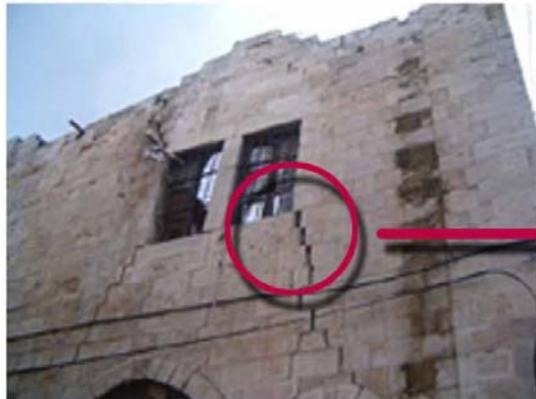
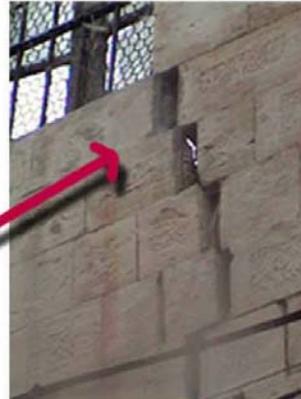
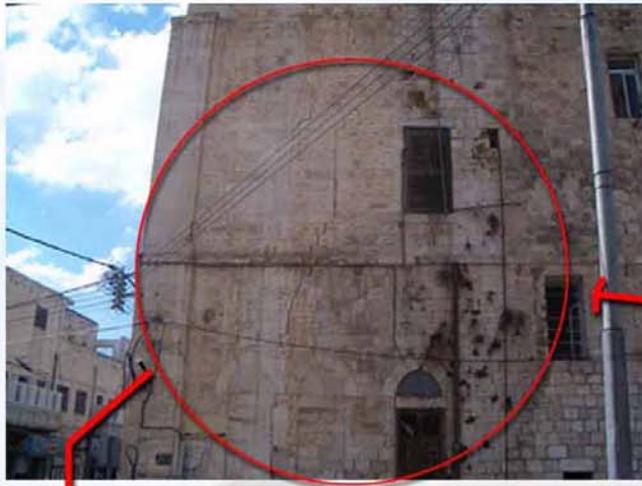
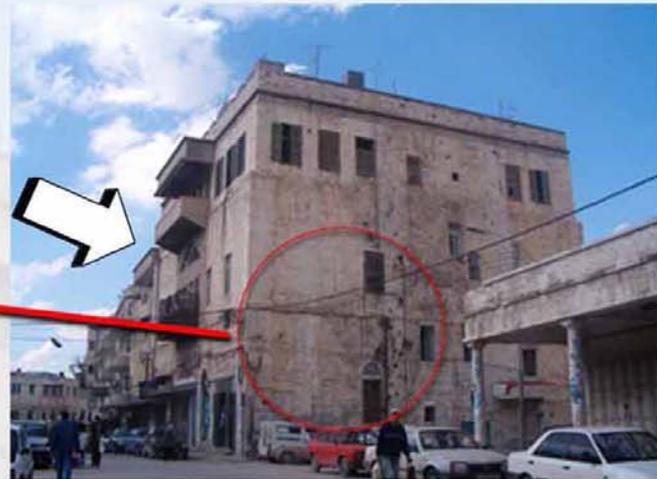
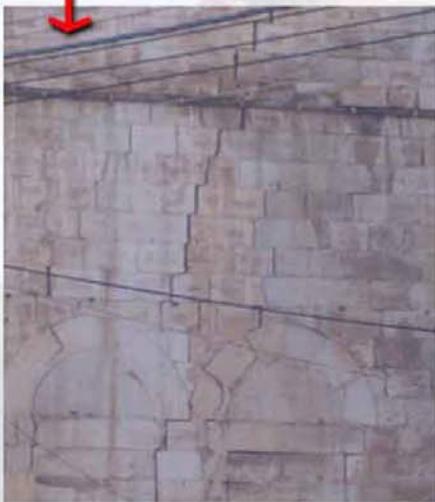
fig.3
Old Masonry
Building
NABLUS City

Crack patterns
