World Housing Encyclopedia Report

Country: Romania

Housing Type: Precast concrete panel apartment buildings

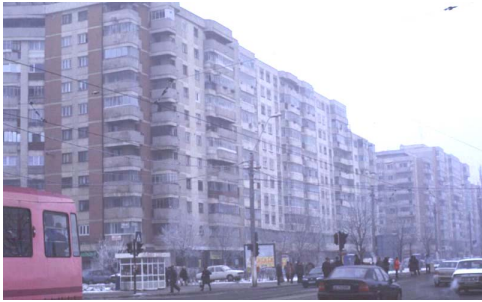
FIGURE 1: A typical building

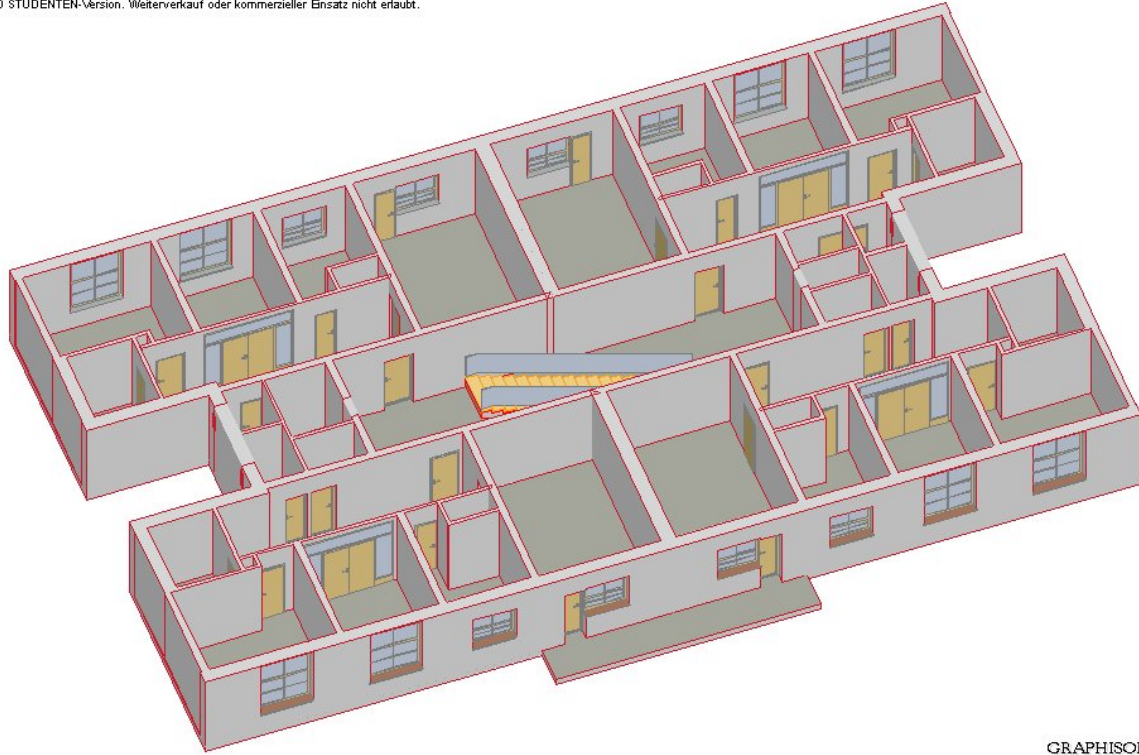
FIGURE 8: Axonometric floor view
