Learning from Earthquakes

Preliminary Observations on the May 1, 2003, Bingöl, Turkey, Earthquake

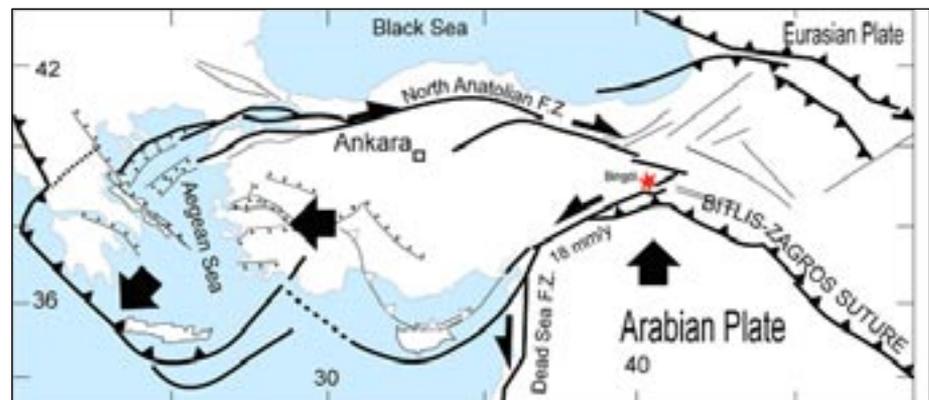
Figure 1. Location of the May 1, 2003, Bingöl earthquake (source: Dr. N. Kaymakçı).

The Bingöl, Turkey, earthquake caused damage in Bingöl Province and at least one village in Elazığ Province. The magnitude $M_w=6.4$ earthquake struck at 3:27 a.m. local time on May 1, 2003, with an epicenter located about 15 km N-NW of Bingöl city (Figure 1). This is a sparsely populated region with one major city (Bingöl), 350 small villages and hamlets, and a population of 253,739 (2000 General Census of Population). Most of the 177 fatalities and 530 injuries occurred in Bingöl City (at least 27 were killed in the collapsed Korkmaz apartments in Düzaðaç mahalle), although 84 students perished in the school dormitory in Çeltiksuyu village.

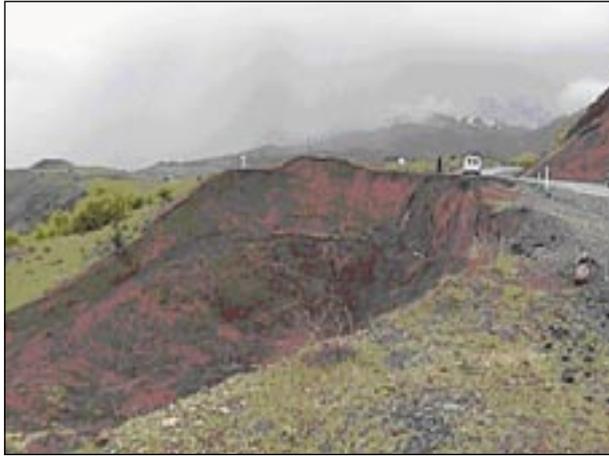
Figure 7. One of the most significant seismically induced landslides along the Sogukcesme section of the country roadway extending from Bingöl to Karliova.

The earthquake caused rock and debris falls, several landslides (Figure 7), and surface tension cracks. Landslides contributed to building damage in Yçpınar and Göltepe ve Çiçekdere villages.

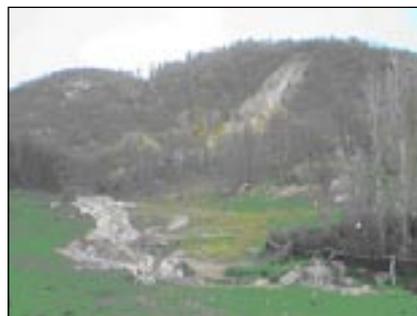
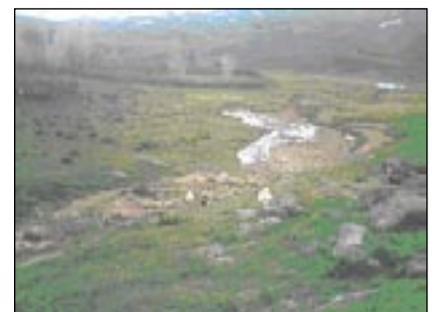
Seismically induced mudflows were observed in several villages, including Kurtulus Village, where mud covered hundreds of meters (Figure 8). Villagers reported that the mudflow started immediately after the earthquake and continued until the next morning.

Figures 8a and 8b. Mudflow at Kurtulus Village.

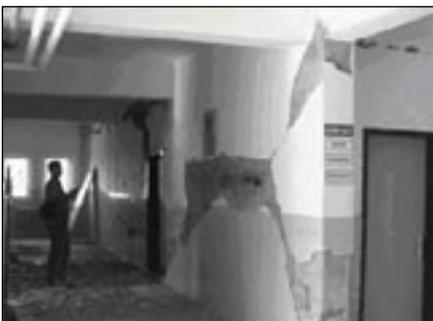
Figure 10. Observed shear failure at shear wall due to insufficient transverse reinforcement and poor concrete quality.

were poor detailing at critical points of structural elements and poor quality concrete (Figures 9 and 10). Site effects also contributed to damage, as can be seen in the subsequent discussion.

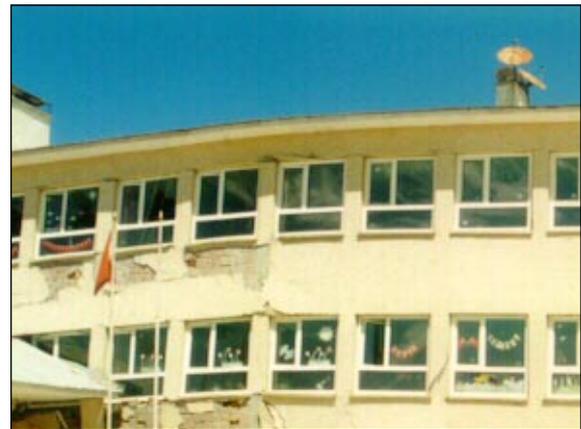
Figure 11. Çeltiksuyu Regional Primary Education School Building. (Note entrance canopy partially visible on left. The ground story collapsed fully in exactly the same way as that in Figure 13.)

The most tragic building collapse occurred at Çeltiksuyu Regional Primary Education School, where both the dormitory building and the adjacent school block were badly damaged (Figures 11 and 12). This building was completed in 1998. An identical school building (Kaleönü) closer to the city and some 7 km

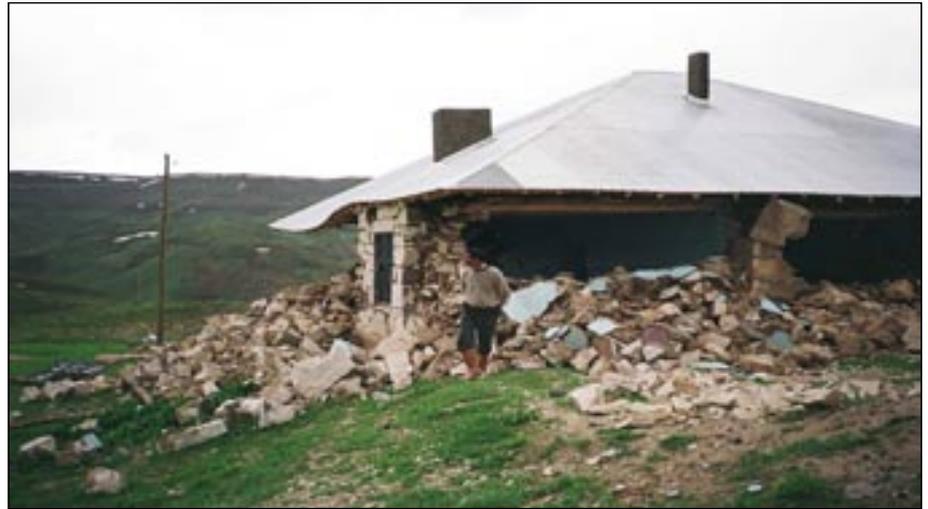
The buildings in rural parts of Bingöl performed comparatively well in general during the May 1 earthquake. While total collapses in this category were rare, the common form of damage was partial failure of exterior, inner, and partition walls (Figure 14).

Figure 14. A traditionally built rural house that was heavily damaged.

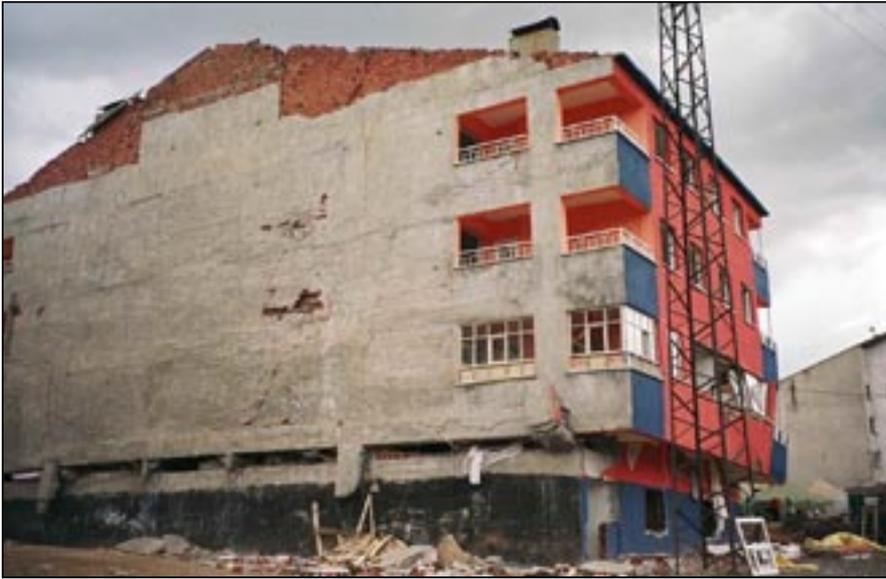
Structural damage in the area was markedly concentrated within about a 50-m-wide strip from the crest of

Figure 16. A collapsed building in the close vicinity of the southern cliff crest of the Gayt Stream valley.

the southern cliff, where habitation was relatively dense. While all of the collapses and a great majority of the heavily damaged buildings in the area were enclosed within in this zone, only a few heavily damaged buildings were observed outside. This discrepancy in the distribution of structural damage can be attributed to the topographic amplification effect of the cliff on the free-field ground motion within a short distance of the cliff.

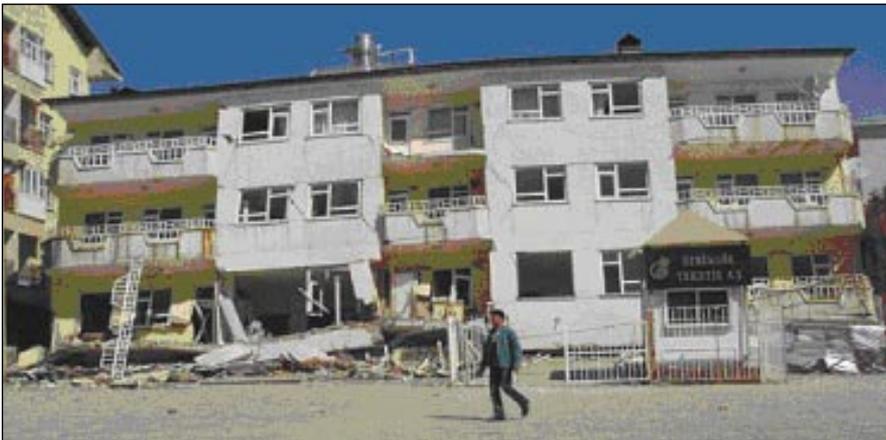
Figure 17. Typical first-story collapse.

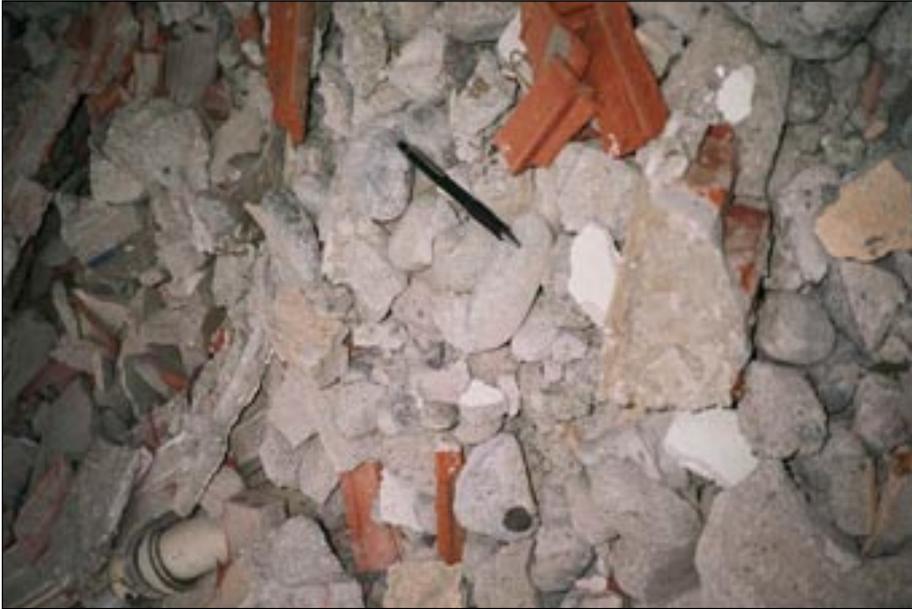
Figure 19. Substandard detached aggregate material in the debris of the collapsed Çeltiksuyu School building.

were not damaged at all. Both the building and the water tower were the same reinforced concrete as the collapsed buildings; (2) in all cases of reinforced concrete building collapse, the aggregate observed was stream run, round or semi-round material with a considerable content of oversize blocks (Figure 19). In several instances, these blocks could be pulled out of the damaged reinforced concrete frame elements by hand; a layer of fine soil could be scratched from the surface of the cavity. This made clear the reason for the rather weak bond: the material used as aggregate was not even washed before it was mixed!

After tests of specimens acquired from collapsed and heavily damaged buildings in Bingöl, the Chamber of Civil Engineers of Turkey reported that the concrete quality was rather poor in general, with compressive strength values as low as one-third of those considered in design. The substandard aggregate material must be a major contributing factor in the overall poor quality of concrete, and hence in the collapse of the buildings.
