Learning from Earthquakes

Val-des-Bois EQ

Report provided by Martha Merriam of Caltrans and Murat Saatcioglu of the University of Ottawa.

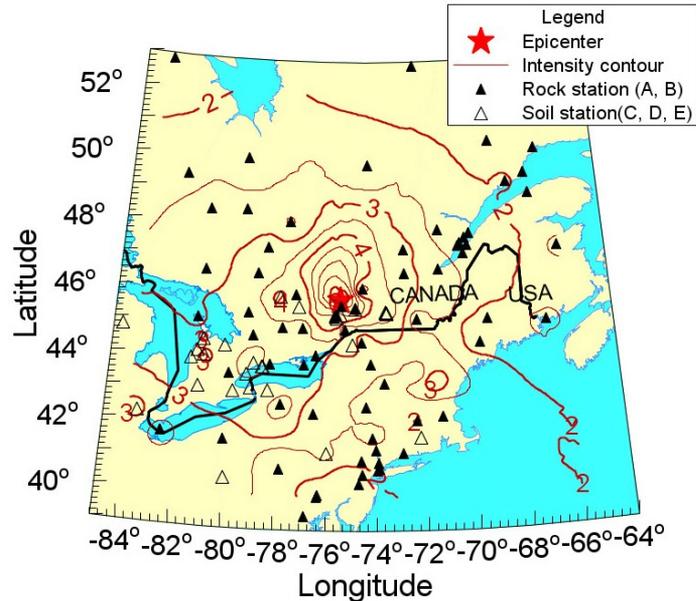
Instrumental Intensity: June 23, 2010 M5.0 Earthquake

A map of intensities was developed from the earthquake, with intensity IV, indicating a level of shaking that is felt by most people.

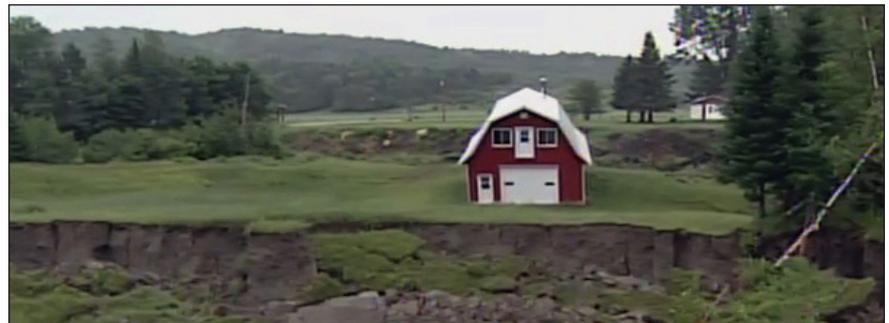
Landslide near the epicenter resulted in 50 m of downhill movement, soil failure, and damage to a barn foundation near Gracefield, close to epicenter.

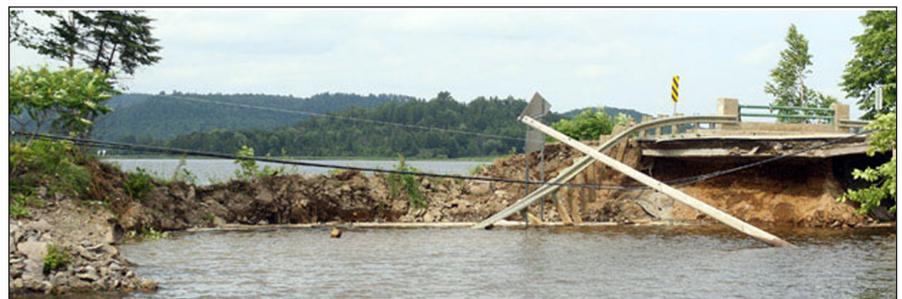
Embankment failure south of Bowman, Quebec (photo: Jean Levac).

about 10 km from the epicenter, a bridge failed as a result of embankment failure.
