Learning from Earthquakes

Eastern Turkey EQ Update

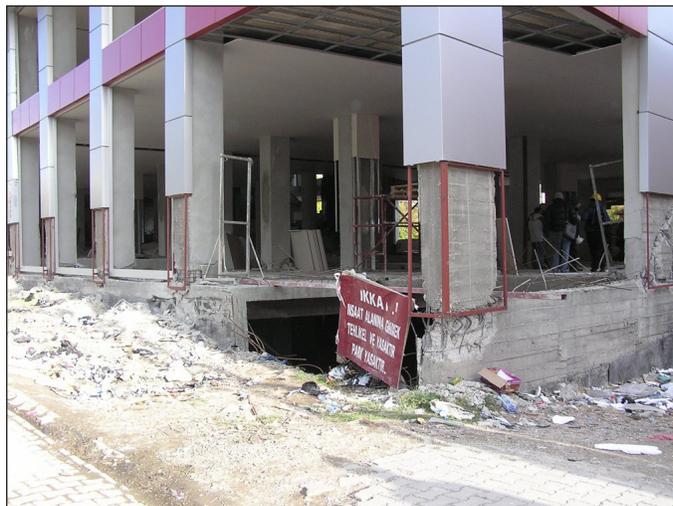
Figure 1. A heavily damaged six-story building in Ercis. The structural layout resulted in excessive floor torsion. The flexible joist floors with block infills had cracks around columns at every floor level. The columns failed at the base of the ground story (photo: A. Irfanoglu).

load-resisting systems, soft stories at ground level (open and tall ground stories for commercial use), floor torsion (Figure 1), mezzanine-level construction resulting in disproportionate loading of structural elements (Figure 2), flexible joist floors with infills, and captive columns. The team also found widespread substandard construction practices, including inappropriate reinforcing detailing and poor quality concrete, suggesting the absence of proper inspection and quality control during the construction process.

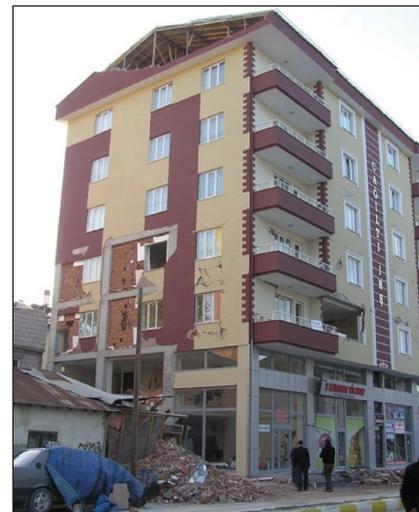
Figure 2. A newer building in Ercis with a typical tall ground story and mezzanine level for commercial use (photo: A. Irfanoglu).
