## Learning from a big quake

### WINDOW ON THE WEST: *Coalinga damage*

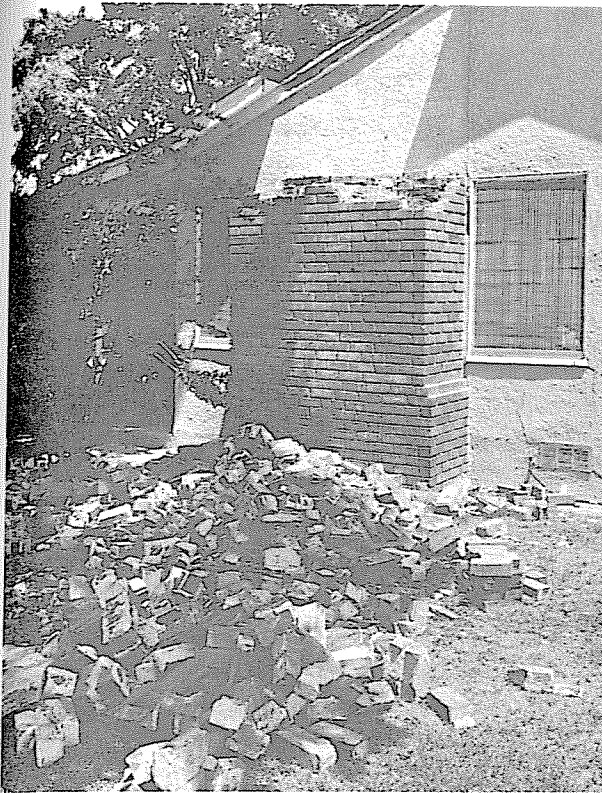
Brick chimneys crumbled or were sheared off many Coalinga houses, as shown at top. Equally vulnerable were short "cripple" walls (see center photograph); when these studs are inadequately braced, they're easily pushed over by a quake's lateral force. The danger of unreinforced masonry is evident in the photograph at left; the five residents survived by seeking protection in an interior wood-frame room.

Brick chimneys and masonry veneer performed poorly, as they have in past quakes; even with adequate mortar, they often toppled. This is a point reminder to locate children's play areas away from where masonry might fall and to consider the hazard of chimneys near sleeping quarters.
