**EARTHQUAKE ENGINEERING  
RESEARCH INSTITUTE  
NEWSLETTER**

**MAGNITUDE 8.1 EARTHQUAKE  
IN MEXICO  
SEPTEMBER 19, 1985**

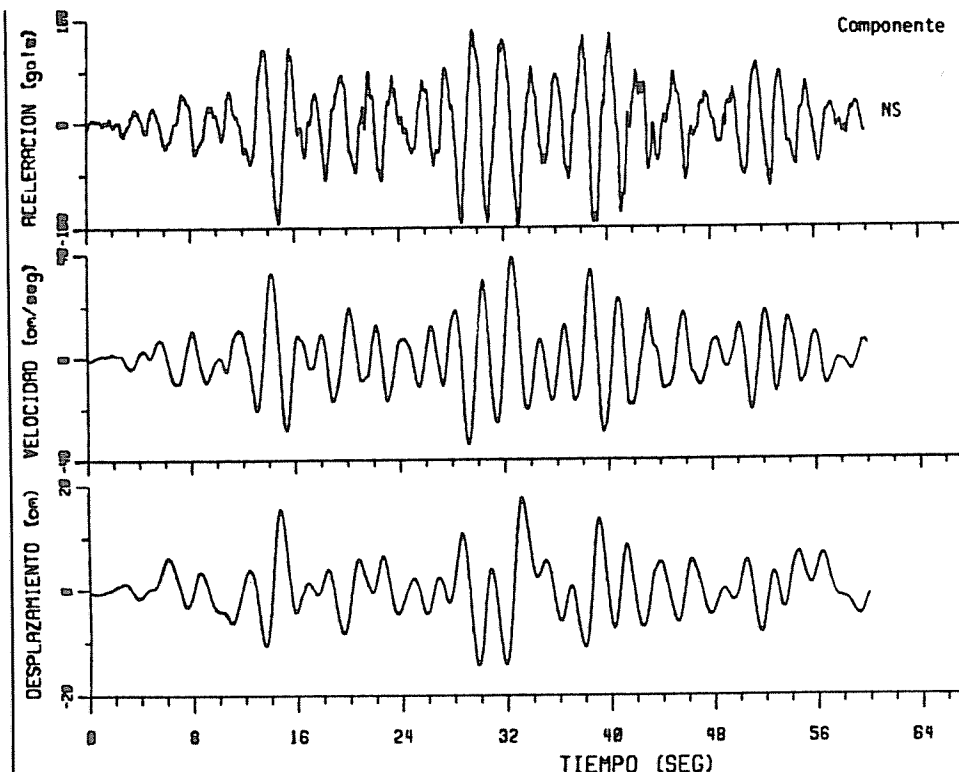
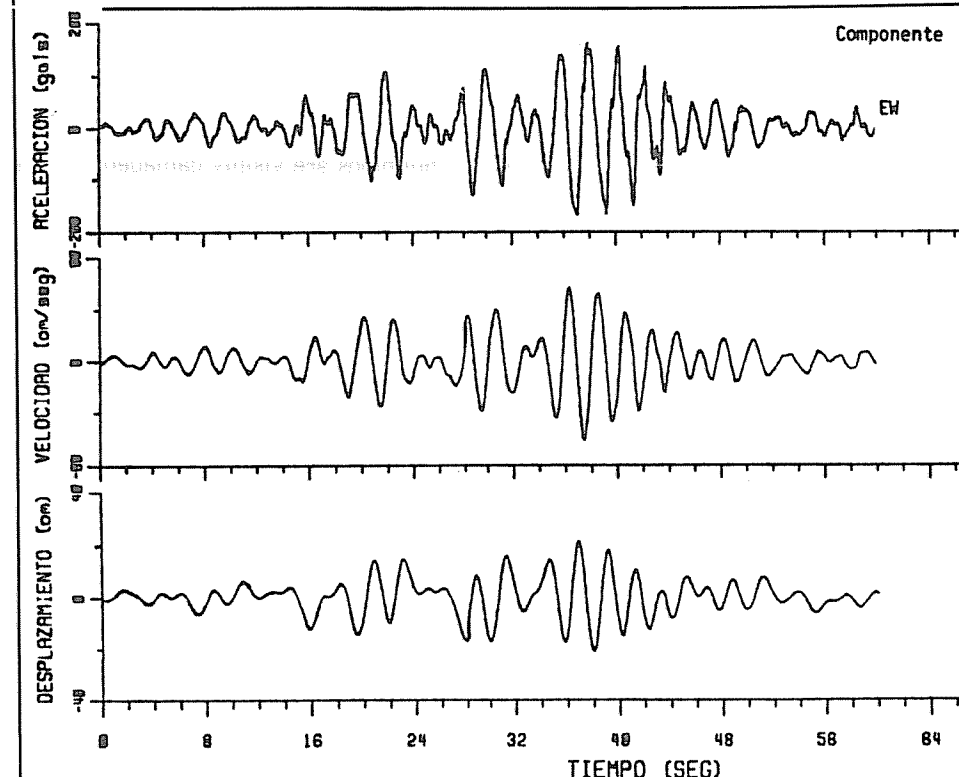
The figures show the corrected acceleration, velocity and displacement for the two horizontal components at the

ground level site. The correction procedure used is the standard Caltech program, with a pass band between 0.1 Hz and 23 Hz. Sixty seconds of motion were recorded, consisting primarily of oscillations with 2 sec period. Peak values of acceleration, velocity and displacement were  $98 \text{ cm/sec}^2$ ,  $39 \text{ cm/sec}$  and  $17 \text{ cm}$  in the NS direction; and  $168 \text{ cm/sec}^2$ ,  $61 \text{ cm/sec}$  and  $21 \text{ cm}$  in the EW direction.

It is reasonable to assume that most of the seriously damaged area of Mexico City, on these soft lacustrine clays, suffered ground motion similar to that pictured here. Some buildings of 5 to 15 stories height, with periods in the 0.5 to 1.5 second range, will have lengthened their period to 2 seconds due to the initial cracking of concrete, and found themselves self destructing as they resonated to this input.
