## Learning from Earthquakes

# Preliminary Observations on the August 14, 2003, Lefkada Island (Western Greece) Earthquake

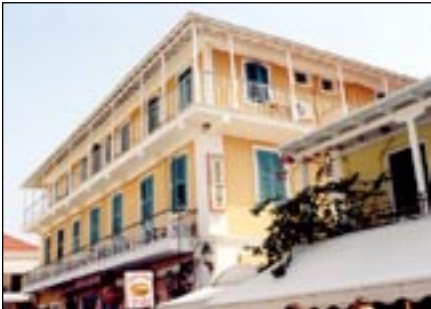
17a▲

**Figures 17a, b, and c.** The traditional earthquake-resistant system of Lefkada. The undamaged structure in Fig. 17a was built at the end of the 19<sup>th</sup> century. In Fig. 17b the wooden columns and beams (w) with wooden corners (c) are visible. In Fig. 17c the special earthquake system is shown under construction (NTUA-UoA team).

dual structural system (category B) behaved in a rather satisfactory way, given the intensity of the main event (ITSAK 2003). In this composite system, a wooden frame has special carved corners (figure 17) that strengthen beam-to-column joints, and wooden stiffening walls with x-braces. In the plane of these stiffening walls, various masonry materials may be added in order to increase the stiffeners and the energy absorbing capacity of the whole system. On the ground floor, the wooden frame comes in contact with the external masonry wall, with which it is well connected. The carved corners are also put in the lower part of the columns that are fixed to the foundation. In some cases, there was partial collapse of masonry walls (figure 18), but the structural stability of the building was ensured by the activation of the secondary (redundant) wood frame on the ground floor level.
