Learning from Earthquakes

The Great Sumatra Earthquake and Indian Ocean Tsunami of December 26, 2004

Report #3

The Effects in Mainland India and in the Andaman-Nicobar Islands

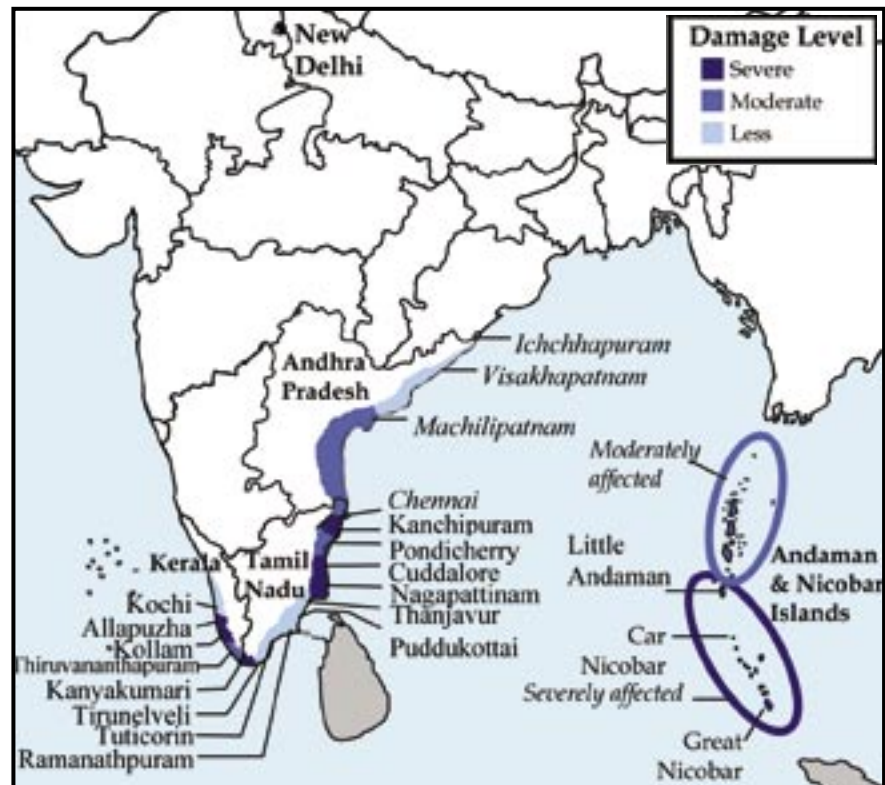
shaking (on the MSK scale) was VII; along the mainland Indian coast, it was V. The tsunami arrived in the A&N Islands between 40 and 50 minutes after the earthquake, with Port Blair recording its arrival at 7:15 a.m., and it caused extensive devastation of the built environment. The tsunami arrived in the states of Andhra Pradesh and Tamil Nadu along the southeast coast of the Indian mainland shortly after 09:00 a.m. At least two hours later, it arrived in the state of Kerala along the southwest coast. Tamil Nadu and Kerala were extensively damaged, while Andhra Pradesh sustained moderate damage (Figure 1).

Figure 1. Map showing relative tsunami-induced damage along the coastal districts (in mainland) and in the islands (in A&N Islands).

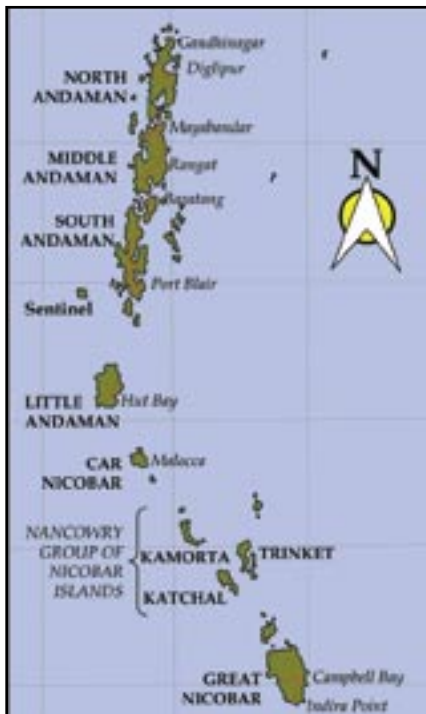
Figure 2. Overall map of A&N Islands showing some of the larger islands of the region.

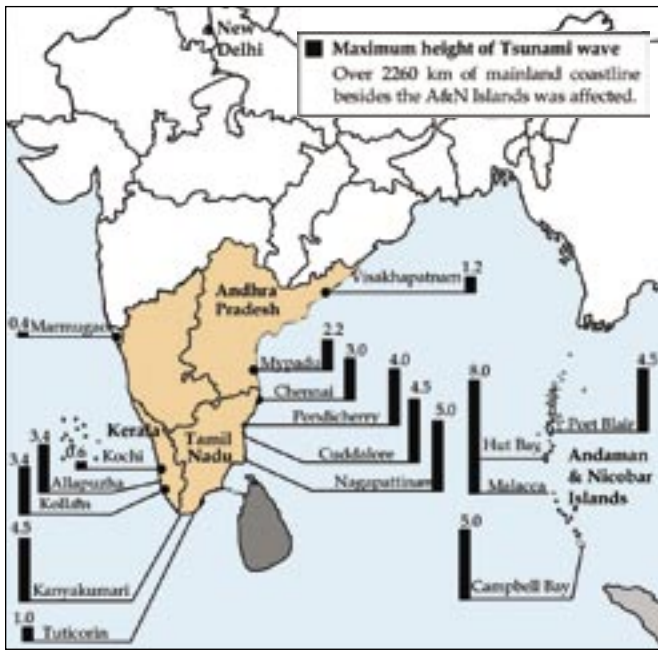
Figure 13 shows variations in run-up height along the coast. It was only 1.6 m in areas in the state of Tamil Nadu that were shielded by the island of Sri Lanka, but was 4-5 m in coastal districts such as Nagapattinam in Tamil Nadu that were directly across from Sumatra. On the western coast, the runup elevations were 4.5 m at Kanyakumari District in Tamil Nadu, and 3.4 m each at Kollam and Ernakulam Districts in Kerala. Some of these amplitudes are based on eyewitness accounts and may be subjective. The time lapse between the waves also varied from about 15 minutes to about 90 minutes.

Figure 13. Maximum tsunami wave heights at various locations. The vertical bar indicates the amplitude of wave height and the number indicates the value in meters.
