### Damage to Housing

### Damage to Reinforced Concrete Buildings

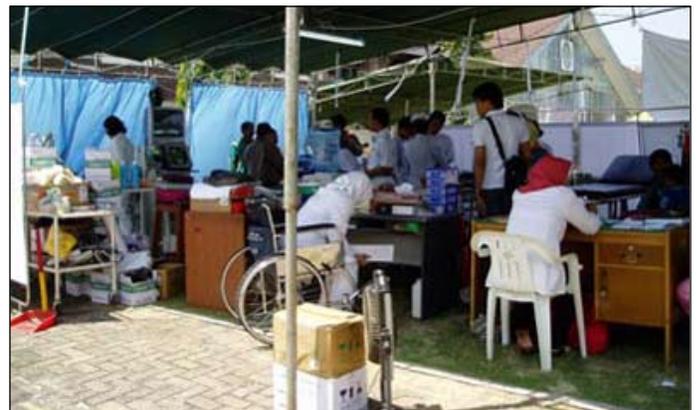
**Hospitals:** Nonstructural damage to hospital buildings in Bengkulu and Padang resulted in cracked masonry in fill walls, chipped plaster, and dust (Figure 21); patients were evacuated to tents (Figure 22). The M. Yunus hospital in Bengkulu was not operational right after the earthquake due to repair work needed. The building code considers masonry infill walls to be nonstructural elements, which has important implications for critical facilities that need to remain operational after earthquakes.

**Figure 21.** Nonstructural damage at M. Yunus hospital in Bengkulu (photo: Boen).
