Learning from Earthquakes

Preliminary Observations on the Bam, Iran, Earthquake of December 26, 2003

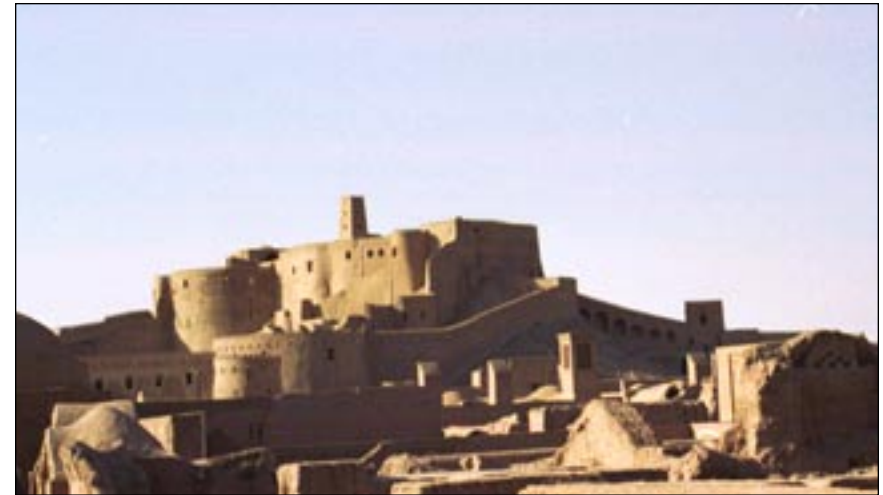
Historic buildings: The historic Arge-Bam Citadel is a complex of one- and two-story buildings surrounded by several tall free-standing walls. Figure 12 shows how it looked before the earthquake. The building's adobe is approximately three feet thick with a layer of straw-reinforced mud cover for rain protection. The free-standing walls are thicker, but have the same construction as the building walls. The roofs consist of domes and cylindrical arches constructed of adobe. These structures have little resistance to earthquake motion so the quake caused widespread and significant collapse of the citadel (Figure 13).

Figure 12 View of the Arge-Bam Citadel before the December 2003 earthquake (www.raphaelk.co.uk/web%20pics/Iran/Iran.htm).

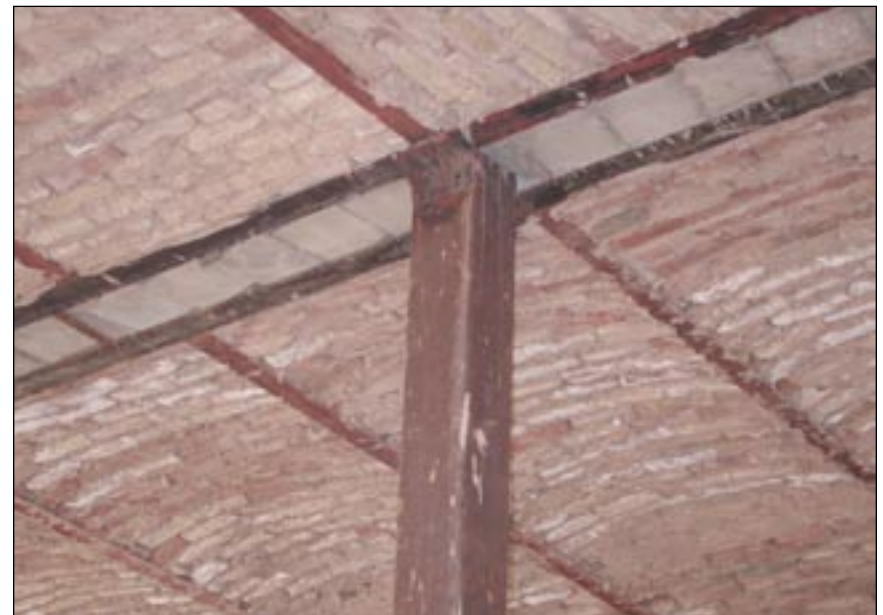
Contemporary construction: The majority of contemporary construction uses steel framing with unreinforced masonry brick infill and/or bearing walls. The floors and roofs in these buildings use a "Jack Arch" system consisting of brick arches spanning between webs of steel I-beams spaced at approximately three feet. The floor beams are supported on steel girders. In many buildings, URM bearing walls at the perimeter provide gravity support. The girder system is typically double "I" or double channel sections passing on both sides of columns and supported by top and bottom angles (Figure 18). This system is also used as moment frame for resisting lateral loads in one direction of the building. In the other direction, URM brick walls (in low-rise buildings) or braced frames (in mid-rise buildings) provide lateral resistance.

Figure 18 Typical steel construction with jack arches.
