Learning from Earthquakes

Preliminary Observations on the Niigata-Chuetsu Oki, Japan, Earthquake of July 16, 2007

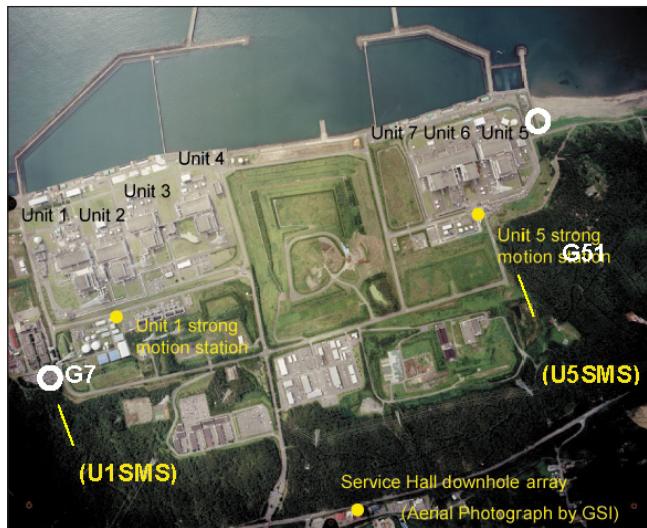
Figure 9: Aerial photograph of Kashiwazaki-Kariwa Nuclear Power Plant area (GSI, 2007).

The Kashiwazaki-Kariwa Nuclear Power Plant: The world's largest nuclear power plant, owned by Tokyo Electric Power Corporation (TEPCO), was located 10-20 km above the southeast-dipping fault plane and 3 km above the northwest-dipping plane (Figure 9). The performance of the facility was mixed. The emergency shutdown system — which had been set to be triggered by horizontal accelerations exceeding 120 gals or vertical accelerations exceeding 100 gals — operated successfully. The main structures did not suffer significant damage. In structures surrounding the primary facilities of the plant, a fire broke out in an electrical transformer. Radiation leaks were caused by spilling of water from spent fuel pools, failure of joints in exhaust pipes, and the falling of drums containing low-radiation nuclear waste.

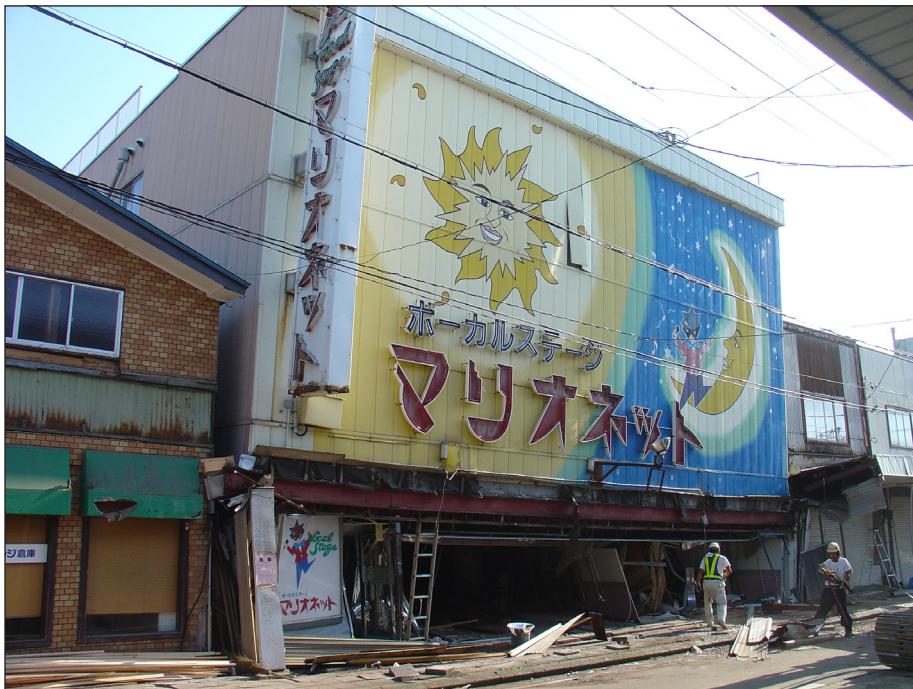
Damage in the other reinforced concrete buildings that were visited ranged from structures with limited cracks not exceeding 1-2.5 mm to several buildings with severe distress (Figures 16 and 17). A three-story building used as a karaoke parlor in downtown Kashiwazaki and a two-story seaside hotel suffered shear failures of columns in its first story. It appears that the spacing of

Figure 17: Karaoke parlor in downtown Kashiwazaki.

ties exceeded the specified maximum of 10 cm, though a maximum spacing of ties of 10 cm has been mandatory in Japan since 1972.
