## Learning from Earthquakes

# Preliminary Observations on the Southern Peru Earthquake of June 23, 2001

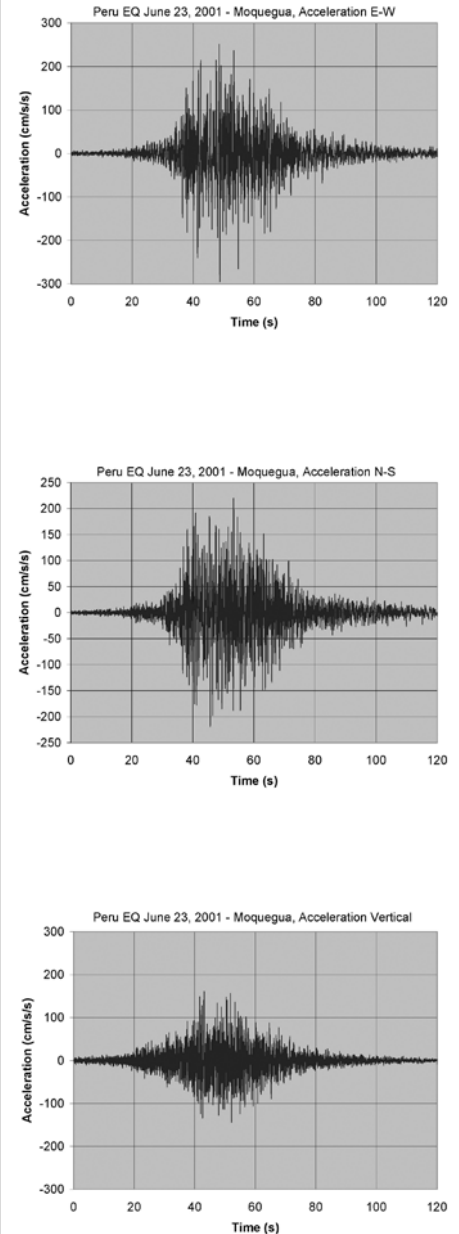
The Universidad Nacional de Ingenieria and the Centro Peruano Japonés de Investigaciones Sísmicas y Mitigación de Desastres (CISMID) recovered and corrected the ground acceleration time histories (Figure 2) and the corresponding acceleration response spectra (Figure 3) from the Moquegua instrument recording in east-west, north-south, and vertical directions. PGA values were .295, .220 and .160g in the east-west, north-south and up directions, respectively. Larger accelerations were observed in the approximately normal-to-fault direction comparatively to the parallel-to-fault-direction. The ratio of peak-vertical to peak-horizontal acceleration was 54%, slightly larger than that in previous Peruvian events.

**Figure 2** Acceleration time histories of the east-west, north-south, and vertical components of the corrected ground-motion recording in the city of Moquegua. (The Universidad Nacional de Ingenieria and the Centro Peruano Japonés de Investigaciones Sísmicas y Mitigación de Desastres [CISMID]).

**Moquegua:** Moquegua was the city hardest-hit by this earthquake. The records (see Figure 2) indicate that the peak ground acceleration was 0.30g and the response spectra had a plateau at approximately 0.65g-0.70g in the range from about 0.15 seconds to 1 second (see Figure 3). The damage in Moquegua is mainly to old and new adobe houses. Numerous adobe buildings collapsed in the downtown area, and many others sustained heavy damage to the point of being almost unstable. In the area of San Francisco, the hillside was nearly totaled due to collapse of new adobe houses. One school had a partial collapse due to short columns (Figures 9 and 10). The cathedral lost one of its vaults, and the Church of Belen sustained damage to its tower and walls.

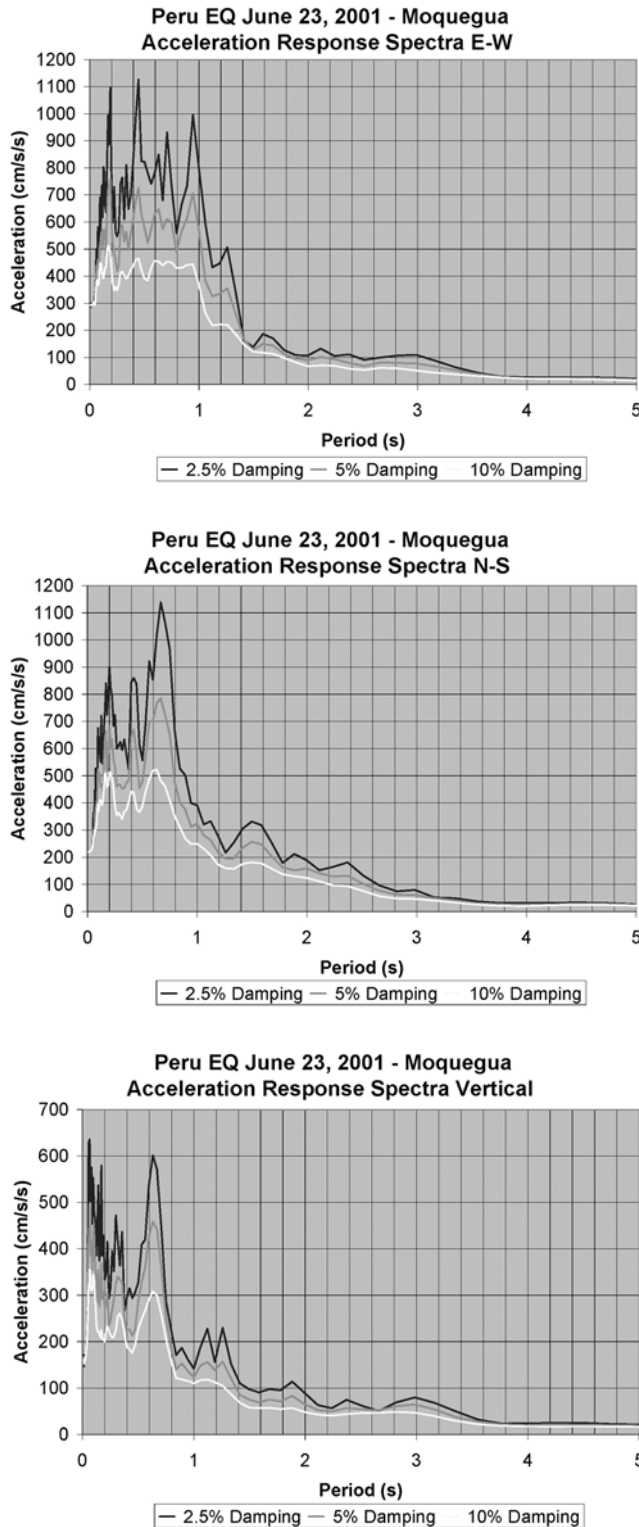
**Figure 3** Acceleration response spectra obtained from the corrected ground motion along the east-west, north-south, and vertical components of the recording in the city of Moquegua. (The Universidad Nacional de Ingenieria and the Centro Peruano Japonés de Investigaciones Sísmicas y Mitigación de Desastres [CISMID])

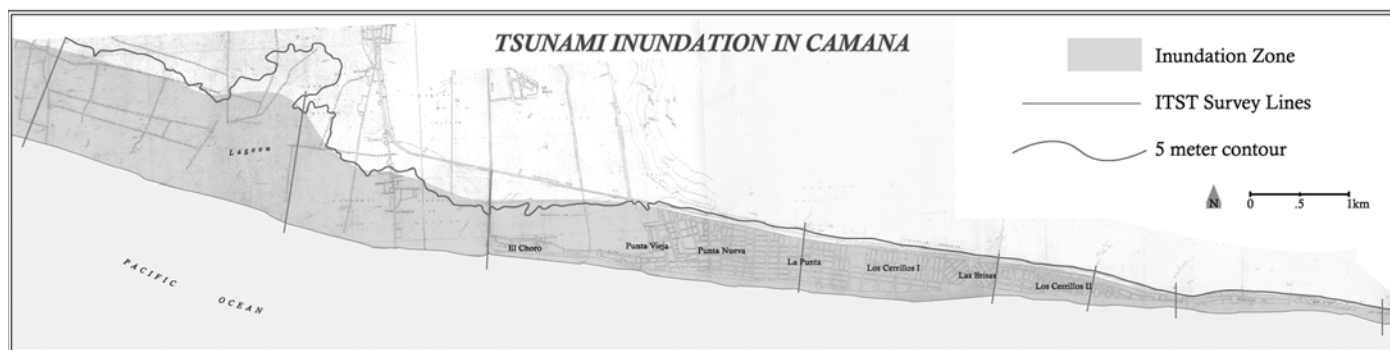
significant than the tsunami effects. The largest waves (5-8 m) and deepest penetration (1-1.2 km) (Figure 7) produced by this tsunami coincided with the most-developed beach resort area along the southern Peruvian coast. La Punta and the adjacent resort communities have many summer homes, occupied by about 5000 residents during the peak summer season.

**Figure 7** Tsunami inundation and ITST survey lines in the Camana area. (Base map from the Planning Department of the Municipalidad Provincial de Camana, inundation by L. Dengler based on ITST data. Map compiled by Verena Kellner, Humboldt State University.)
