Learning from Earthquakes

Preliminary Observations on the Tecomán, Colima, Mexico, Earthquake of January 21, 2003

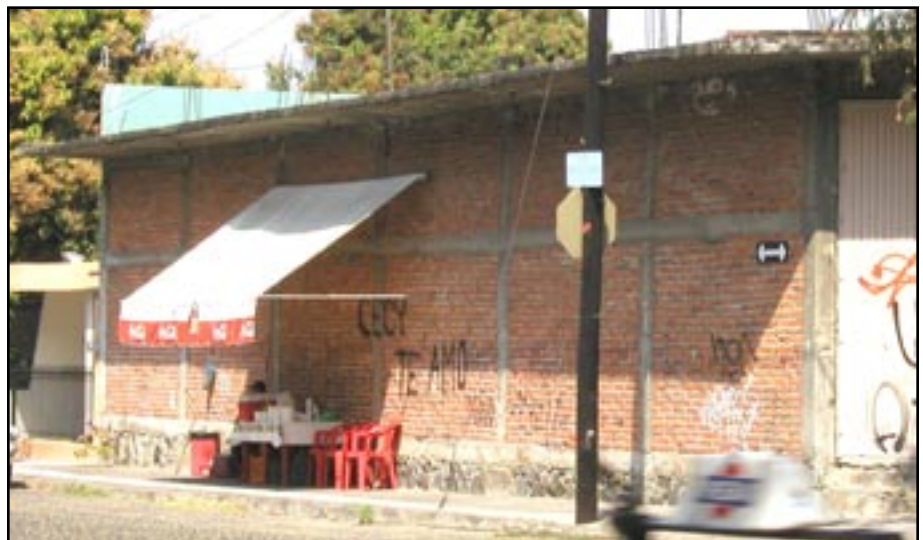
Confined Masonry — As commonly used in Latin America, confined masonry consists of unreinforced masonry panels, typically measuring 1-2 m in each direction, and joined by horizontal and vertical reinforced concrete elements that are poured in place after the masonry is laid (figure 11). Such confining elements generally are roughly square in

Figure 11 - A typical confined masonry structure, which performed well in the Tecomán earthquake.
